**Eurasian water milfoil (*Myriophyllum spicatum*)
Pre/Post Herbicide and Fall Bed Mapping Surveys
Lower Vermillion Lake – WBIC: 2098200
Barron County, Wisconsin**

Endangered Resource Services, LLC
Matthew S. Berg, Research Biologist
St. Croix Falls, Wisconsin
May 18 and September 30, 2012

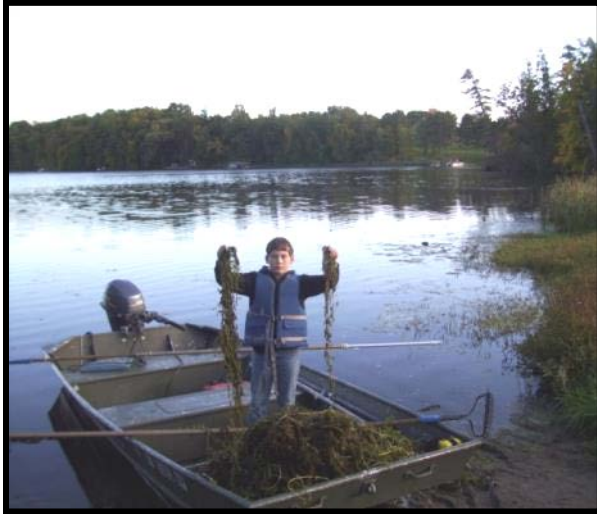
EWM raked out of the west bay of Lower Vermillion Lake

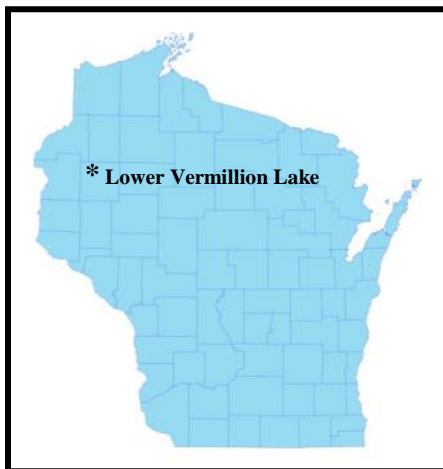
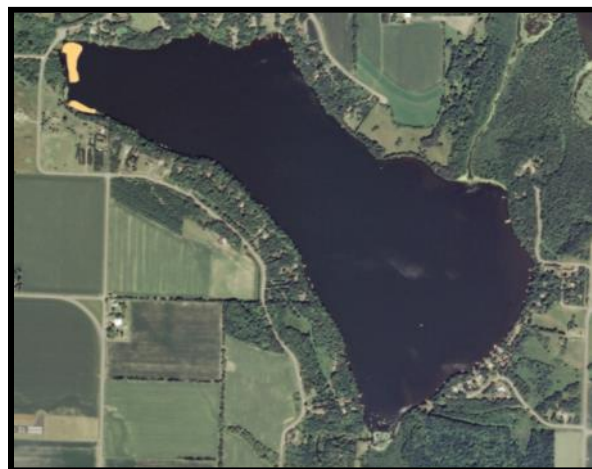
Proposed 2012 EWM treatment areas

In 2008, the Wisconsin Department of Natural Resources (WDNR) confirmed the presence of Eurasian water milfoil (EWM) (*Myriophyllum spicatum*) in Lower Vermillion Lake, and the Vermillion Lakes Association (VLA) has been actively managing to control this invasive exotic species ever since. Following the 2011 fall EWM bed mapping survey that found EWM in scattered patches throughout the northwest bay near the boat landing, the VLA, under the direction of Short, Elliot, Hendrickson, Inc. (SEH) and in accordance with the WDNR approved Vermillion Lakes Aquatic Plant Management Plan, decided to chemically treat two areas in 2012. Combined, they totaled 1.76 acres or 0.8% of the lake's surface area (Figure 1).
