# Eurasian water milfoil (*Myriophyllum spicatum*) Pre/Post Herbicide and Fall Bed Mapping Surveys Lower Vermillion Lake – WBIC: 2098200 Barron County, Wisconsin

Survey Conducted by and Report Prepared by:

Endangered Resource Services, LLC

June 1, August 1, and October 11, 2014

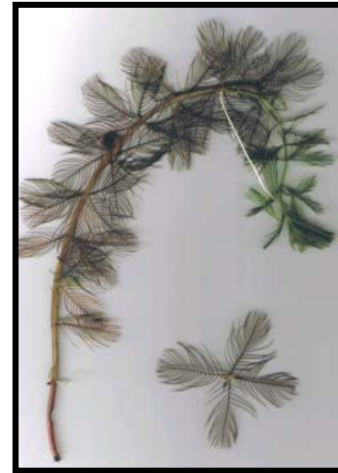
2014 EWM Posttreatment Distribution Lower Vermillion Lake

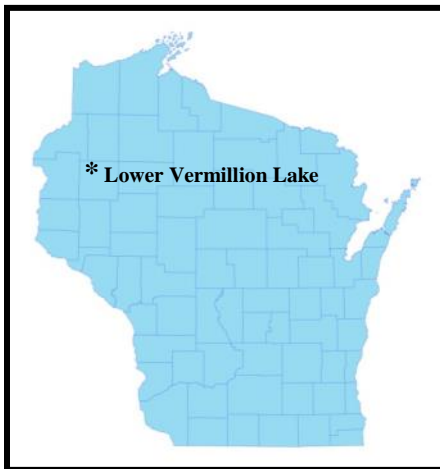
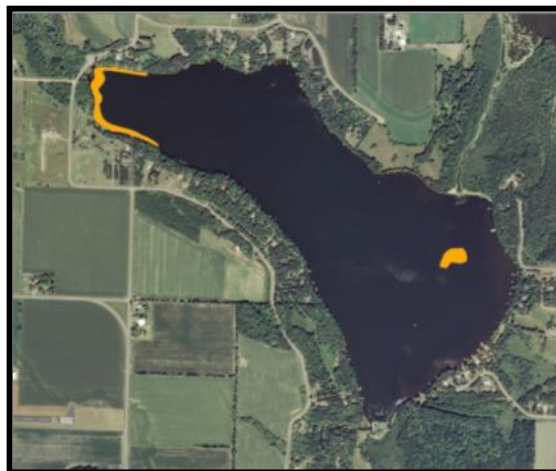
2014 EWM treatment areas

In 2008, the Wisconsin Department of Natural Resources (WDNR) confirmed the presence of Eurasian water milfoil (EWM) (*Myriophyllum spicatum*) in Lower Vermillion Lake, and the Vermillion Lakes Association (VLA) has been actively working to control this invasive exotic species ever since. Following the 2013 fall EWM bed mapping survey that found a few EWM towers in the eastern bay and scattered patches throughout the northwest bay near the boat landing, the VLA, under the direction of Lake Education and Planning Services LLC (LEAPS) and in accordance with the WDNR approved Vermillion Lakes Aquatic Plant Management Plan, decided to chemically treat two areas in 2014. Combined, they totaled 4.34 acres or 2.0% of the lake's total surface area (Figure 1).

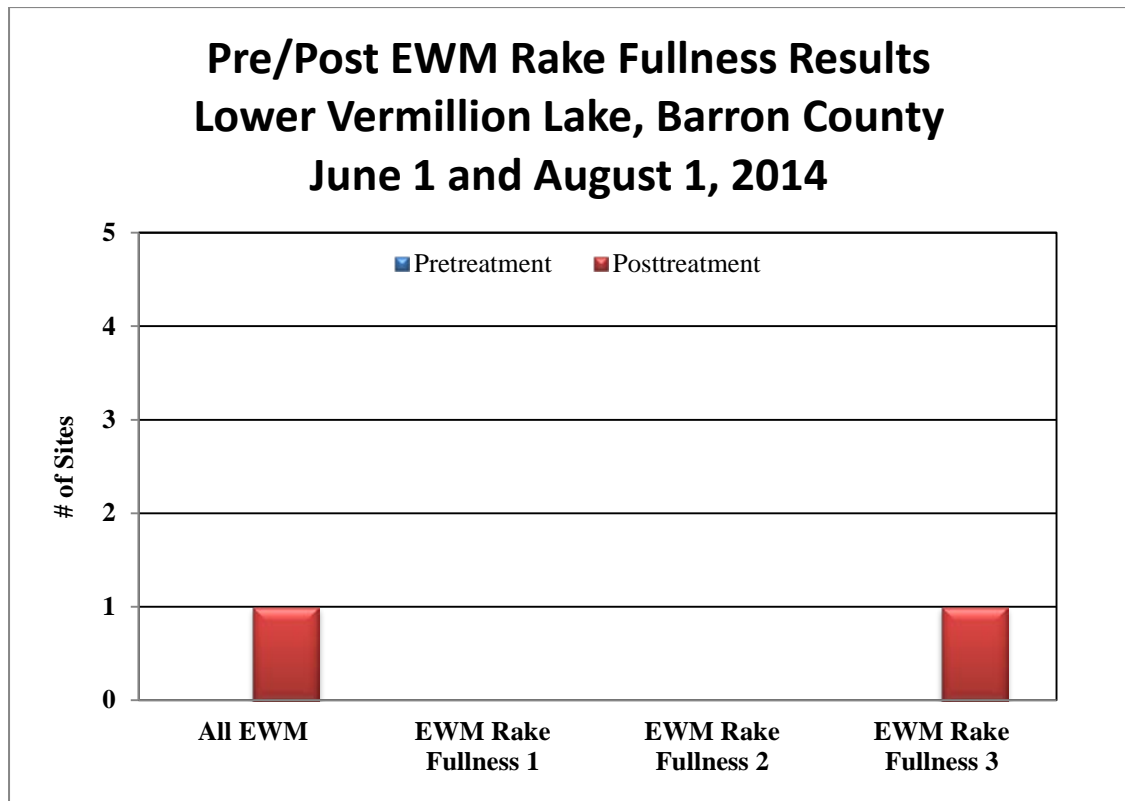
**Figure 8: Pre/Post Changes in EWM Rake Fullness**

We didn't find EWM in the rake at any survey points during the pretreatment survey. Despite this, we did note plants as visuals at two points and also found them inter-point in both treatment areas. During the posttreatment survey, we located EWM at a single point in the eastern bay, and it rated a 3 as the point was within a small dense bed. We again recorded EWM as a visual at two points (Figure 7) (Appendix V). Our findings suggested there was no significant change in EWM within the treatment areas (Figure 8).

Significant differences = \*  $p < .05$ , \*\*  $p < .01$ , \*\*\*  $p < .005$
