Aquatic Plant Survey Report

Round and Little Round Lakes

Sawyer County, Wisconsin, 2014

Project initiated by:
Round Lake Property Owners Association

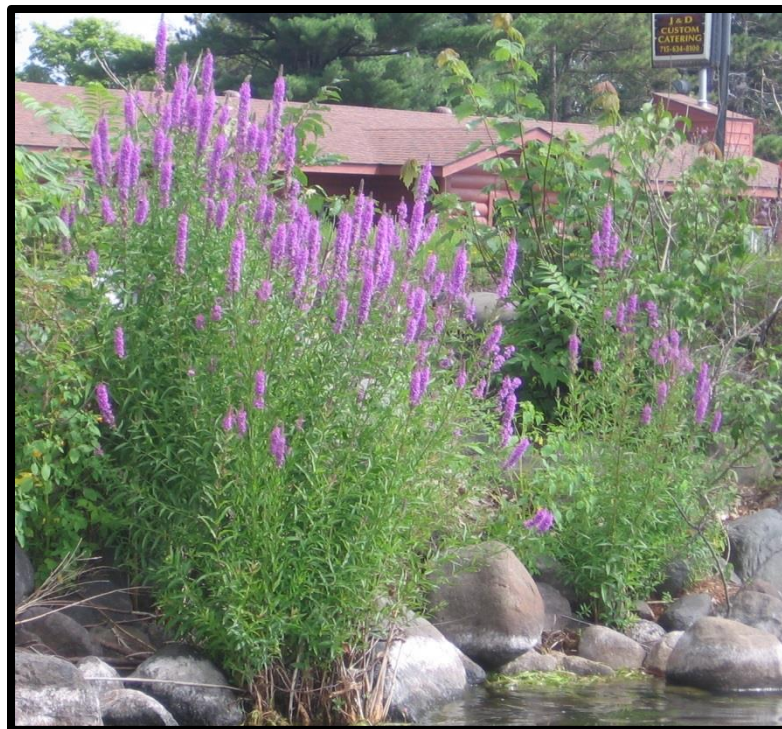
Figure 13 - Purple Loosestrife on Little Round Lake

Purple loosestrife was found at one point on Little Round Lake near County Highway B, just west of the bridge (Figure 13). The plant was found as part of the boat survey, therefore it was greater than 6 feet from any survey point but it was closest to survey point 303. The occurrence was not very substantial and could be controlled manually by cutting the plant a couple times each growing season before any flowering occurs, thereby not allowing seeds to form. There may already be a bank of seeds in the soil, so continued monitoring of the site after any removal will be required. Keeping this purple loosestrife occurrence from spreading is important because there are areas in Little Round Lake that would be ideal for purple loosestrife to infest and possibly outcompete native species (i.e., the two bays along the southern shore that are quite wetland-like with shallow water, mucky sediment, and dense emergent and floating vegetation).

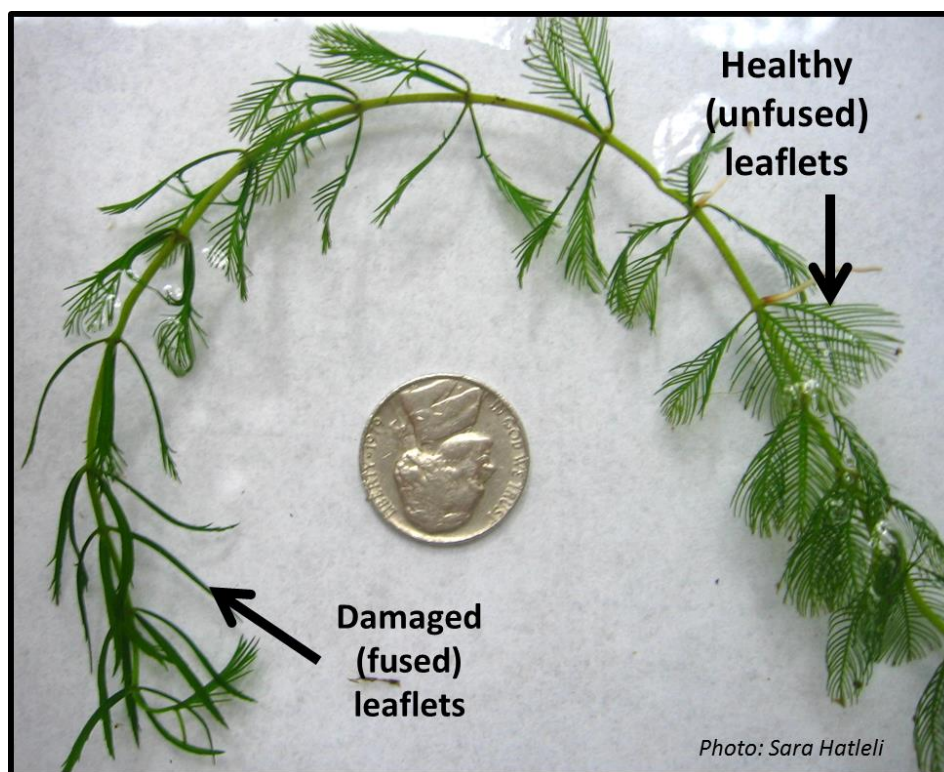
During the 2005 aquatic plant survey, EWM was documented at 3 sites while in 2014 it was found at 12 survey sites with a rake fullness value of 1 and was visually observed near an additional three points (Figure 15). The relative frequency of EWM is low (1.21%, Table 5) when compared to the relative frequency of native species. At four sites, the EWM showed signs of damage from chemical treatment such as fused leaflets, especially toward the top of the plant where new growth occurs (Figure 14). More detailed surveying of EWM in 2014 was completed by a licensed herbicide applicator to determine the best areas for chemical treatment. Detailed information regarding management are found in the updated Aquatic Plant Management Plan for Round and Little Round Lakes.

Figure 14 - Damaged EWM from Little Round Lake
