SOUTHEASTERN WISCONSIN REGIONAL PLANNING COMMISSION

SEWRPC Staff Memorandum

WATER QUALITY SAMPLE EVALUATION FOR SILVER LAKE, WAUKESHA COUNTY

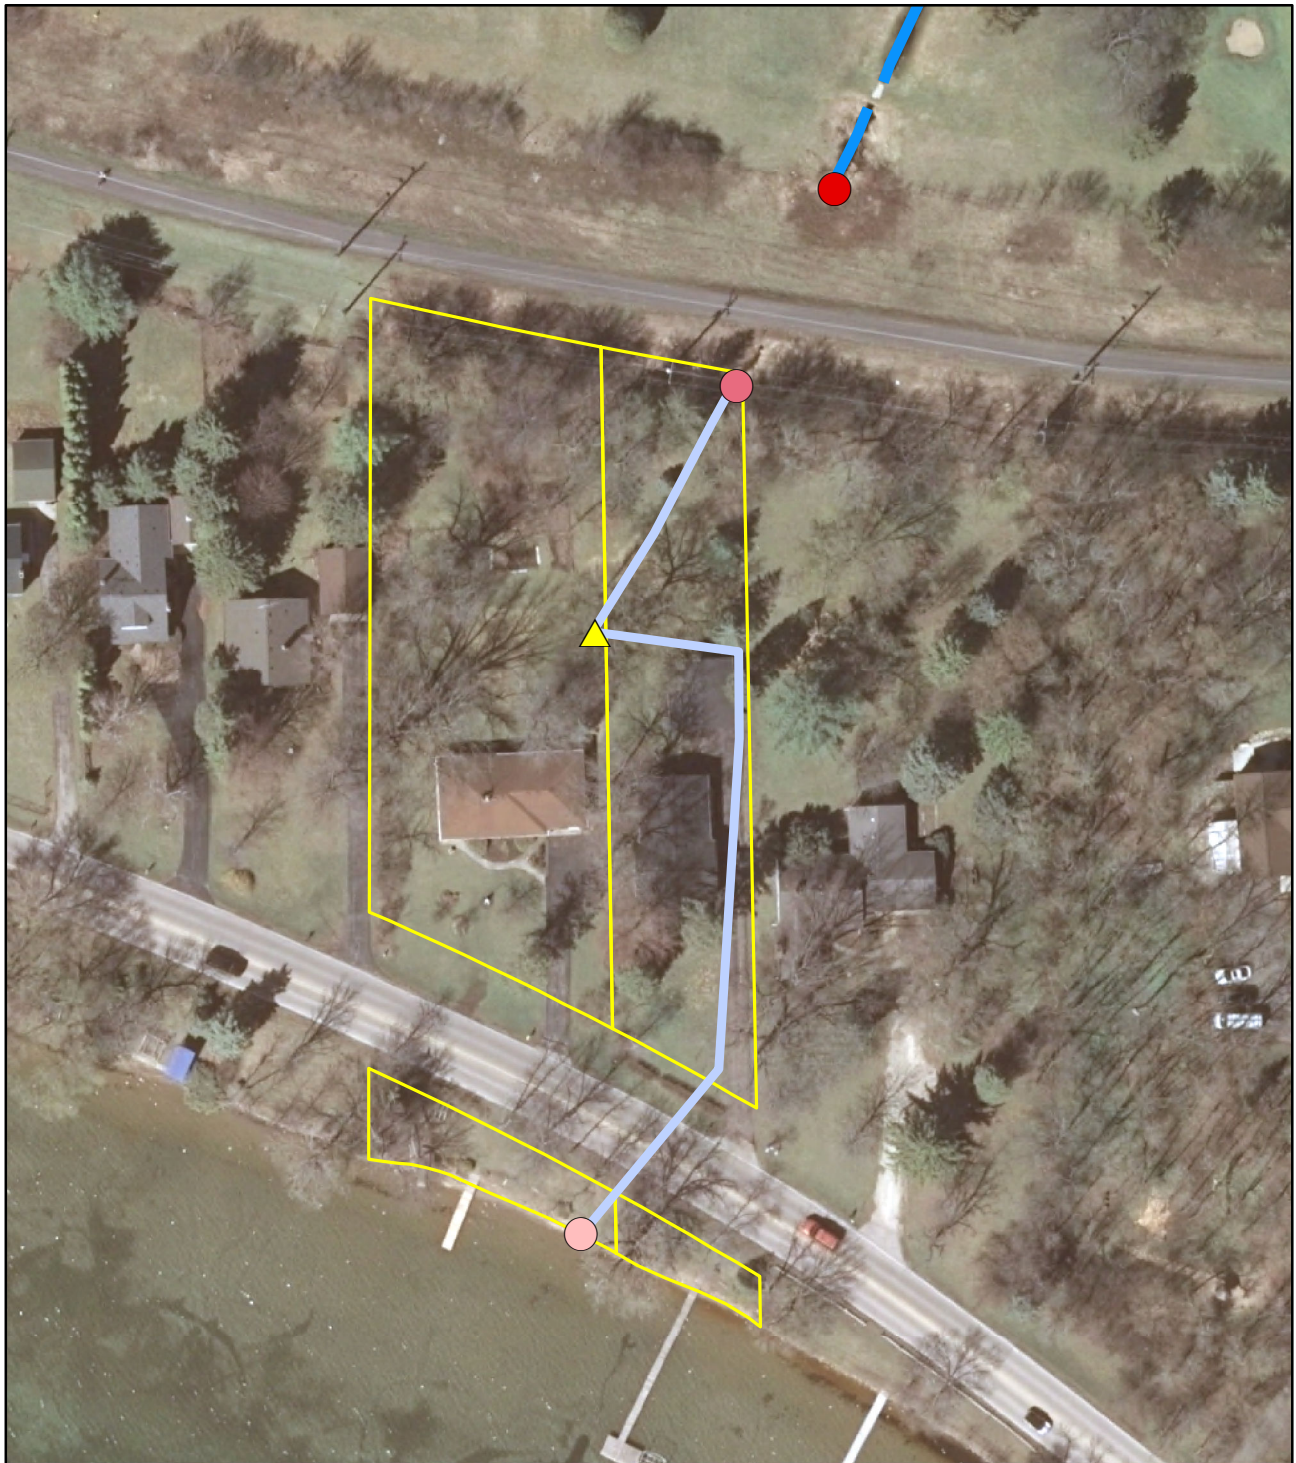
LOCATION OF STORMWATER DRAINAGE PIPES COMING FROM THE PAGANICIA GOLF COURSE

| STORMWATER INLET | STORMWATER DRAINAGE PIPE |

1. The Paganica Golf Course tributary (see Map 1; north end of the Lake)
There has historically been extensive controversy surrounding the water draining into the Lake from the Paganica Golf Course located within the northern portion of the watershed.²⁷ This controversy spurred a bio-assessment completed by WDNR in 1974 which found no evidence of organisms that could harm humans in the golf course discharge.²⁸ Despite these results, the runoff coming from the golf course has continued to be an issue of concern primarily because the runoff water is such a drastically different color than the Lake water itself. However, as discussed in the “Color” subsection earlier in this memorandum, color does not always equate to pollution. In fact, a brown color in the water is generally just an indication of the amount of organic material the water has come into contact with. However, since golf courses may be sources of pollution, it was still deemed necessary to investigate the water coming from this site. Consequently, this area was deemed the primary “area of concern” in this study.

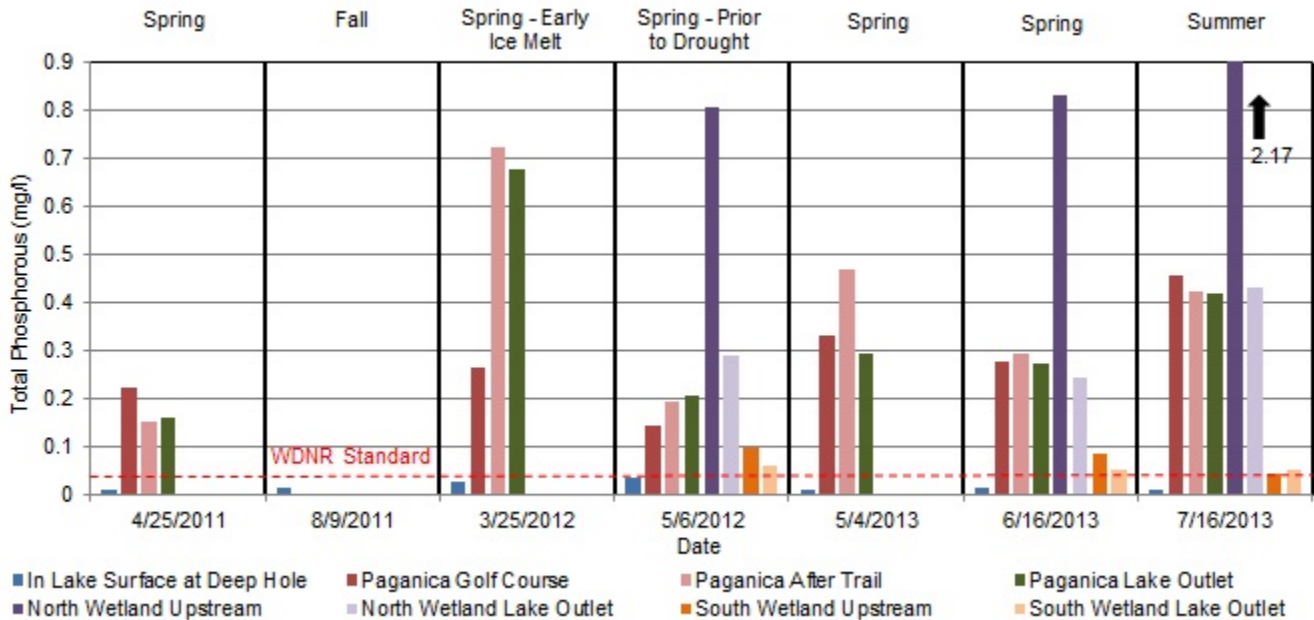
Figure 11

It is important to note that, though phosphorous concentrations are high at all of the sites, they were particularly high in the North Wetland upstream site, potentially indicating an unexpected source of contamination may be coming from the contributing residential and commercial property north of the site (see Appendix A “North Wetland Upstream Site”). Though it is possible that natural leaf matter from the wooded area located adjacent to these properties is contributing to phosphorus loads, these sources should be investigated to ensure phosphorous containing fertilizers are not being used. At this site and the south wetland site, it should also be noted that the sample concentrations downstream from the wetlands were much lower than upstream from the wetlands, indicating that the wetlands themselves, as well as the detention basin located at the south wetland site, are efficiently removing phosphorus pollution. Consequently, the following actions should be considered a priority: 1) preserving of these wetlands and preventing invasion of invasive species (which limit wetland effectiveness), such as purple loosestrife (see Figure 12); and 2) ensuring the continued maintenance of the detention basin located east of the “South Wetland Lake Outlet” site.

Another interesting result is that, though still high, phosphorus concentrations coming directly out of the golf course are generally lower than the phosphorus levels found just across the trail, i.e., in most instances the levels increase at the site downstream from the golf course. In March 2012 phosphorus levels almost doubled once the water left the golf course. This pattern indicates there is a significant source of phosphorus contributing to the Paganica discharge pipe aside from the golf course. Considering this source seemed to increase during the spring runoff, it is possible this other source may be pet waste accumulation from the winter which is draining towards the Lake from the residential area and the recreational trail to the west of the site. This would need to be investigated further.

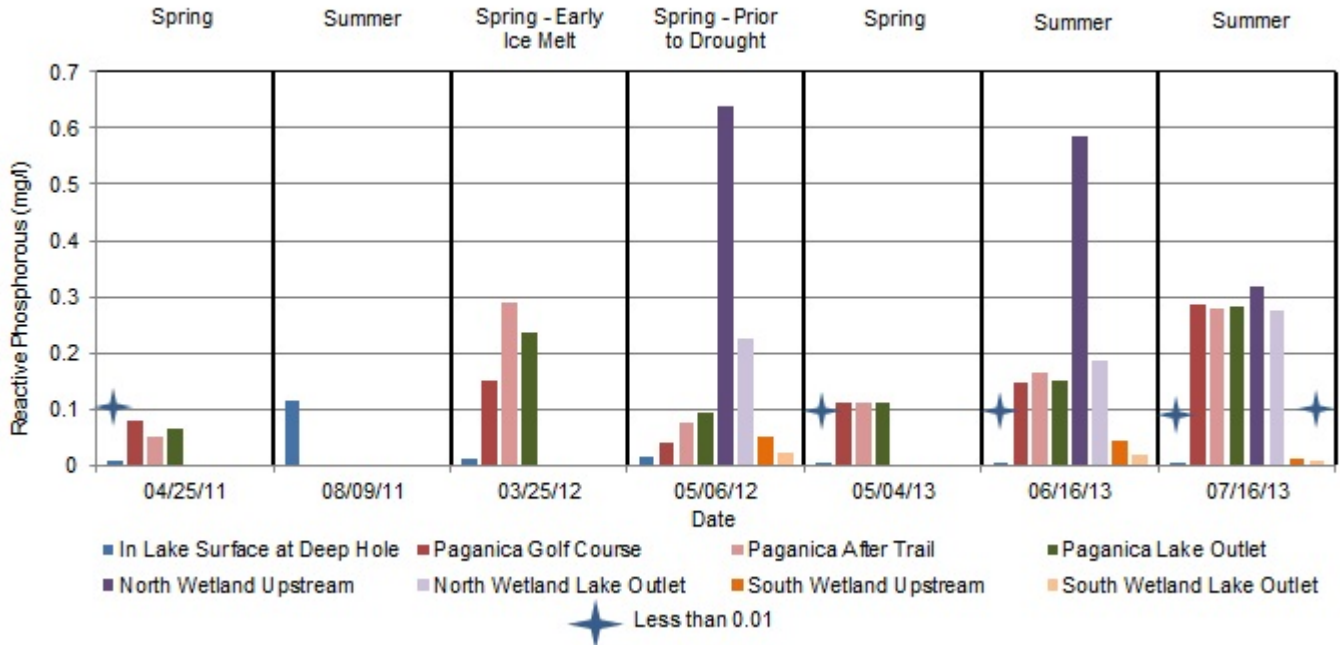
Figure 13

The highest reactive phosphorus levels were found in the North Wetland Upstream site, further emphasizing the presence of an unknown source of phosphorus. However, for the two pairs of wetland sampling sites (north wetland upstream and north wetland lake outlet; south wetland upstream and south wetland lake outlet), the highest concentrations were recorded for

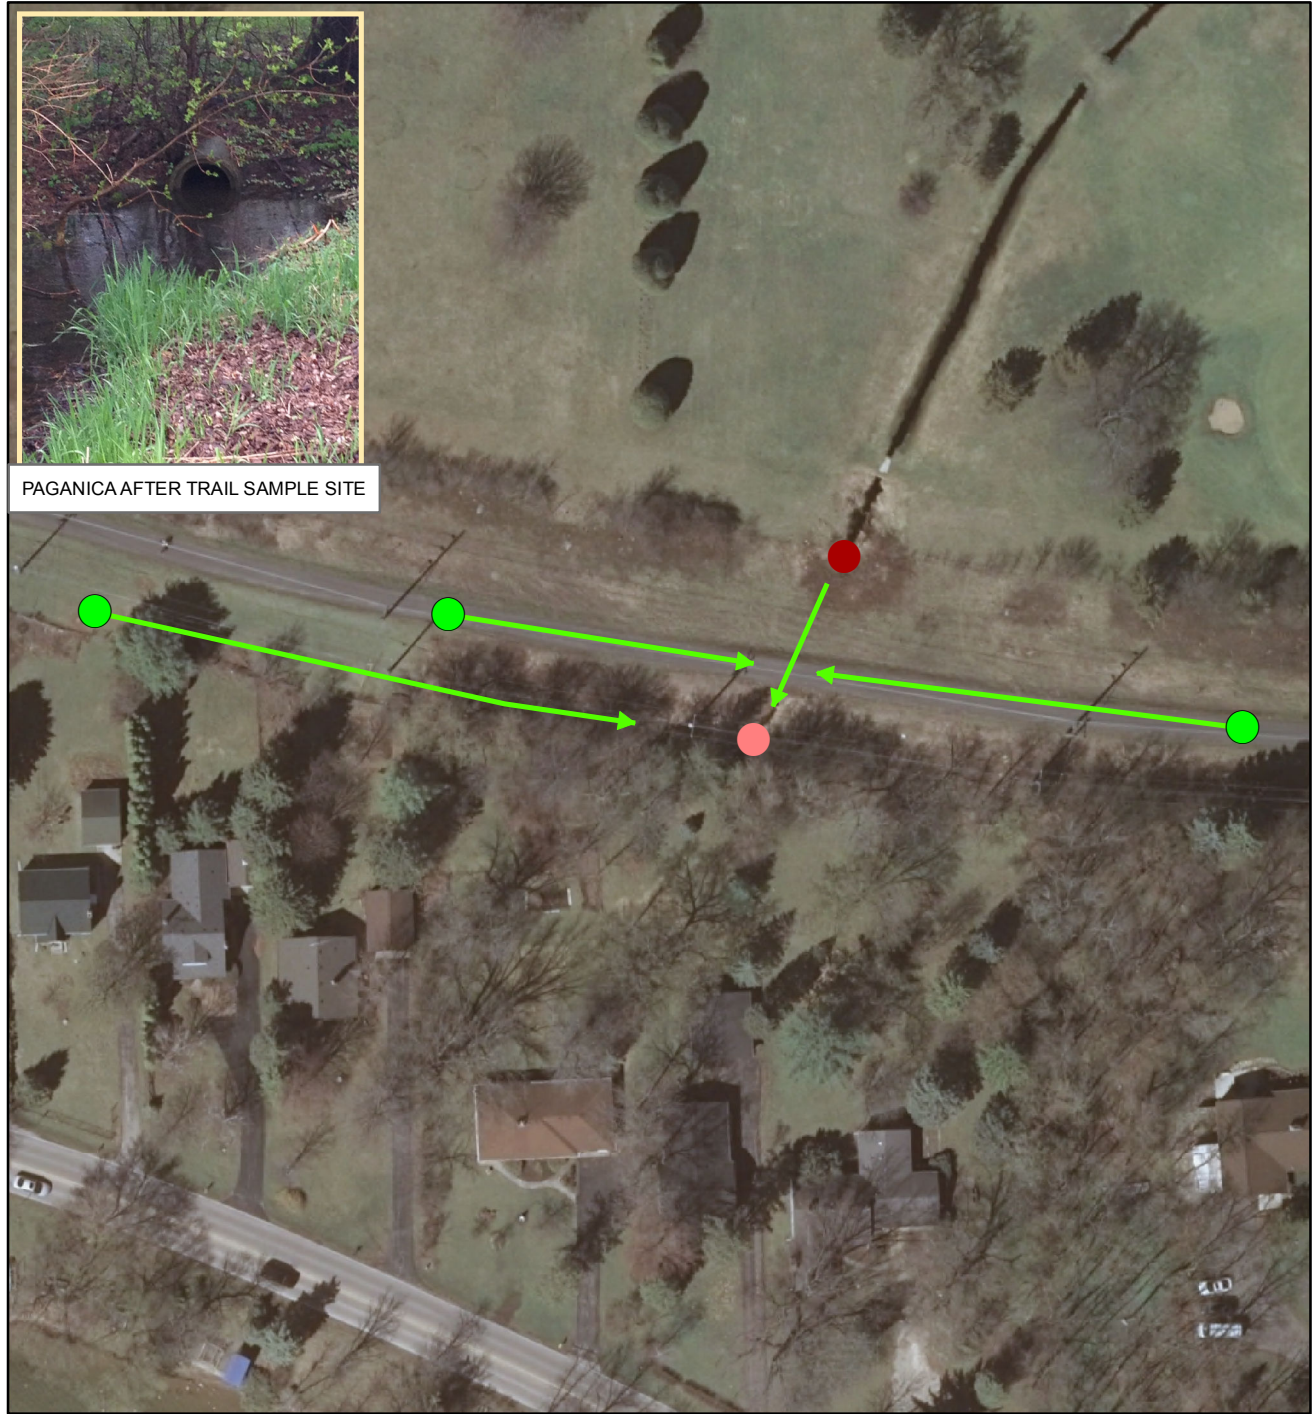
Map A-2

- DRAINAGE SOURCE
- DRAINAGE FLOW
- PAGANICA AFTER TRAIL
- PAGANICA GOLF COURSE

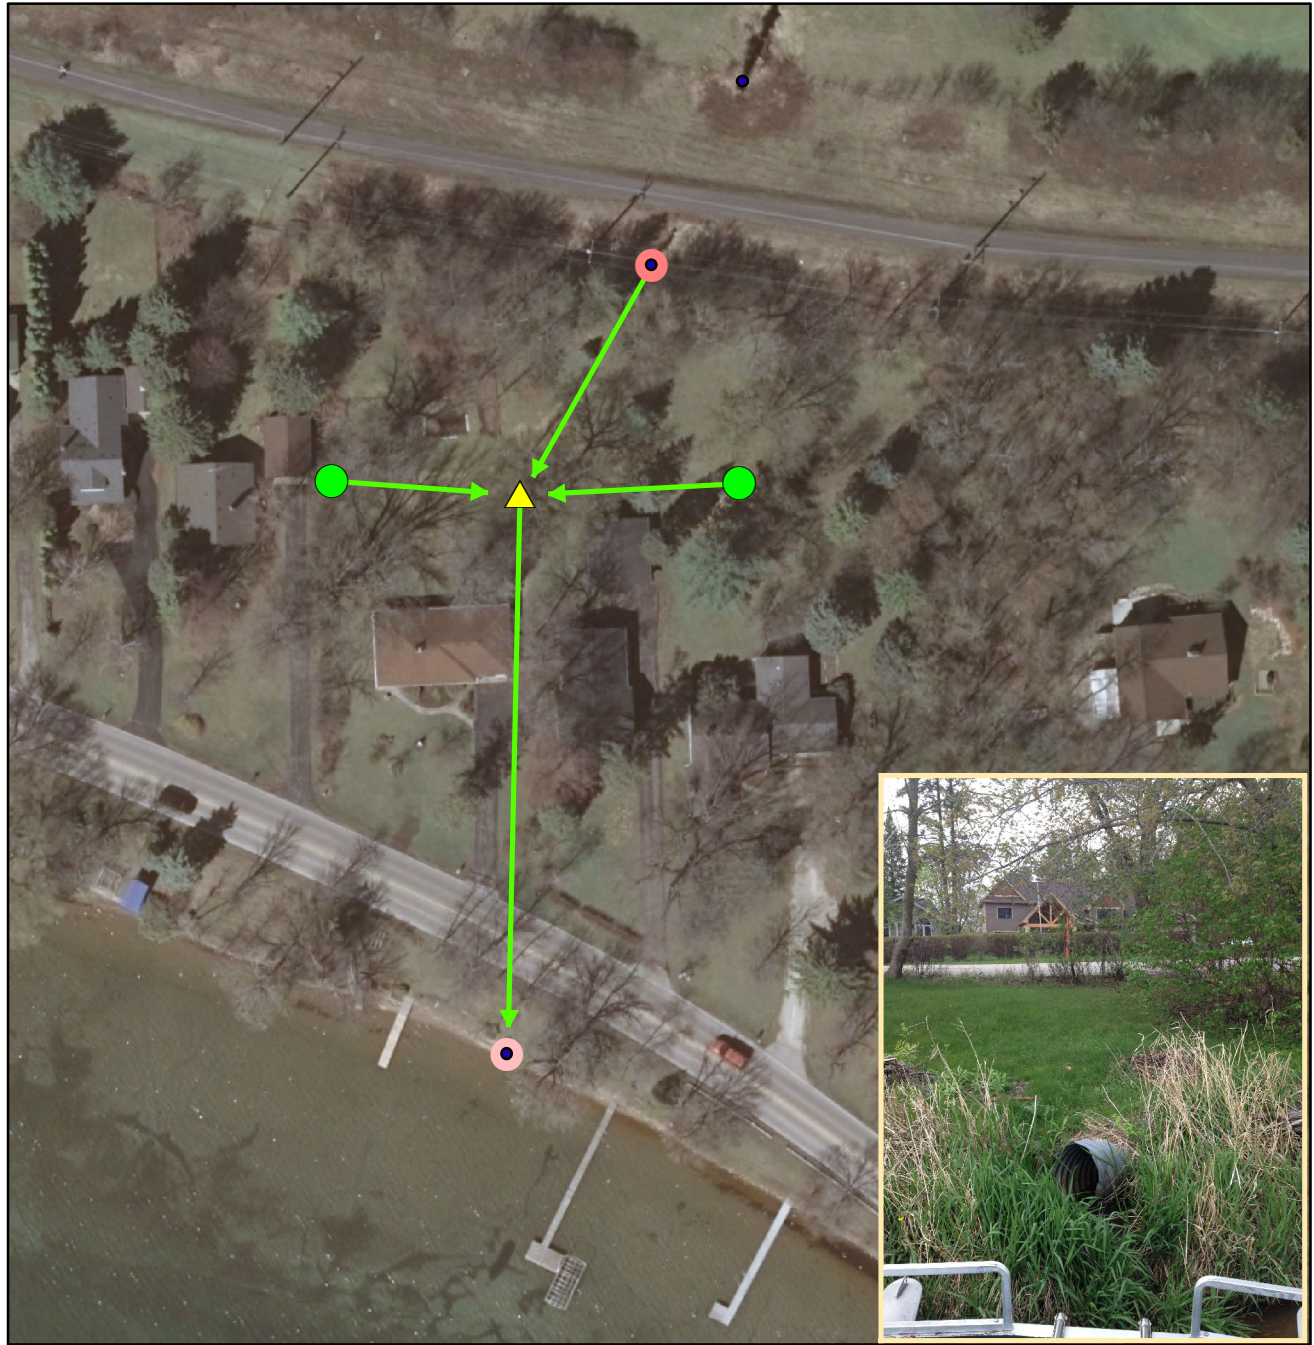
Map A-3

- DRAINAGE SOURCE
- PAGANICA AFTER TRAIL SAMPLING POINT
- ➔ DRAINAGE FLOW
- PAGANICA LAKE OUTLET SAMPLING POINT

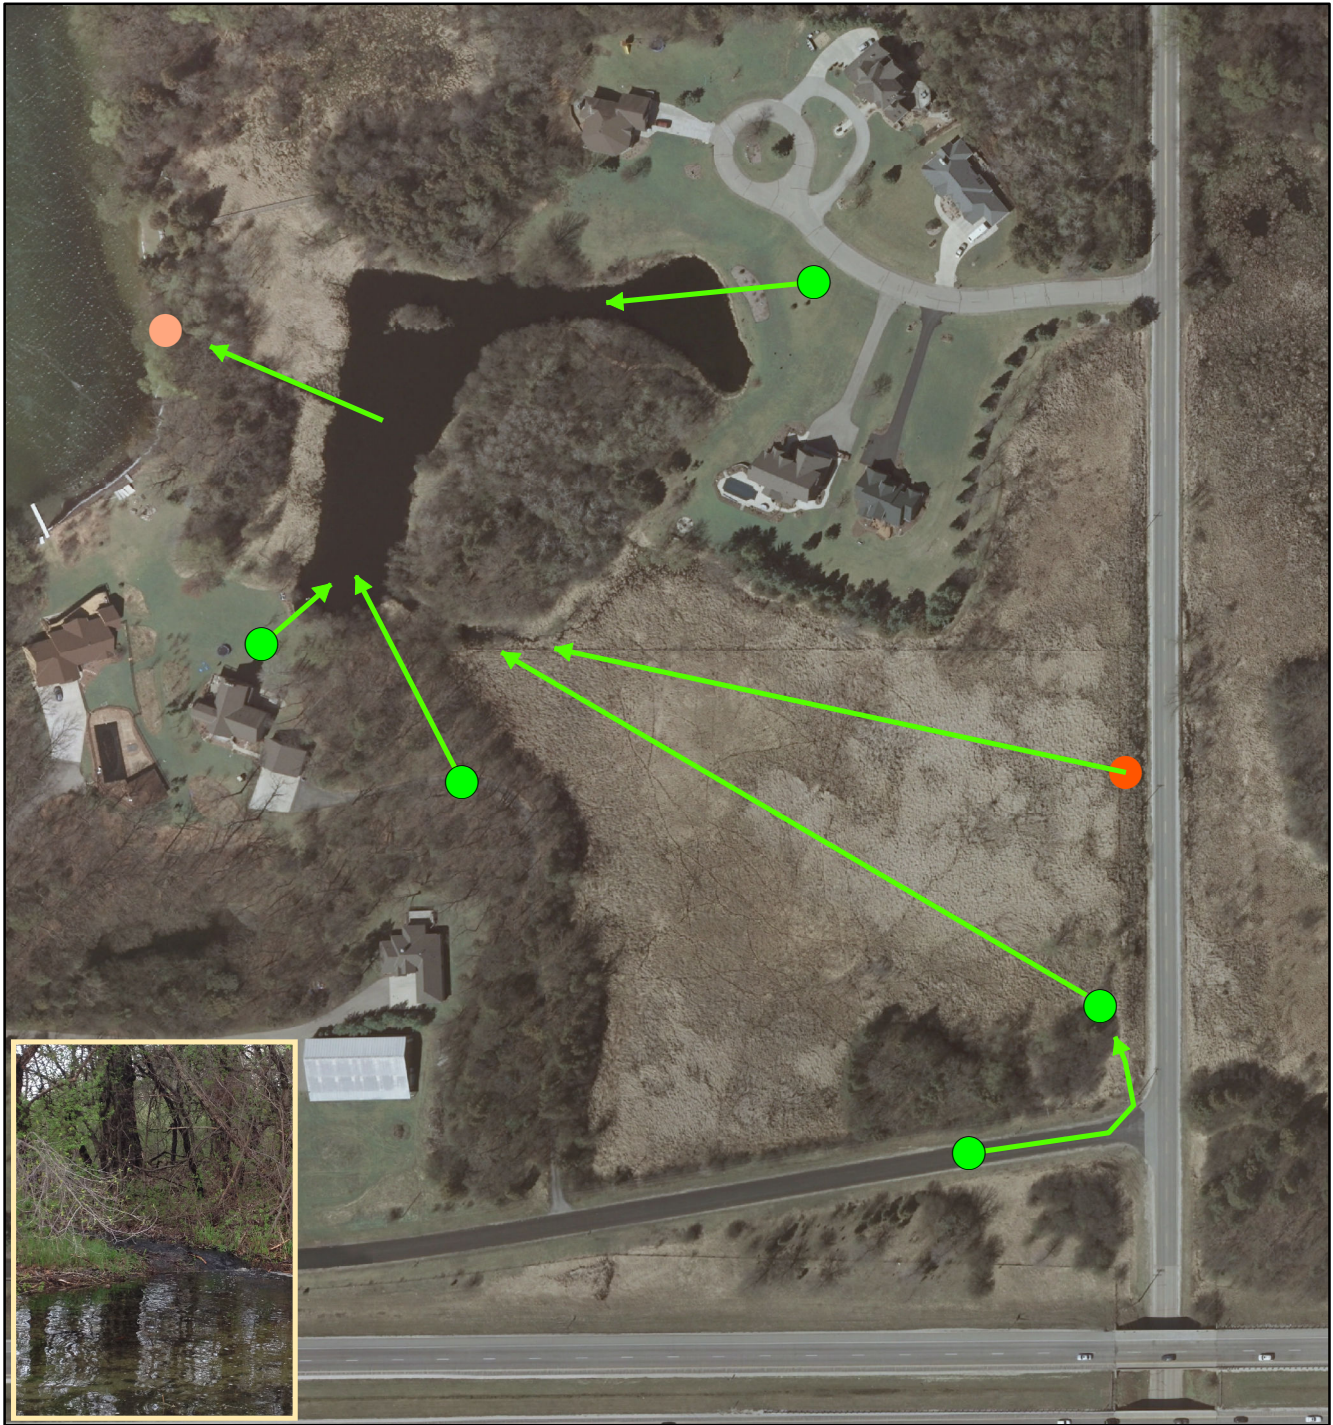
Map A-7

- DRAINAGE SOURCE
- SOUTH WETLAND LAKE OUTLET SAMPLING SITE
- ➔ DRAINAGE FLOW
- SOUTH WETLAND LAKE UPSTREAM SAMPLING SITE
