NESHKORO TRIBUTARY TO WHITE RIVER

STREAM CLASSIFICATION

NOVEMBER 1990

WISCONSIN DEPARTMENT OF NATURAL RESOURCES

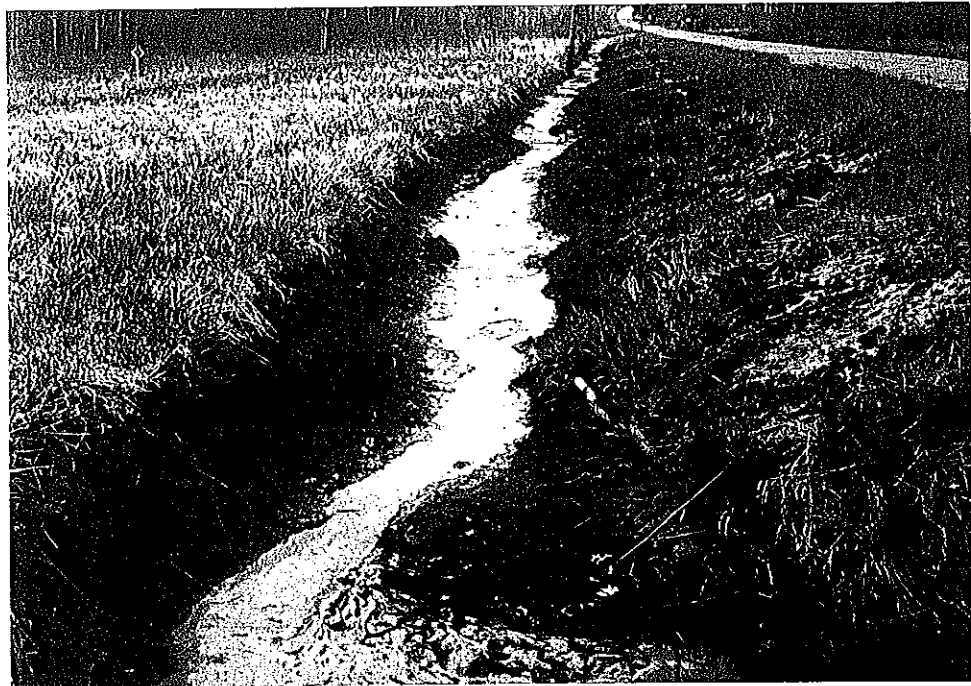
RECENTLY EXCAVATED LATERAL  
DITCH CONNECTING TO TRIB.

Sludge Deposits	1			
Silt and Sediment			3	SOME LATERAL DITCHING ON TOWN RD IS CAUSING SEDIMENT TO ENTER STREAM
Channel Ditching	1			
Down/Up Stream Impoundment	1			
Low Flows			3	INTERMITTANT FLOW IS QUESTIONABLE (SHOWN ON USGS AS INTERMITTANT)
Wetlands			3
