**A Wisconsin Lake Management
Planning Grant Program
Final Report**

A LAKE MANAGEMENT PLAN FOR

**TOWN OF PALMYRA
JEFFERSON COUNTY, WISCONSIN**

**Developed by the
Board of Commissioners
Blue Spring Lake Management District**

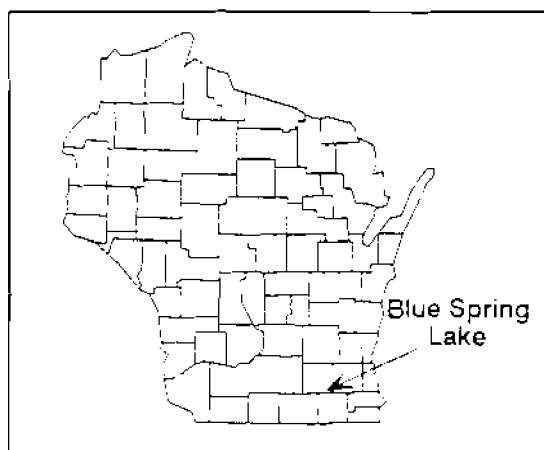
Figure 4.1

LOCATION OF BLUE SPRING LAKE

Blue Spring Lake is located in the southeast corner of Jefferson County, Wisconsin, Figure 4.1. The lake is situated at the base of the Kettle

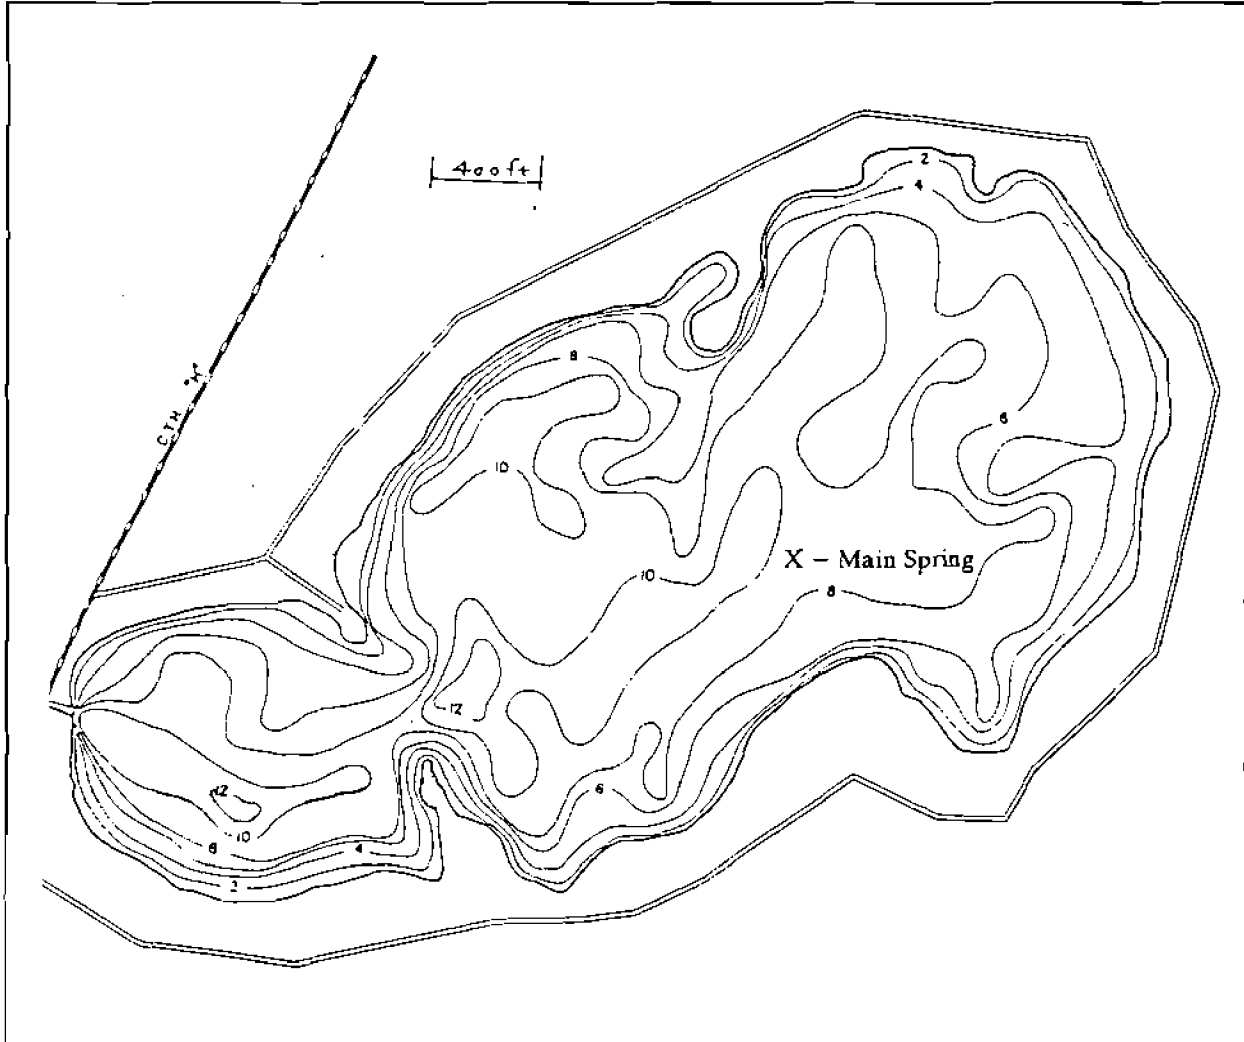
Figure 4.3

BATHYMETRIC MAP

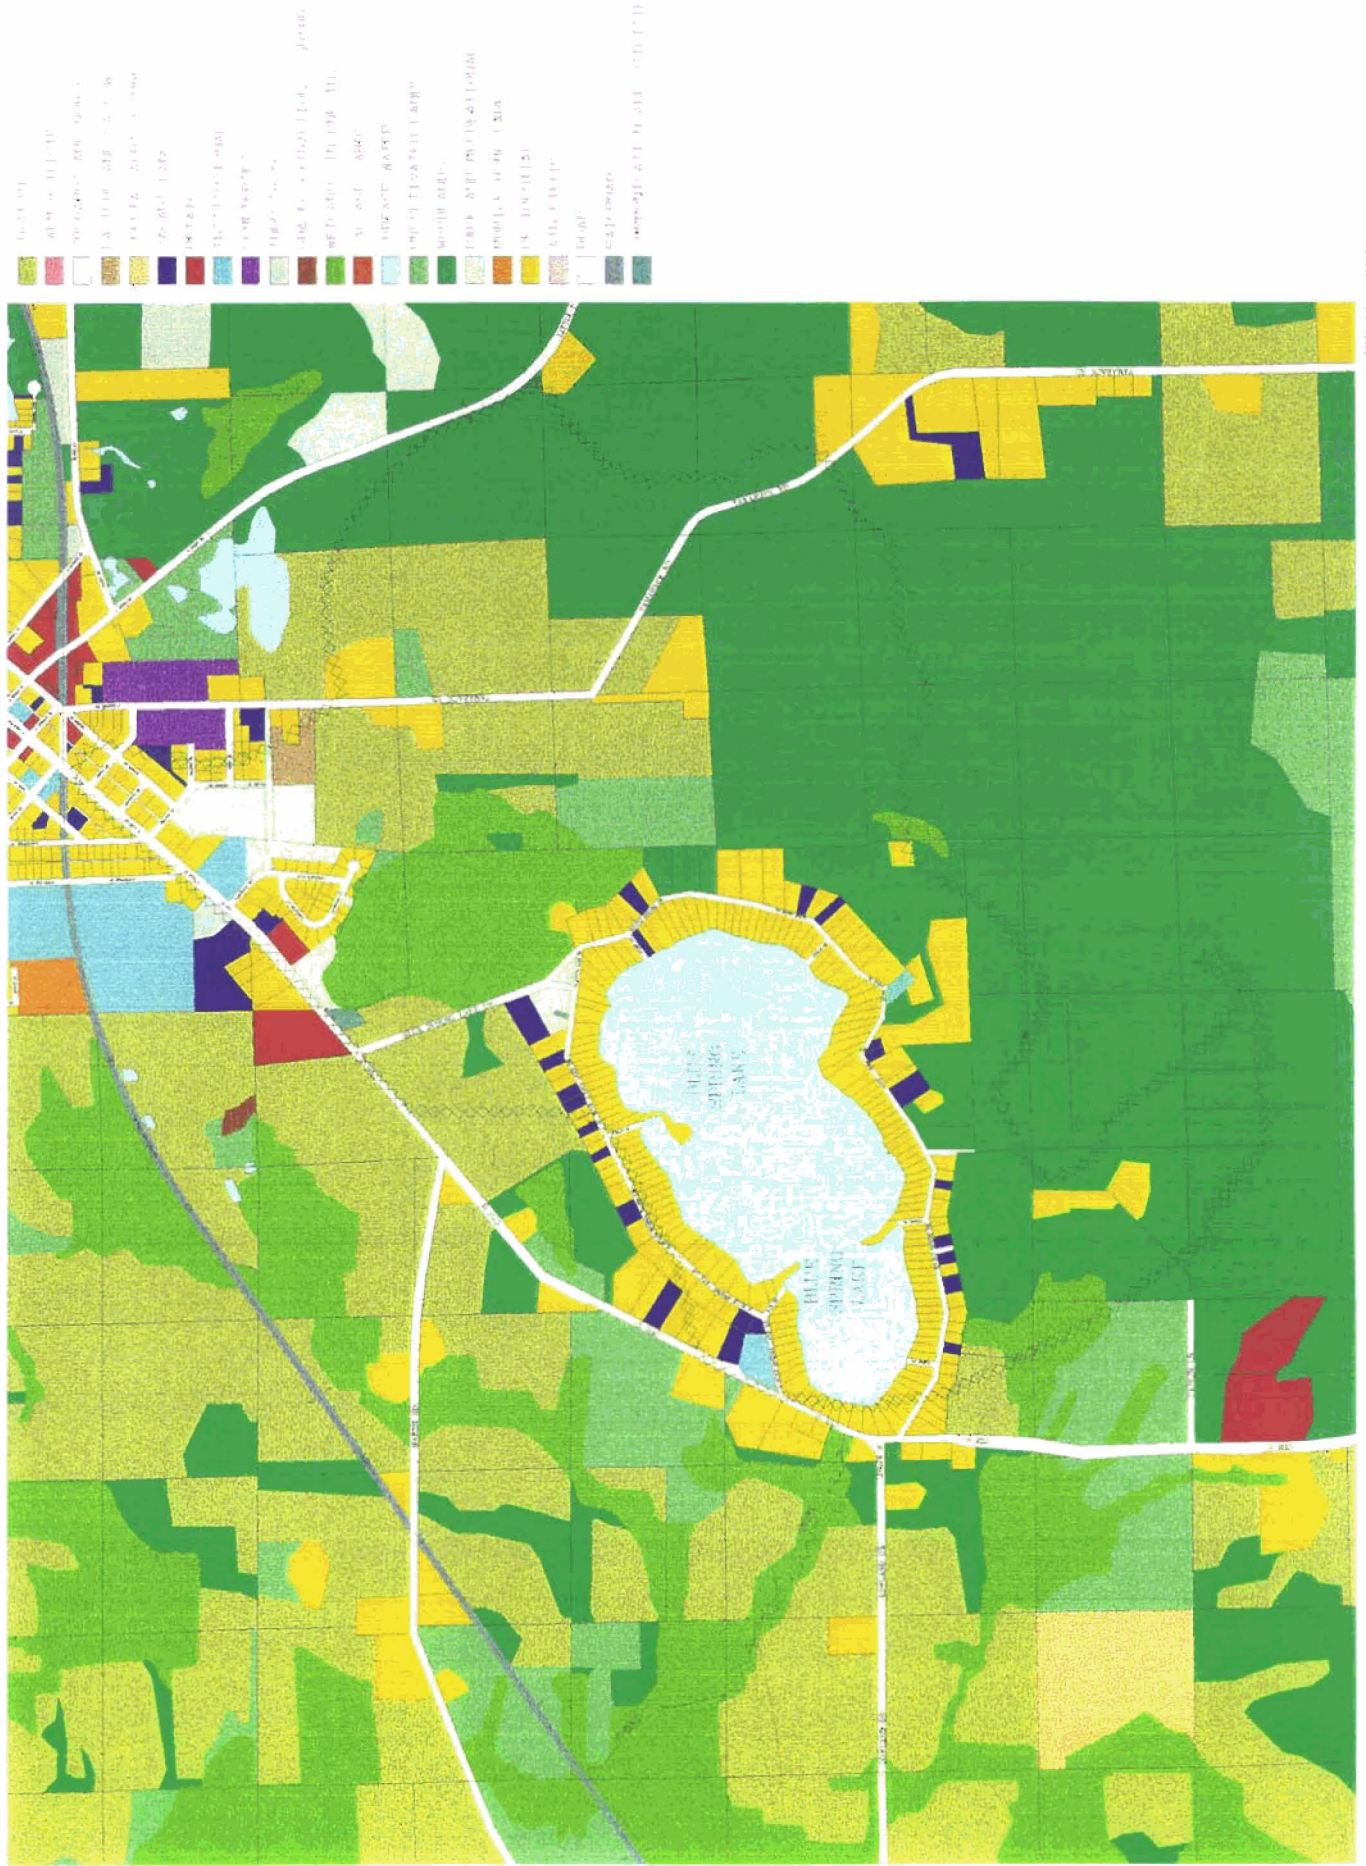
FIGURE 4.4 LAND USES IN THE BLUE SPRING LAKE AREA

Watershed land uses determined in the 1994 inventory are shown in Table 4.1. A more detailed analysis and Geographical Information System (GIS) mapping of land uses has recently been completed by Jefferson County as part of their effort to develop a comprehensive land-use plan for the county. Figure 4.4 shows the results of their land use mapping of the Blue Spring Lake area. The county's new computerized mapping capabilities will be invaluable to future planning

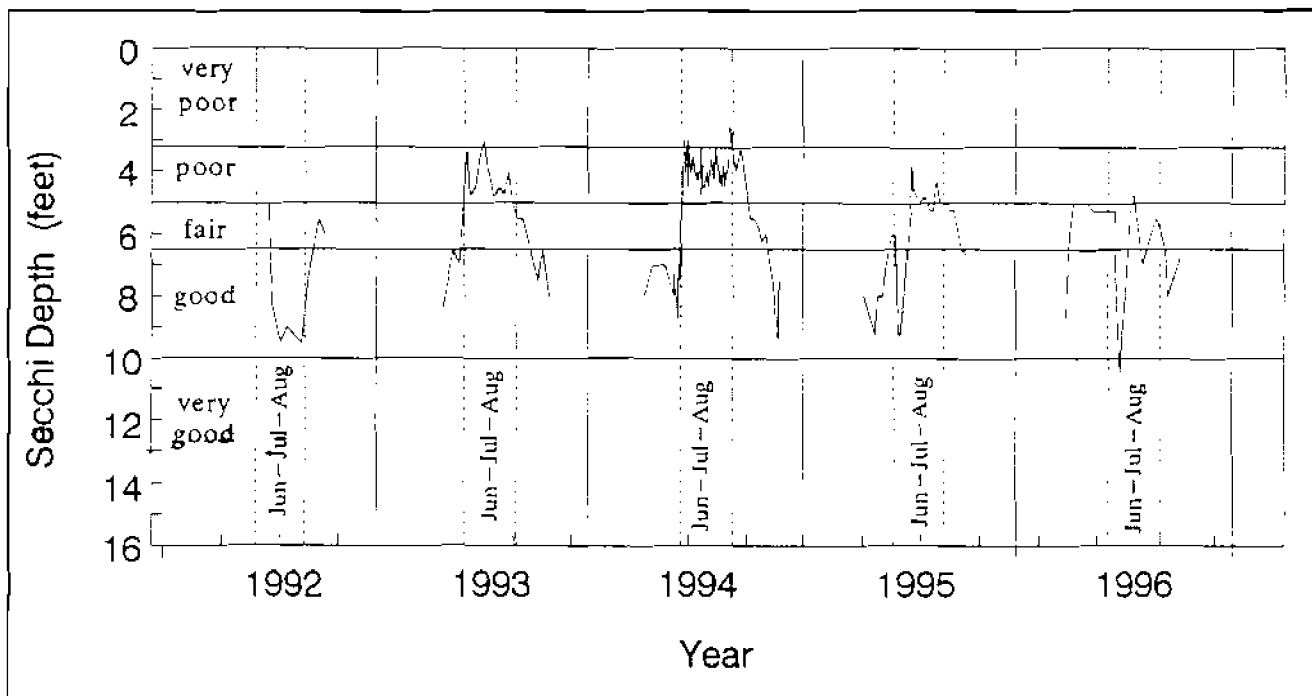
Figure 4.5

BLUE SPRING LAKE WATER CLARITY, 1992-1996

on Blue Spring Lake since 1992, primarily due to the efforts of resident and aquatic plant harvester, Jerry Peplinski. These data are plotted in Figure 4.5. Generally, the water clarity decreases during the summer months as algal populations increase from warmer water temperatures, and sediments are disturbed from increased power boating in the shallow lake. This change, however, is not always

consistent from year to year and significant variations have occurred. On average, clarity was quite good in 1992, poor in 1993 and 1994, and improved during 1995 and 1996. In the last two years, short periods of very high clarity occurred. While these recent trends are encouraging, Blue Spring Lake's clarity is still less than about 70% of all Wisconsin lakes.

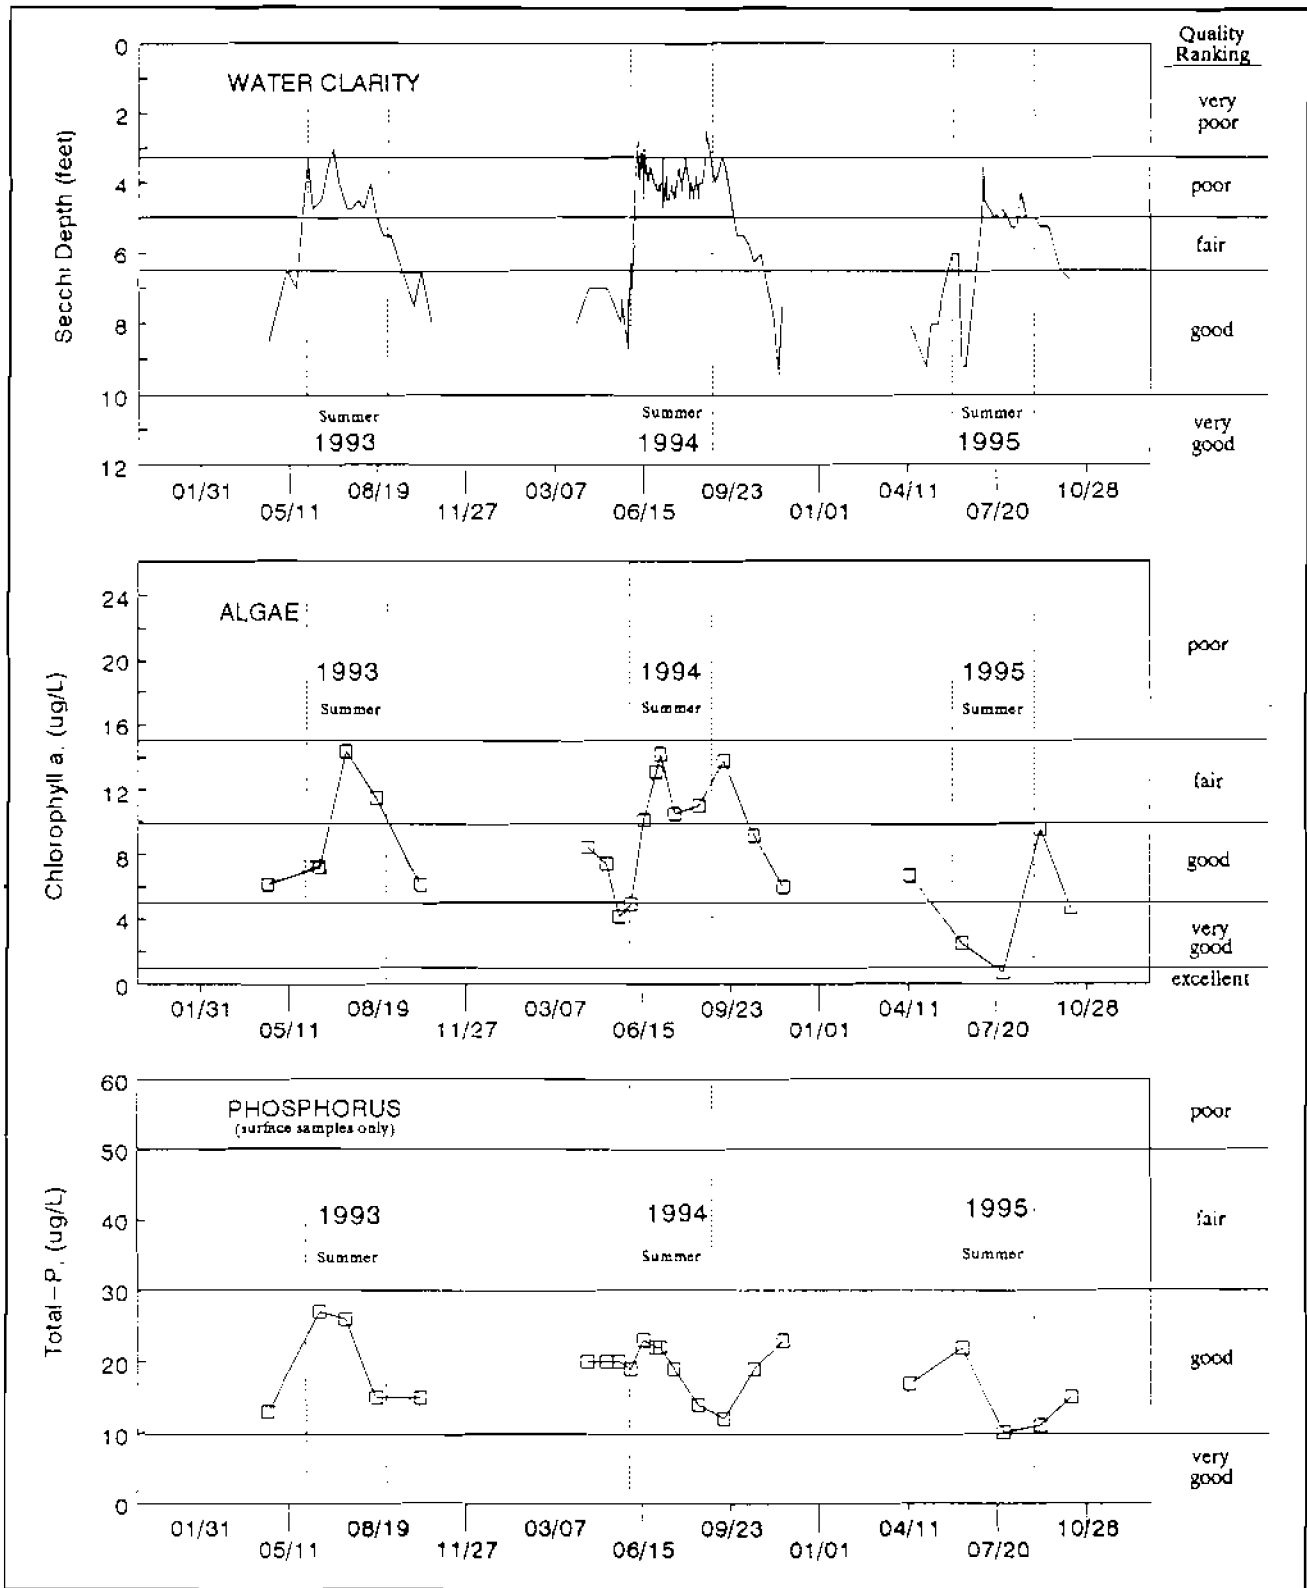
BLUE SPRING LAKE WATER QUALITY, 1993-1995

pigment found in green plants and is an indicator of the amount of algae in the water. Phosphorus is a chemical element and an essential nutrient for all life forms. Excessive concentrations of this nutrient are often an indicator of water pollution. These TSI Program measurements are plotted in Figure 4.6 for the years 1993 to 1995. (1996 results for phosphorus and chlorophyll-a were not available at the time of writing this report).

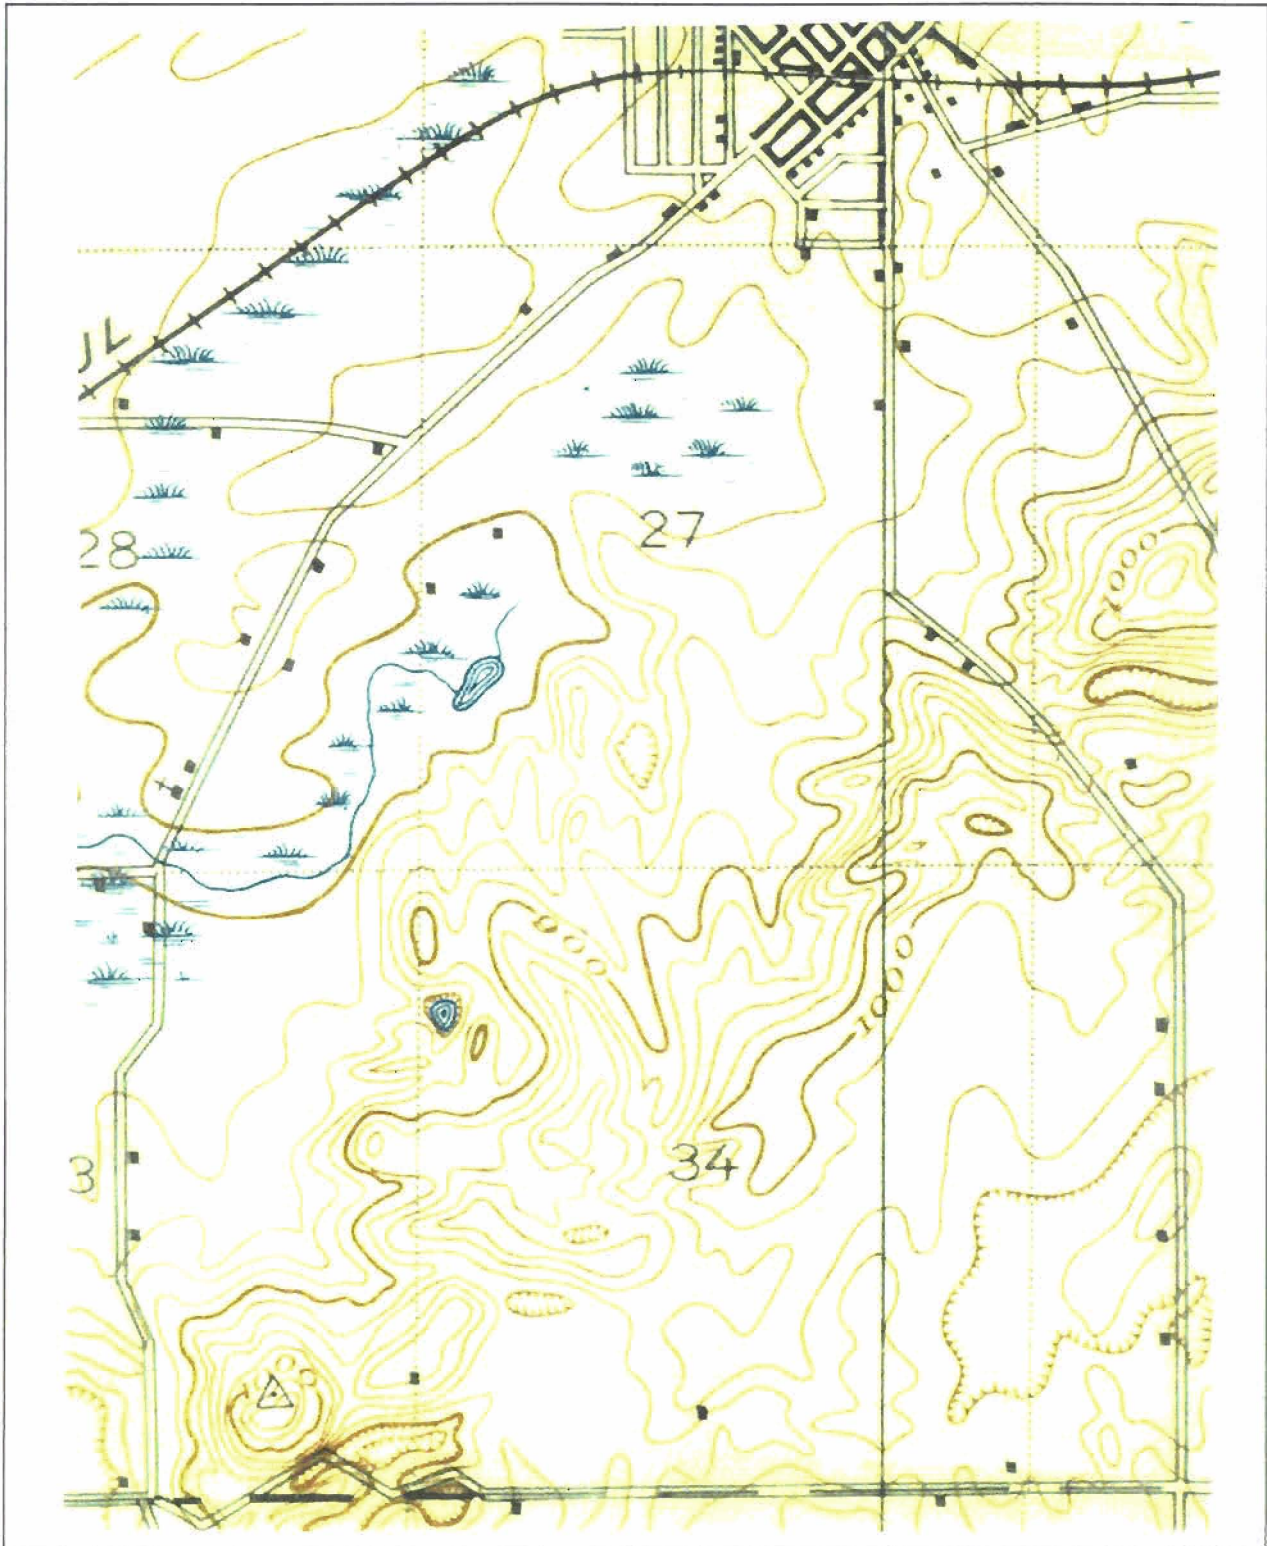
Figure 4.7

1927 USGS MAP OF BLUE SPRING LAKE AREA
