**Use Designation Information – Required**

Water Body Name Unnamed Creek 26-12	WBIC # 1397200	Date 02/23/2005
--	-------------------	--------------------

Segment Description for Segment 3 of 3 (headwater = segment 1)

SUBJECT: Rudolph and Wisconsin State Dairy Cheese Stream Classification

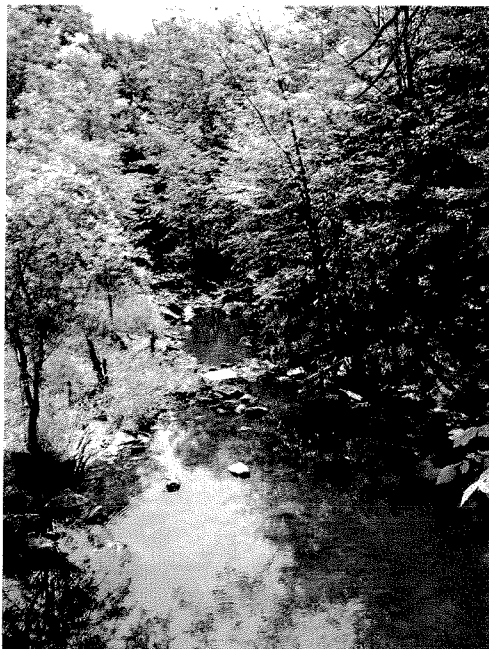
The Rudolph tributary at Oak Road is located approximately 3.4 miles downstream from the Rudolph WWTP outfall and 2.3 miles upstream from the mouth. A fishery and habitat survey was completed in a 120 meter station upstream from the bridge. Fishery survey results found 652 fish per 100 meters represented by 14 species. The percent of fish tolerant to low dissolved oxygen was 21%. The dominant fish species collected include creek chub, white sucker and brook stickleback. One young of year northern pike was also collected during the survey.

*Rudolph Tributary at Oak Road*  
(Baseflow Conditions)

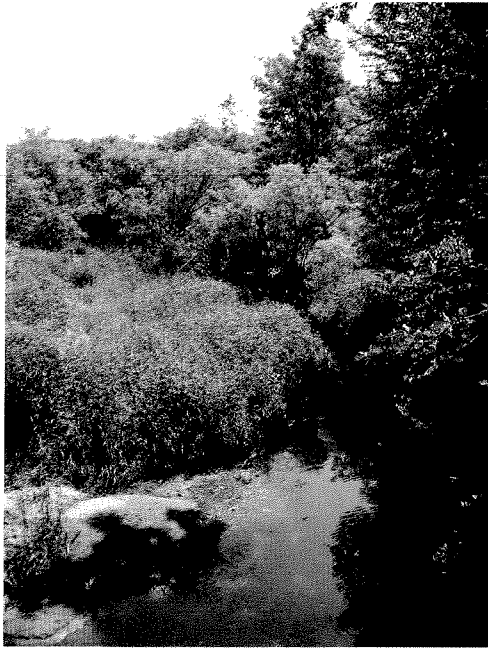
The Rudolph tributary at Third Avenue is located approximately 2.3 miles downstream from the treatment plant outfall. A fishery and habitat survey was completed in a 120 meter station starting downstream from the bridge. Fishery survey results found 271 total individuals per 100

*Rudolph Tributary at Third Ave.  
(Baseflow Conditions)*

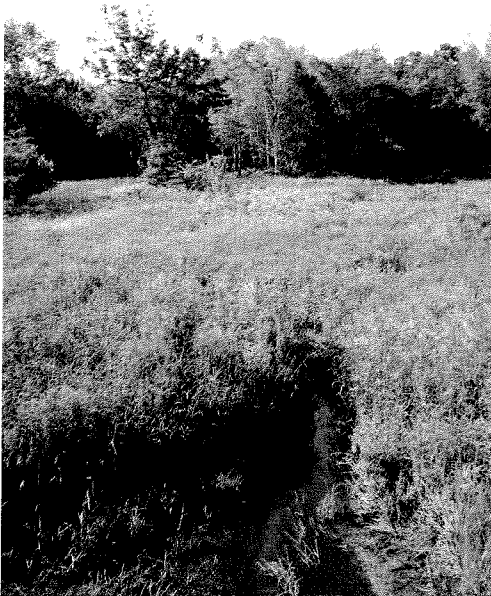
Plum Road is located approximately 0.9 miles downstream from the treatment plant outfall. A fishery and habitat survey was completed in a 100 meter station starting upstream from the bridge pool. Fishery survey results found 80 individuals represented by two species, which included brook stickleback and central mudminnow. The percent of fish tolerant to low dissolved oxygen was 100%. Electro-shocking efficiency was not optimal due to the highly conductive water.

*Rudolph Tributary at Plum Road  
(Baseflow Conditions)*

The Limited Forage Fish community found at the Plum Road crossing likely represents the potential use of this stream segment. Limiting factors preventing this reach from achieving a higher classification include low flow, past channelization and physical habitat conditions. Two of the three reference sites near the Rudolph tributary could not be surveyed due to the lack of water. These two sites were tributary streams to the Rudolph tributary and were similar in size and drainage area. The Rudolph tributary would have also been dry without effluent discharged by the treatment plants. This reach flows through a wetland area and would be characterized as low gradient. Minimal streamflow and poor instream habitat conditions resulting from past channelization, does not provide adequate water depth, proper substrate and habitat diversity to support a Diverse Fish and Aquatic Life community. Without the augmentation of streamflow from the discharges this reach of the Rudolph tributary would have been dry with an existing use of Limited Aquatic Life. The continuous discharge from the treatment plants provides a small year round flow that raises the potential of the stream to a Limited Forage Fishery. Moccasin Creek at CTH C was similar to the Rudolph tributary and was surveyed earlier in the summer when streamflow was present. The survey on this stream segment also found a Limited Forage Fish community when water was present. The lack of permanent streamflow and poor habitat conditions from past channelization in this segment of Moccasin Creek are significant limiting factors to the fishery.

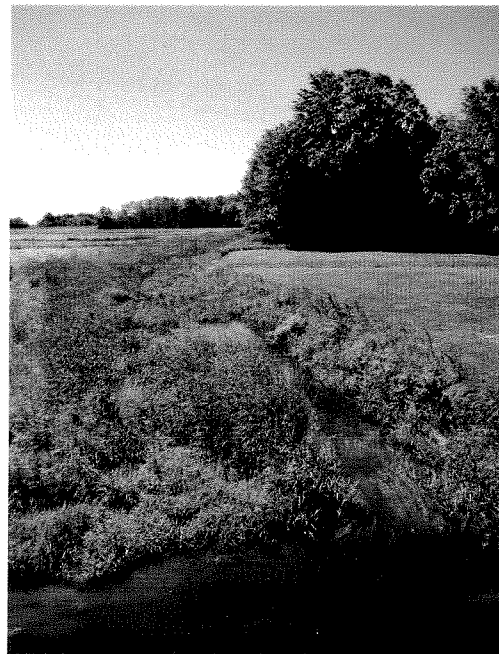
Moccasin Creek at CTH C is similar to the Rudolph tributary at Plum Road in size, channel morphology and drainage area and was selected to serve as a reference site. As with the Rudolph tributary, this reach of Moccasin Creek had been ditched in the past and represents an intermittent headwater area. A fishery survey was completed in early July when streamflow was present. Streamflow at this time was likely augmented from a non-permitted de-watering activity from an upstream gravel operation. Fishery survey results found 27 total individuals per 100 meters represented by 5 species. The percent of fish tolerant to low dissolved oxygen conditions was 85%. Moccasin Creek had no flow from the headwaters downstream eight miles by middle to late summer. According to local residents, it is not unusual to see this reach intermittent during the summer months. Below STH 13, the stream steadily increased streamflow from groundwater inputs, which supported a brook trout fishery below George Road.

*Moccasin Creek at CTH C  
(>Baseflow Conditions)*

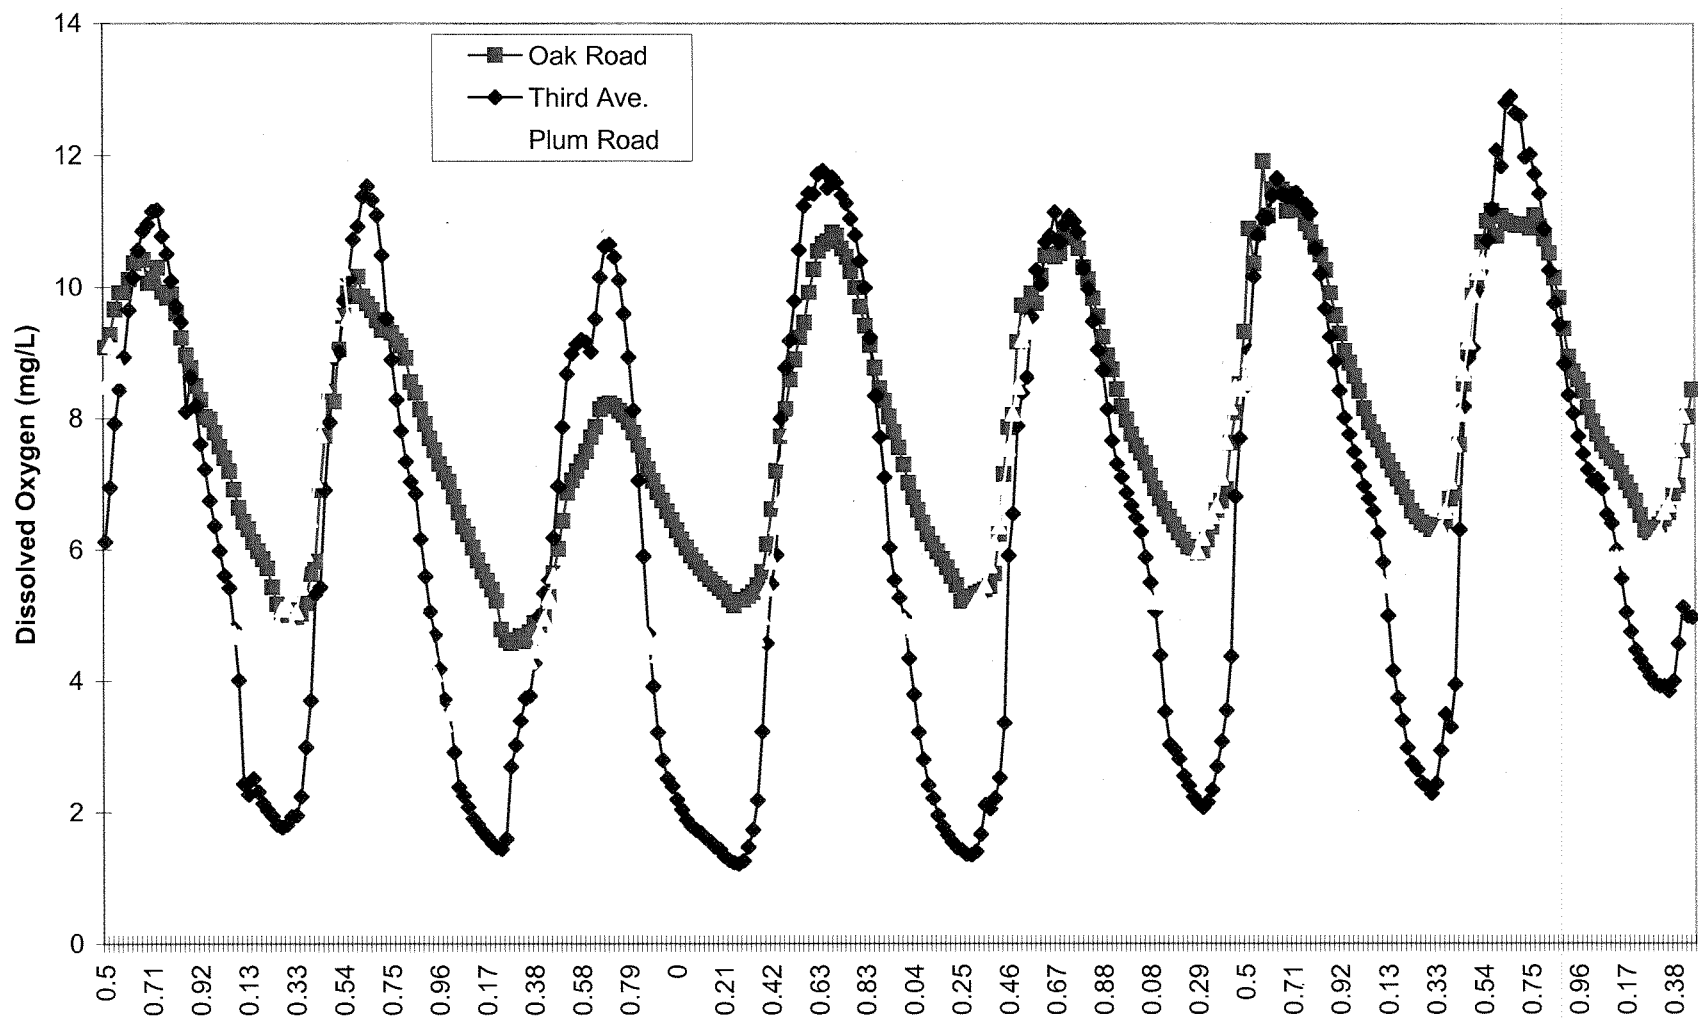
Figure 3. Rudolph Trib Continuous Dissolved Oxygen Monitoring  
July 19 - 26, 2004

stream reaches monitored in the watershed. Low oxygen concentrations were a result of low streamflow conditions and/or photosynthetic activity of filamentous algae and aquatic plants. Low streamflow conditions or minimal groundwater input seems to be a natural phenomenon that was likely exacerbated by drought conditions from the previous two years. Several small streams and headwater reaches of larger streams had minimal streamflow during deployments and some were completely dry by late summer. The lack of surface turbulence reduces stream aeration and prevents adequate oxygen exchange with the atmosphere. Also, the respiration of aquatic organisms likely contributed to the low oxygen concentrations.

Dissolved oxygen concentrations fluctuated significantly in streams with abundant filamentous algae growth. The photosynthetic activity of algae created super saturated oxygen conditions during day but by early morning hours oxygen was consumed during respiration. Oxygen concentrations fell well below saturation due to the lack of adequate stream aeration and respiration of aquatic life.

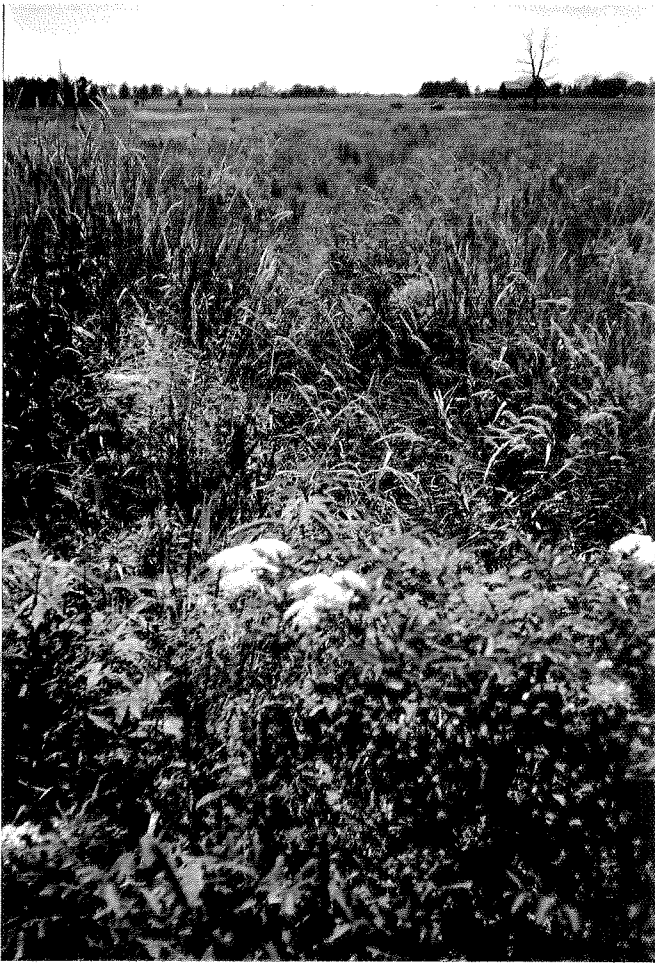
Effluent ditch receiving Rudolph discharge.

Recommendations: The unnamed tributary to the Wisconsin River that receives the discharge from Rudolph should have the effluent ditch hydrologic classification from the outfall to the crossing of the first town road. From that point down to Section 26, T23N, R6E, at the point where it meets the ditch that parallels the Biron Flowage, it should be classified noncontinuous. This entire segment should have the "marginal" water quality classification. The remainder of the stream down to the Wisconsin River should be classified continuous and "not supporting a balanced aquatic community."

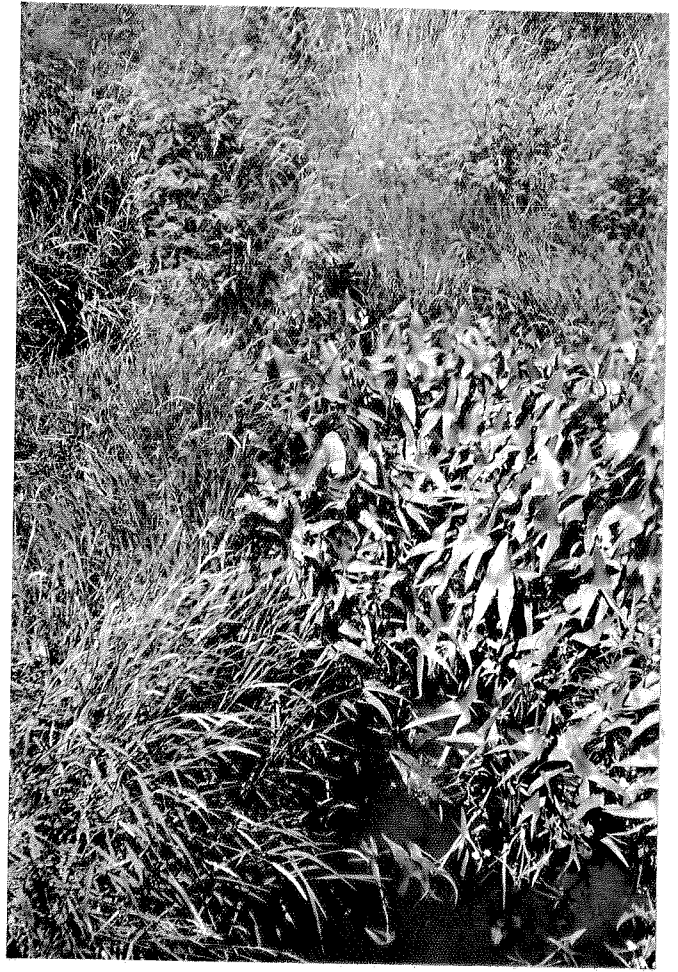
Rudolph Tributary at first Town road below discharge.

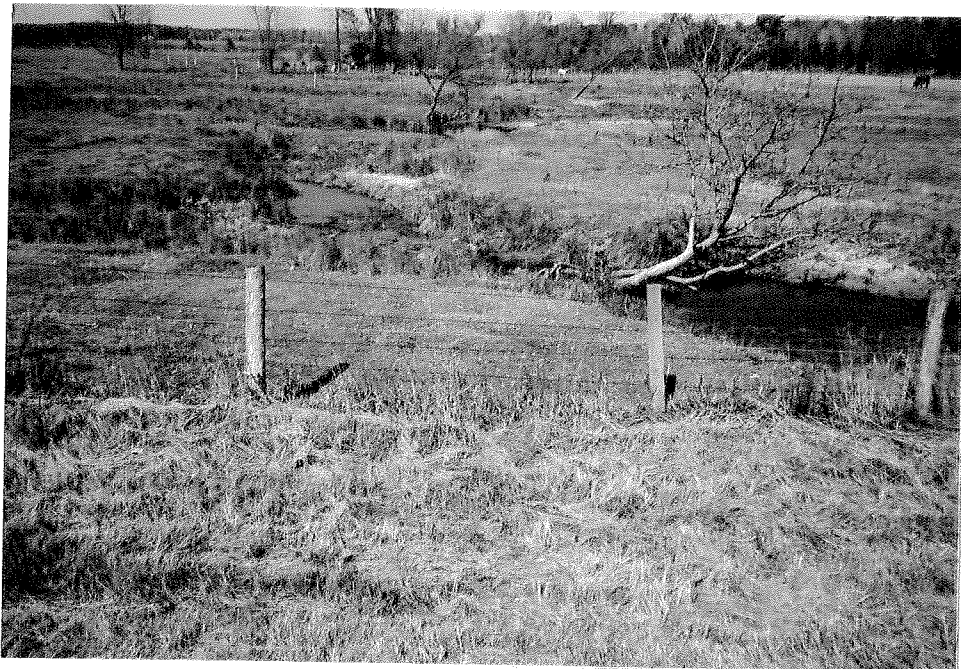
Rudolph Tributary at CTH "P".

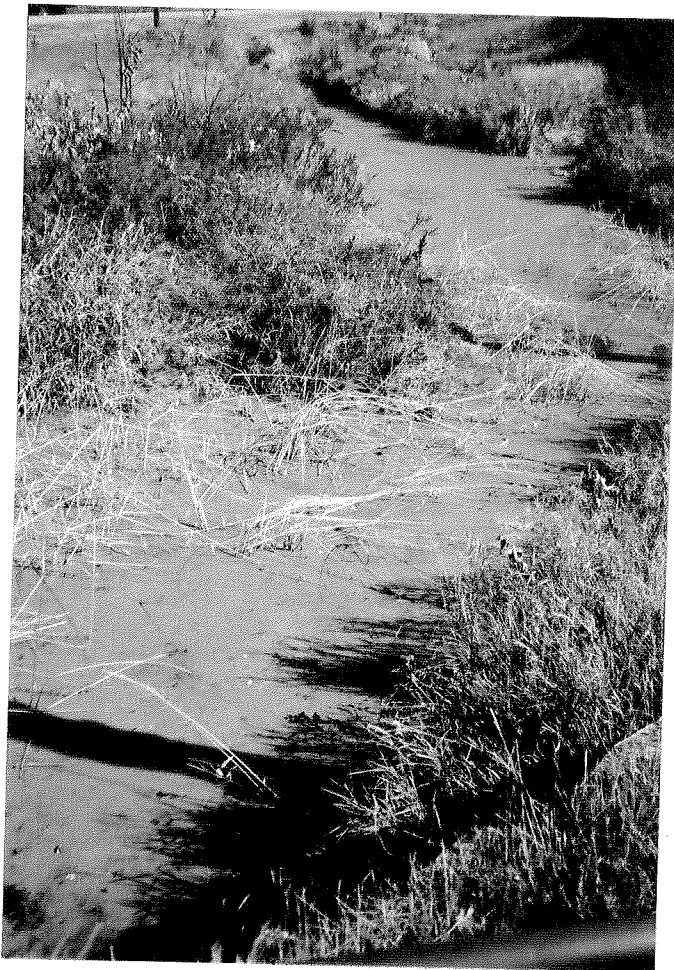
Rudolph Tributary at Biron Dam.
