**Wisconsin Department of Natural Resources  
Bureau of Watershed Management**

**Sediment TMDL for Gills Coulee Creek**

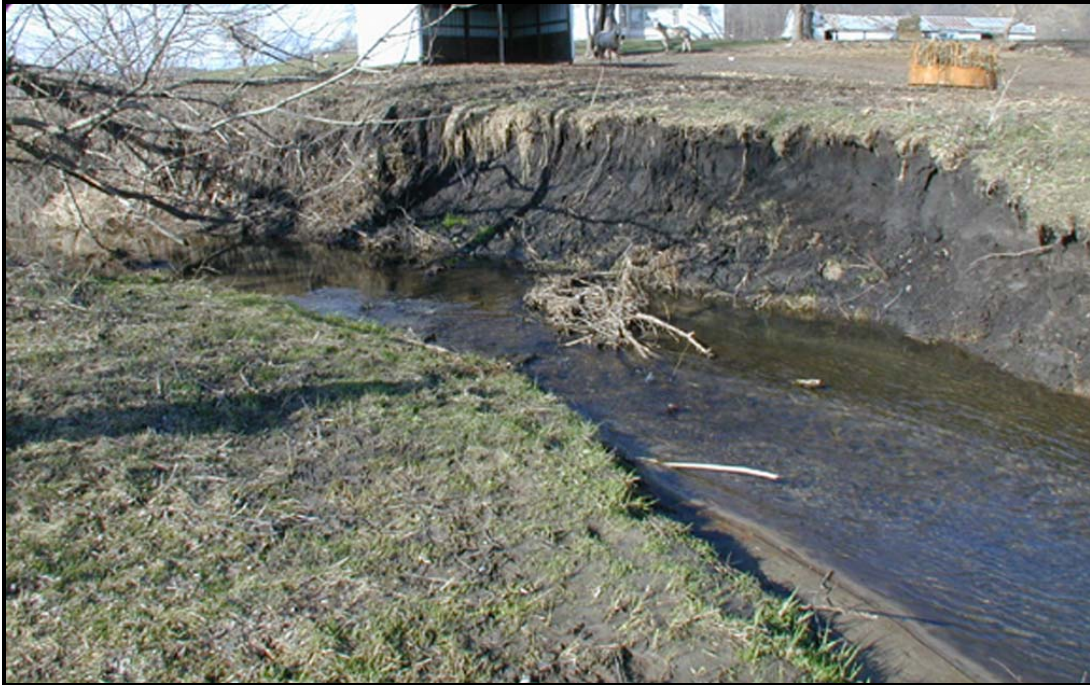
Figure A-4. Stream bank erosion located in upper third of stream.

Establishing the link between watershed characteristics and resulting water quality is a crucial step in TMDL development. By striving to return watershed characteristics closer to natural conditions, improvements in overall stream health can be achieved. Determining the natural stream bank conditions of this stream is challenging because of a lack of historical data to represent conditions prior to human disturbance. It is believed that stream bank instability was initially caused by heavy pasturing and overgrazing of the hillsides in the early 20<sup>th</sup> century. Removal of trees and compaction of the soils due to the grazing of hillsides caused gullies to form. Tons of sediment moved from the hillsides during rain events via gullies to the valley floor. In parts of La Crosse County, 12 to 15 feet of sediment transported from the hillsides can be documented at the streambank. Currently, during high velocity runoff events, sediment is carved out from severely exposed banks, contributing further to sedimentation and stream bank instability. Some portions of streambank are eroding due to livestock trampling (See photographs in Appendix, Section A-4).

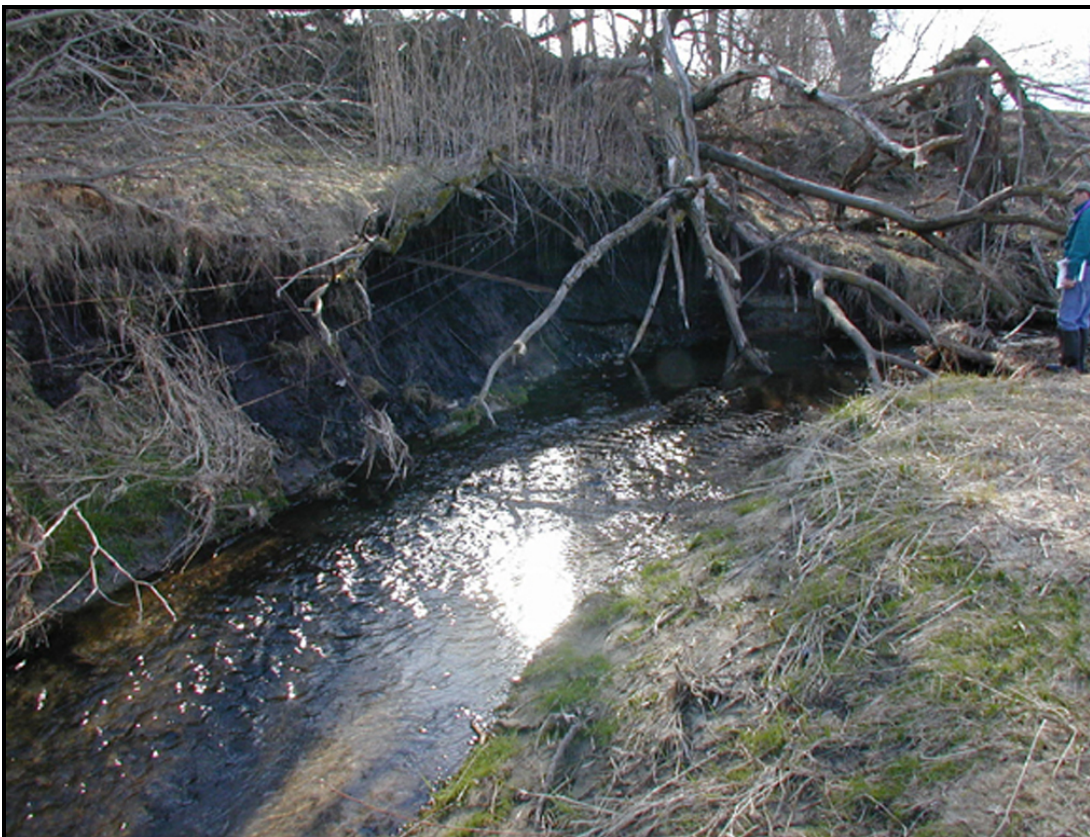
Figure A-5. Stream bank erosion located in upper third of stream.

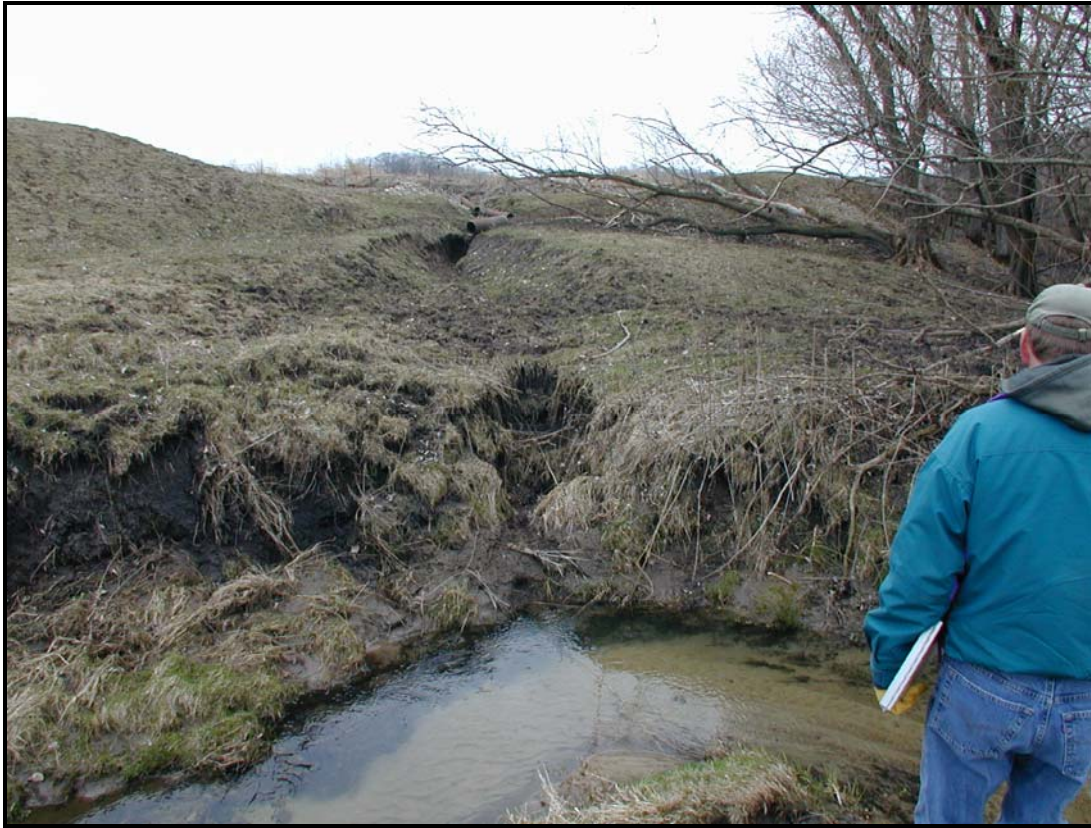
Figure A-6. Stream bank erosion located in middle section of stream.

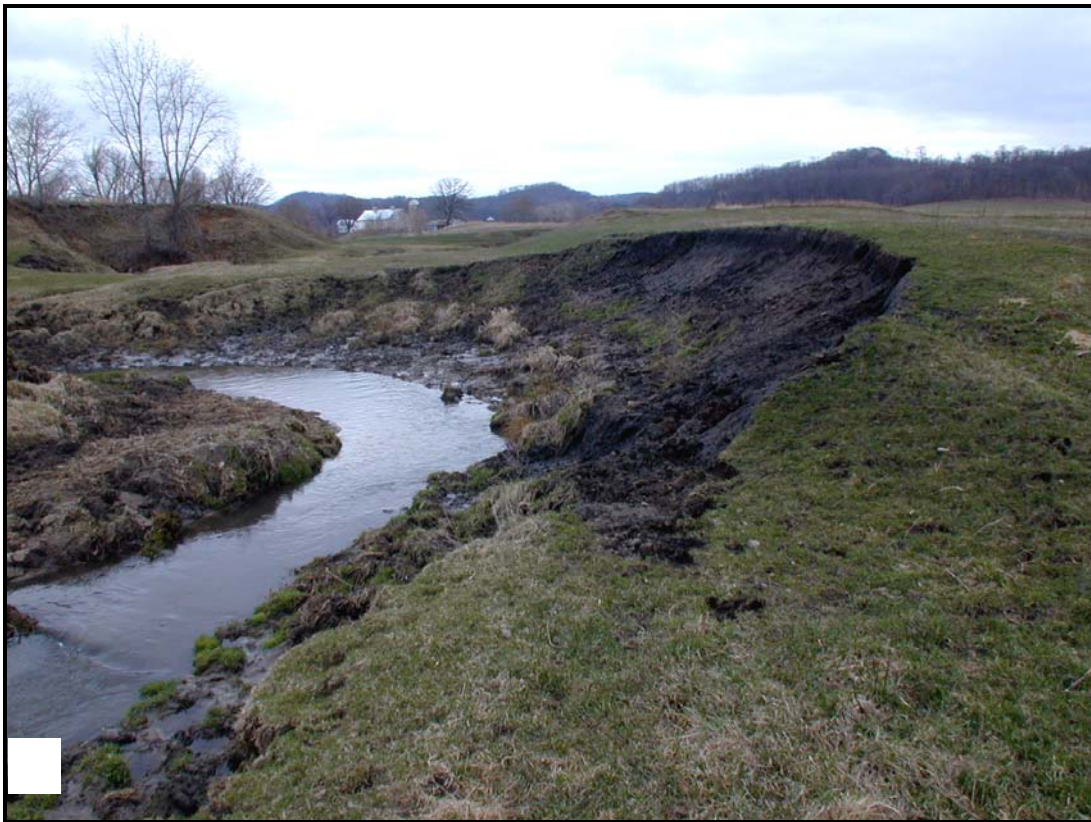
Figure A-7. Stream bank erosion located in middle section of stream.

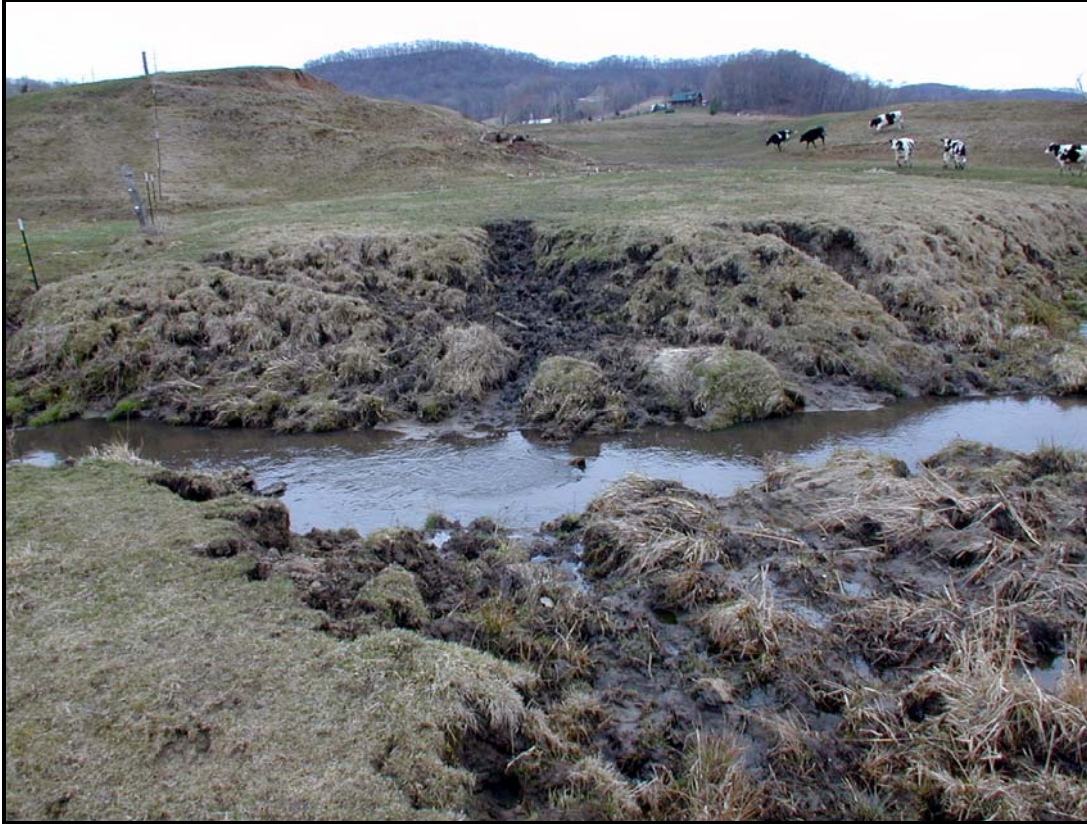
Figure A-8. Streambank erosion located in lower third of stream.

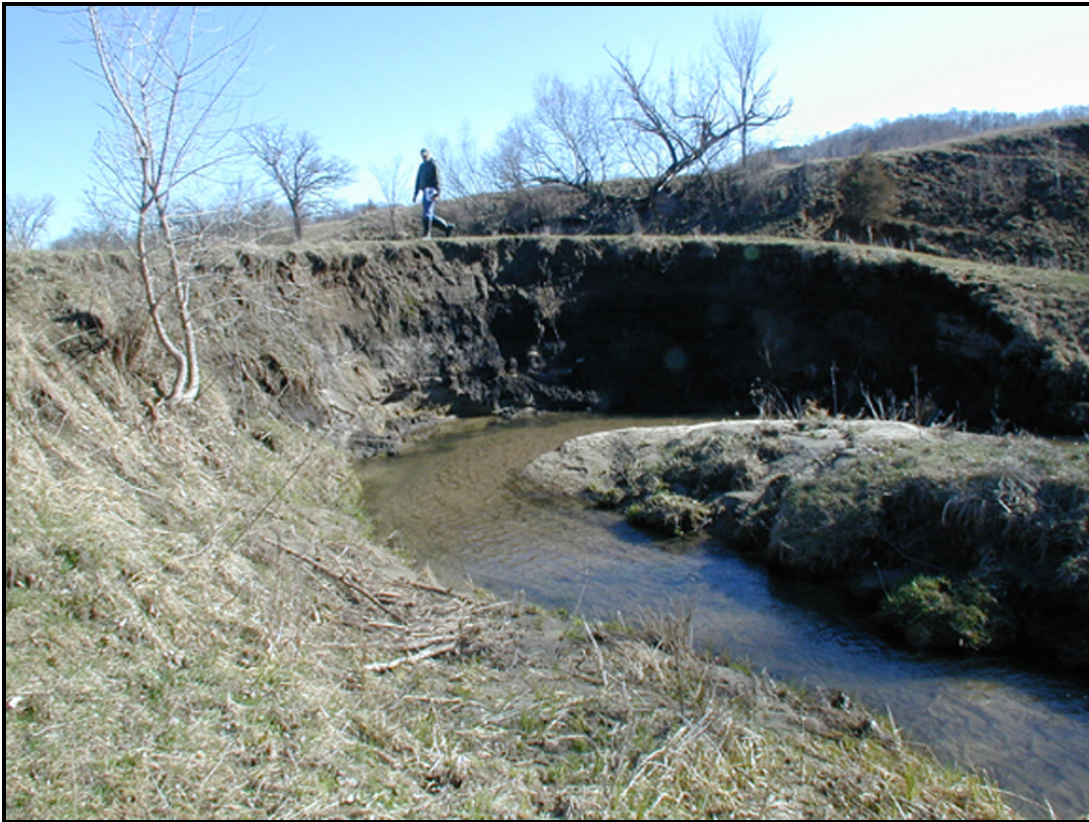
Figure A-9. Stream bank erosion located in lower third of stream.

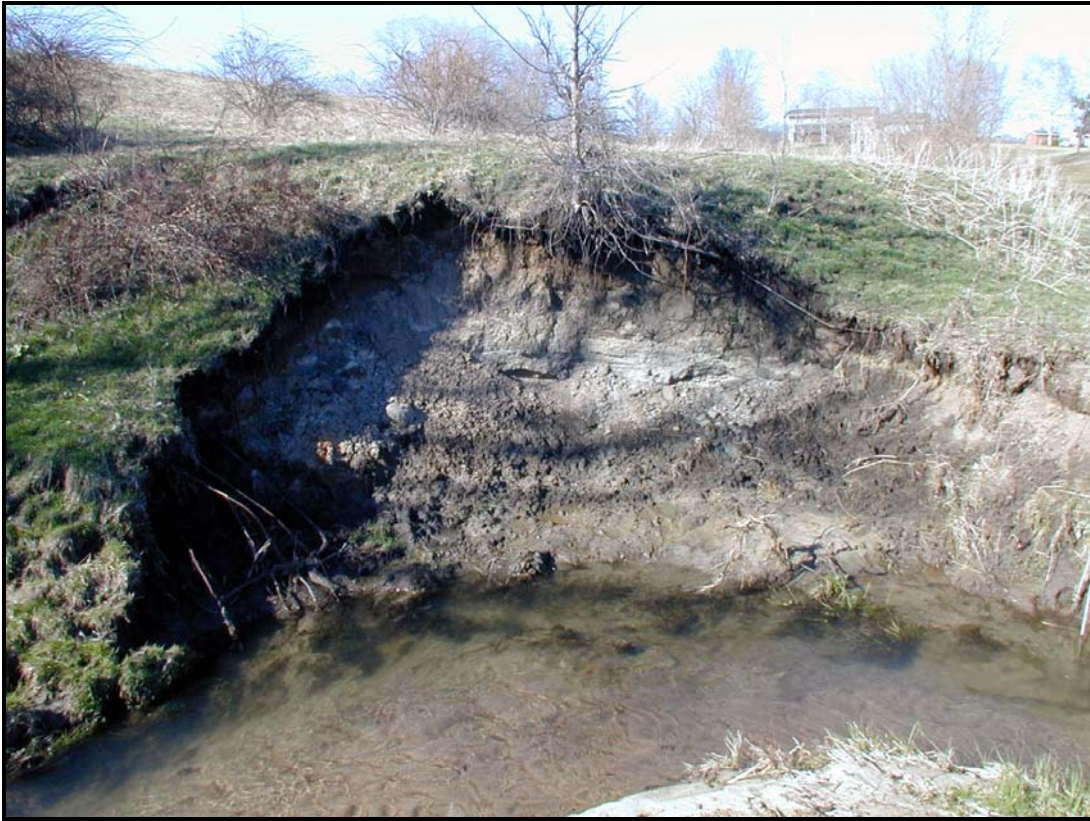
Figure A-10. Stream bank erosion located in lower third of stream.

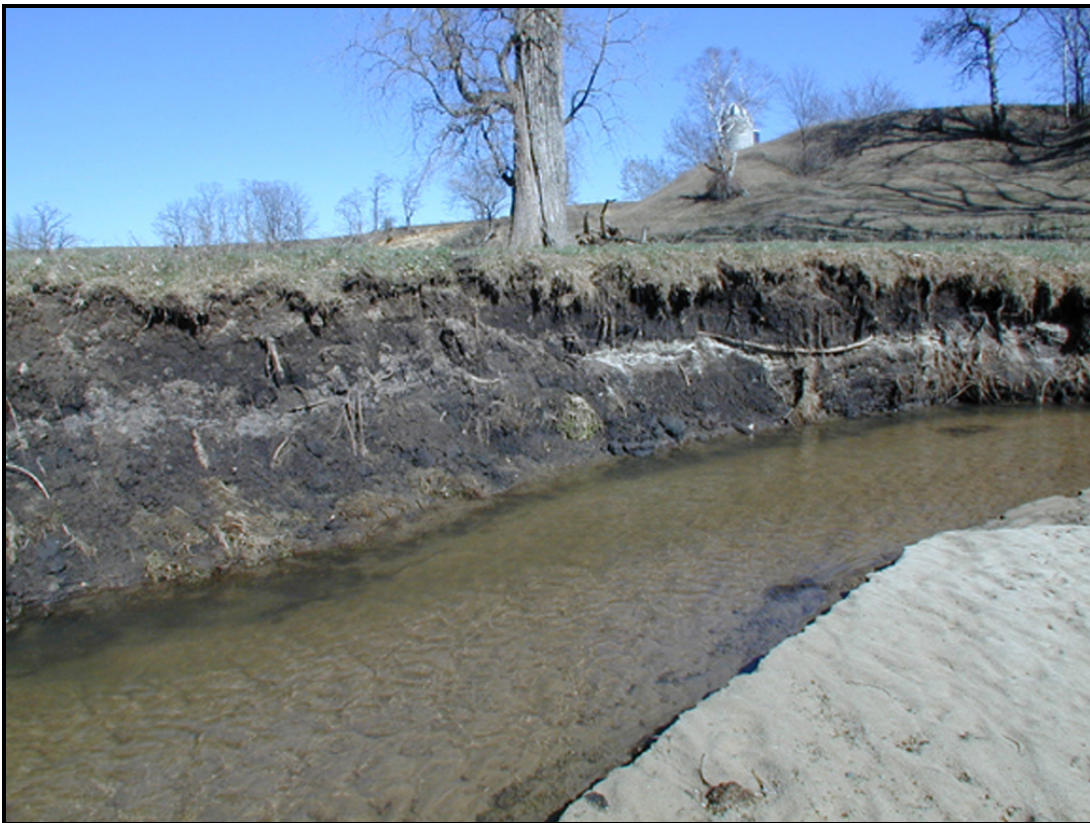
Figure A-11. Stream bank erosion located in lower third of stream.

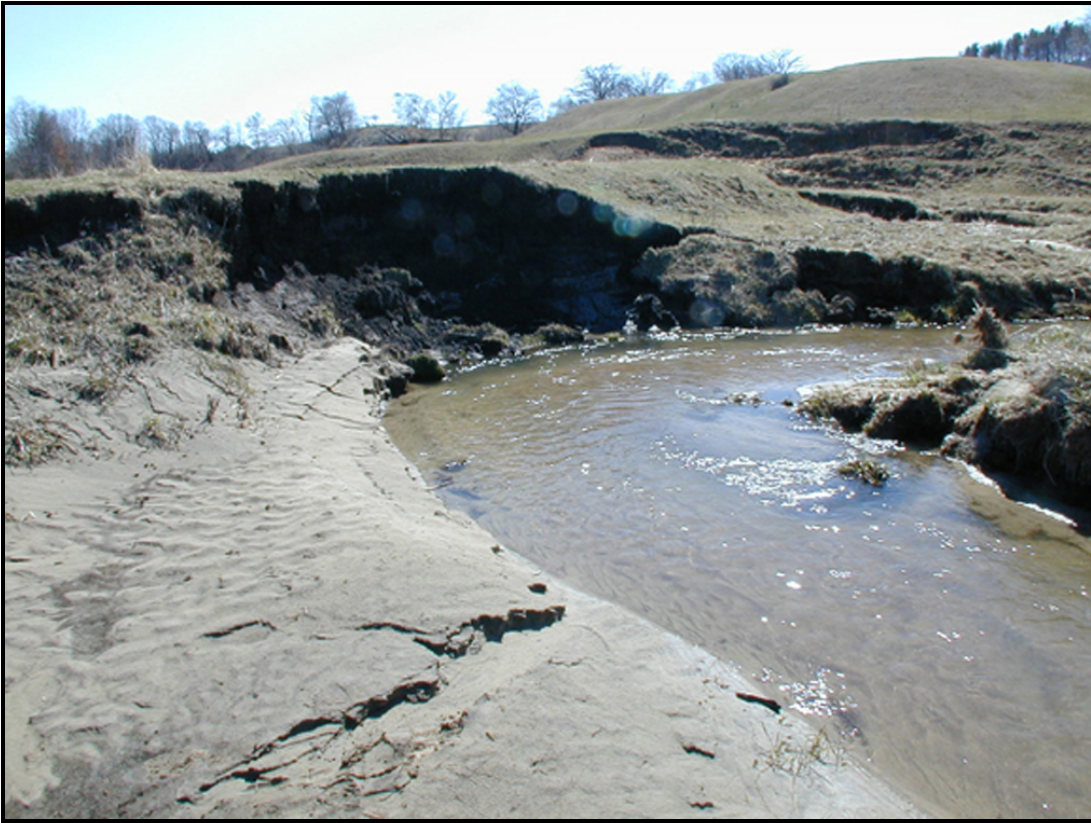
Figure A-12. Stream bank erosion located in lower third of stream.

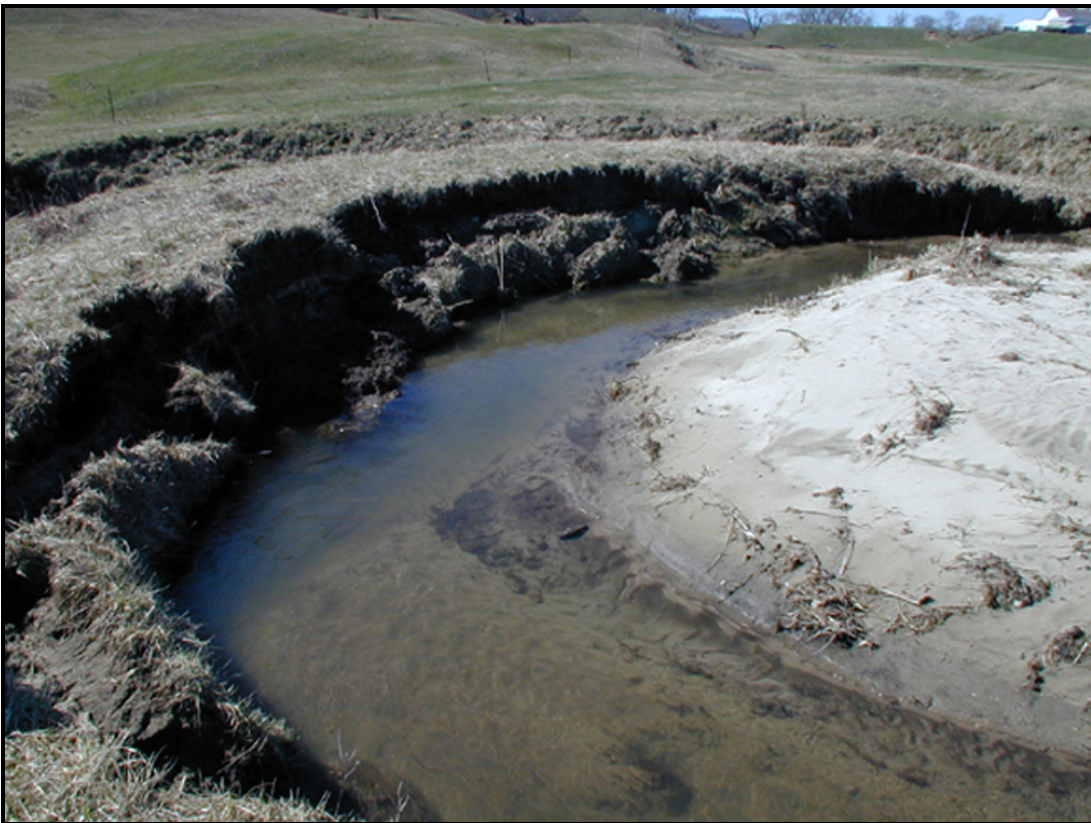
Figure A-13. Stream bank erosion located in lower third of stream.
