**An Evaluation of the Impacts Septic Systems have on  
the Groundwater and Surface Water Quality of  
Minocqua Lake, Wisconsin**

James Lindemann, Dr. Byron Shaw and Brett McKinney

College of Natural Resources  
University of Wisconsin-Stevens Point  
1996-97

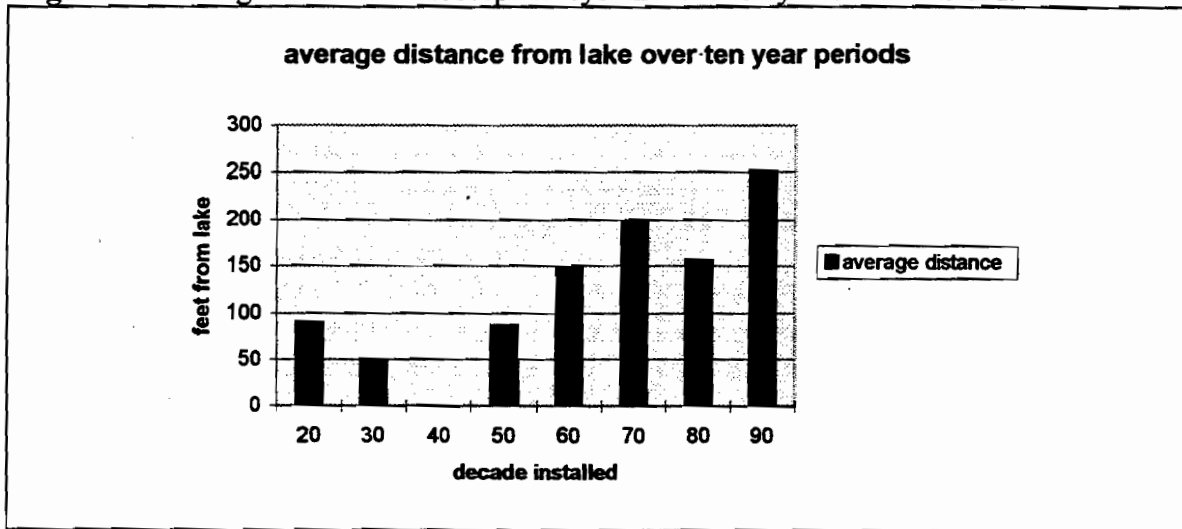
**Figure 1. Average distance of absorption system to lake by decade installed.**

The four systems that were found to be less than the require 50 feet from the lake were all older systems, and due to grandfather clauses are most likely not in violation. However, these are systems of great concern for lake impacts. But the set back code is not always a good indicator of systems that may possibly impact groundwater and surface water. Any septic system in close proximity of groundwater or surface water has the potential of impacting both groundwater and surface water quality. The data collected shows that measures are being taken to further the distance of septic systems to Lake Minocqua. Figure 1 shows that on average, septic systems are being installed further from the lake as time goes by. This decreases the possibility of septic systems impacting surface water. As septic systems are installed further from lakes, not only is the distance from the lake increased but the distance to groundwater is also increased leaving longer travel distances and greater possibilities for attenuation of contaminants.

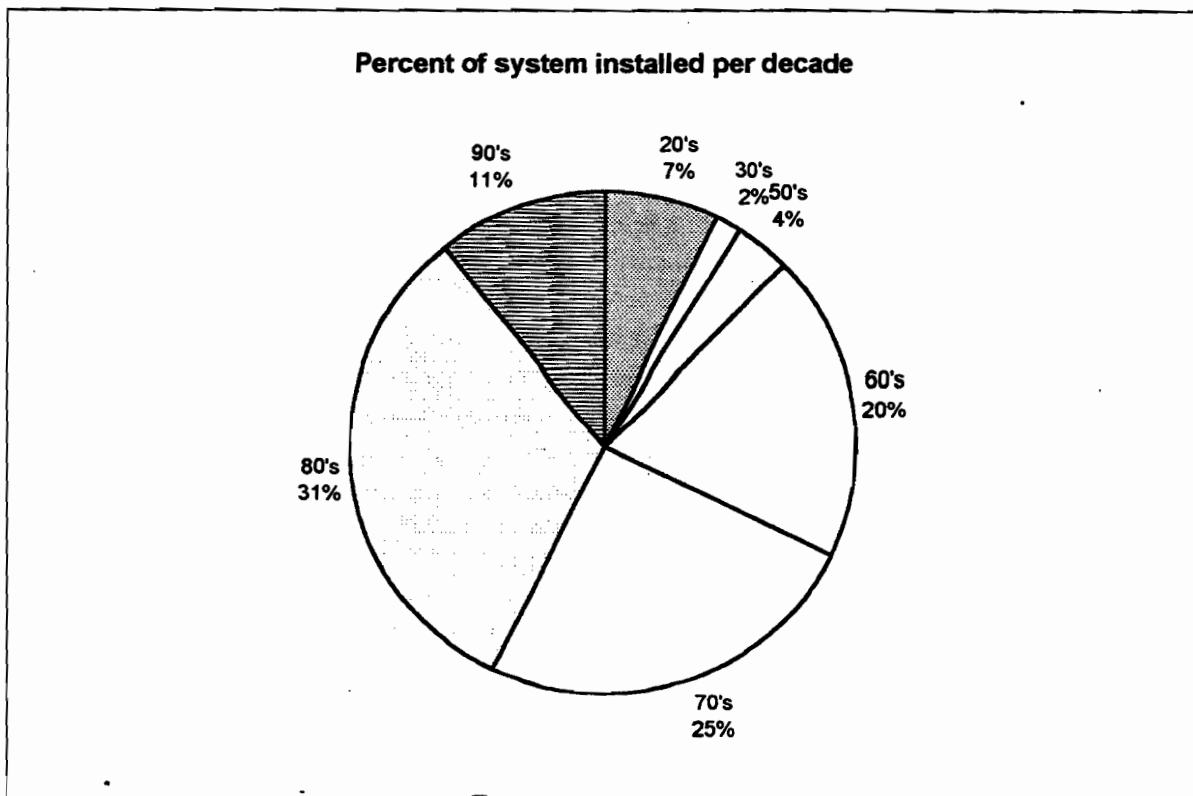
**Figure 2. Percent of septic systems installed by decade. (includes only septic systems that were inspected)**

It was also determined that of the sites surveyed, more than half of the systems on these sites were installed during the 70's and 80's. Figure 2 shows the percentage of septic systems installed in the corresponding decade. However, because participation in the survey was voluntary, some owners with older systems that may not meet many of the current codes or may be failing may have opted not to participate in the study.

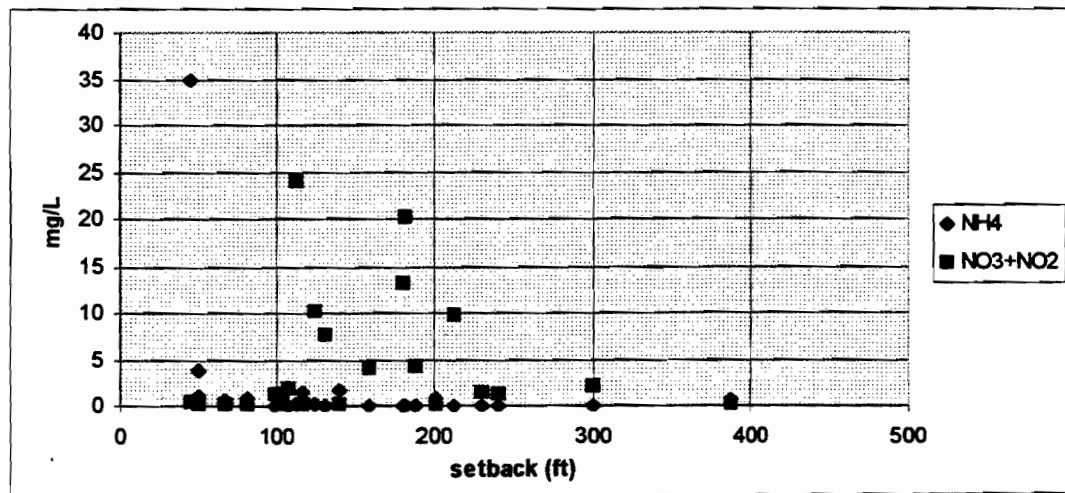
**Figure 9.** Concentrations of nitrate and ammonium found in piezometer samples verses distance of septic system setback.

A similar trend exists when nitrate and ammonium data is compared to the setback distance of the septic system from the lakeshore. This trend is generally true because the further from the lake the greater the depth to groundwater. In figure 9 it is shown that the major source of nitrogen at distances less than 100 feet from the lakeshore is ammonium. At distances greater than that nitrate level show a significant increase. However, this is not always the case. There are some relatively high levels of ammonium, which enter the lake in areas where the septic systems are greater than 100 feet from the lake. This discrepancy in the trend could be caused because more important than distance to the lake is distance to groundwater. In the case of some of these sites the setback may be of adequate distance but because of gentle sloping topography or low spots in the topography the distance to groundwater is not adequate to convert ammonium to nitrate.

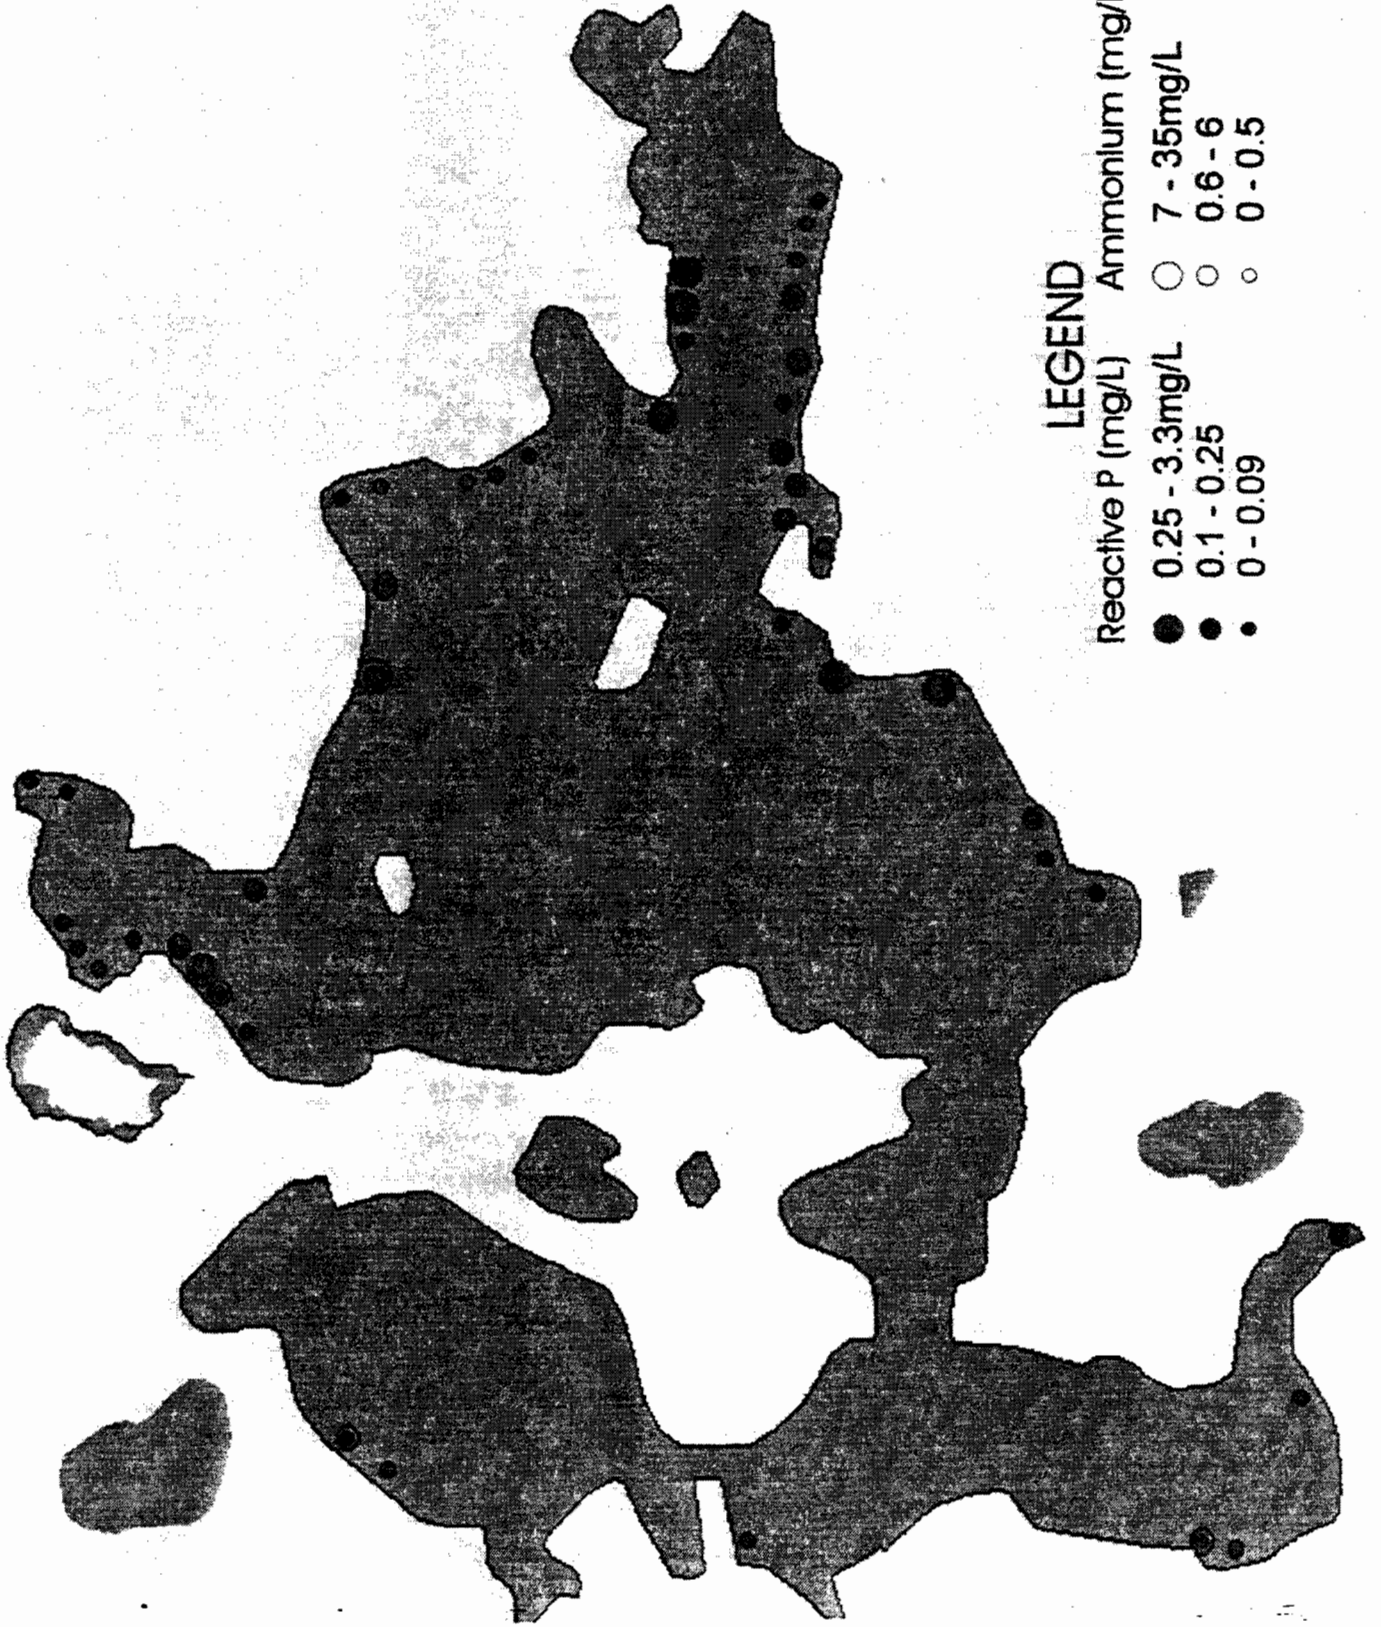
Figure 13

# Minocqua Lake Wisconsin Relationship Between Reactive Phosphorus and Ammonium Concentrations

This relationship is also evident when it is illustrated in a map form like that found in figure 13. From this map it becomes clearer that the relative concentrations of phosphorus and ammonium entering the lake relate to one another in most cases. Those with relatively high concentrations of ammonium are often coupled with high levels of phosphorus.

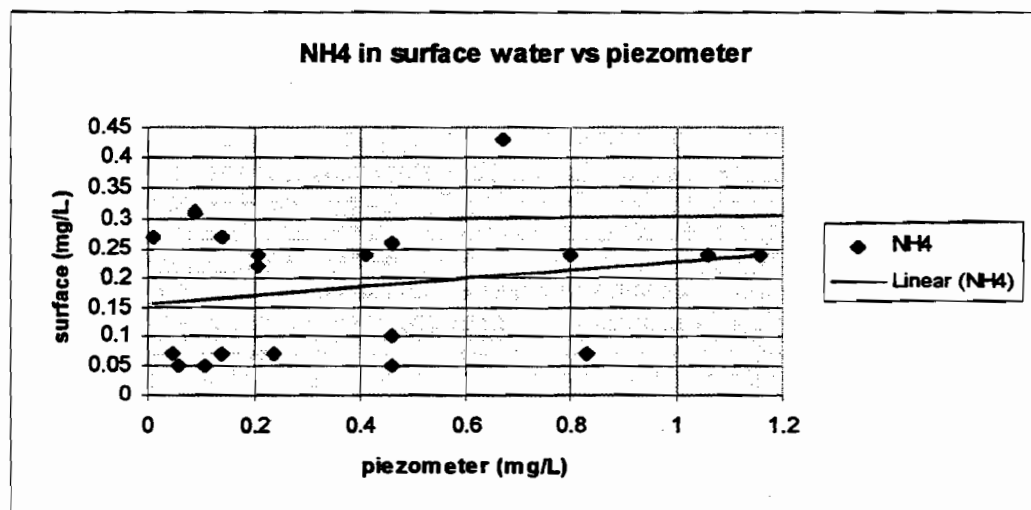
**Figure 14.** Scatter plots of various chemical parameters found in surface water verses that found in groundwater and how they relate to one another.

groundwater flows into the lake contaminate levels in the lake were relatively low compared to that of groundwater samples taken from the piezometers. Another reason for the lower levels of nutrients in the surface water compared to that of the groundwater samples is the fact that the aquatic plants in the area are using these nutrients during the summer months when sampling took place. However, somewhat of a trend still exists between some chemical parameters found in groundwater and that found in surface water. Figure 14 shows the relationship between some chemical parameters found in surface water and how they relate to the piezometer data at the same sample site. The trends are not statistically significant but this may be explained by the vast amount of dilution and mixing that takes place as the groundwater enters the lake. It can also be explained considering the fact that aquatic plants area using the nutrients in the groundwater entering the lake, which also varies around the lake.

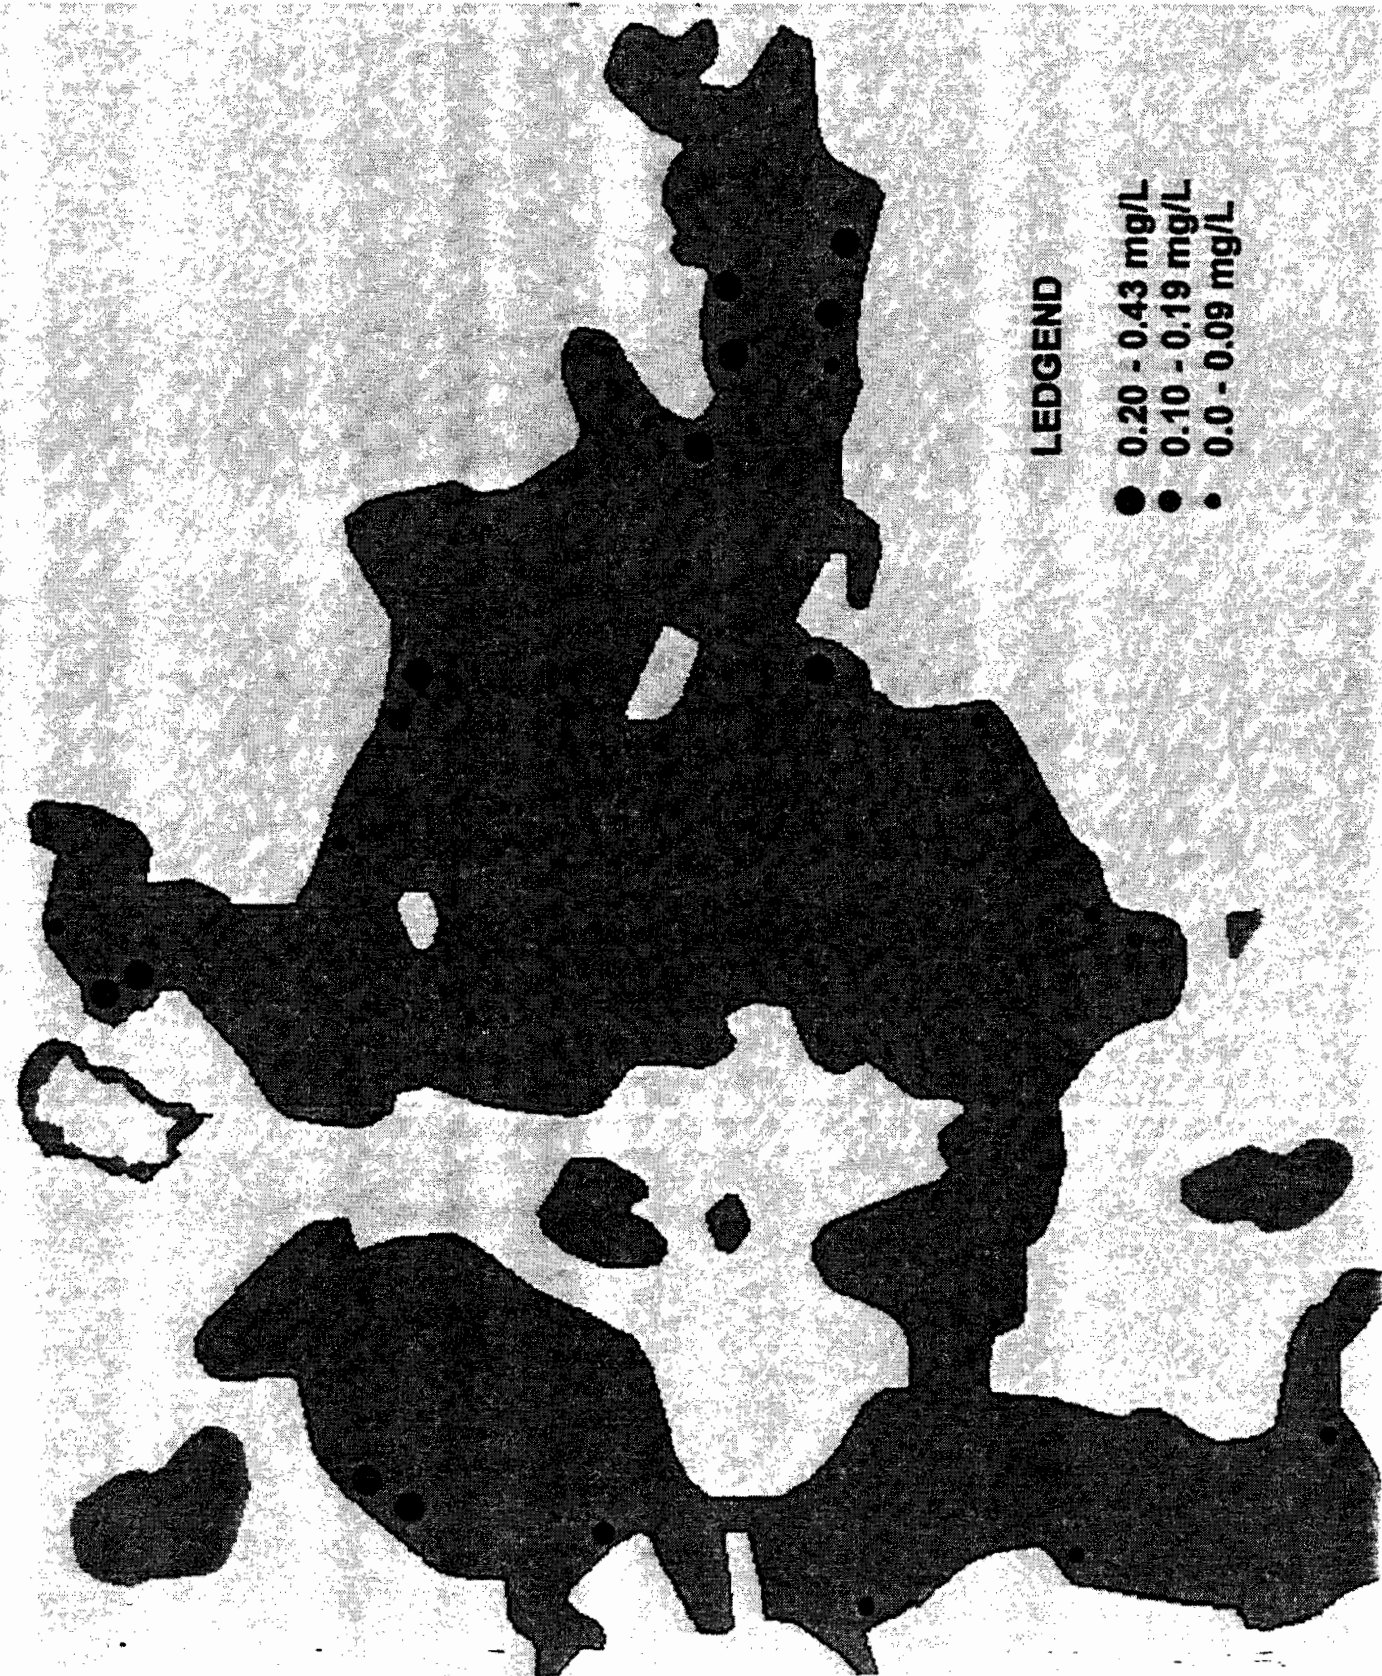
Figure 16

MINOCQUA LAKE WISCONSIN  
AMMONIUM FOUND IN SURFACE WATER SAMPLES
