**WETLAND DELINEATION REPORT**

**PROPOSED SANITARY SEWER ROUTE BETWEEN THE WEST  
BEND WASTEWATER TREATMENT PLANT & PROPOSED  
TRENTON ROAD**

**SE Quarter, Section 18, T11N, R20E  
CITY OF WEST BEND & TOWN OF TRENTON  
WASHINGTON COUNTY  
WISCONSIN**

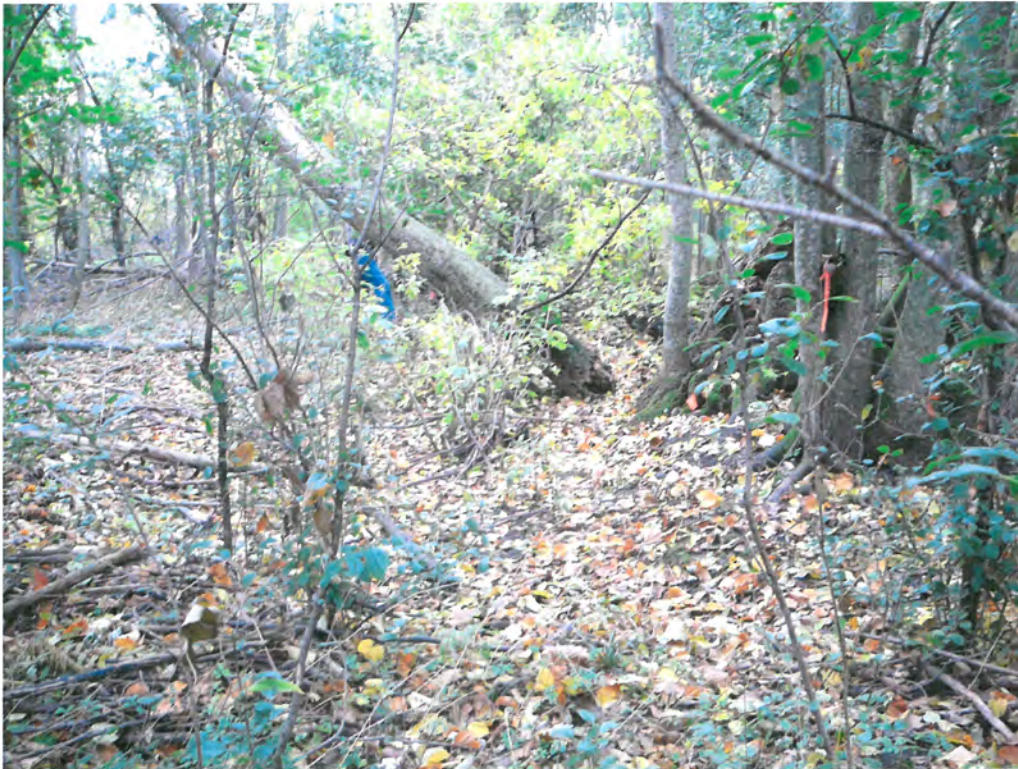
Photo 1. Northeast view from sampling point 1.

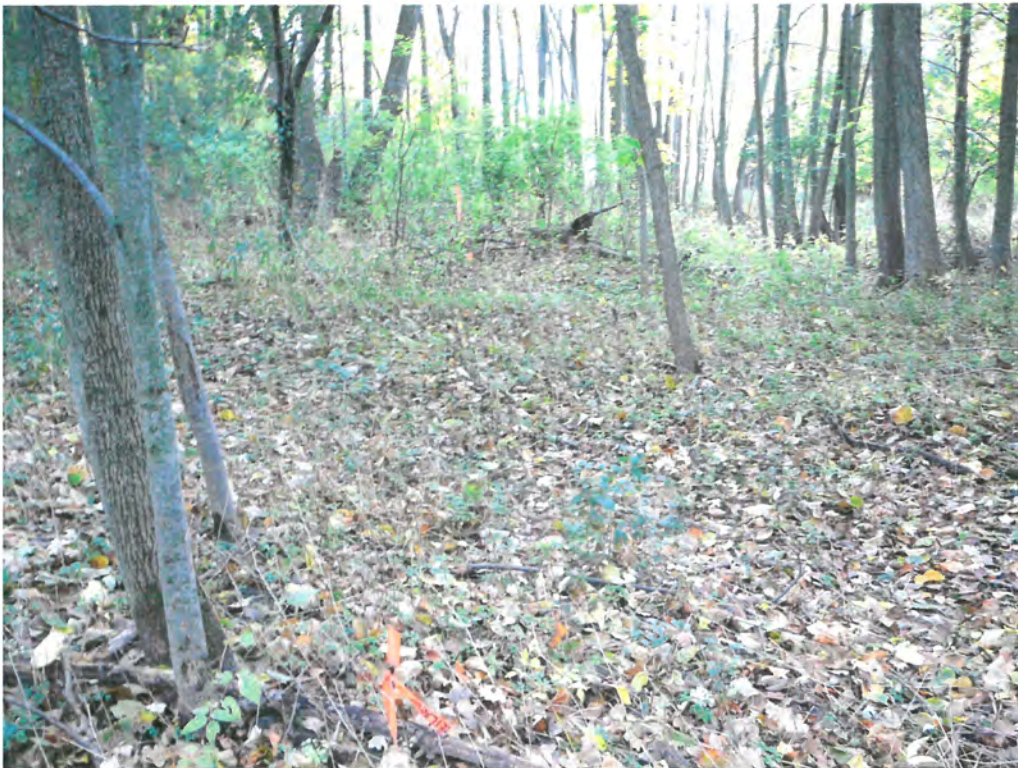
Photo 2. Southern view from sampling point 1.

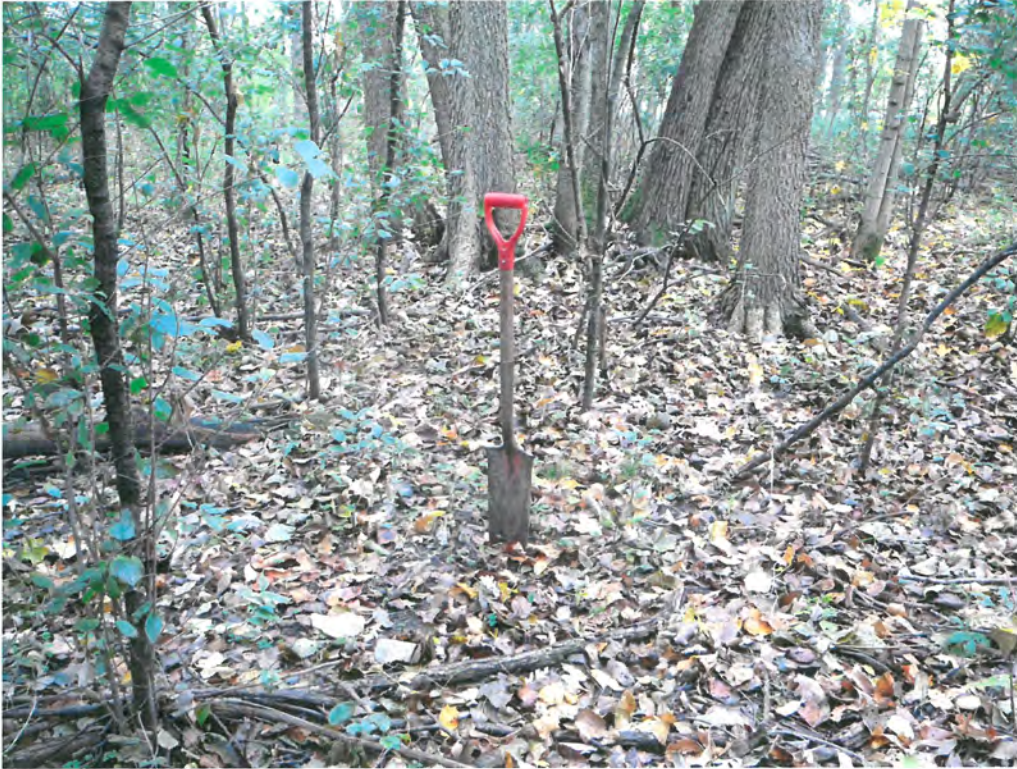
Photo 3. Mixed hardwood in Milwaukee River floodway at sampling point 2.

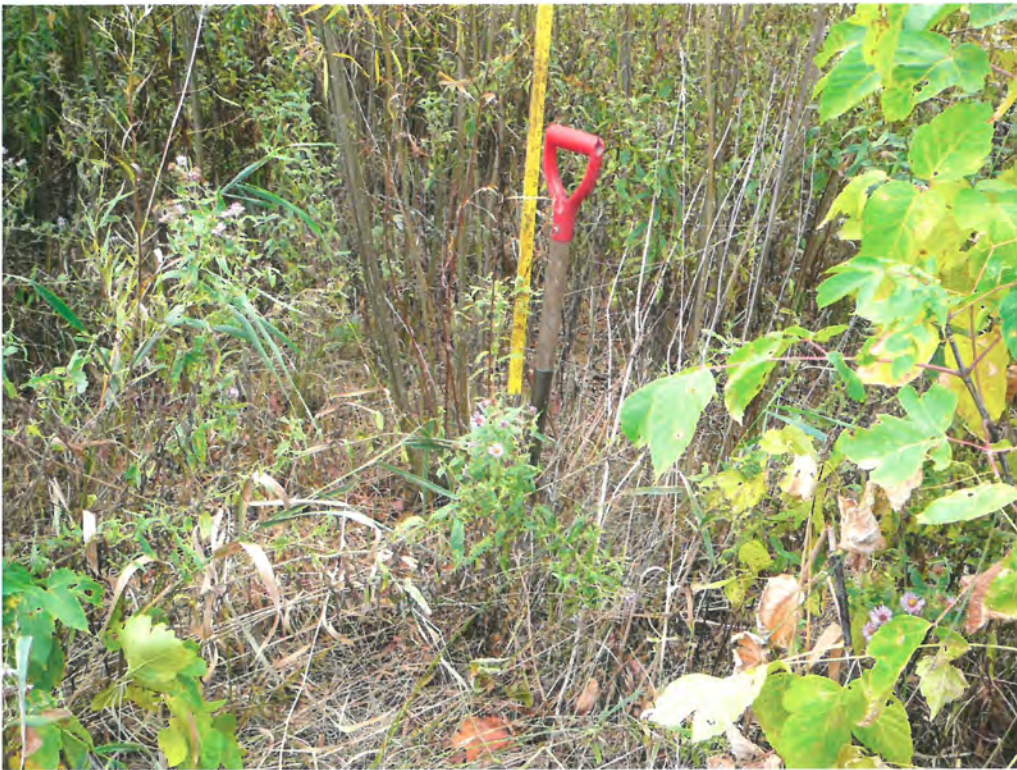
Photo 4. Fresh (wet) meadow and willow thicket at sampling points 4 and 5.

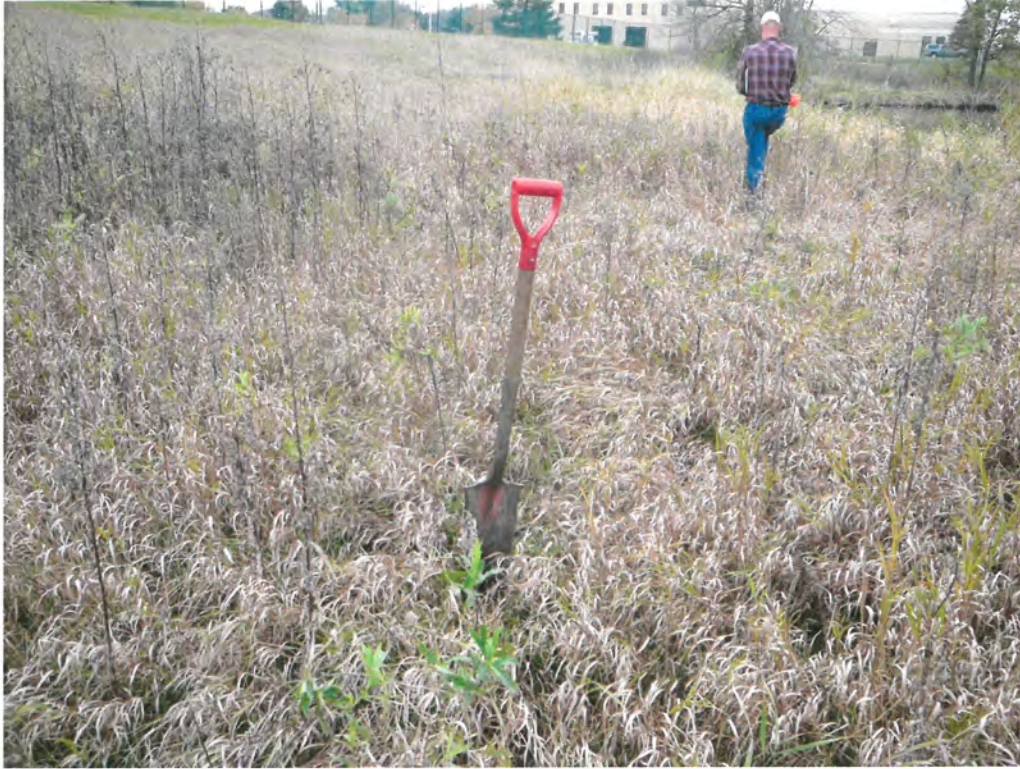
Photo 5. Western view from sampling point 6.

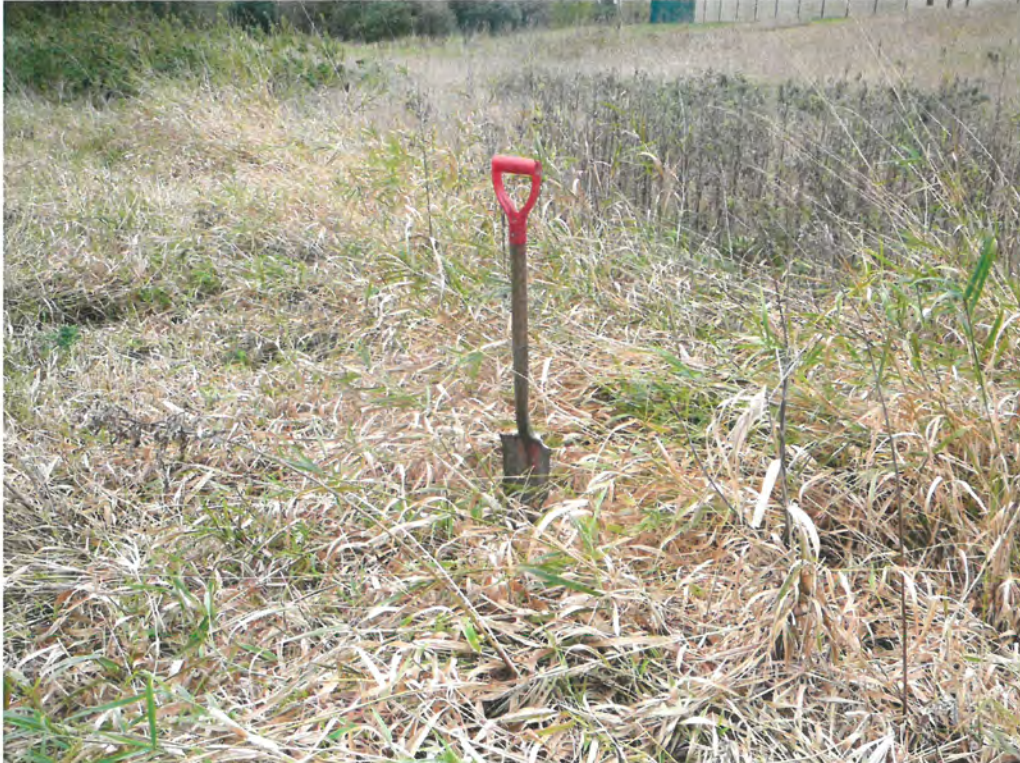
Photo 6. Bed of *Phalaris arundinacea* at sampling point 7.
