Lake Middleton Rehabilitation Report

PHEASANT BRANCH CREEK/BOAT LANDING RESTORATION FEASIBILITY STUDY

Prepared by: Nahn and Associates, L.L.C.

Date: May 18, 2005

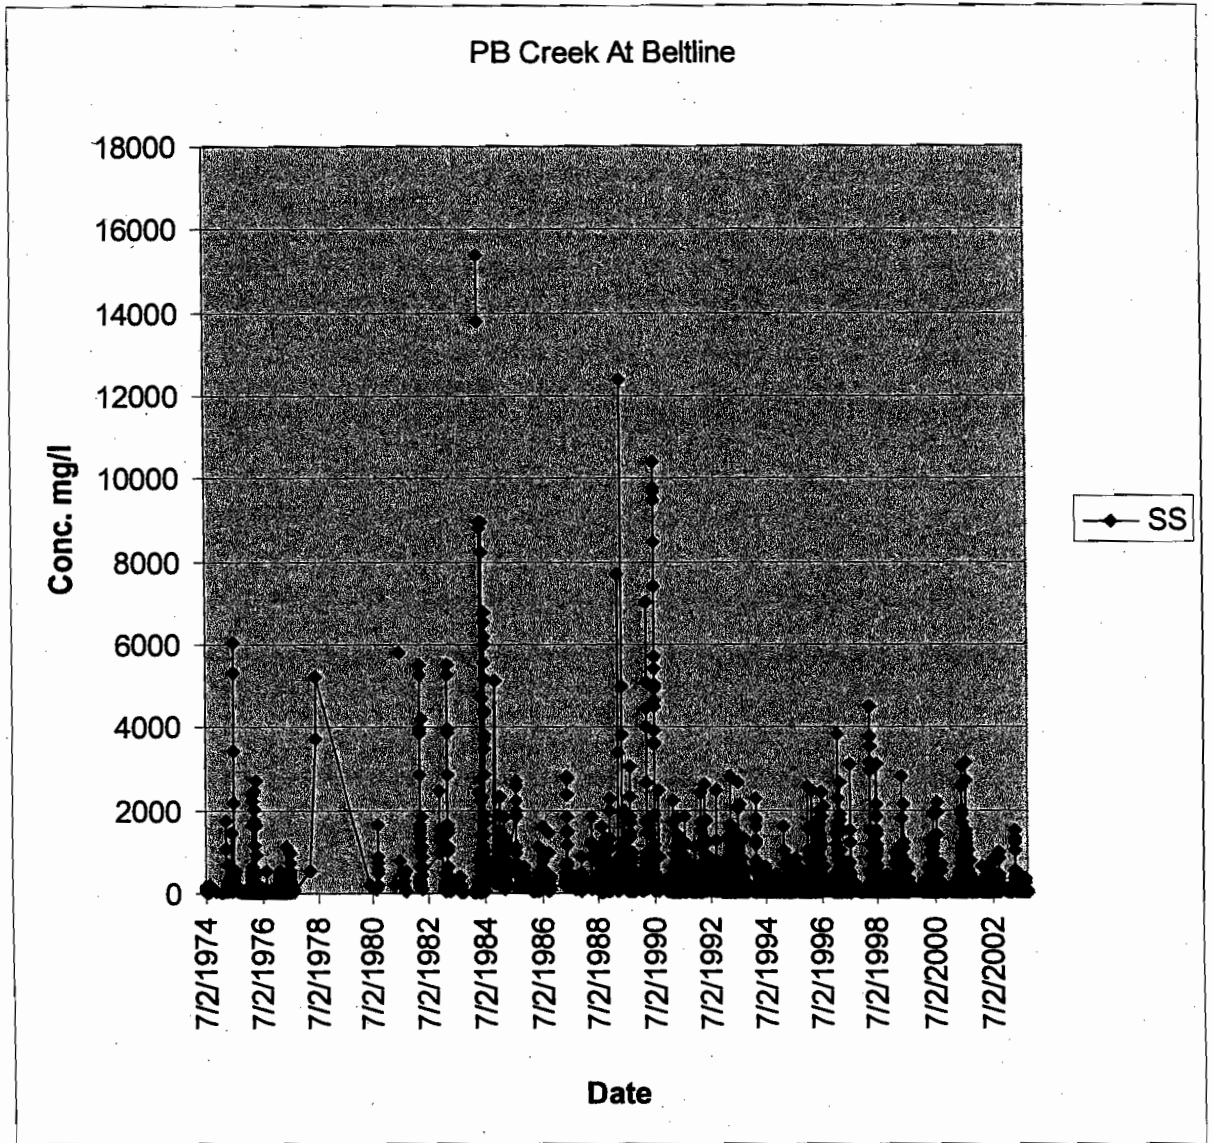
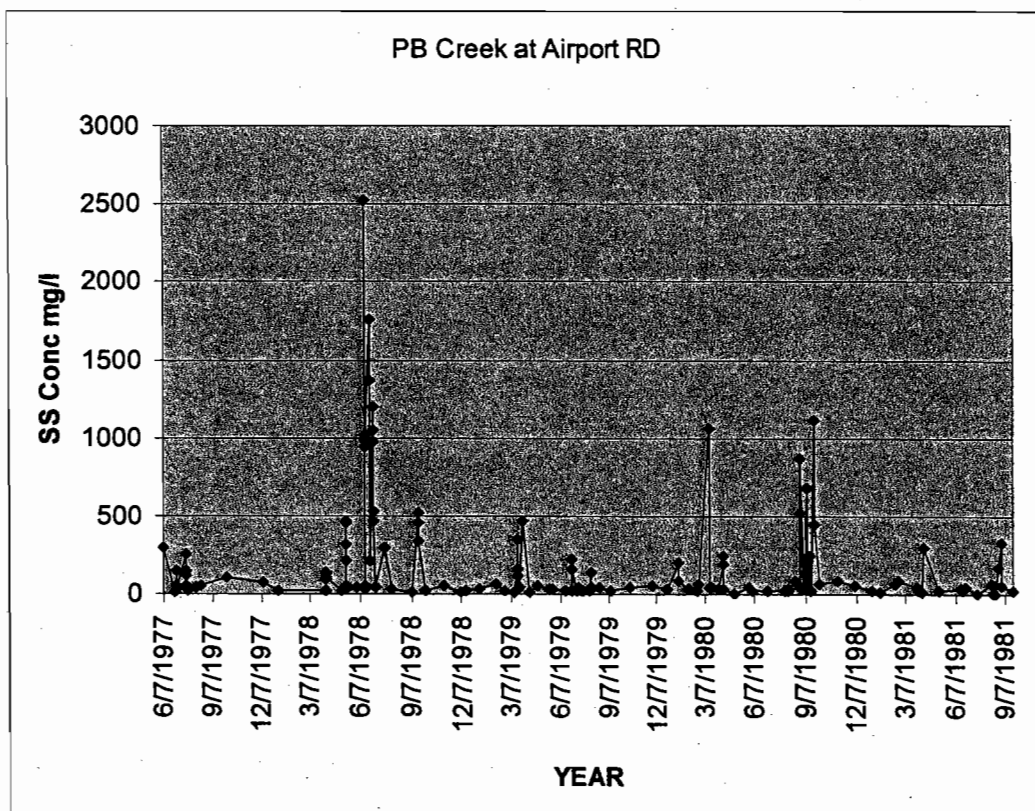
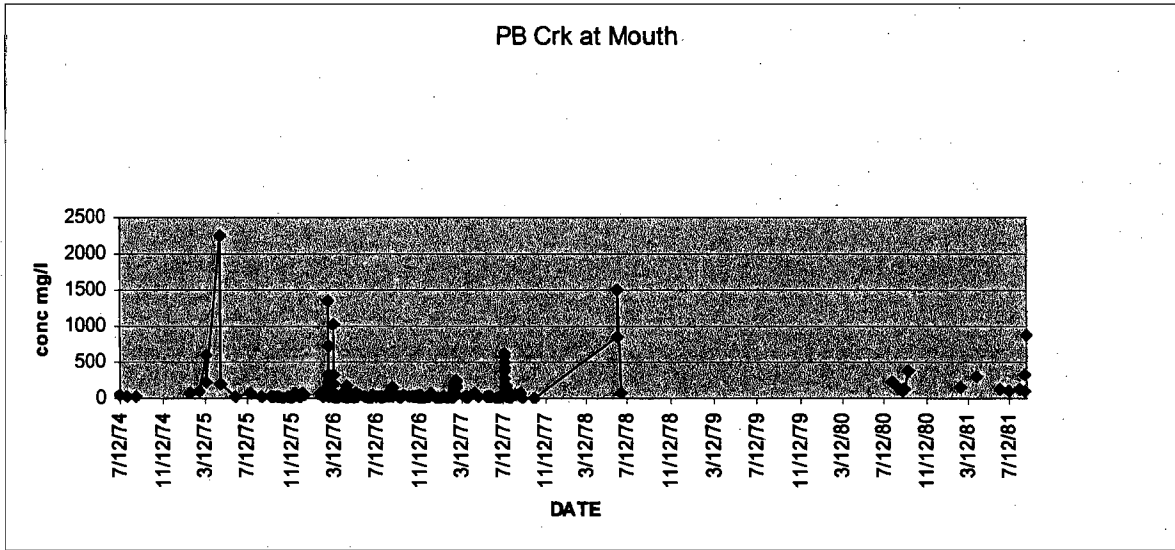
FIGURE 5a- RECORDED TSS CONCENTRATIONS AT 4 USGS GAGING STATIONS IN/NEAR MIDDLETON

FIGURE 5b(continued)- RECORDED TSS CONCENTRATIONS AT 4 USGS GAGING STATIONS IN/NEAR MIDDLETON

FIGURE 5c(continued)- RECORDED TSS CONCENTRATIONS AT 4 USGS GAGING STATIONS IN/NEAR MIDDLETON

FIGURE 5d(continued)- RECORDED TSS CONCENTRATIONS AT 4 USGS GAGING STATIONS IN/NEAR MIDDLETON

The locations of these stations are shown in Figure 4a-d. Figure 5a-d shows the TSS concentration data collected at these stations since 1974.

2. **Sediment transport is consistent throughout the creek to the marsh** - For the overlapping period of record for the four stations from 1974 to 1981, the large peaks in suspended sediment concentration coincide with each other. These peaks are large rainfall events which increase the suspended sediment concentration throughout the creek.

3. **The marsh acted as a sediment sink during spring and summer months.**- In comparing the concentration of suspended sediment moving in the downstream direction, the concentrations at the mouth shows a large decrease indicating that the marsh was trapping sediment during the late 70's and early 80's. The USGS report estimates that 4000 tons of sediment was trapped in the marsh from 1978 to 1981 and for larger storms as much as 80% of the sediment load was reduced. Unfortunately, no data exists currently at the mouth to give an indication of how the marsh is functioning currently as a sink.
