**Subject: 2008 Purple Loosestrife Report for Holcombe Hydro (P-1982),
Cornell Hydro (P-2639), Jim Falls Hydro (P-2491), Wissota
Hydro (P-2567), Chippewa Falls Hydro (P-2440) and Dells
Hydro (P-2670)**

PURPLE LOOSESTRIFE ASSESSMENT – 2008

**Dells Pond, Chippewa Falls Flowage, Lake Wissota, Old Abe Lake,
Cornell Flowage and Lake Holcombe**

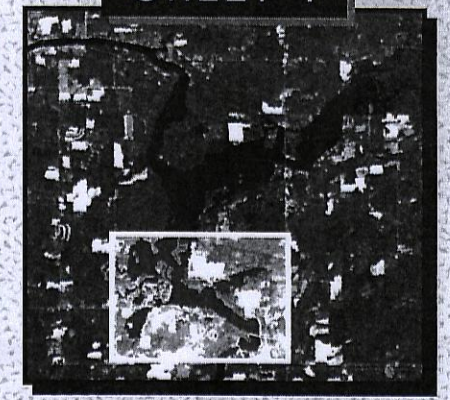
SHEET 1

A single plant was seen at a private residence at the end of 274th Ave (Sheet 1). And three plants were seen among the backwater complex near 272nd Ave. Two of these four location have been noted on and off over the last few years; the other two are new plant locations. All four of these locations are on private lawn areas.

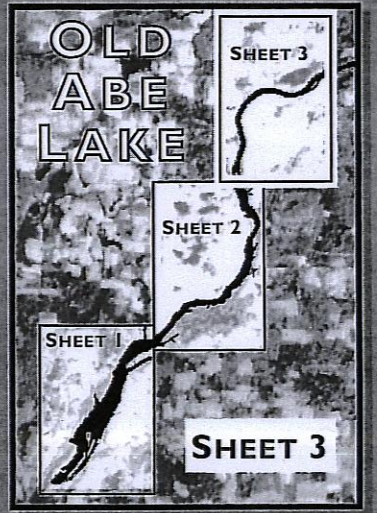
OLD ABE LAKE

Four small loosestrife infestations were found on the upper portion of Old Abe Lake (see Old Abe Lake Bathymetric Map - Sheet 3). Two of these are the exact same locations noted during last year's survey. Both of the locations were on the west shoreline; the upstream location consisting of a single loosestrife plant, and the downstream location consisting of 3 plants spread over 20 feet of shoreline. The two new locations were single plants located on the east shoreline. None of the purple loosestrife locations on Cornell Flowage are on Xcel Energy lands. The total amount of shoreline affected by purple loosestrife on Old Abe Lake is less than 25 feet.

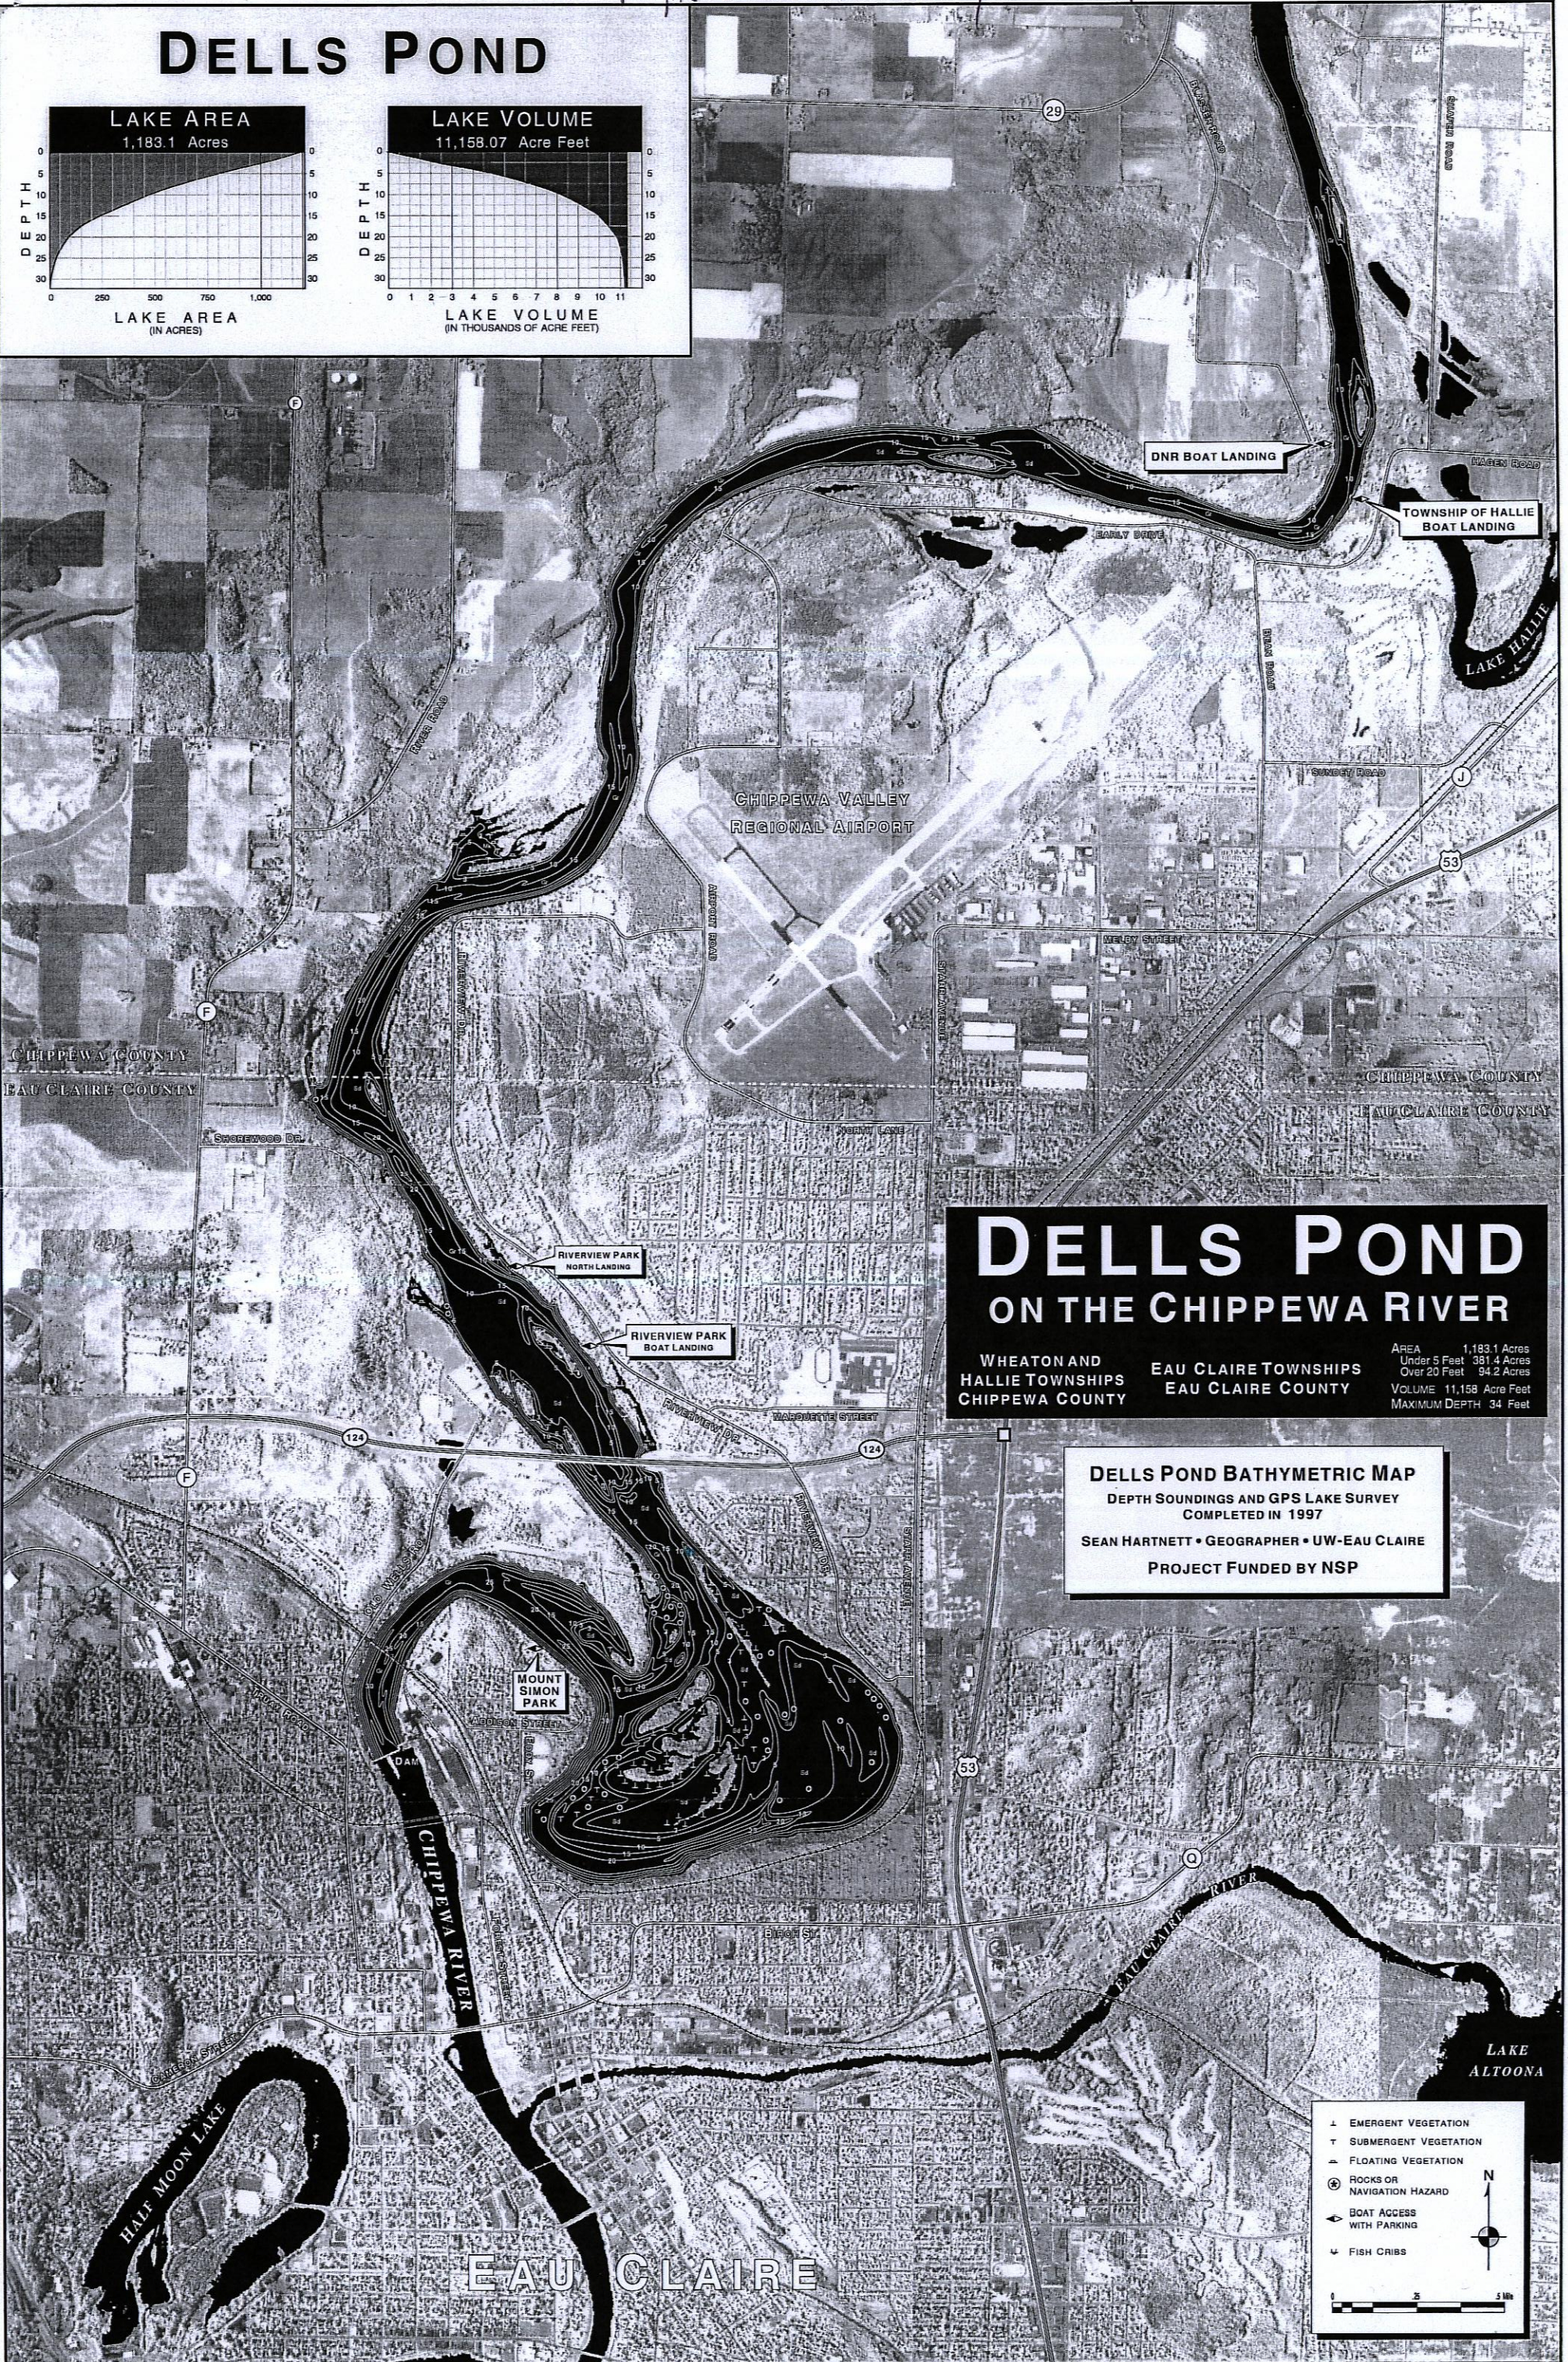
DELLS POND

A single purple loosestrife plant was found on Dells Pond. This plant was observed on one of the islands just downstream from the Highway 312 bridge (see Dells Pond Map). Loosestrife plants were noted (and treated) in this location in 2005, but not in 2006; and three plants were seen in 2007. It is common for purple loosestrife to grow some years and lie dormant during others. This island is owned by NSP, and this loosestrife plant was treated with herbicide.
