**Re: Grandmother Falls Hydroelectric Project, FERC License No. 2180 – Exotic Species Monitoring Report for CY2008**

# GRANDMOTHER FALLS HYDROELECTRIC DAM

FERC PROJECT 2180-WISCONSIN

## EXOTIC SPECIES MONITORING REPORT YEAR 5 – 2010

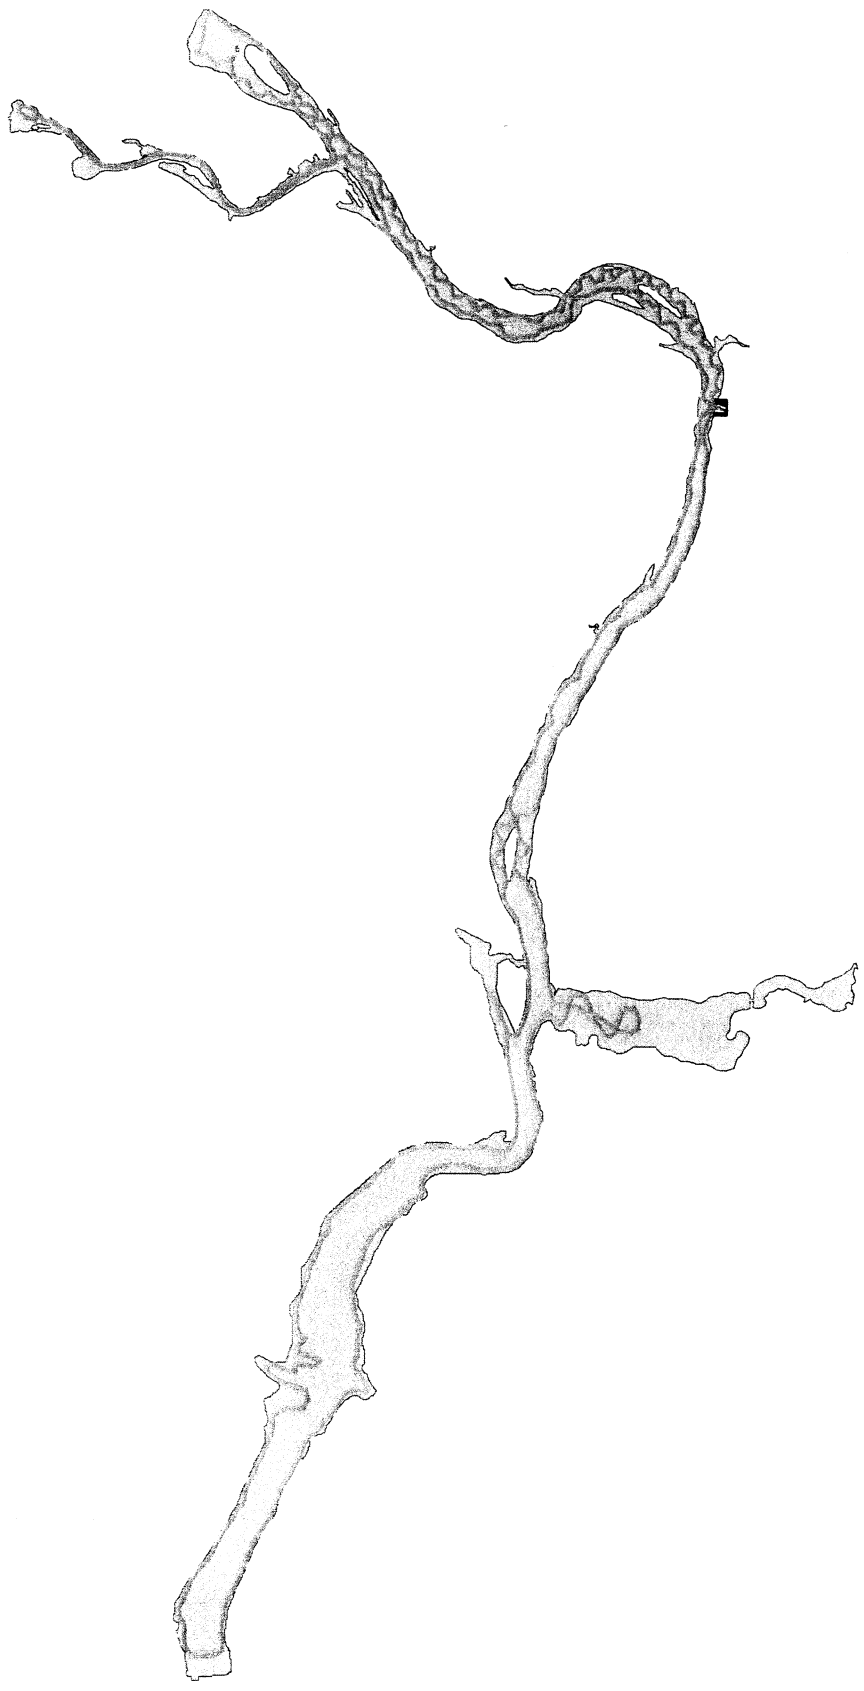
## Map 2

- Legend**
- Survey Path  
(Points recorded along line at 30-second intervals)
  - Public Access

**Grandmother Falls  
Flowage**  
Lincoln, County Wisconsin  
**Curly-leaf Pondweed  
Survey Track**

No colonies of curly-leaf pondweed were encountered during the meander survey conducted on June 10, 2010. To document the mid-June survey, GPS tracking logs were automatically recorded and are displayed on Map 2.

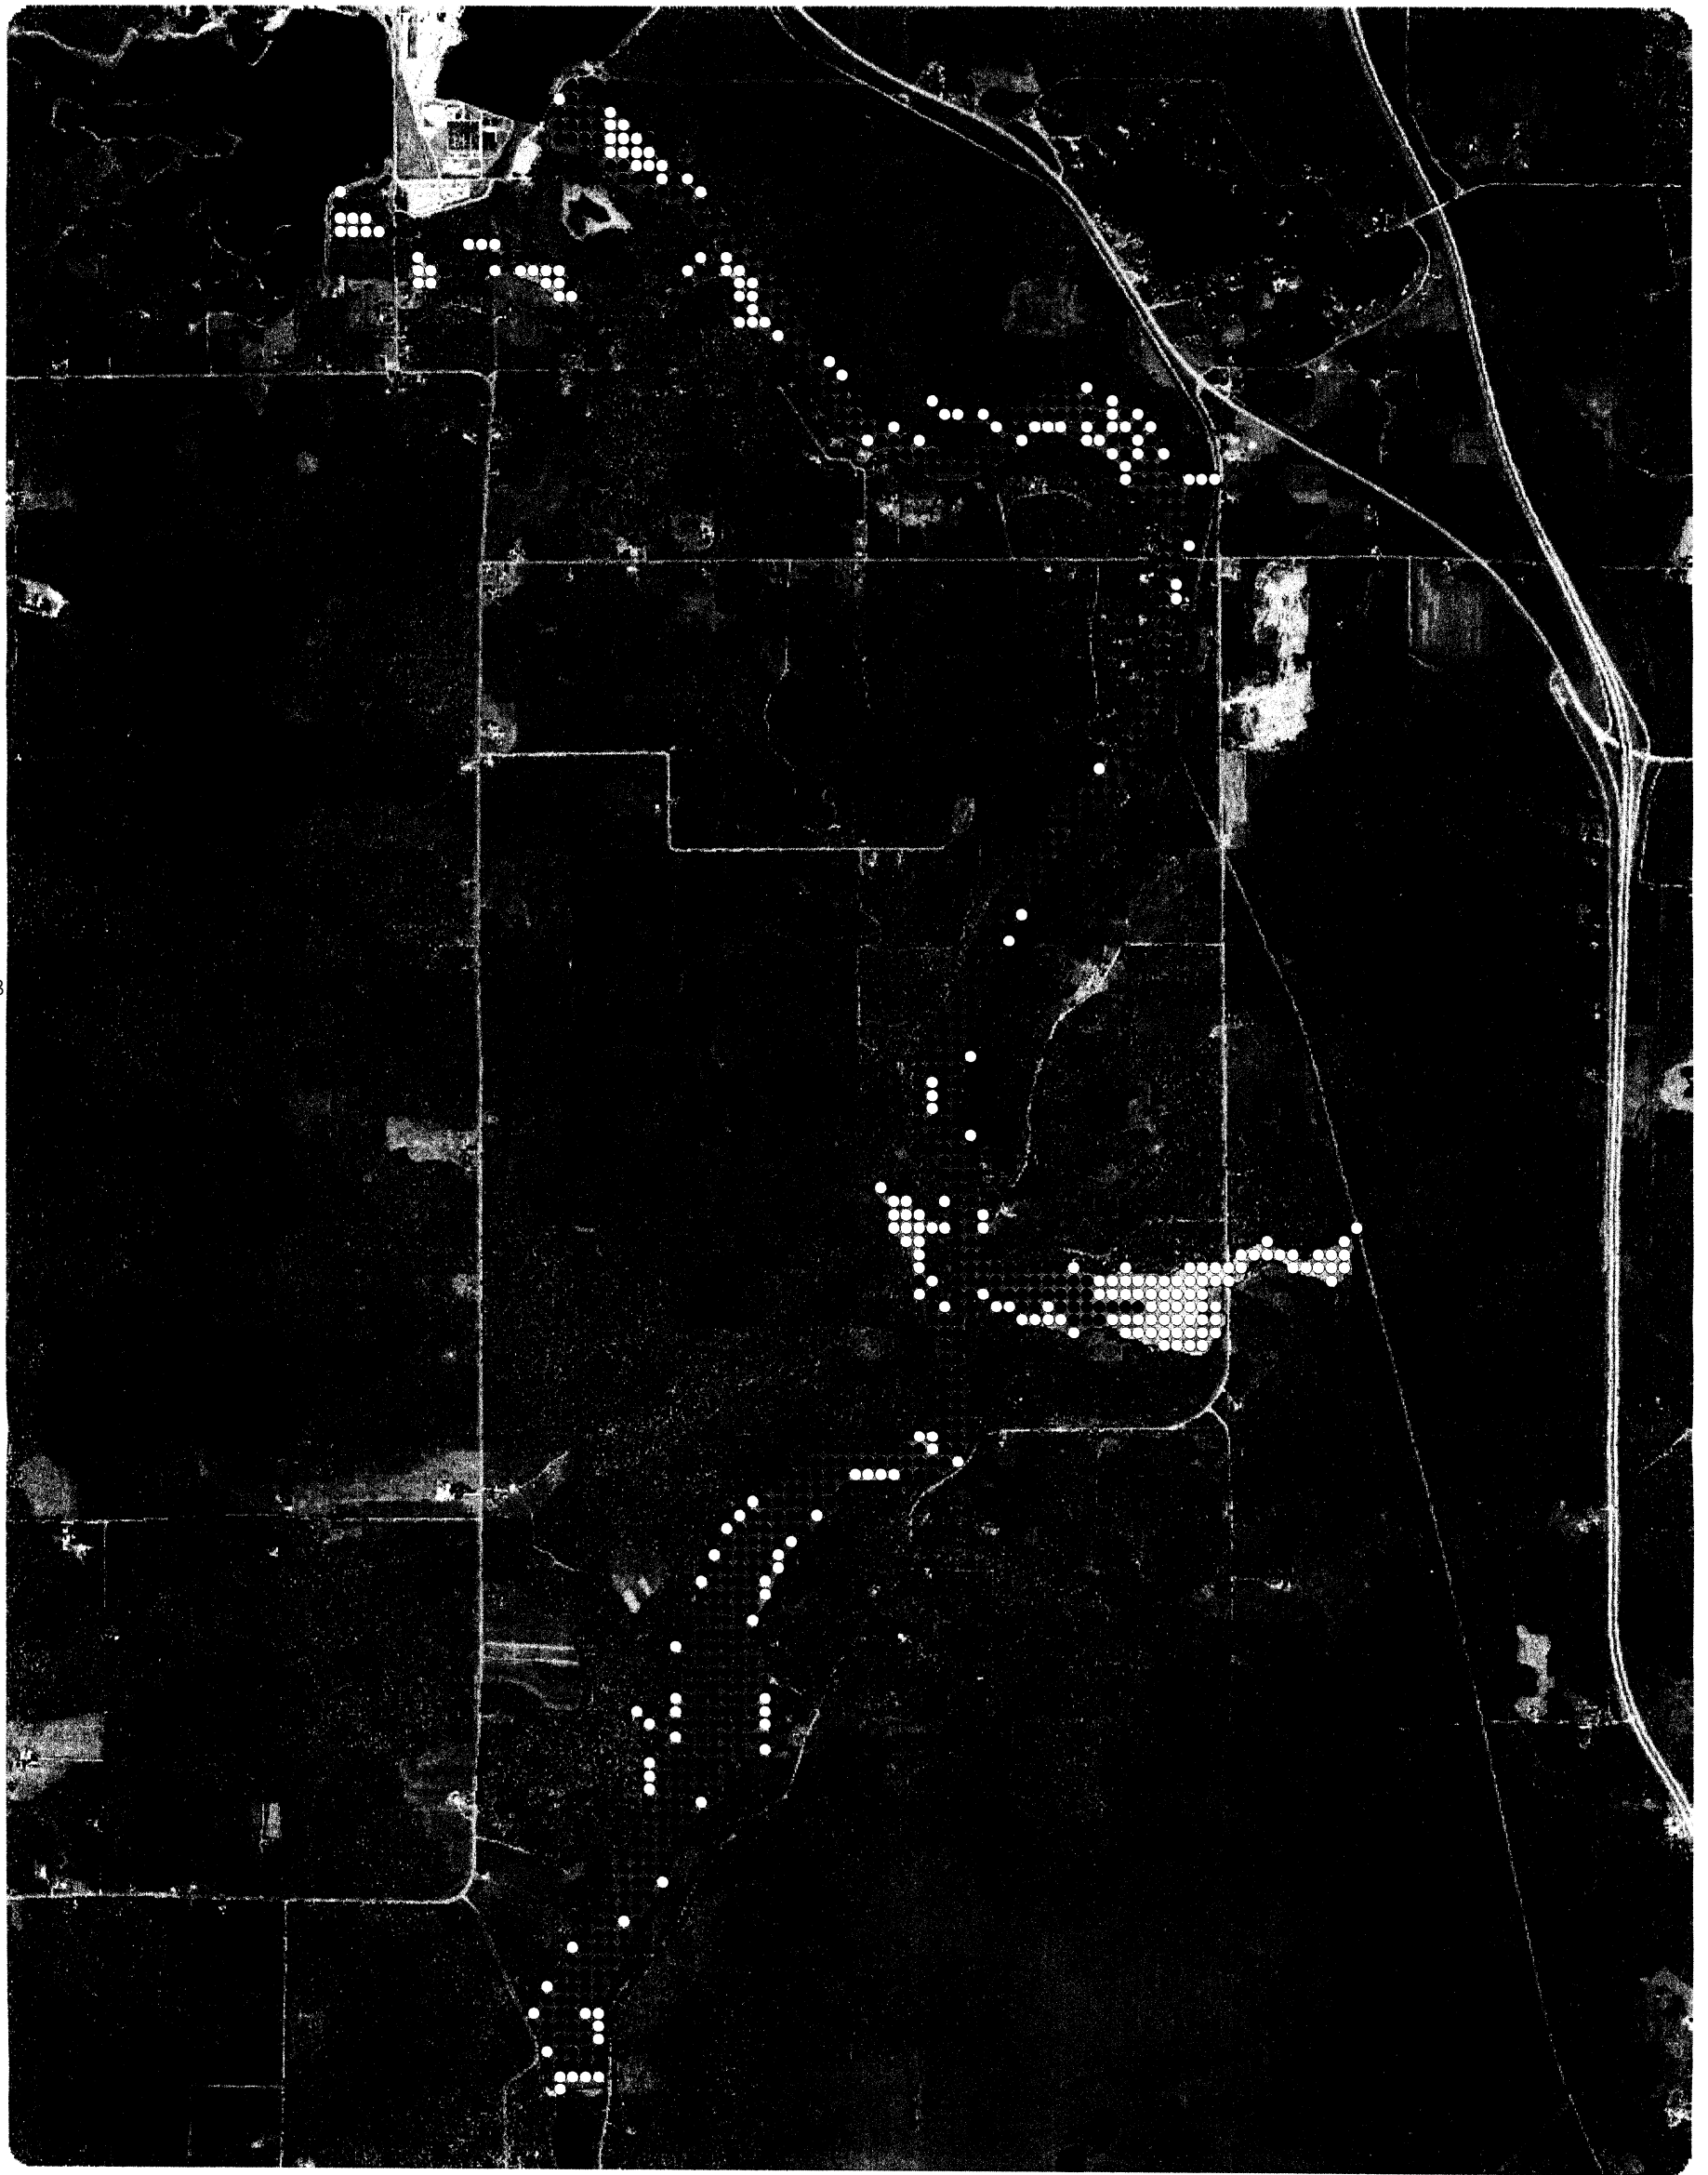
## Map 3

- Contains EWM
- Visited
- Not Visited
- Too Deep
-

### Base Point-Intercept Locations

A total of 885 points were selected within the project waters based on WDNR guidelines; however, only 458 of these points were surveyed due to existing field conditions. The remaining 427 points were either inaccessible by boat ("not visited") or they were at depths of  $\geq 10$  feet ("too deep"), beyond the depth of plant growth (Map 3).
