Little Quinnesec Falls Hydroelectric Project, FERC No. 2536 – Article 409, 2007 Exotic Species Report

**Monitoring The Little Quinnesec Falls Hydroelectric
Project for Eurasian Water Milfoil and Purple Loosestrife
FERC Hydro Project No. 2536, Little Quinnesec Falls**

Date: October 2007

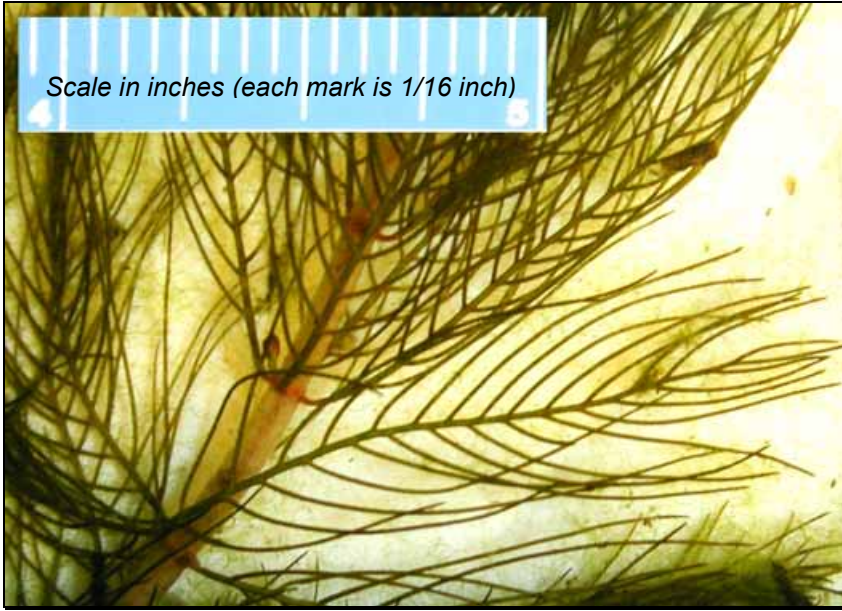
Photo 1. *Mryiophyllum spicatum* (Eurasian water milfoil) with a typical number of leaflets (14 on this specimen -counting on one side of the leaf).

As in past years of monitoring at the Little Quinnesec Falls project area, the plants identified as Eurasian water milfoil exhibit considerable morphological variation. The numbers of leaflets are sometimes intermediate between the northern water milfoil and the Eurasian water milfoil. Appendix B presents photos that illustrate some of the variability (these photos were taken during the 2006 survey).

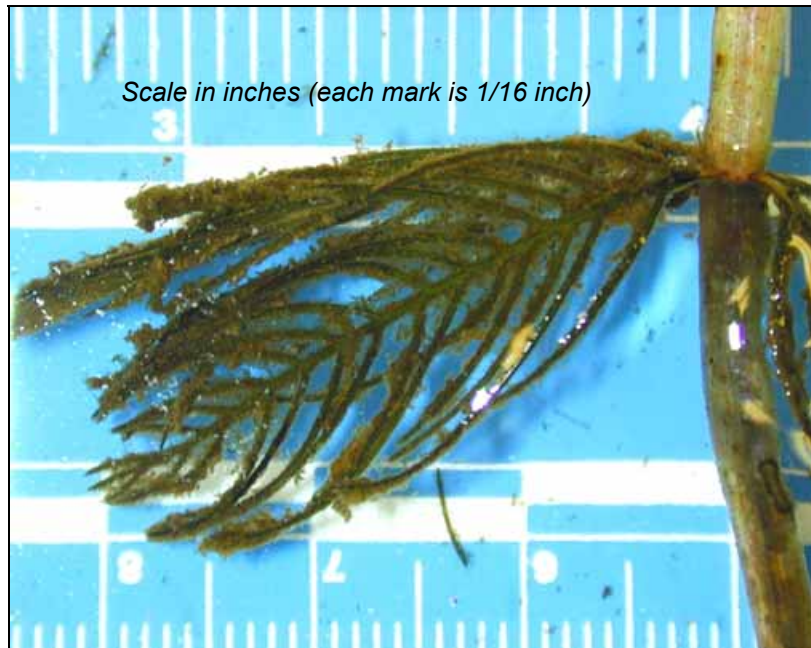
Photo 3. Eurasian water milfoil leaf with a typical number of leaflets and some calcium precipitate encrusting the leaf (this specimen was from the human-made channel designated Location D on Figure 1).

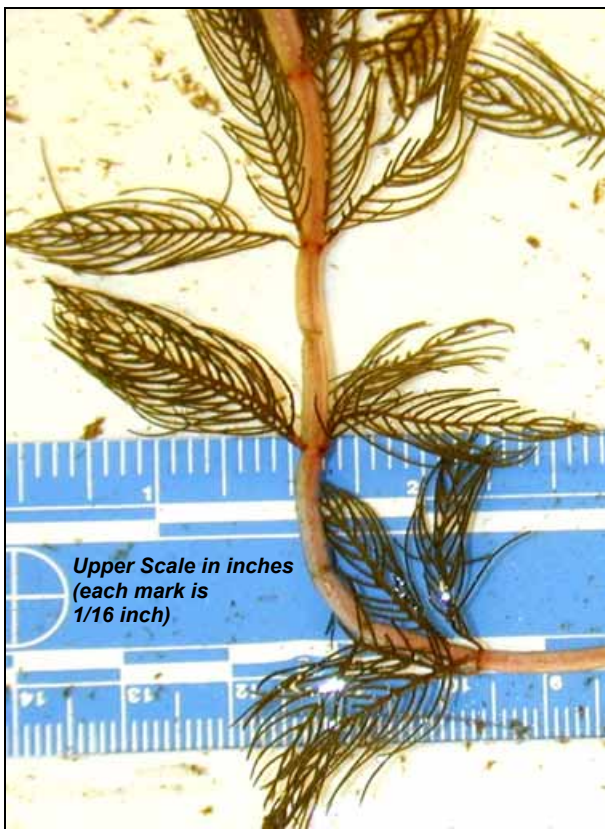
Photo 4. Eurasian water milfoil leaf displaying no evidence of weevil damage to the stems. (Despite careful inspection, no weevil evidence was detected on Eurasian water milfoil in the Little Quinnesec Falls population.)
