Subject: Site Inspection Summary and Required Follow Up

## **Inspection Report – Well Contamination Investigation (10/03/14, revised 12/30/14)**

Date: September 12, 2014  
Farm Owner: Charles Preisler  
Site Address: N2247 CTH T, NE¼ SE¼ S4 T21N R15E, Town of Hortonia (Outagamie County)  
DNR Staff: Erin Hanson, Nonpoint Source Coordinator – Northeast Region

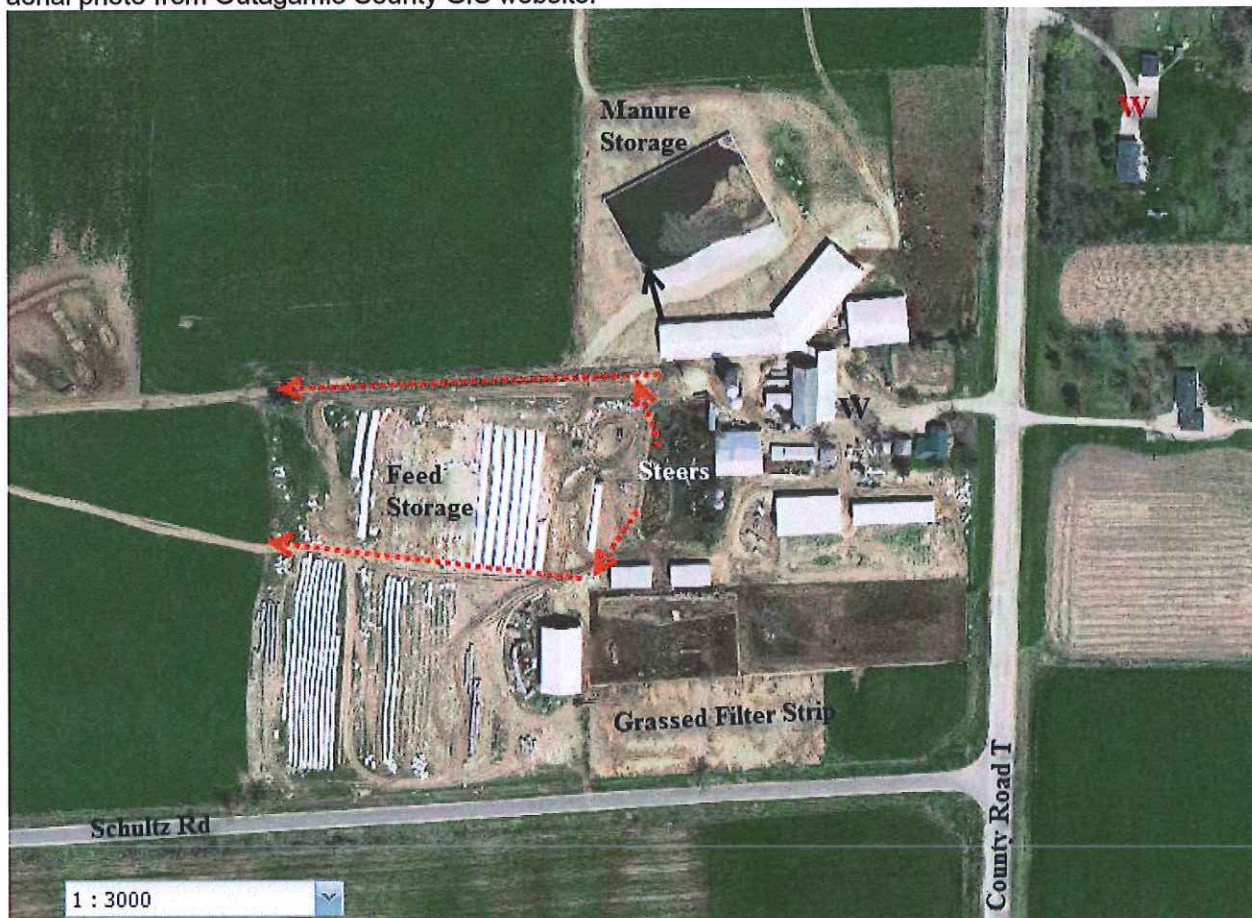
Photo 1. Site overview showing approximate locations of contaminated well (red W), old abandoned well (black W), new manure storage and temporary transfer pipe (black arrow) and approximate manure runoff paths (red arrows). 2014 aerial photo from Outagamie County GIS website.

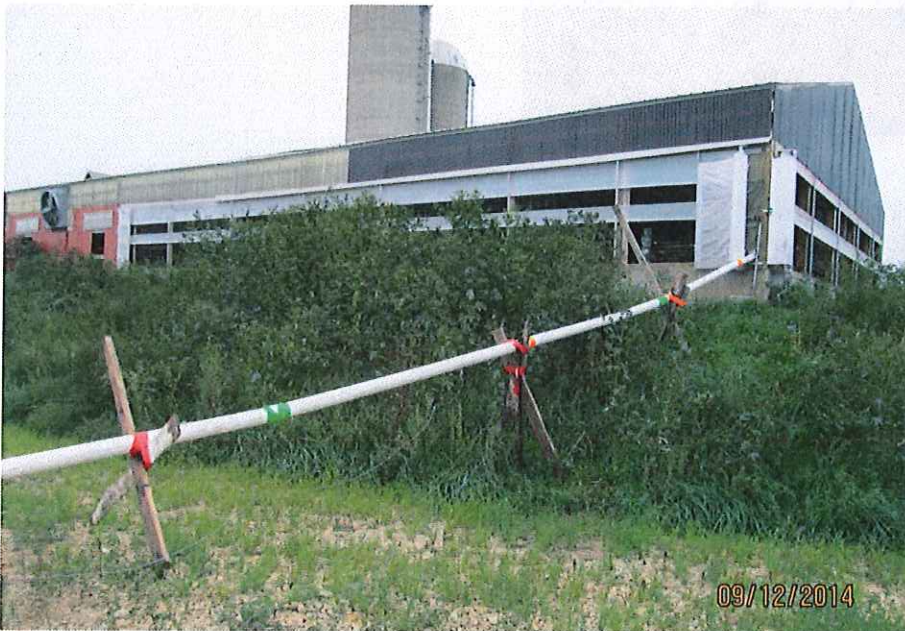
In 2013 federal EQIP funds and a state TRM grant provided cost share for new manure storage and associated waste transfer systems at the farm. Poweleit worked on the design and construction and said construction met the NRCS 313 standard. Preisler said the manure transfer pump in the barn doesn't work properly so he has been using a temporary pipe to direct liquid manure to the storage (photos 2 and 3) and land spreading solid manure. Hanson saw spilled manure at the southwest corner of the barn where Preisler had been loading spreaders and a clear runoff path from the barn to the west (photo 4). Baneck and Poweleit said that there is a closed depression in the field to the west and bedrock is shallow in the general area, indicating that the manure runoff is a serious runoff concern.

Photo 2: South end of temporary manure transfer system from the barn to manure storage. Preisler needs to repair the manure transfer systems and stop using the temporary transfer pipe.

- 1) Preisler will stop using the temporary, inadequate manure transfer pipe and return both manure transfer systems to a functional status.
- 2) Preisler and Outagamie County will repair joints in new manure storage to ensure no further manure leaks from the storage. Outagamie County will examine the manure storage at that time to identify if additional repair is needed.

Hanson told Preisler that he was required to maintain the manure transfer systems as designed and installed because of the cost share requirements and concerns about contaminated runoff. Outagamie County offered to work with Preisler if he needed assistance with the repairs.

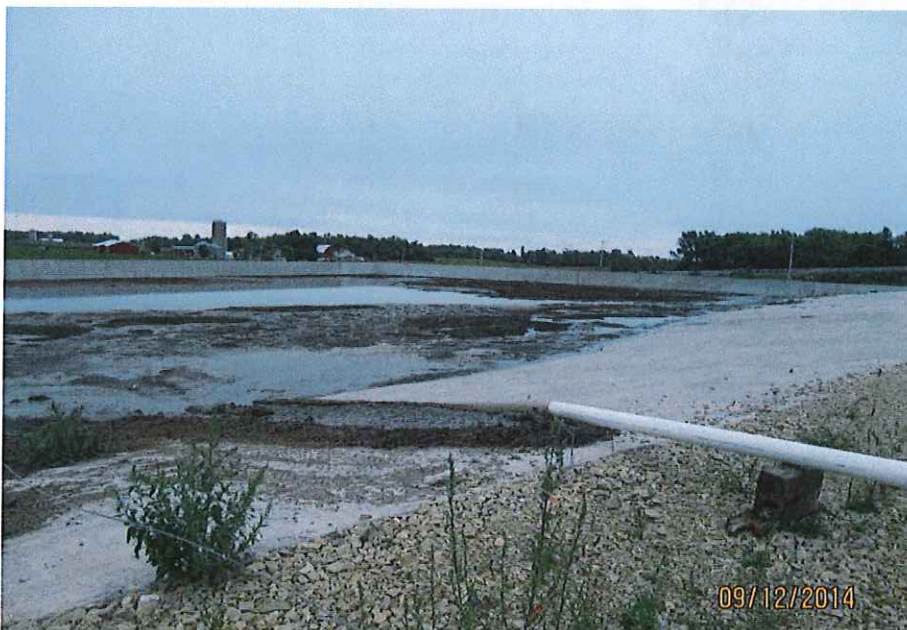
Photo 3: North end of temporary manure transfer pipe as it enters the manure storage.

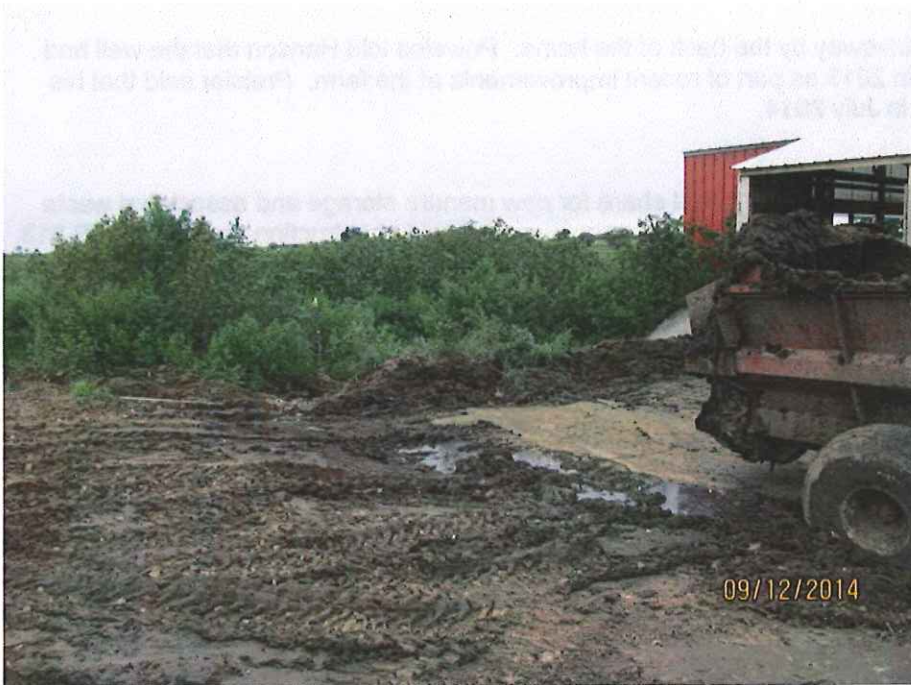
Photo 4: Manure solids at southeast corner of the barn. Runoff drains through the vegetated area seen in the photo and to the west.

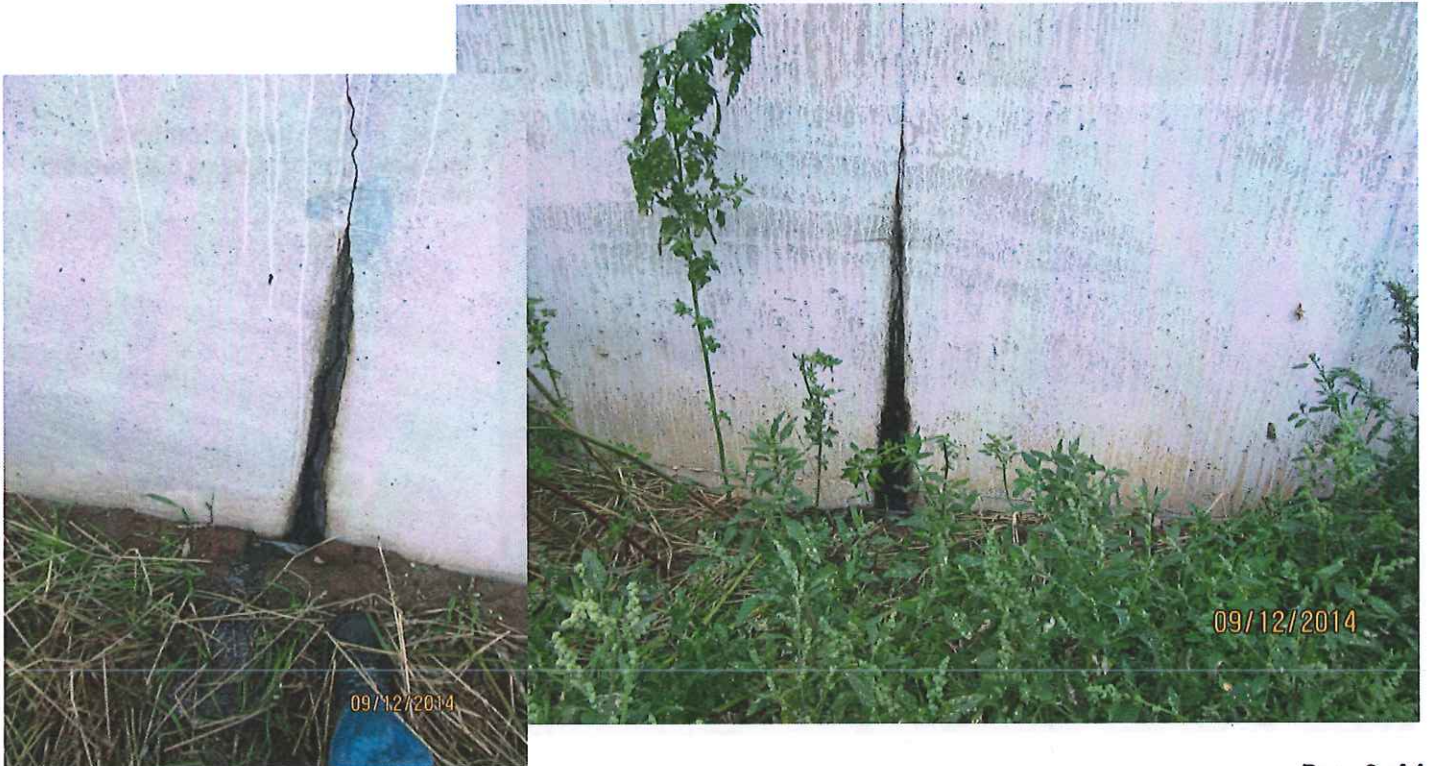
Preisler said the storage has been leaking from the concrete joints since it was installed. Poweleit, Baneck, and Hanson walked the perimeter of the storage and identified staining and ponded liquids on the ground adjacent to the storage in many locations (photos 4 and 5). Baneck said that repairs could be completed with a caulk that is injected into the cracks. Baneck and Poweleit offered to work with Preisler to repair the manure storage. Hanson told Preisler that this was required as part of the cost share requirements and concerns about contaminated liquids seeping into groundwater.

Photos 5 and 6: Dark stains and ponded manure at two of many similar locations on the exterior of the manure storage.

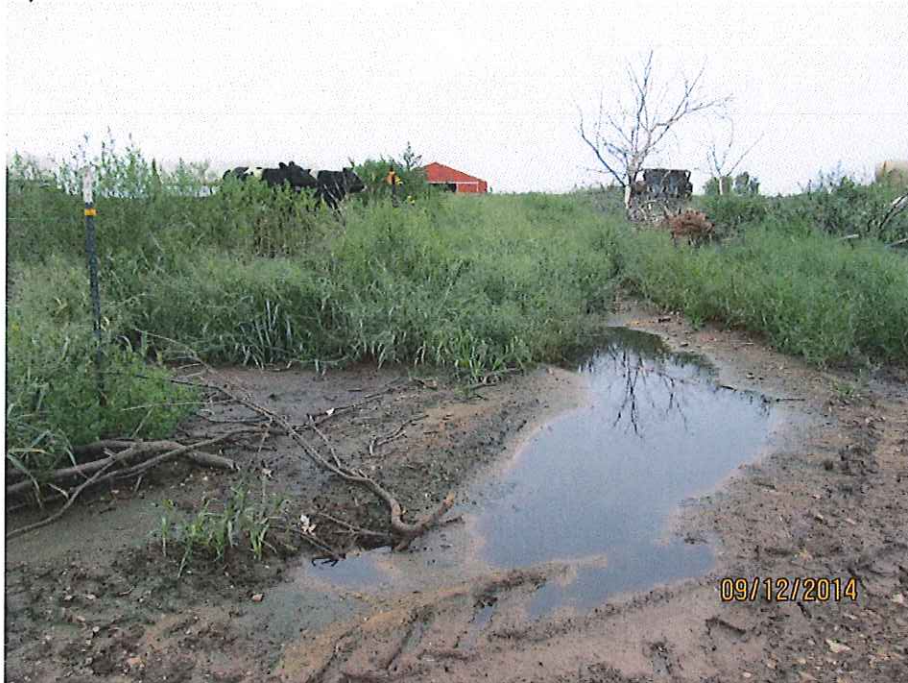
Preisler had previously worked with Outagamie County to install a grassed filter strip south of the heifer lots along Schultz Rd. He indicated that he was also willing to work with them to address remaining areas of concern on the farm, including runoff from the steer lot immediately south of the barn. Approximately 50-60 steers are kept on the earthen lot with no runoff controls. Contaminated runoff drains primarily to the west on both the north and south of the feed storage area (photos 1, 7 & 8). Feed is kept in silage bags on bare ground with no leachate runoff controls. Improved management of these areas could reduce the risk of runoff. Outagamie County is also willing to apply remaining TRM grant funds towards a permanent solution.

Photo 7: Ponded runoff from the steer lot in the driveway that eventually drains towards a closed depression to the west.

- 3) Preisler will work with Outagamie County to continue planning and install runoff controls for other areas of concern on the farm. Work may be completed with funding from the existing TRM grant that expires in December 2015.

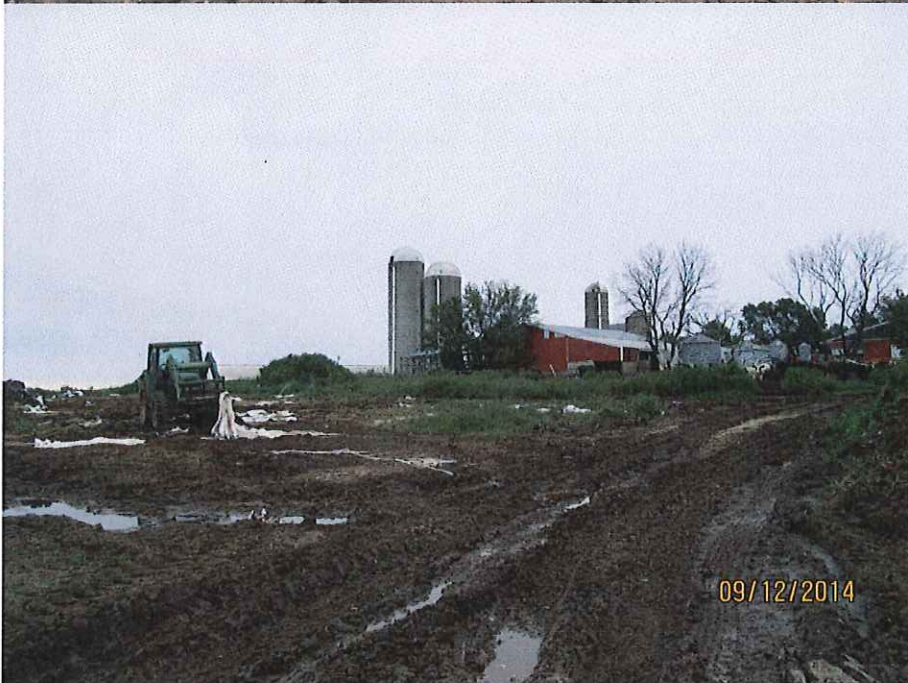
Photo 8: Looking east towards the steer lot (photo right) from the feed storage area. Runoff from this area also drains towards a closed depression to the west.
