**Subject: 2015 Purple Loosestrife Monitoring Report  
Holcombe Hydro (P-1982), Cornell Hydro (P-2639), Jim Falls Hydro (P-2491),  
Wissota Hydro (P-2567), Chippewa Falls Hydro (P-2440) and Dells Hydro (P-  
2670)**

***PURPLE LOOSESTRIFE ASSESSMENT – 2015***

**Dells Pond, Chippewa Falls Flowage, Lake Wissota, Old Abe Lake, Cornell  
Flowage, Lake Holcombe and Jim Falls Spillway Channel**

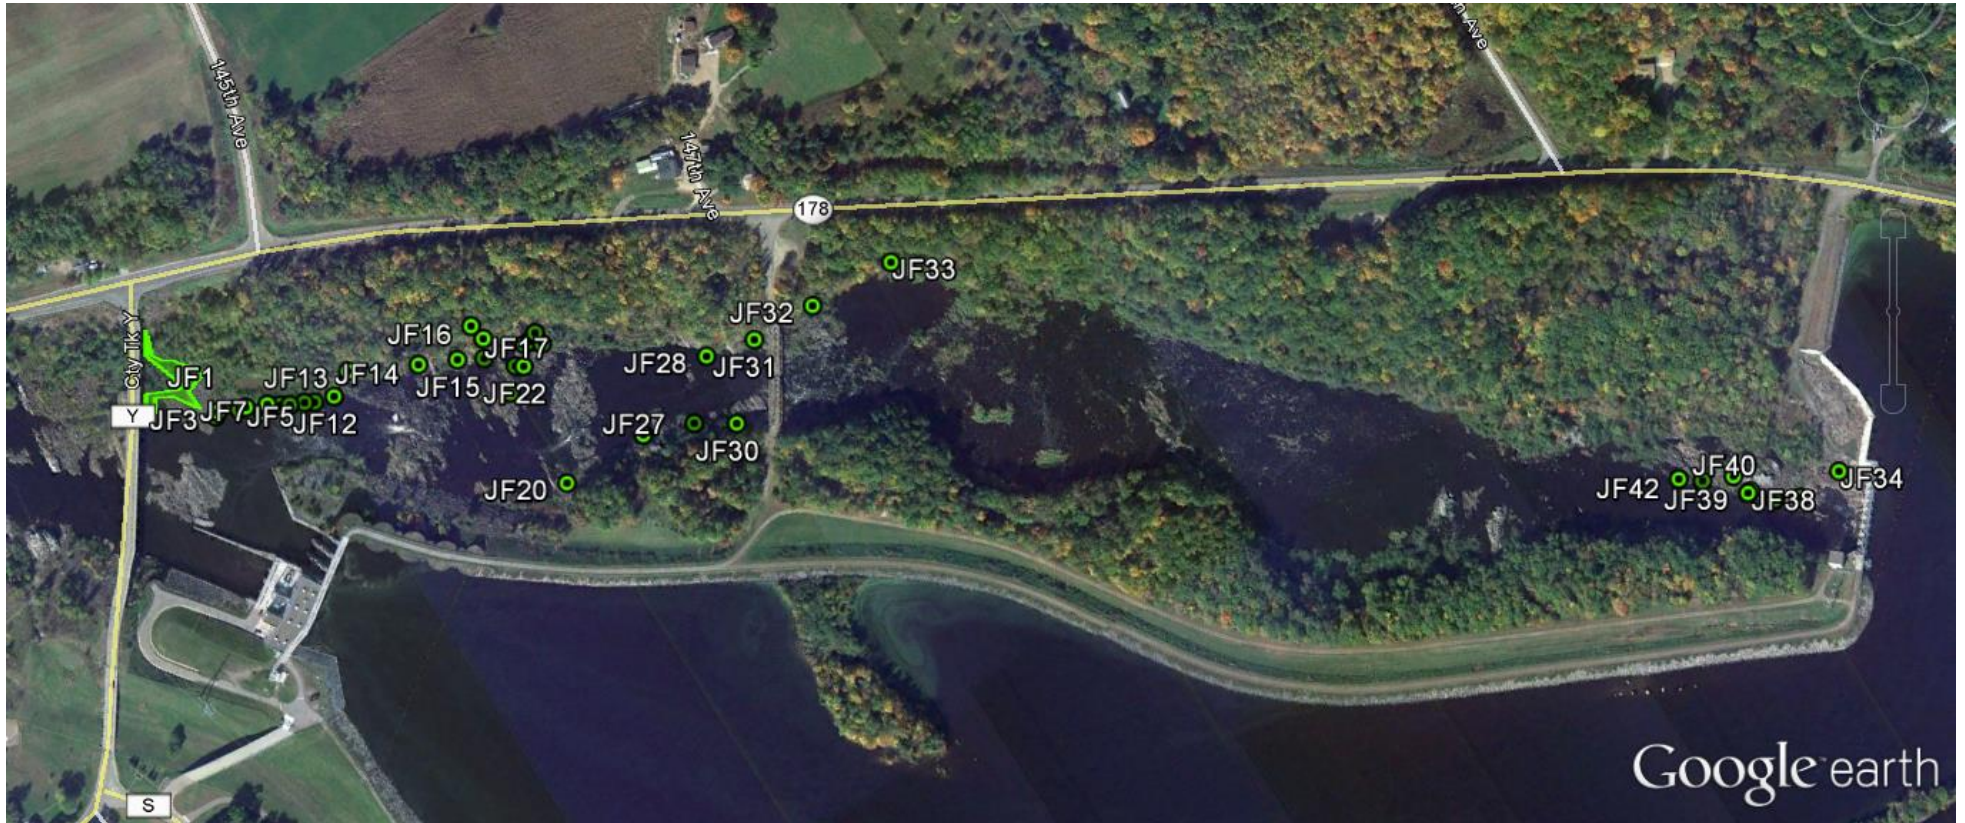
Jim Falls Spillway Channel Purple Loosestrife Assessment – 2015 (Map 1 of 4)

The minimum flow channel at Jim Falls Hydro remains infested with a relatively high concentration of purple loosestrife plants. A significant decrease in the number of plants was noted in 2012 followed by a rebound in 2013 and 2014. This year, the degree of infestation decreased slightly (Table 3). Loosestrife was found scattered throughout the channel, with the lower third of the channel being moderately infested (see maps of Jim Falls Spillway Channel). The area of greatest concentration occurs just upstream from the County Highway Y Bridge (see Jim Falls Spillway map 2). The coverage of loosestrife in this area has decreased from approximately 11,064 square feet in 2014 to 9,461 square feet in 2015 (Table 4). The loosestrife is scattered throughout the area and appears to be less dense overall than

in previous years. The total number of loosestrife infestations in the spillway channel remained the same as in 2014 (42 total locations), however, coverage decreased slightly from the previous year. Collectively, these locations amounted to 217 feet of infested shoreline versus 239 feet in 2014. Most of these locations were comprised of small plant clumps infesting between one and ten feet of shoreline, with a few more significant areas of infestation. Five years have passed since the introduction of the bio-control beetles. While it is difficult to make a determination as to their success, the fact that the density of loosestrife in the lower area of the spillway channel is continuing to decrease, and the fact that loosestrife infestation in the remaining portion of the channel appears to be stabilizing are encouraging.
