PREOPERATIVE AND INDUSTRIAL POINT
SOURCE IMPACT STUDY OF BLACK OTTER
CREEK RELATED TO THE EFFLUENTS OF
THE CITY OF HORTONVILLE PUBLICLY OWNED
TREATMENT WORKS AND THE LARSEN COMPANY

Publication Date: June 1983

GENERAL INFORMATION

Location of Study Reach: Black Otter Creek from the dam of Black Otter Lake downstream to approximately 3/4 miles above the Wolf River, T22N, R15E; Sections 26, 35, Hortonia Township, Outagamie County.

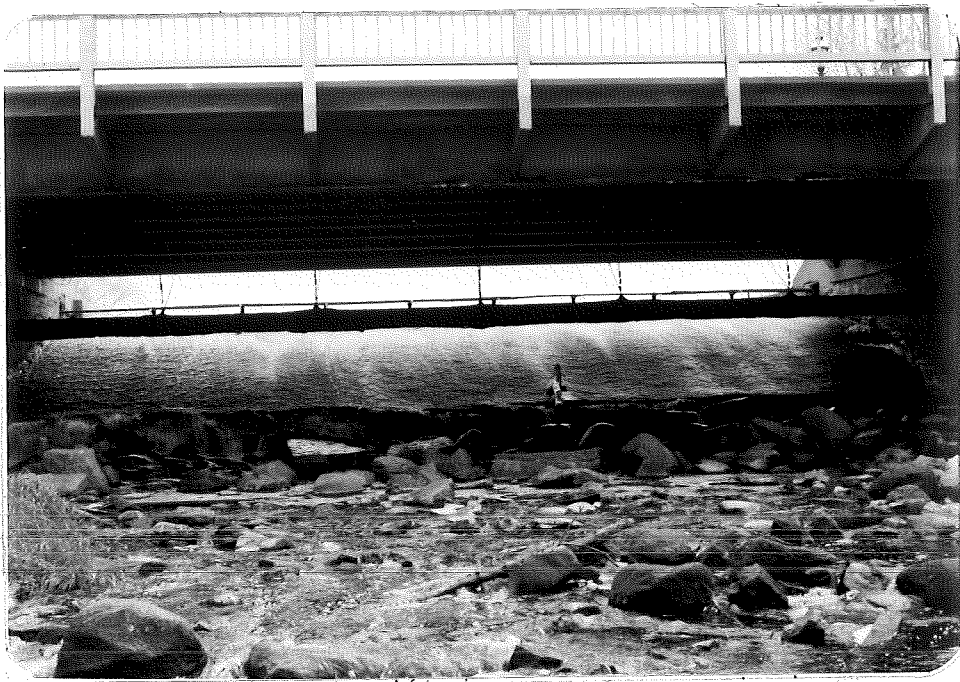
Black Otter Creek
looking upstream
toward the dam
(4-30-81).

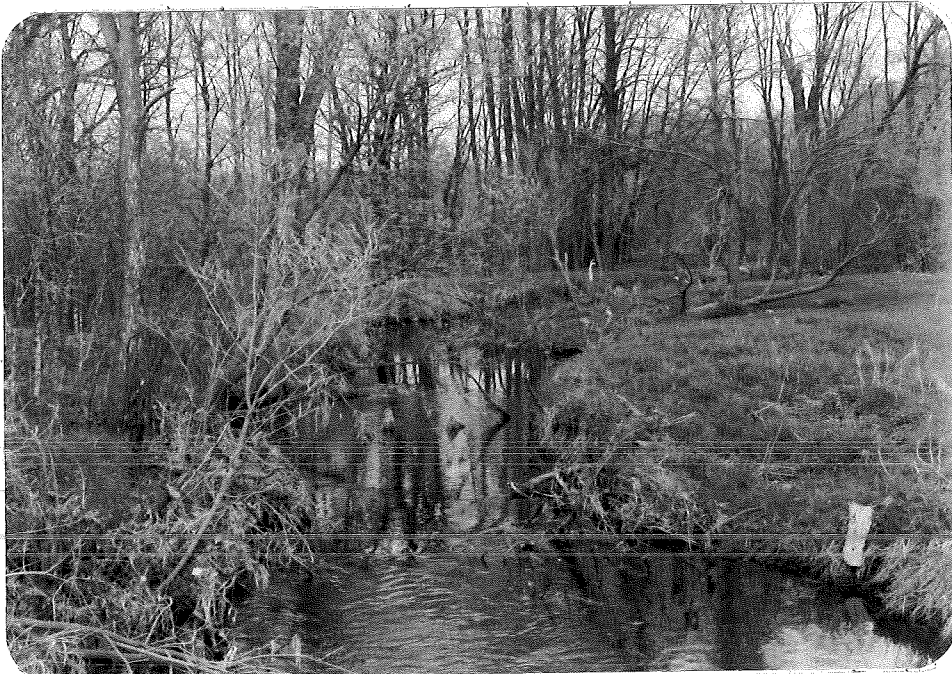
Black Otter Creek
looking upstream
from the sag point,
site 9.
(4-30-81)

Macroinvertebrate site 6 was located at the sag point (Figure 1) and was somewhat more degraded physically than M4 or M5 (Table 7) exhibited by somewhat slower current and a muddier bottom. However, lower B.I.'s at M6 in the spring and fall than at M5 indicates the stream recovers somewhat from the degrading effect of the Village POTW effluent. The current, and as a result point velocity, was noticeably slower in the fall than spring at this site. From this site down to the end of the study reach, the stream noticeably flattens out nearly becoming stagnant during low flow periods as discussed in the chemical survey results and discussion.

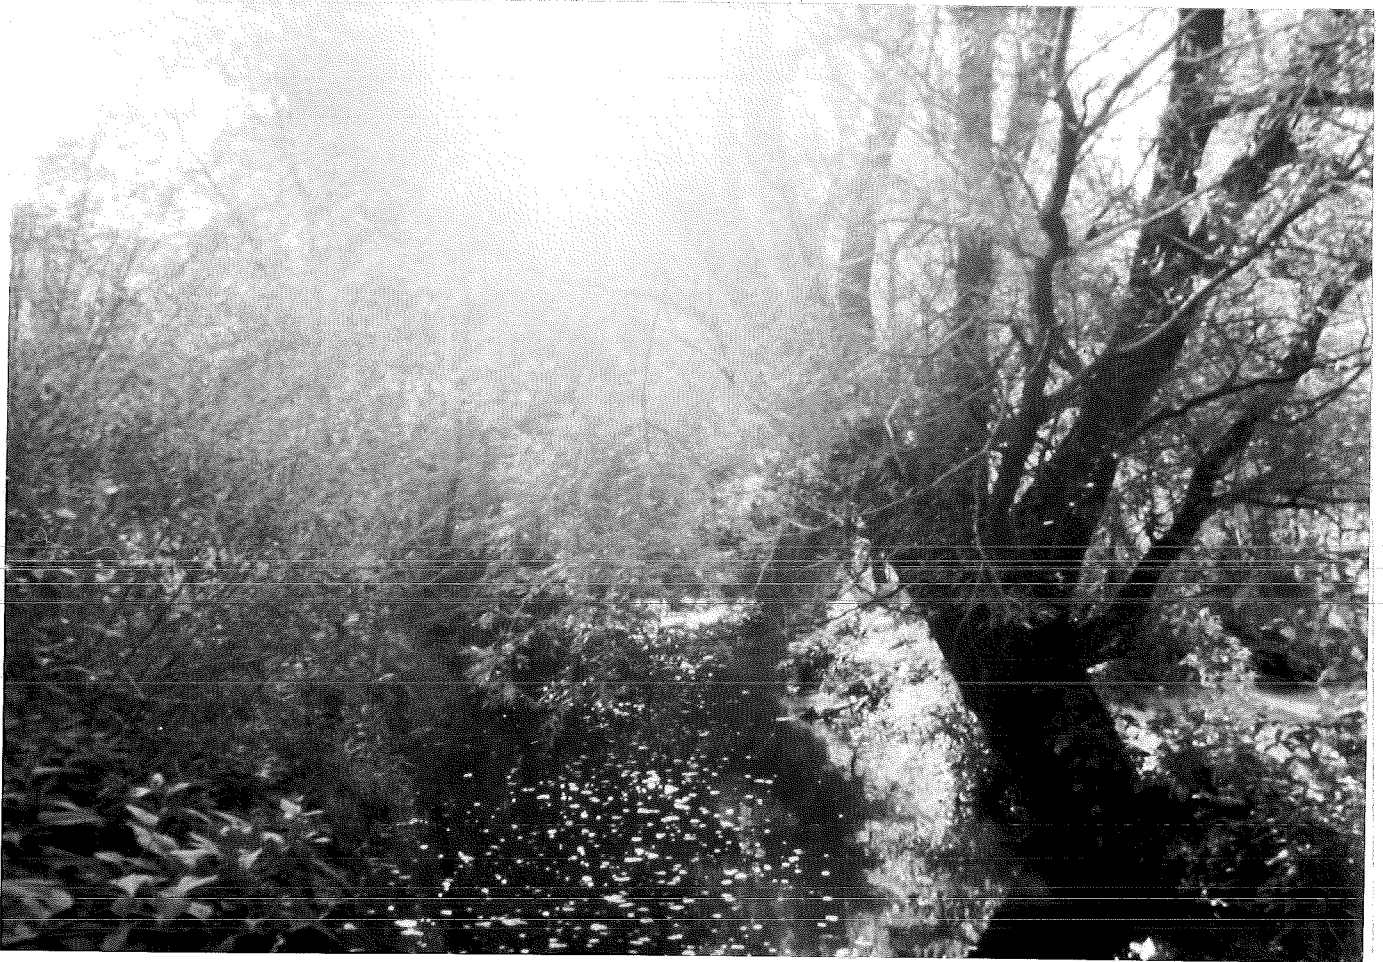
Macroinvertebrate site 3 was located at the mixed point below the Larsen Company's 001 ditch (Figure 1). The physical characteristics of this site were very similar to M2 (Table 7). In the fall of 1981 the macroinvertebrate community at this site was very similar to M2 (Tables B2 and B3) and the biotic indices very similar (Table 6). However, collection time had to be more than double that of M2 to collect 100 macroinvertebrates because of the heavy growth of S. natans which took up more of the attachment space for macroinvertebrates. This heavy bacterial growth was the result of Larsen Company's 001 and along with the decrease in macroinvertebrate numbers is definite evidence for water quality degradation caused by the Larsen Company's 001 effluent.

Black Otter Creek looking upstream from site 4 past Larsen Company 001 ditch which enters the creek from the right in the lower center of this photograph (September 7, 1982).

- c. The Larsen Company's 001 effluent quality being upgraded so the heavy slime growth in Black Otter Creek is eliminated.
 - D. The POTW effluent discharge being moved to discharge to the Wolf River which has already occurred.
9. As a result of a fish survey of Black Otter Creek above Hwy 45 in the fall of 1982, it appears the creek possesses a high number of young northern pike indicating natural reproduction of northern pike, many of which probably move down to supplement the Wolf River fishery. Further improvement of the water quality may increase the number of panfish and forage minnow species present in Black Otter Creek.
10. The post-operative portion of this study should be conducted after the degradation of Black Otter Creek by the Larsen Company cooling water has been eliminated.

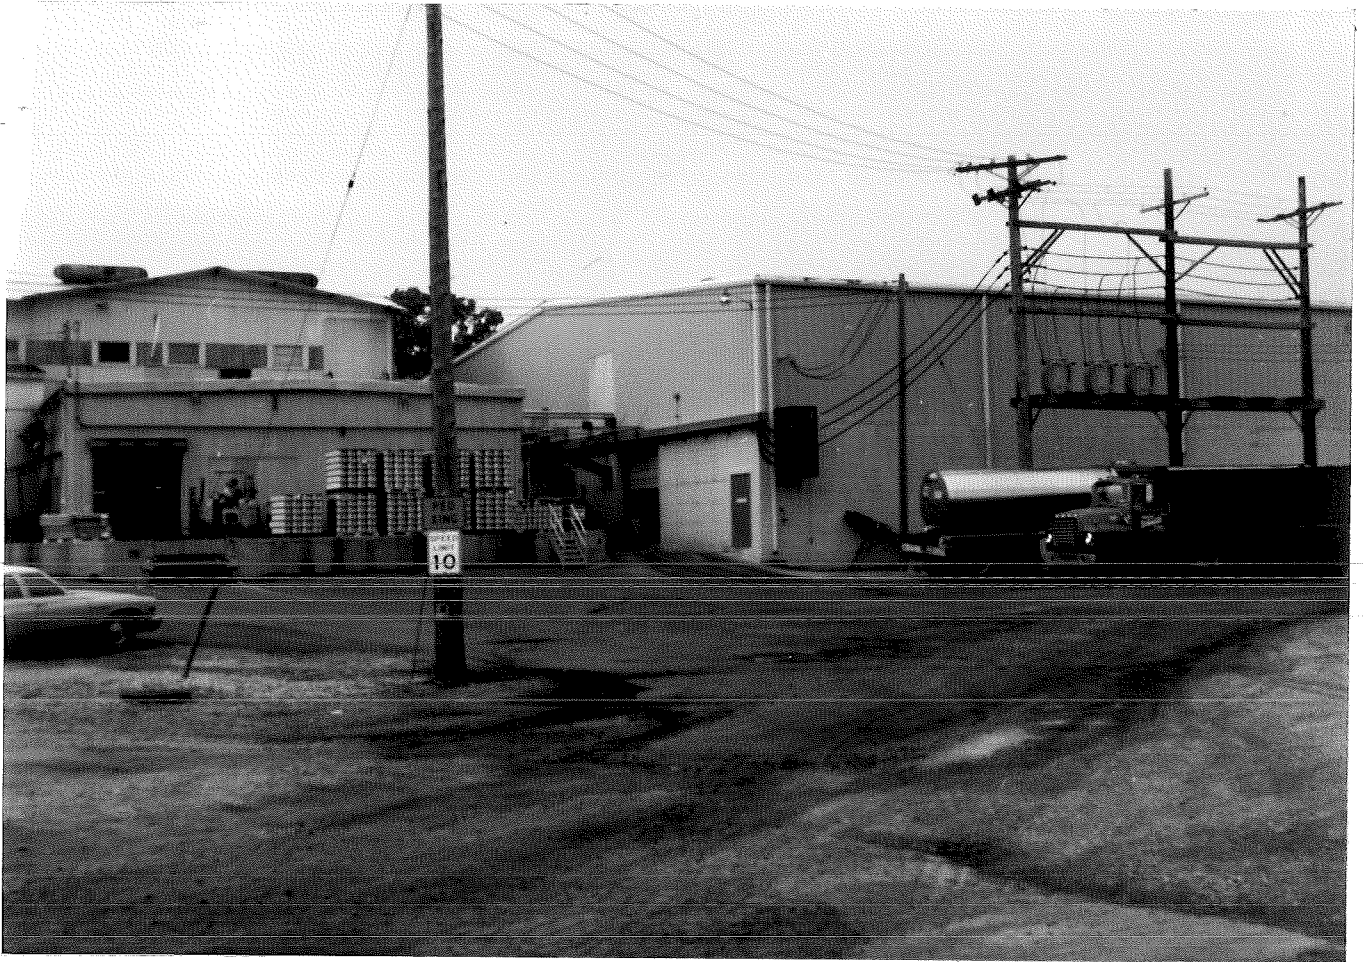
Approximately one-quarter mile below the dam Black Otter Creek is degraded by the contact cooling water and yard runoff of the Larsen Company. During the August 6, 1981, chemical survey, as well as my compliance monitoring surveys of September 23, 1981 and August 19, 1982 (see DNR industrial wastewater file for correspondence), a large growth of Sphaerotilus natans covered the bottom of the cooling water ditch and Black Otter Creek in the mixing and mixed zone below the cooling water ditch. There was a drop in D.O. from above to below the cooling water ditch down to site 6 above the POTW on August 6, 1981. At least part of this D.O. drop can be assumed to be due to the cooling water. Bottom samples were collected on August 19, 1982, from 5 feet above the cooling water discharge and in the mixing zone 5-10 feet below the cooling water ditch for algae, filamentous bacteria and fungi identification. No filamentous bacteria was found above, but it was found below, the cooling water ditch. T-P concentrations were raised in Black Otter Creek by nearly 100% (0.24 to 0.46 mg/l) resulting from the cooling water discharge (Table A4). Nitrogen concentrations had no significant change.

Larsen Company plant looking NW across the parking lot past the 001 sampling manhole which is located in the lower left center. Note the puddle of corn serum in the center and lower center. It appeared that some of this high BOD substance had gotten into the storm sewer through the manhole and into Black Otter Creek. (September 7, 1982)

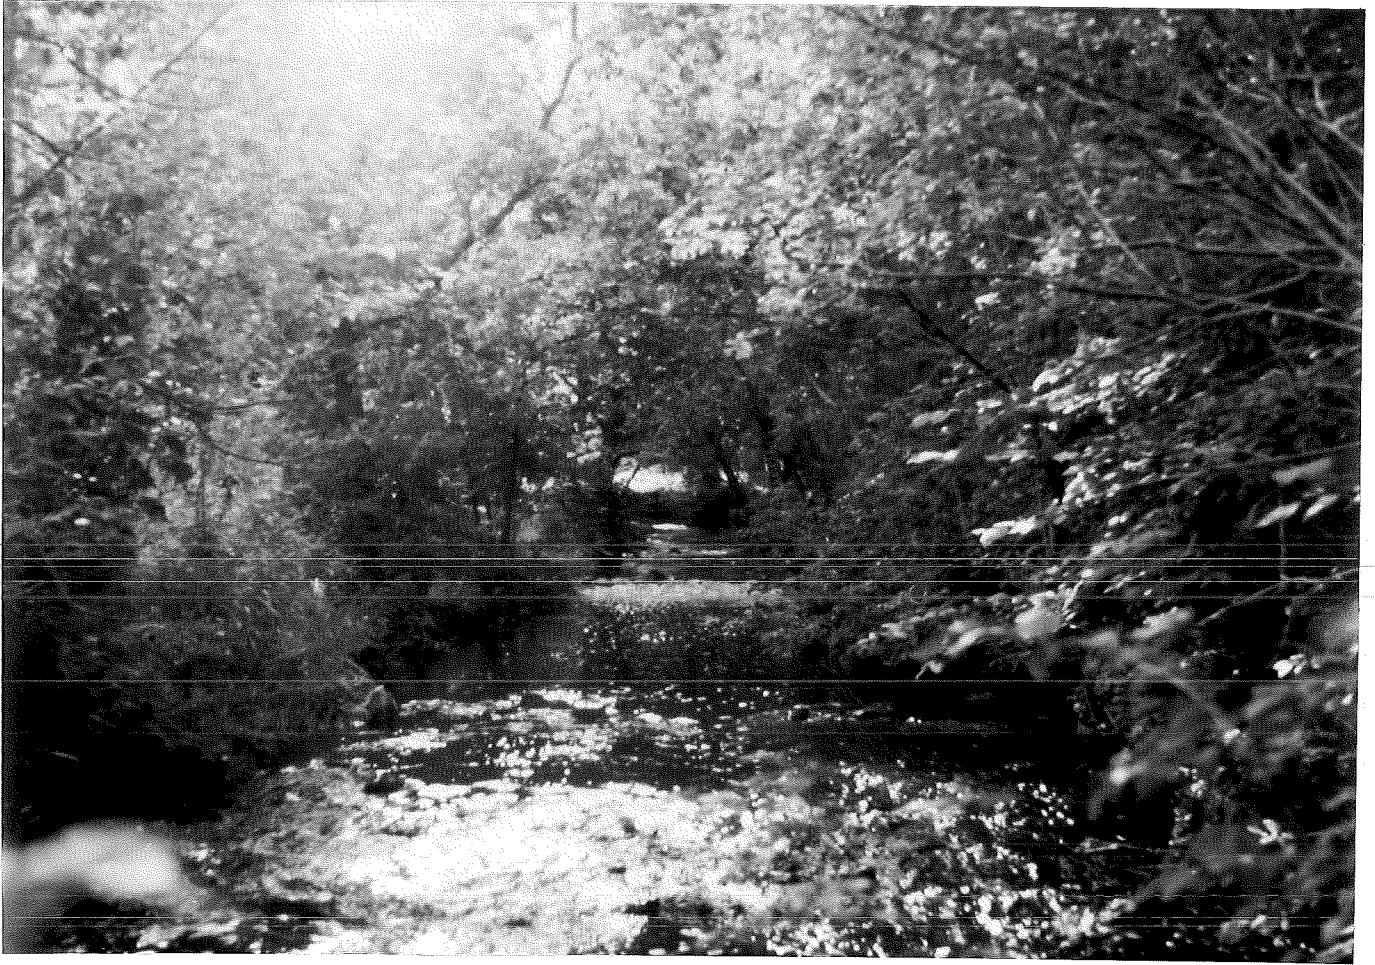
Black Otter Creek looking upstream from
site 2 (September 7, 1982).

Much of the above is also true at macroinvertebrate site 2 though stress on the macroinvertebrate community is not as great here as M1, since the creek has less width and less area is left dry under low flow conditions. As a result, the B.I. here was 0.76 units lower than M1 in the fall (3.54 at M2 compared to 4.30 at M1; see Table 6 and Figure 8). Given good stream flow (near 5 cfs), the physical characteristics of the site, as well as M1, M3, M4, and M5, present very good to excellent habitat for macroinvertebrate community development. M2 as well as M3 were not sampled in the spring (4/30/81) since Larsen Company's 001 was not discharging at that time.

During my September 7, 1982, compliance monitoring survey of the Larsen Company, I re-sampled M2 and M3 and found a very similar situation to the 1981 fall sampling though the growth of S. natans was noticeably heavier. The macroinvertebrate community was found (as in 1981) to be much lower in numbers at M3 than M2 and though similar in composition to M2 was definitely more dominated by Asellus intermedius which directly caused the B.I. to be 0.71 units higher at M3 than M2 (Table 6). This is further evidence to the significant degradation of Black Otter Creek by Larsen Company's 001.

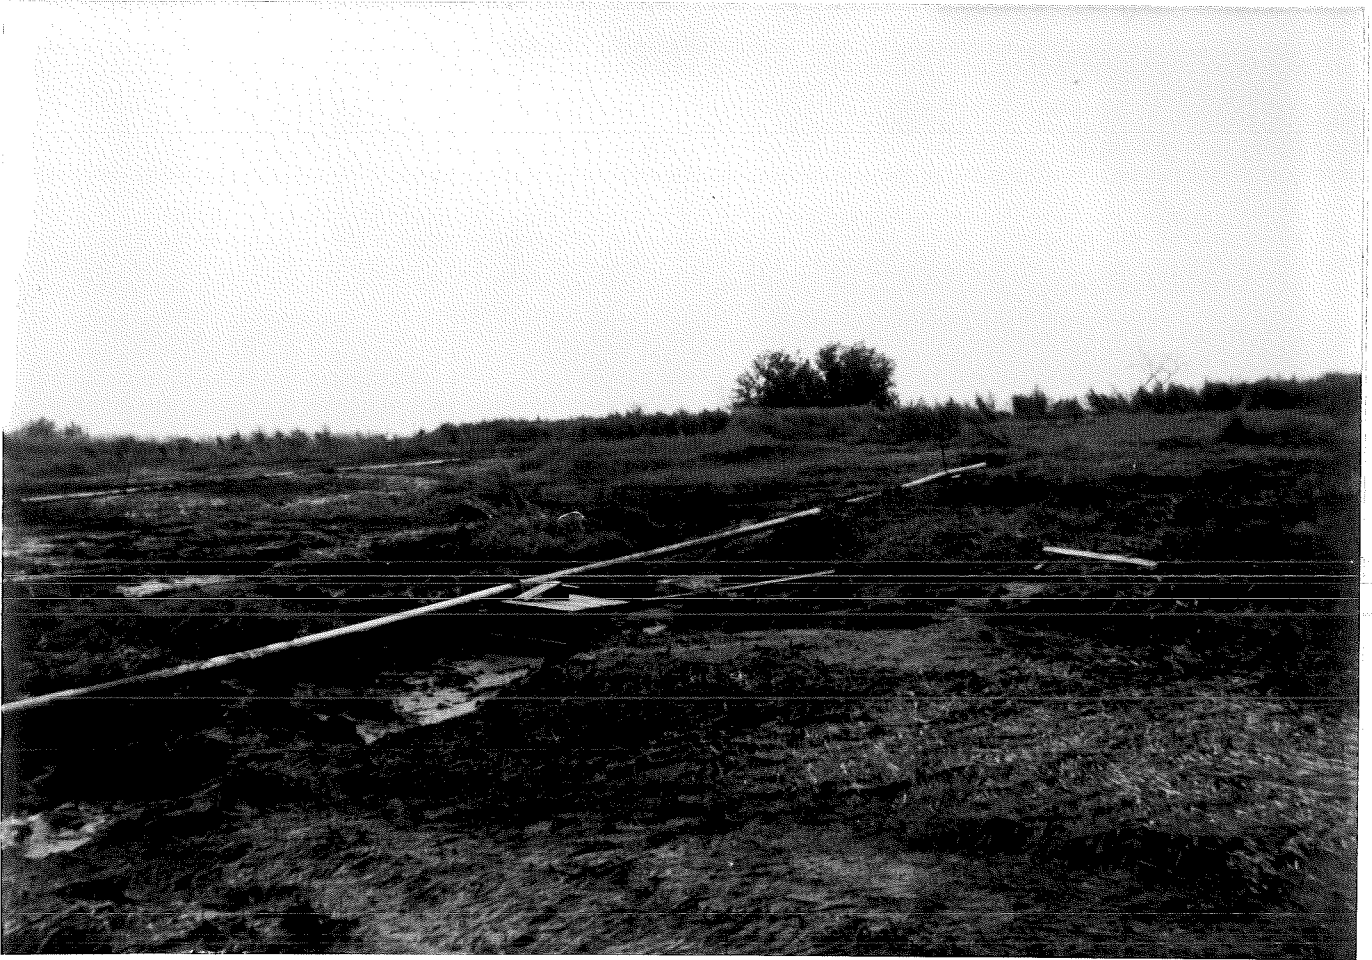
Larsen Company spray irrigation field. Note the heavy erosion and dead vegetation resulting from overloading of wastewater. (September 7, 1982)

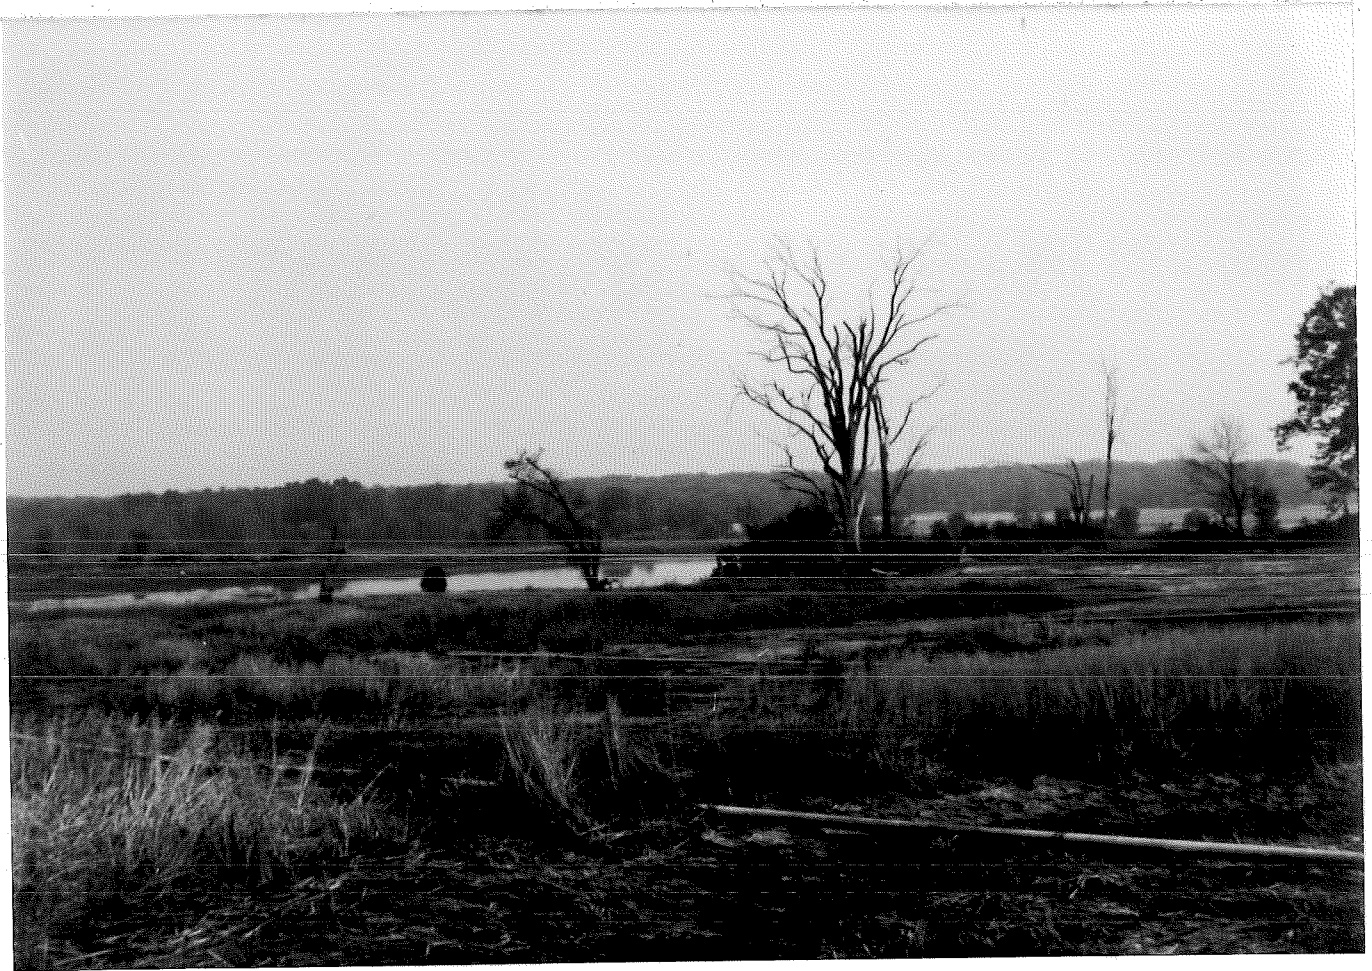
Larsen Company spray irrigation field looking SE past the lagoons. The wastewater is sprayed onto this field and then allowed to drain into the lagoon in the center of the photograph. Note the large amount of dead vegetation resulting from wastewater overloading of the field. (September 7, 1982).

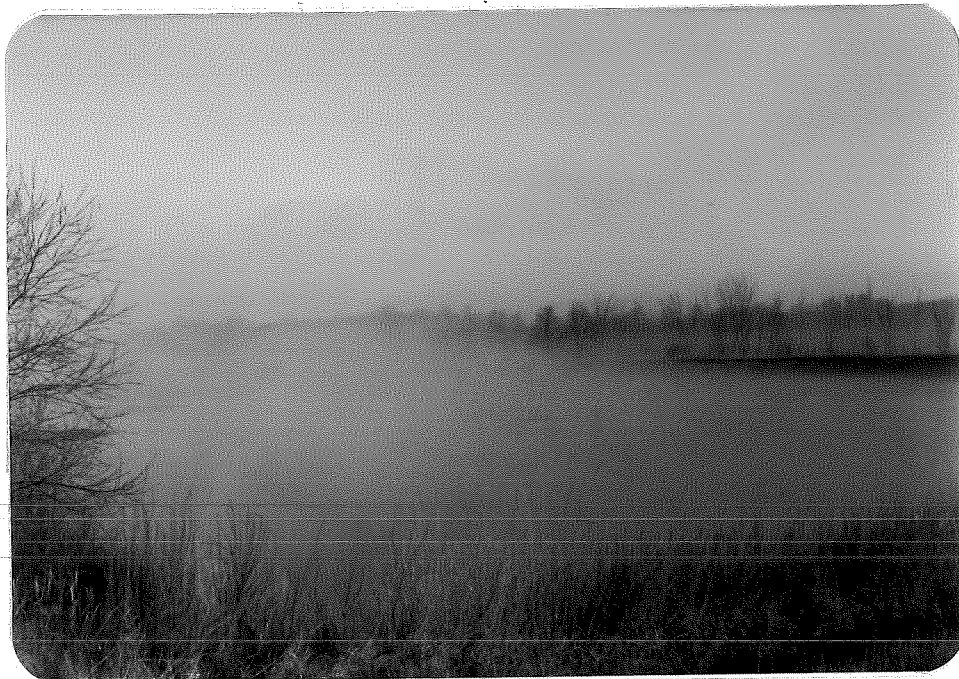
Larsen Company lagoon 4 was discharging on April 30. It had a large effect on phosphorus, SS, BOD₅ and conductivity levels (Table A2 and Figure 4). The high SS solids concentration in the effluent was due to algae. The effluent was a bright green color as a result of the algae. The low NH₃-N and NO₂+NO₃-N levels and high TKN levels in the effluent indicate nitrogen to be tied up in the algae.

Larsen Company
Lagoon 4. in
early morning
looking NNE
(4-30-81).
