Watershed Assessment and Management Plan Update for Black Otter Lake, Outagamie County, Wisconsin

June 2014

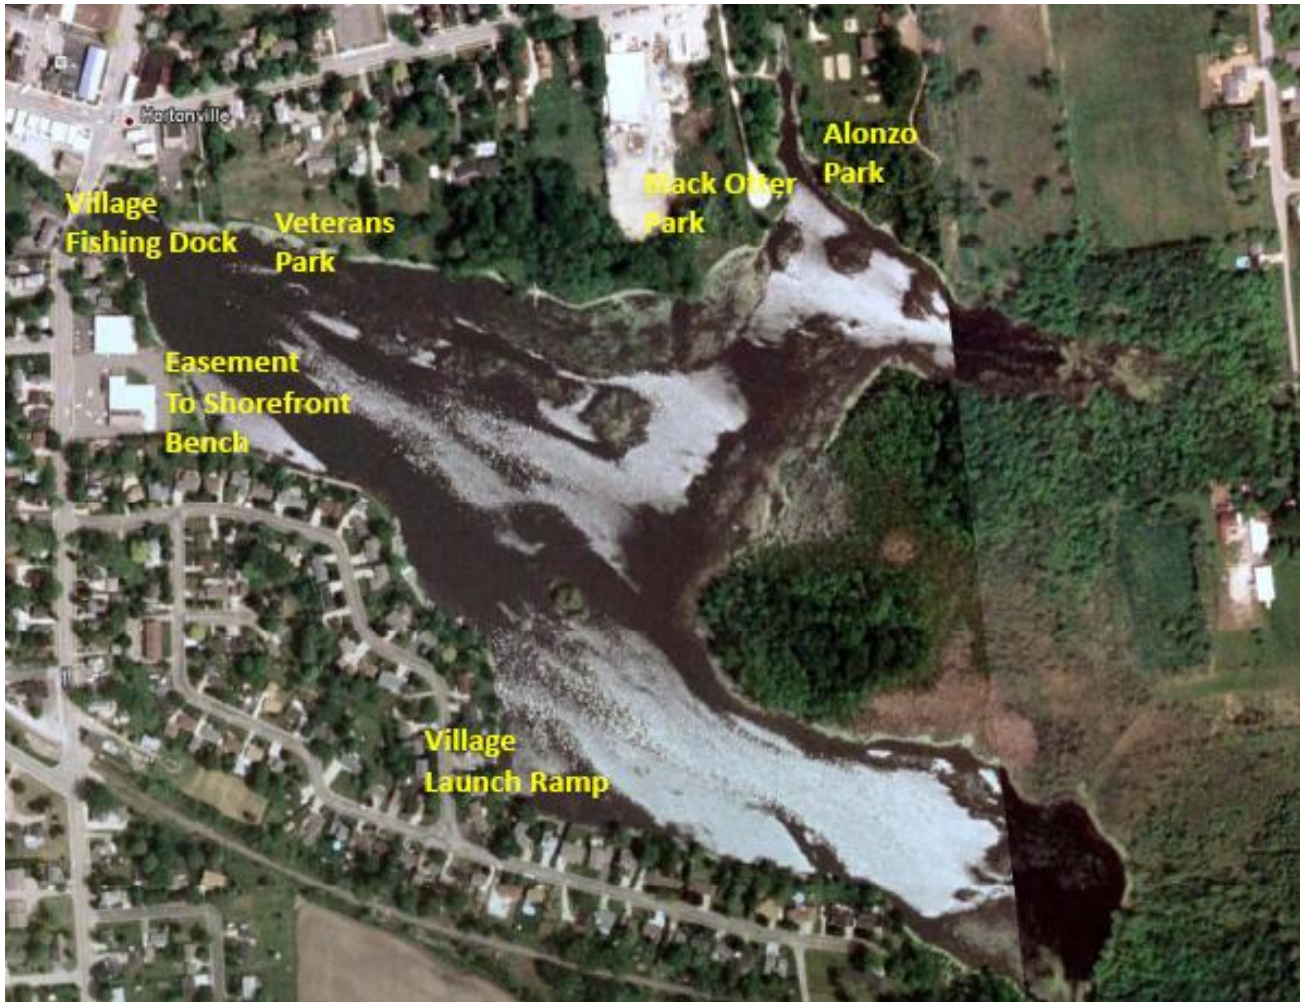
Figure 2. Public access locations surrounding Black Otter Lake, Outagamie County, WI

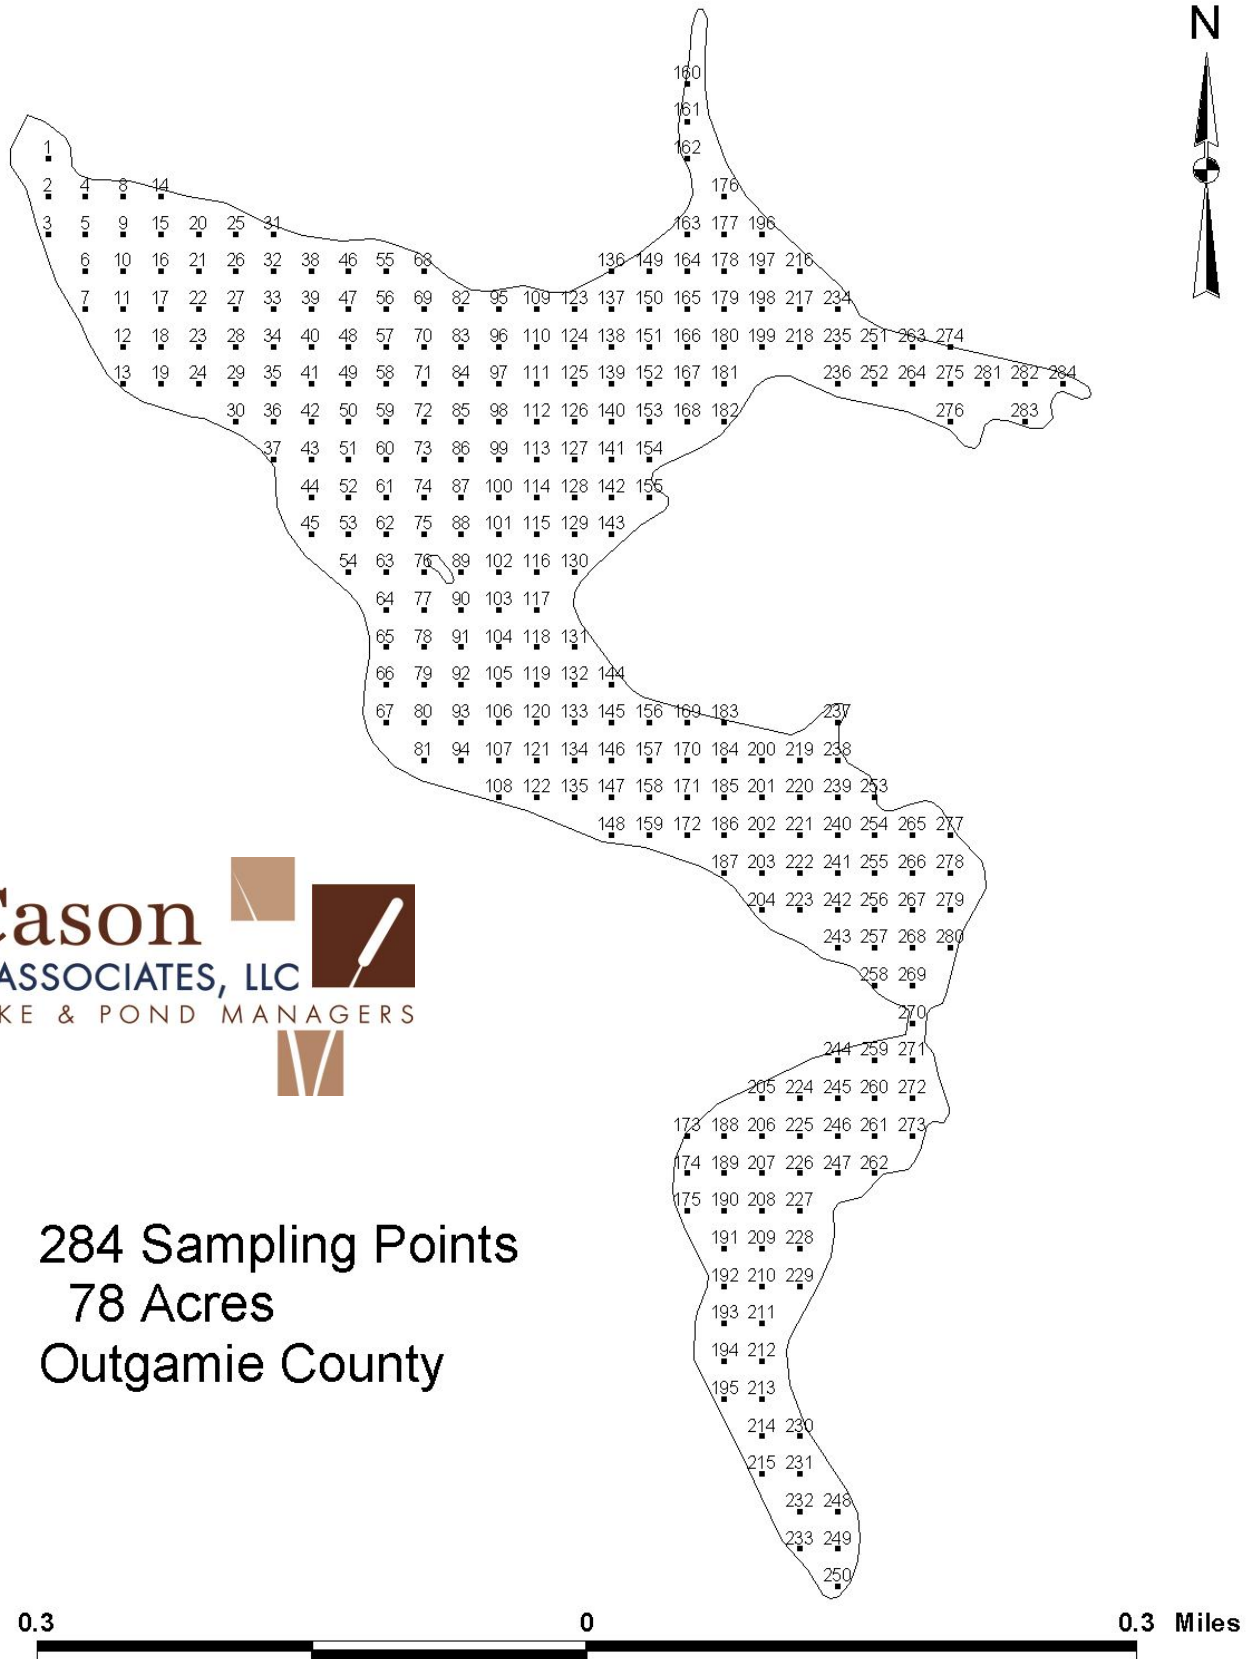
Figure 4. Aquatic plant survey map for Black Otter Lake, Outagamie County, WI.

In order to best manage aquatic invasive species in Black Otter Lake, detailed mapping surveys were conducted in 2013. Spring and fall surveys of Black Otter Lake were conducted for curly-leaf pondweed and Eurasian watermilfoil, respectively. Cason & Associates staff monitored the results of previous treatments and identified the locations where these species were in need of further treatment. Care was taken to accurately document the distribution and density of these species during each survey in order to track the progress made by management efforts. The spring survey was conducted on May 8, 2013 and served to best identify the distribution and treatment needs of curly-leaf pondweed while the fall survey, conducted on October 24, 2013, focused primarily on Eurasian watermilfoil. The spring survey utilized the point-intercept map provided by the Wisconsin DNR (**Figure 4**). At each location the presence or absence of invasive species were determined using surface observations and rake tows. The abundance of these species was also recorded following the same guidelines used during the summer plant survey and detailed in **Figure 5**. During the fall survey, a meandering survey of the littoral area of the lake was conducted to identify Eurasian watermilfoil. Particular attention was paid to the northeast section of the lake where milfoil had been identified during the August survey.

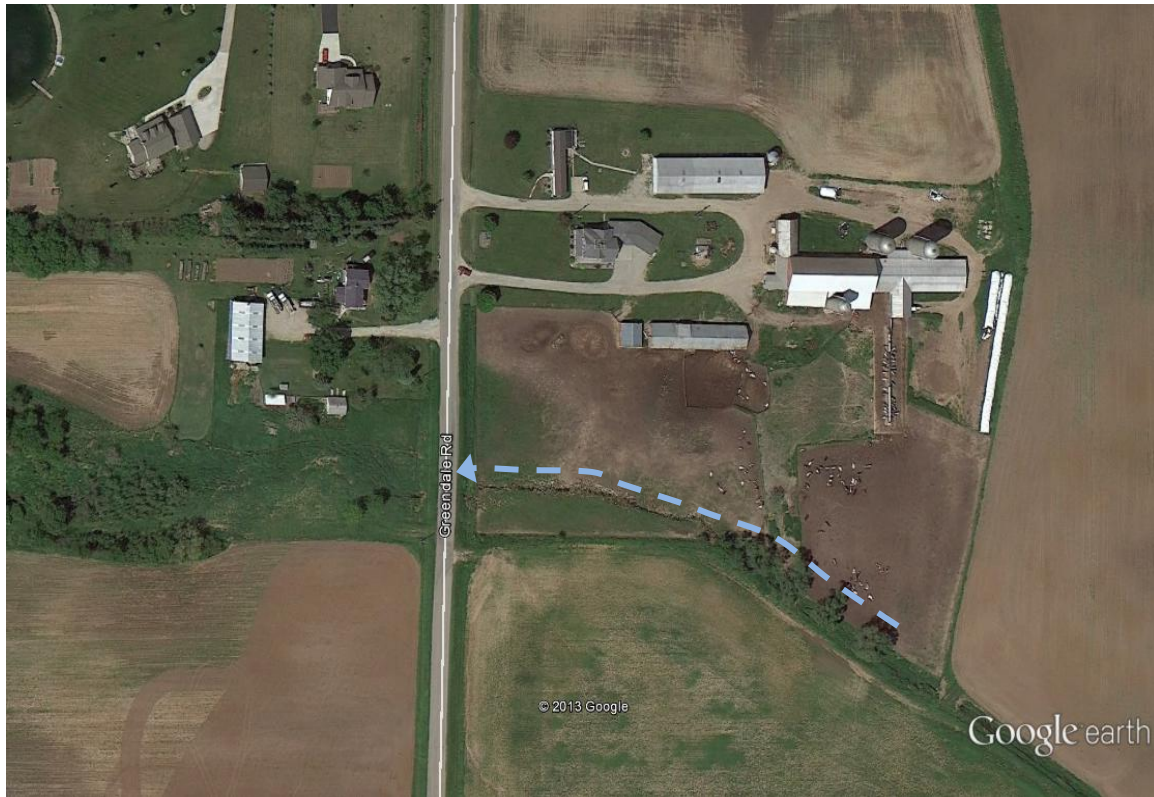
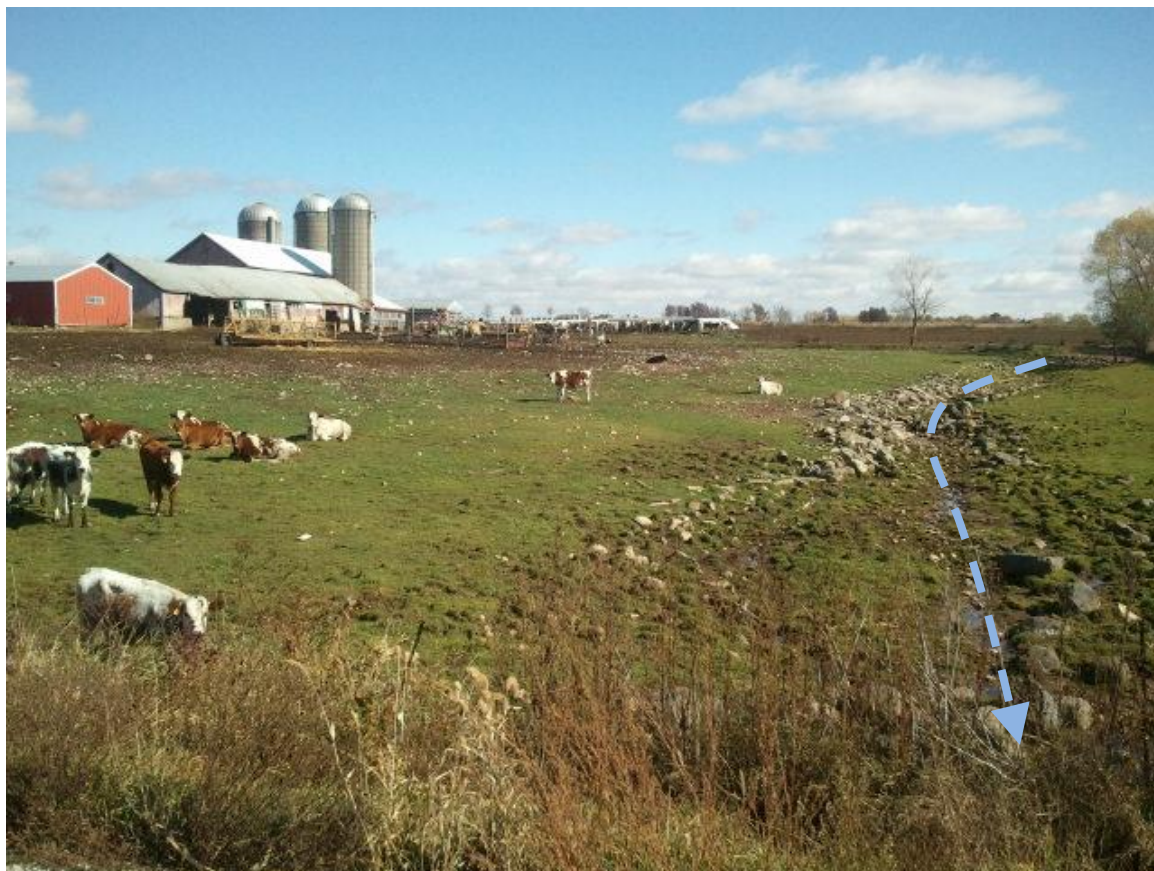
Figure 13. Location of direct runoff from livestock located at N2024 Greendale Road, Hortonville, WI.

Many farms in the State have livestock fenced within areas where the animals have direct access to surface water such as the intermittent stream located at N2024 Greendale Road. There is a clear advantage for the livestock to have a constant source of water available. Unfortunately, in areas such as this, sediments and manure are able to freely move into tributaries and ultimately into Black Otter Lake. These sediments and manure contain high levels of nutrients which then contribute to declines in the water quality of Black Otter Lake.

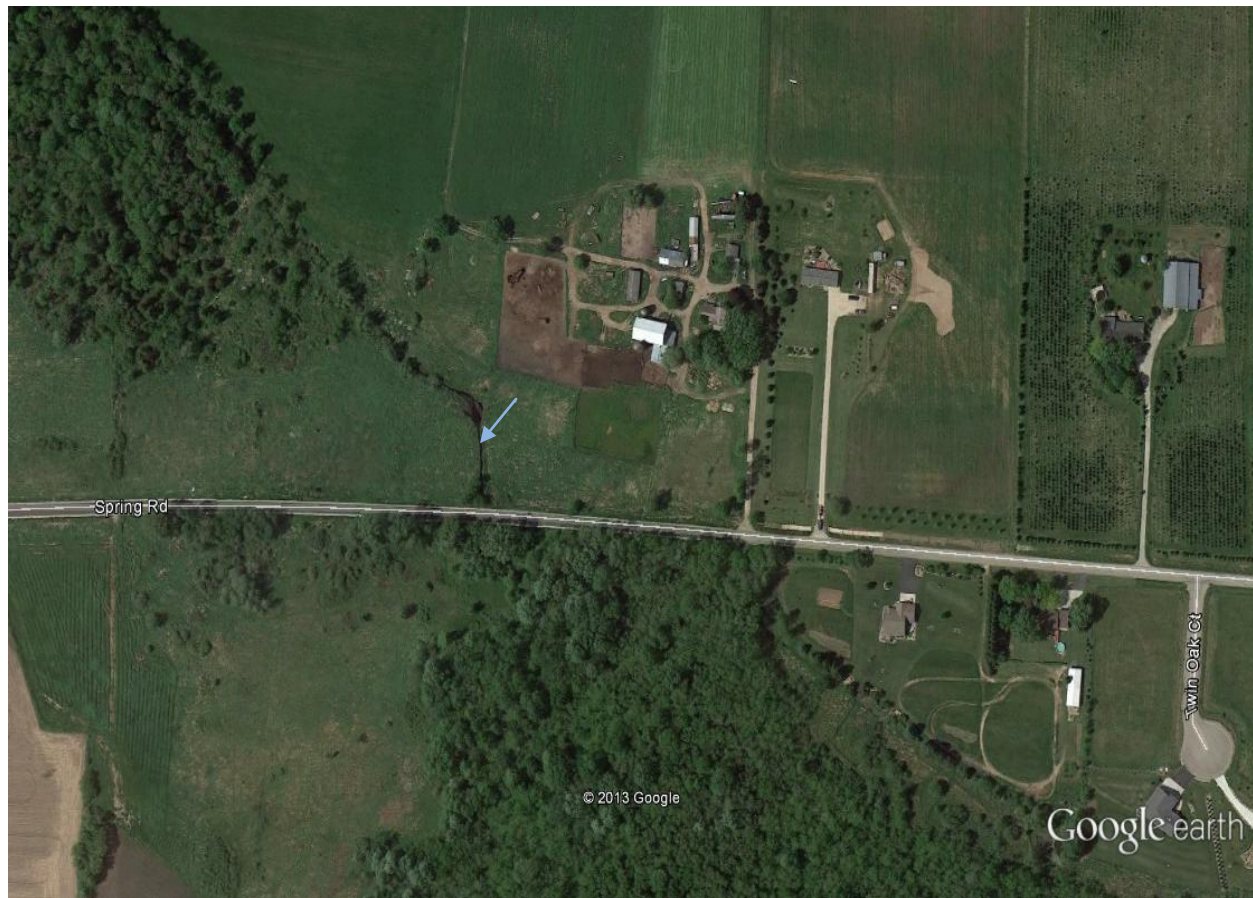
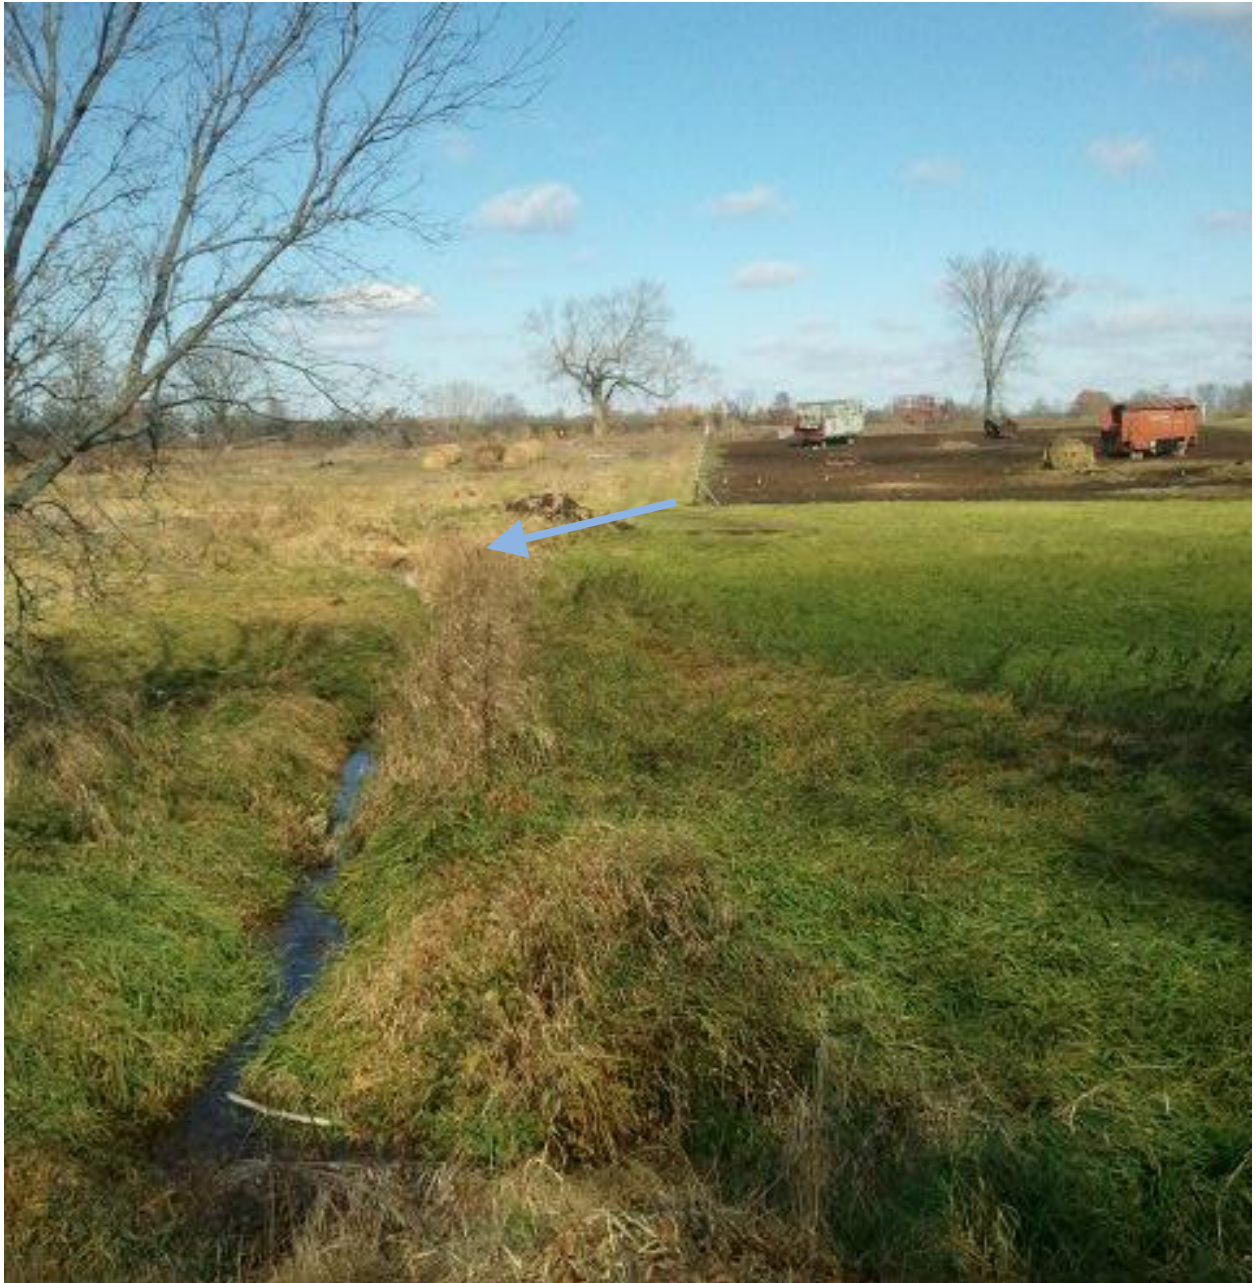
Figure 14. Location of direct runoff from livestock located at W9104 Spring Road, Hortonville, WI.

Figure 14 (continued). Location of direct runoff from livestock located at W9104 Spring Road, Hortonville, WI.

Similar to the Greendale Road farm, the farm at W9104 Spring Road has the potential of contributing significant nutrient loads to Black Otter Lake. On this property, the livestock area noticeably slopes to the south and west where a tributary stream of Black Otter Lake flows to the north then northwest. Unlike the Greendale Road farm, the livestock do not have direct access to the water. However, the fenced area is approximately 65 feet from the water's edge. It is likely during rain events and the spring snow melt, more sediments, manure and nutrients flow overland into this stream.

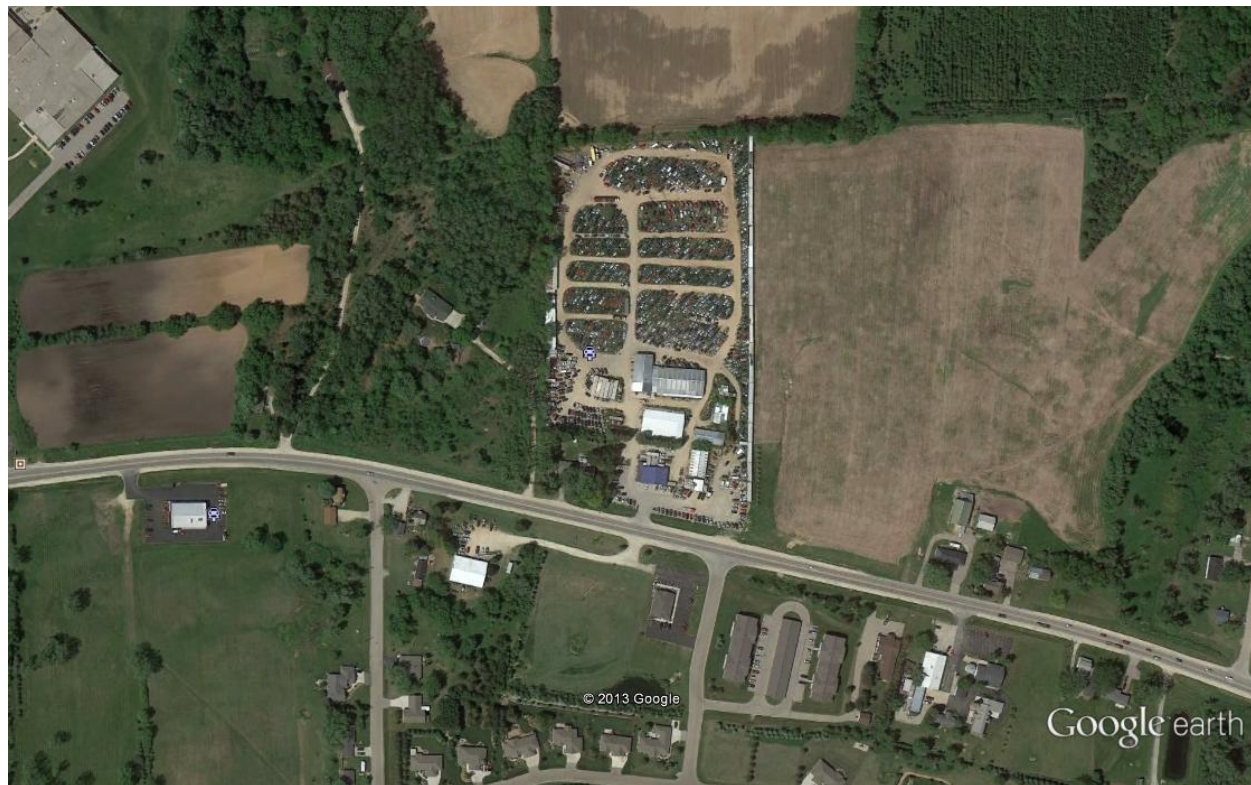
Figure 15. Location of Schmidt's Auto Salvage on East Main Street, Hortonville, WI.

Members of the Lake District are concerned over the potential of runoff from Schmidt's Auto Salvage flowing into Black Otter Lake. If and when runoff from this location occurs it has the potential to carry more than nutrients and sediments, like in other runoff scenarios. It may also contribute measureable levels of automotive pollutants such as petroleum-based fuels, oils and other fluids. After conferring with the offices of Outagamie County, it was determined this does not fall within the jurisdiction of either the Zoning or Land Conservation Departments. Runoff concerns fall within the jurisdiction of the Wisconsin Department of Natural Resources (WDNR). If District members witness runoff actively leaving this site, it should be addressed to the WDNR.

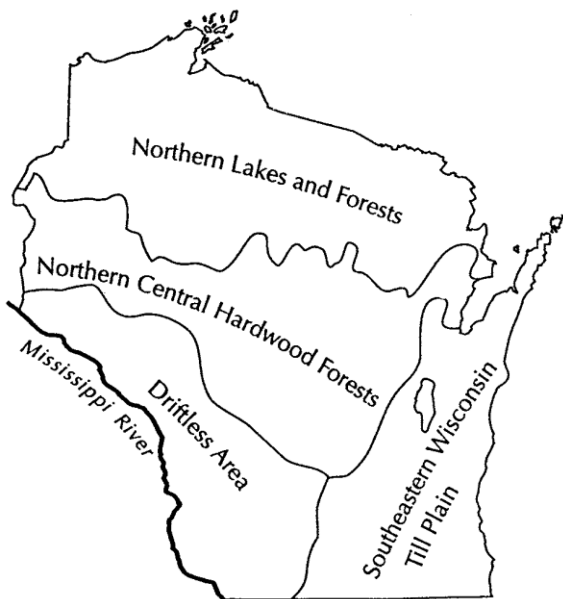
Figure 17. Ecoregions of Wisconsin (after Omernick and Gallant, 1988)

A total of 16 submergent, floating-leafed and emergent aquatic plant species were found during the 2012 survey (**Table 14**). This is above the state-wide average of 13 species. Black Otter Lake lies within the Northern Central Hardwood Forests region of Wisconsin⁽¹⁾ (**Figure 17**). The average number of species found in lakes in this region is 14 species. The percent frequency values listed in **Table 14** reflect the relationship between the number of locations where a particular species was found versus the total number of locations sampled. Relative frequency values reflect the abundance of a particular species in relation to all other species found.
