Van Vliet Lake

Vilas Counties, Wisconsin

Aquatic Plant Management Plan Update –

Mechanical Harvesting Feasibility Study & Planning Project

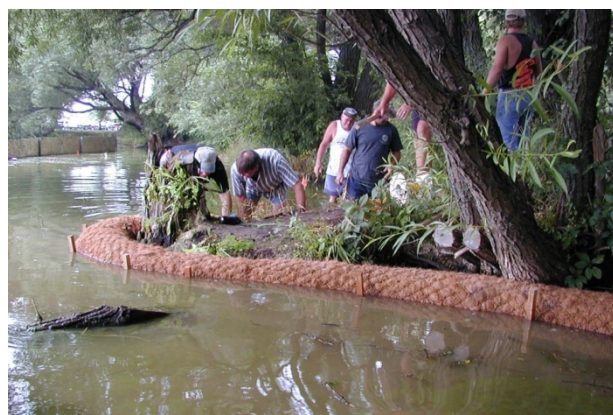
Photo 3.1-2. Example of a bio-log restoration site. Long Lake, Manitowoc Co.

In recent years, many lakefront property owners have realized increased aesthetics, fisheries, property values, and water quality by restoring portions of their shoreland to mimic its unaltered state (Photo 3.1-2). An area of shore restored to its natural condition, both in the water and on shore, is commonly called a shoreland buffer zone. The shoreland buffer zone creates or restores

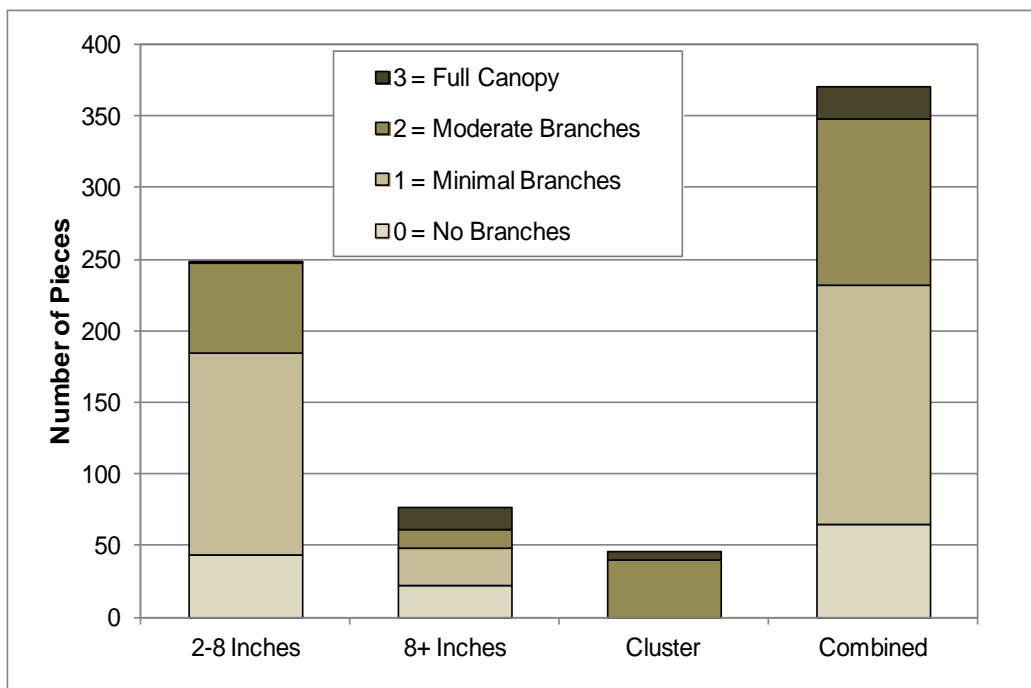
Figure 3.1-3. Van Vliet Lake coarse woody habitat survey results. Based upon a fall 2013 survey. Locations of Van Vliet Lake coarse woody habitat can be found on Map 2.

During this survey, 371 total pieces of coarse woody habitat were observed along 5.3 miles of shoreline, which gives Van Vliet Lake a coarse woody habitat pieces to shoreline mile ratio of 70:1 (Map 2, Figure 3.1-3). To put this into perspective, Wisconsin researchers have found that in completely undeveloped lakes, an average of 345 coarse woody habitat pieces may be found per mile (Christensen et al.

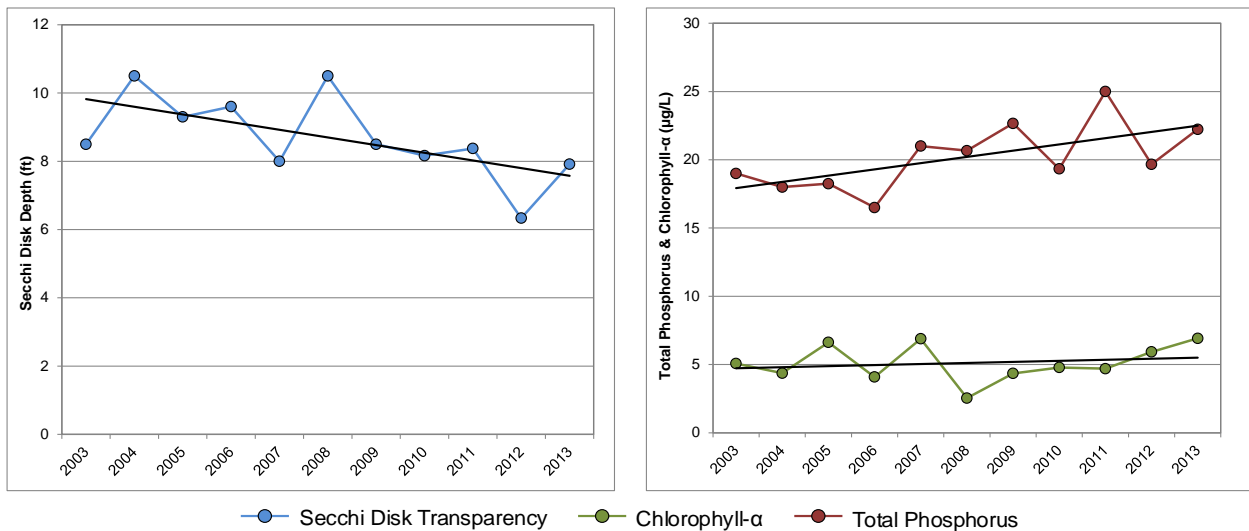
Figure 3.2-7. Van Vliet Lake 2003-2013 average annual Secchi disk transparency, chlorophyll-α, and near-surface total phosphorus. Created using data collected by the Van Vliet Lake Citizens Lake Monitoring Program.

Figure 3.4-7 displays the average growing season Secchi disk transparency, chlorophyll- α , and near-surface total phosphorus data collected by the Van Vliet Citizens Lake Monitoring Program (CLMN) from 2003 to 2013. Secchi disk transparency data indicate that a decreasing trend in water clarity has occurred over this time period. There has also been a slight positive trend in the level of free-floating algae as measured via chlorophyll- α , most notably from 2008 to 2013. And finally, near-surface total phosphorus concentrations have also increased from 2003 to 2013. These three variables are usually correlated with one another; as total phosphorus increases, chlorophyll- α increases, and Secchi disk transparency declines. While the investigation into what may be causing these trends is outside the scope of this project, these data indicate that water quality as it relates to total phosphorus, chlorophyll- α , and Secchi disk transparency in Van Vliet Lake may be declining, and may be worth investigating in the future.

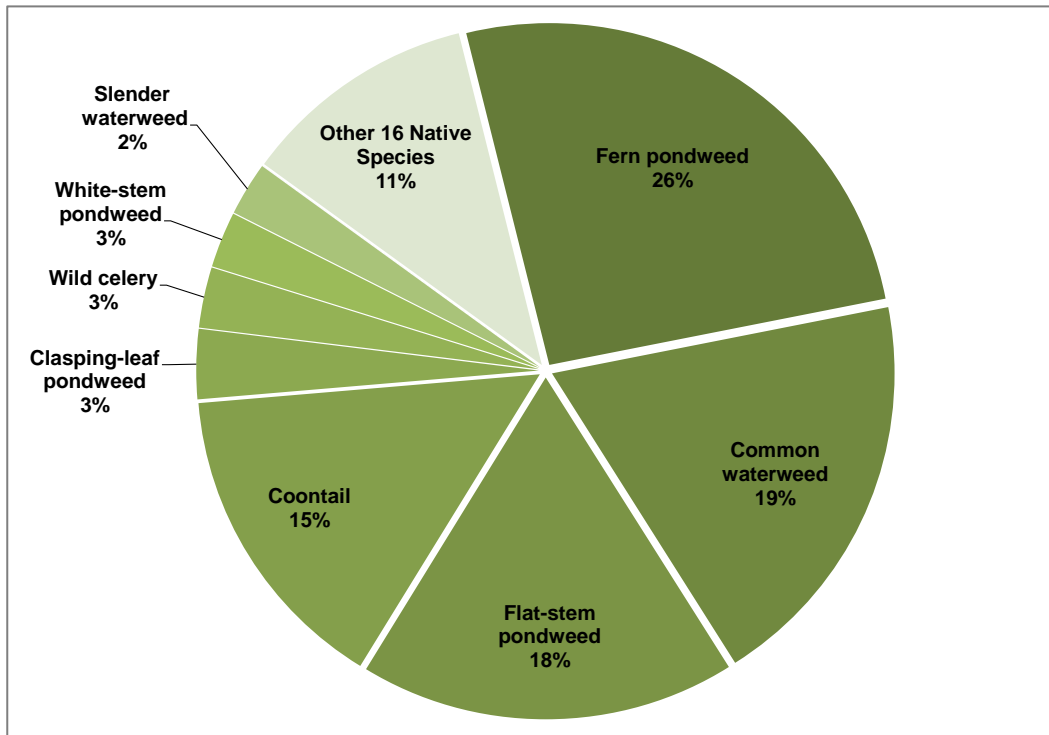
Figure 3.2-10. 2013 relative frequency of occurrence of aquatic plant species in Van Vliet Lake. Created using data from White Water Associates 2013 point-intercept survey.

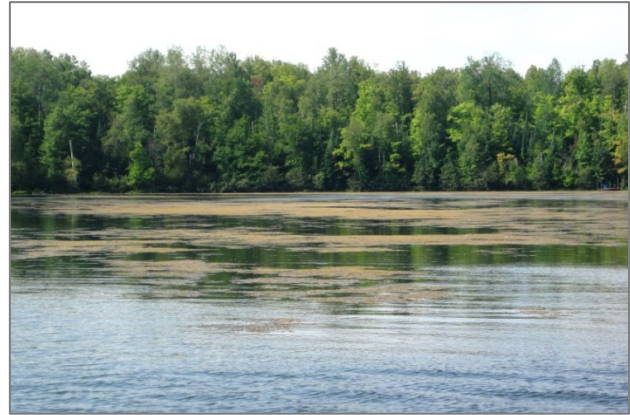
Photo. 3.2-2. Surface-matted native aquatic vegetation on Van Vliet Lake. Taken during August 2013 survey.

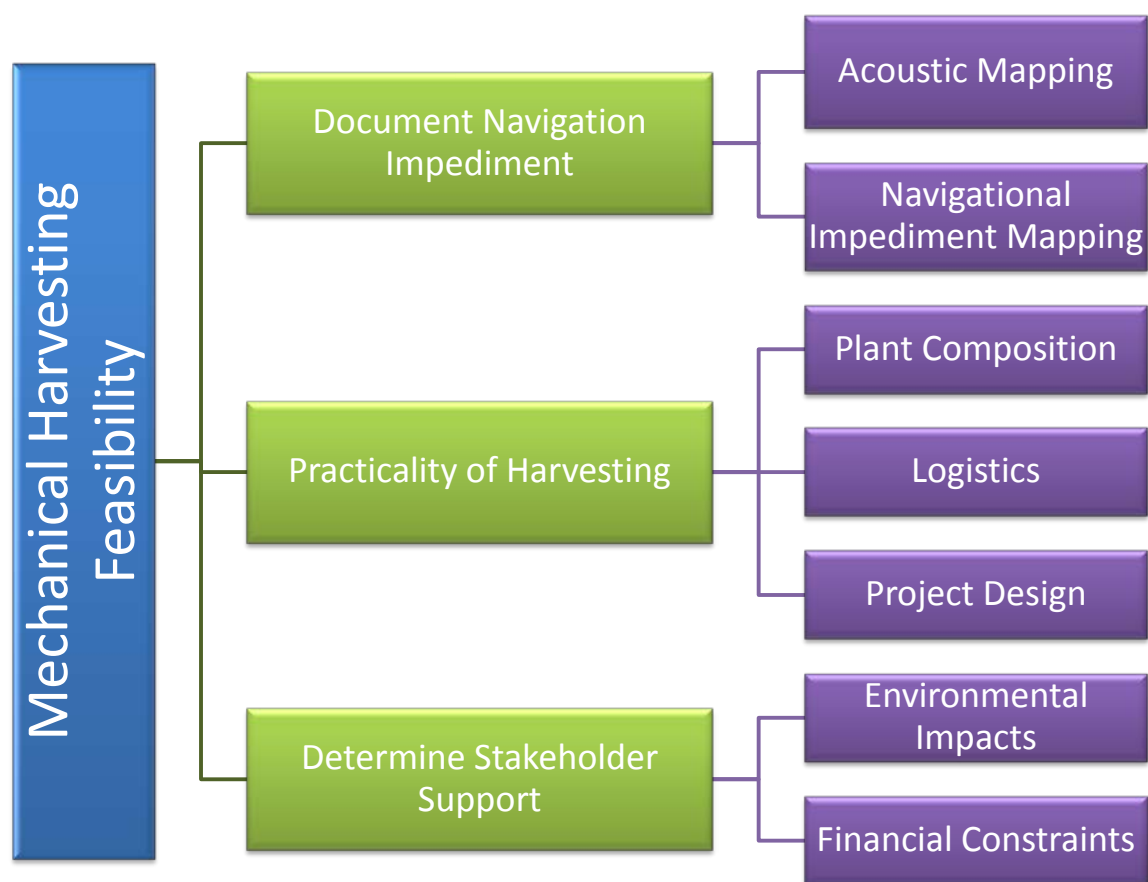
Figure 4.0-1. Flow chart addressing steps taken to address the feasibility of mechanically harvesting on Van Vliet Lake.

As discussed in many of the sections above, nuisance levels of native aquatic plants within Van Vliet Lake ultimately spurred the VVLA to initiate this planning effort. The goal of the project was designed to assess the aquatic plant communities in Van Vliet Lake and create a mechanical harvesting plan, if feasible, which would aim to improve navigability and recreational opportunity on the lake. During this project, Onterra identified three main components which required addressing within this project: documentation of navigation impediment, practicality of harvesting, and determining the level of stakeholder support for carrying out a developed mechanical harvesting plan (Figure 4.0-1).
