Invasive Species Monitoring and Control Report

Badger-Rapide Croche Hydroelectric Project

FERC Project No. 2677

October 2015

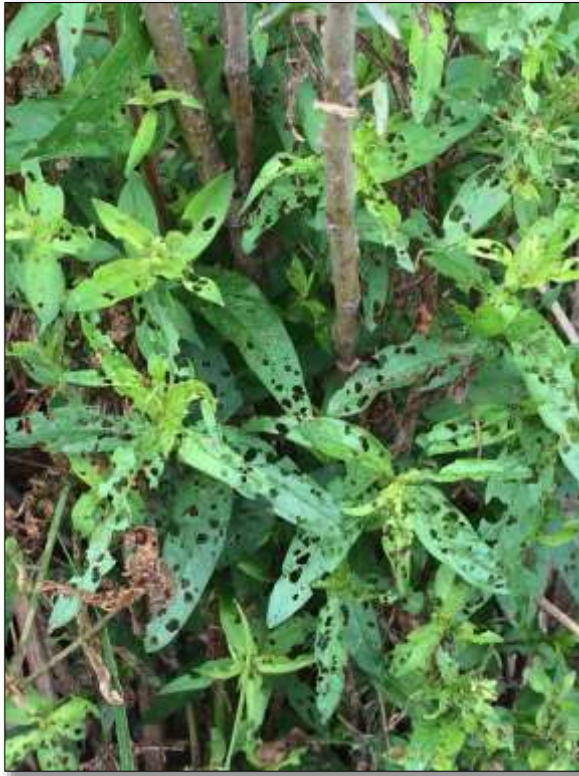
Figure 1. (Left) Example of weevil damage and purple loosestrife Aug 4th, 2015.

No invasive plants of Table 2 were documented within the monitoring limits around influent streams or drainages along the project. However, we noticed and mapped two locations outside the influent stream limits where natural or human control of loosestrife was occurring. Several loosestrife plants on map sheet 4 were dead or severely pruned (Figures 1-2 below) as a result of the black-margined loosestrife beetle (*Galerucella californiensis*). Another loosestrife plant on map sheet 5 had apparently been sprayed with herbicide and effectively killed by the adjacent landowner.

Photos comparing a beetle-killed plant and a healthy loosestrife plant are on the cover of this report. Evidence of the loosestrife beetle among such a thinly-scattered population of loosestrife is a new and encouraging development, as is the fact that at least one riparian property owner has undertaken control of this noxious weed.
