Eurasian water milfoil (*Myriophyllum spicatum*) Pre/Post Herbicide and Fall Bed Mapping Surveys Sand Lake - WBIC: 2661100 Barron County, Wisconsin

Project Initiated by: The Sand Lake Management District, Lake Education and Planning Services, LLC, and the Wisconsin Department of Natural Resources

Survey Conducted by and Report Prepared by: Endangered Resource Services, LLC Matthew S. Berg, Research Biologist St. Croix Falls, Wisconsin June 17, August 1, and October 12 and 26, 2014

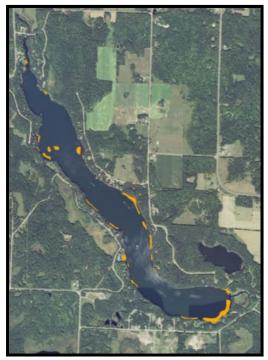
Figure 1: 2014 June EWM Treatment Areas

Eurasian water milfoil (*Myriophyllum spicatum*) (EWM) was discovered in the lake in 2002, and the Sand Lake Management District (SLMD) is engaged in active management to control this invasive exotic species. Following the 2013 fall EWM bed mapping survey that found EWM plants and beds scattered throughout the lake, the SLMD, under the direction of Lake Education and Planning Service, LLC (LEAPS), decided to chemically treat 21 areas in June of 2014. Collectively, they totaled 15.27 acres or 4.7% of the lake's surface area (Figure 1).
