**Eurasian water milfoil (*Myriophyllum spicatum*)  
Pre/Post Herbicide and Fall Bed Mapping Surveys  
Echo Lake – WBIC: 2630200  
Barron County, Wisconsin**

Echo Lake Association, Short Elliott Hendrickson Inc. and the  
Wisconsin Department of Natural Resources

Endangered Resource Services, LLC  
Matthew S. Berg, Research Biologist  
St. Croix Falls, Wisconsin

June 10, July 20, and October 6, 2013

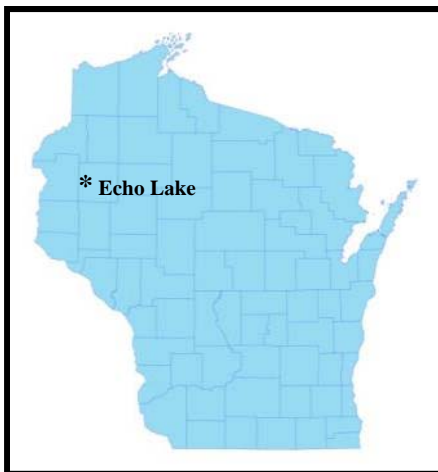
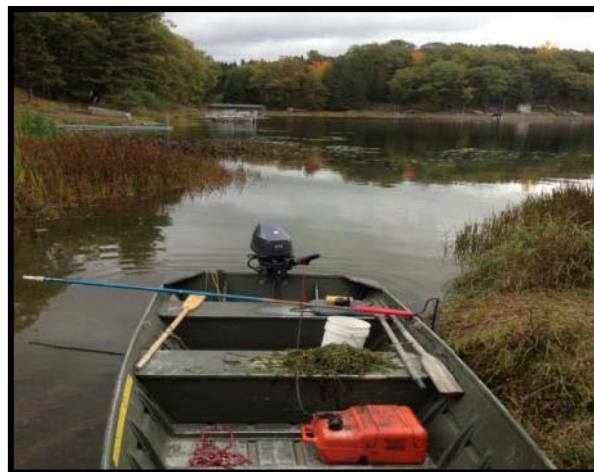
EWM Removed from Echo Lake During the Fall 2013 Bed Mapping Survey

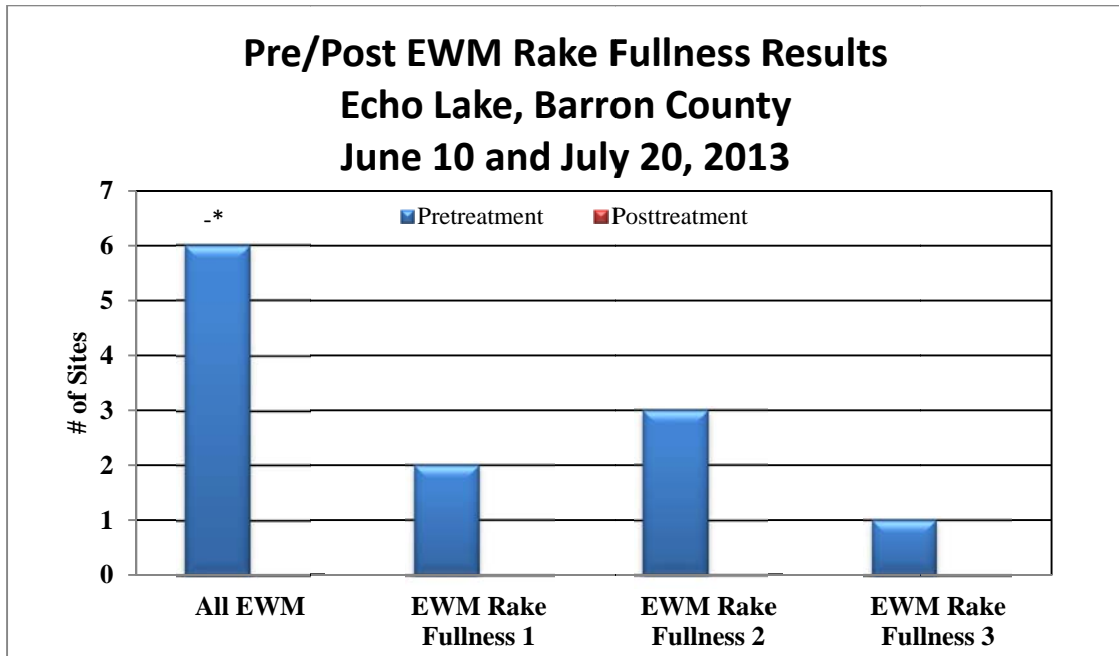
**Figure 8: Pre/Post Changes in EWM Rake Fullness**

We found EWM at only six sites during the pretreatment survey. Of these, one had a fullness rating of 3, three had a rating of 2, and two were represented by a single stem. This resulted in a mean rake fullness value for EWM at all sites of 1.83. We also recorded EWM as a visual at eleven points. During the posttreatment survey, we didn't find EWM in the rake anywhere, but it was a visual at a single site (Figure 7) (Appendix V). These results suggested a significant reduction in overall EWM (Figure 8).

Significant differences = \*  $p < .05$ , \*\*  $p < .01$ , \*\*\*  $p < .005$

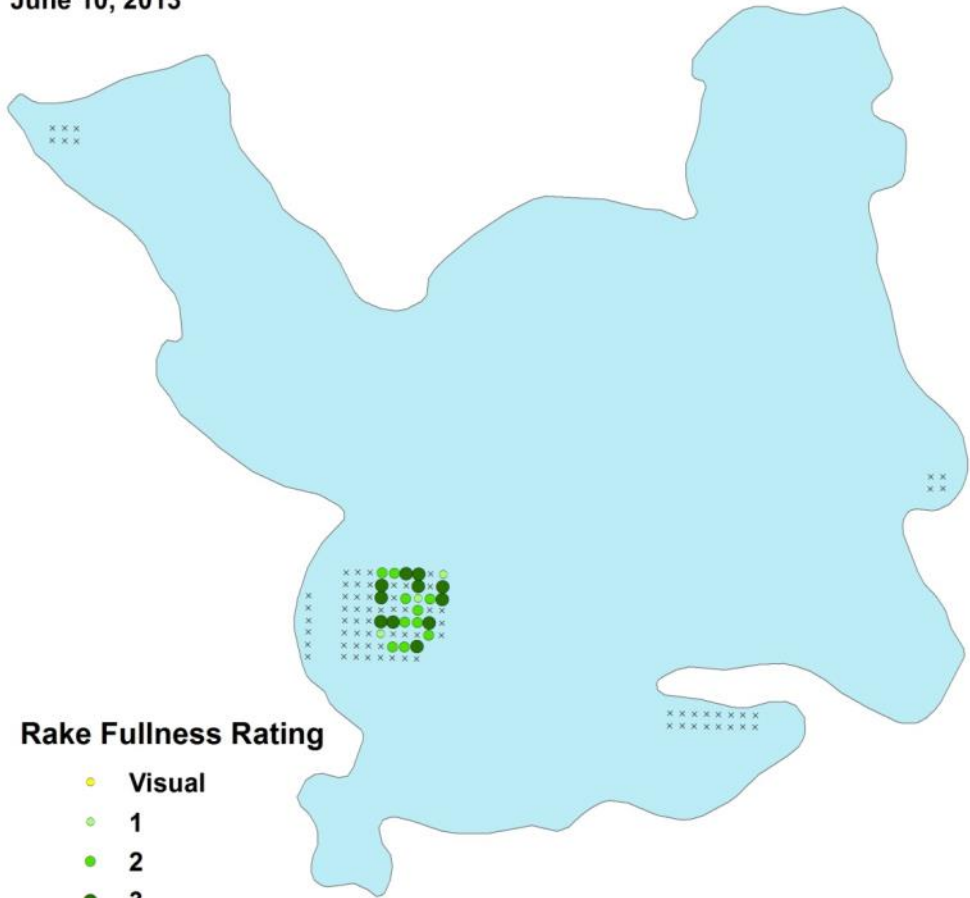
**Nitella**  
**(*Nitella* sp.)**  
Coefficient of Conservatism = 7  
Pretreatment Survey  
Echo Lake  
Barron County, WI  
June 10, 2013

**Rake Fullness Rating**

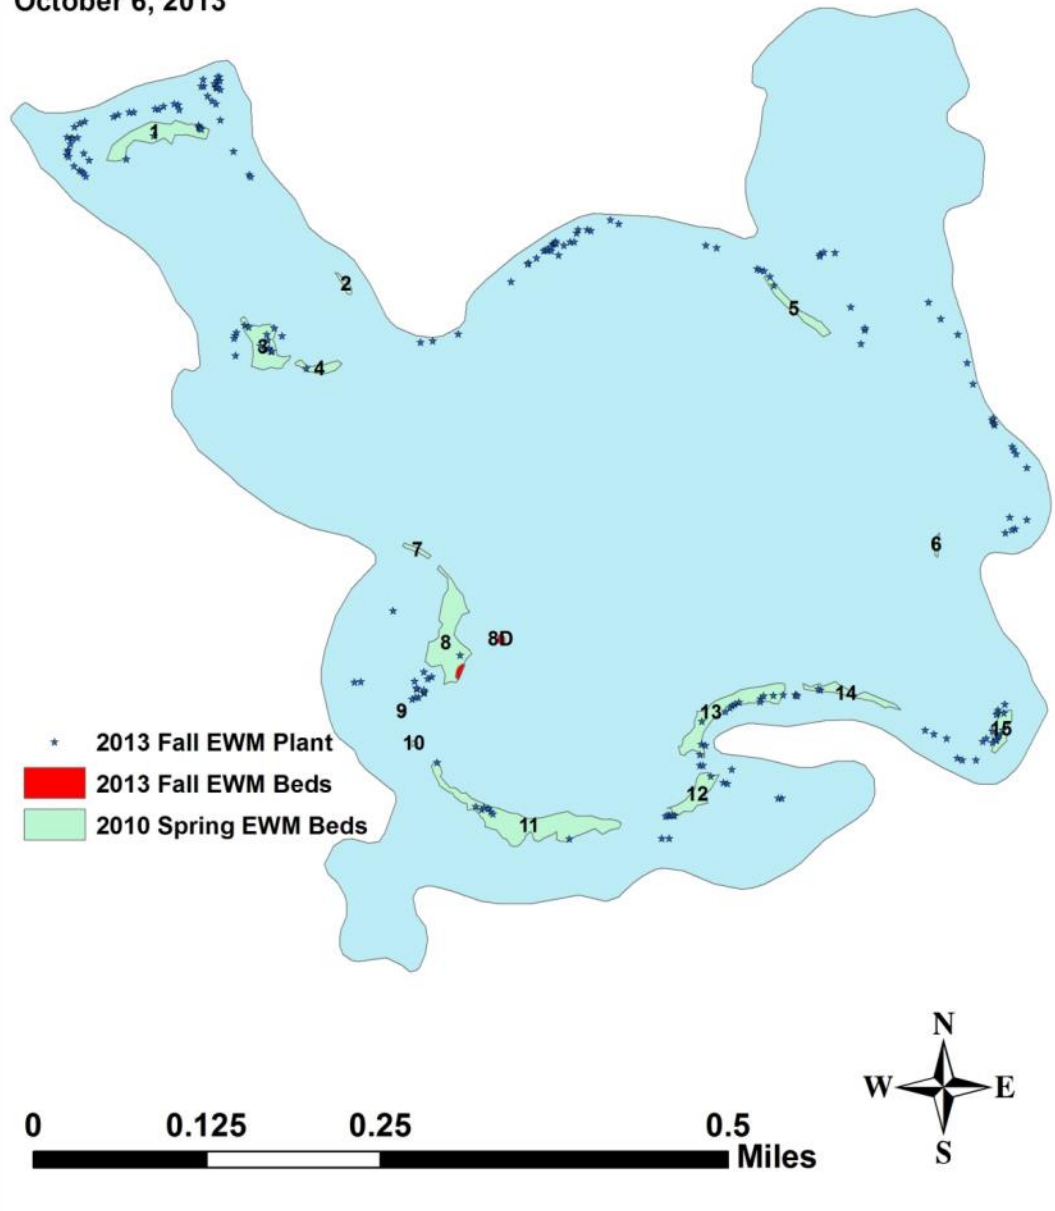
# Eurasian water milfoil (*Myriophyllum spicatum*)

Exotic species  
Fall Bed Mapping Survey  
Echo Lake  
Barron County, WI  
October 6, 2013

Compared to 2012 when we found five beds totaling 0.21 acres, 2013 would seem to show a reduction in EWM on the lake (-0.17 acres) (Table 5). Unfortunately, while we only found 35 additional EWM plants outside of the mapped beds in 2012 and were able to rake remove all of them, in 2013, we located 209 additional plants outside these two small beds and could not remove them all. Most of these plants were found in 5-9ft of water and were scattered throughout this lake within this zone. Comparing the location of these plants to our first bed mapping survey in the spring of 2010, we noted that EWM seems to be recolonizing, albeit at very low densities, many of these areas.

In fall 2012, we recommended continued rake removal throughout the 2013 growing season. Although we rake removed numbers of plants on each of our three trips to the lake, it is our understanding that there was no additional volunteer pulling in 2013 (D. Blumer, pers. comm). Without a consistent effort in this regards, it is likely that additional herbicide applications will be needed in the future to maintain EWM at the lake's current low levels. Additionally, as EWM was so widely distributed but occurred at such low densities in fall 2013, we believe using a shoreline survey before establishing treatment areas and pre/post points in the spring of 2014 is an idea worth considering.
