**Curly-leaf pondweed (*Potamogeton crispus*)
Point-Intercept and Bed Mapping Surveys, and
July Full Point-Intercept Macrophyte Survey
Big Moon Lake (WBIC: 2079000) - Barron County, WI**

Endangered Resource Services, LLC
Matthew S. Berg, Research Biologist
St. Croix Falls, Wisconsin
June 12, 16, and July 13, 2013

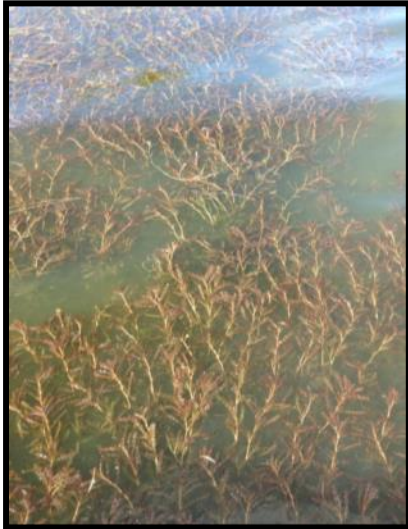
Canopied CLP Near the Lake Outlet (Berg 2013)

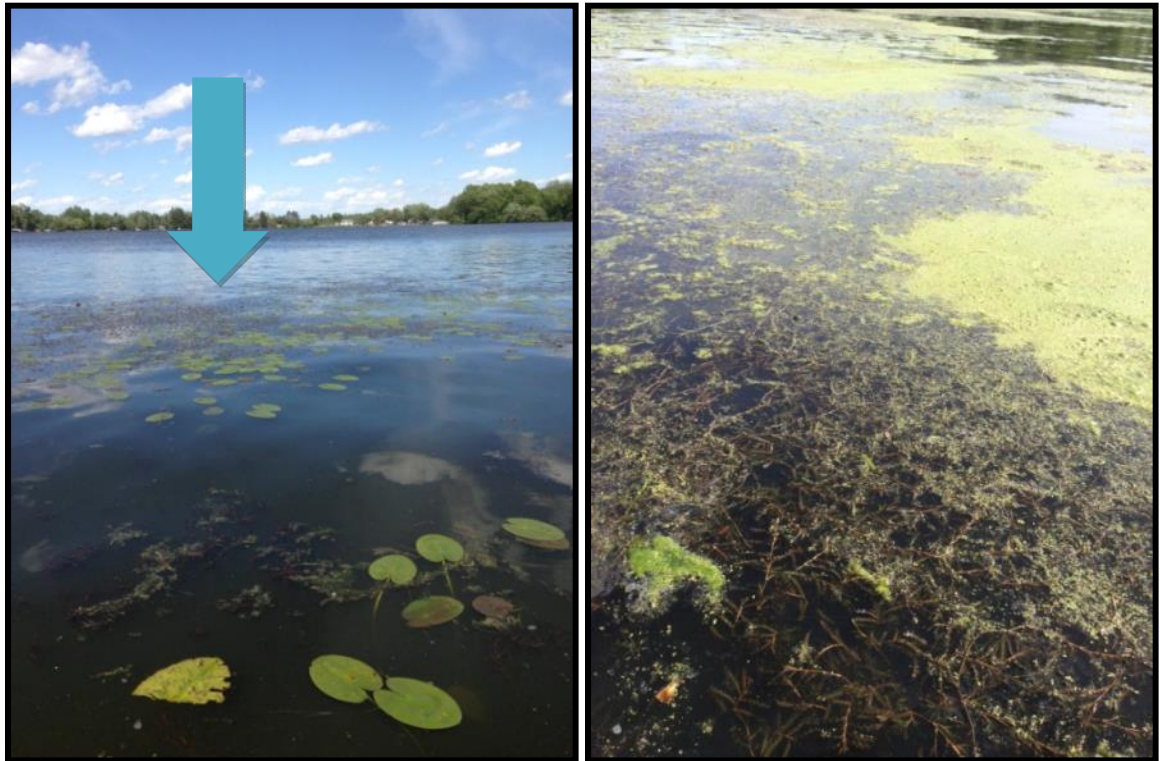
Figure 5: Representative CLP in Beds 1 and 3

Bed 1: Located at the entrance to the “Lagoon” and stretching across the entire bay, Bed 1 was moderately dense and canopied, but not monotypic (Figure 5). In addition to “lily pads”, we noted that valuable habitat providing native species like Large-leaf pondweed (*Potamogeton amplifolius*) and Northern water milfoil (*Myriophyllum sibiricum*) were found here and almost nowhere else in the lake. Because of this, we believe this is an area where any future CLP management, if not avoided, should be done very cautiously.

Beds 2 and 3: CLP in Beds 2 and 3 extended to 9ft, was canopied throughout, and was often dense to the point of being a potential navigation impairment (Figure 5). Fortunately, there were few residences in these areas as the majority of the beds were bordered by undeveloped wetlands. Although nearly monotypic CLP in June, Coontail (*Ceratophyllum demersum*) and Flat-stem-pondweed (*Potamogeton zosteriformis*) filled in many of these areas by the time of the July survey.

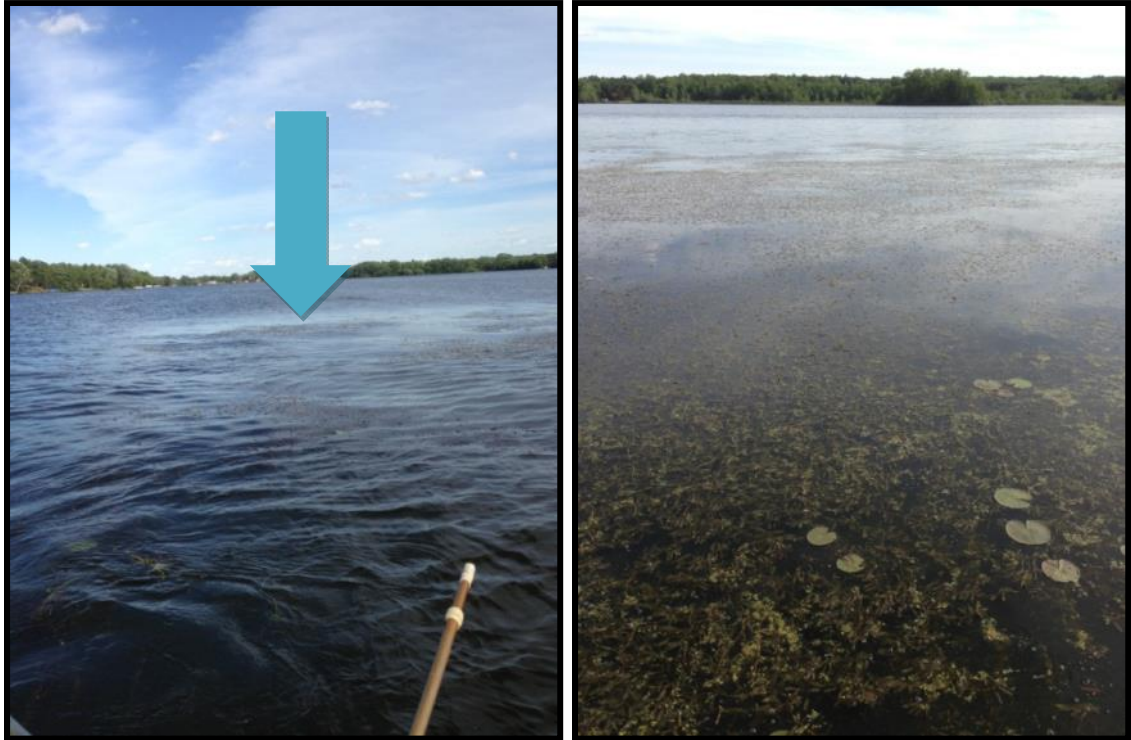
Figure 6: Canopied CLP in Bed 4 (on the bar) and Bed 5

Beds 4 and 5: We found that Beds 4 and 5 were also moderate to dense and canopied along the western shoreline and the northwest bays. However, as the worst of these areas were again adjacent to undeveloped wetlands and too shallow (<2ft in the bays) to be boated through, it seems unlikely that they would cause navigation issues. The only area in the beds that could have the potential to interfere with recreation was the eastern finger of Bed 4 which covered the gravel/sand bar projecting to the southeast (Figure 6).

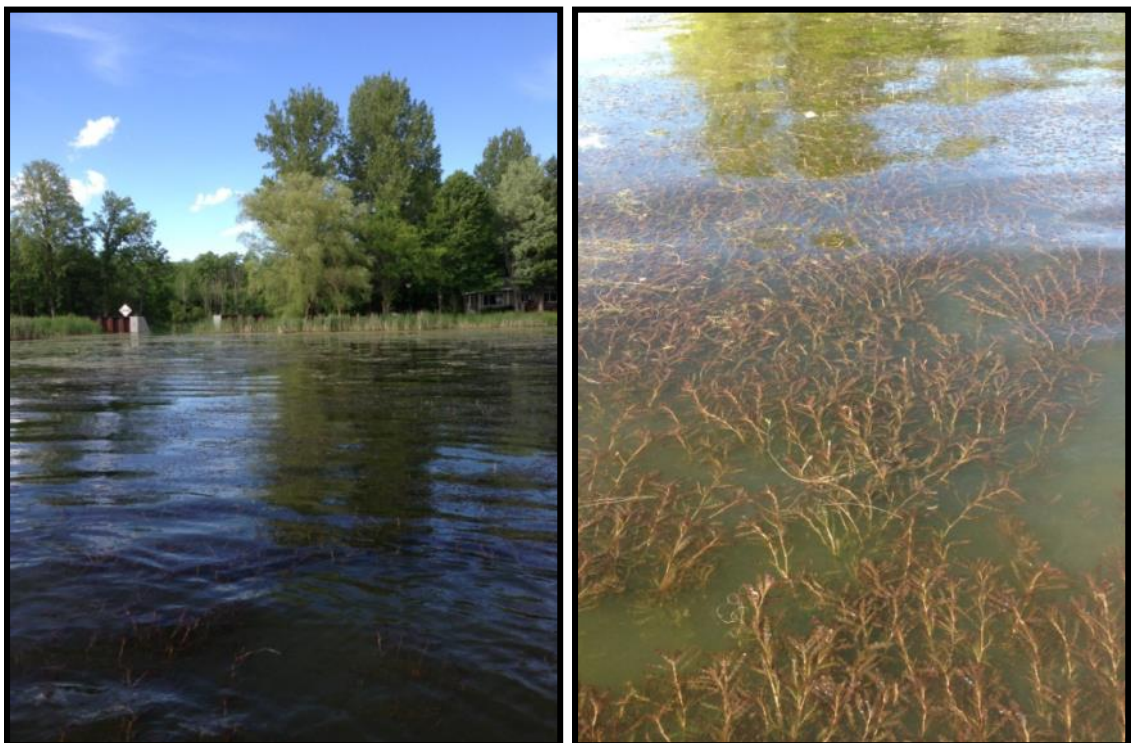
Figure 7: CLP in Bed 8 at the Dam Outlet

Beds 8 and 9: These dense beds were established near the lake outlet. Although there were a few residences in the area, regular boat traffic, water flow, or a combination of the two appeared to be keeping a navigable channel open between the two beds (Figure 7).

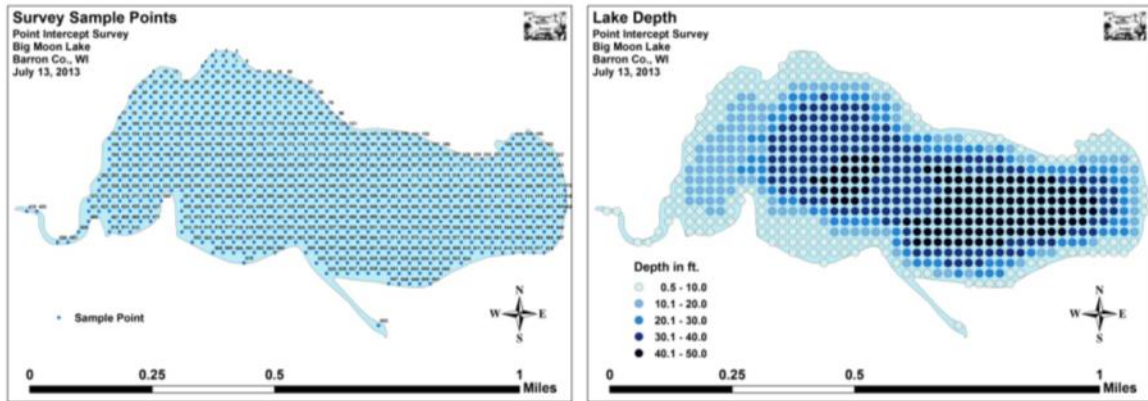
Figure 8: Survey Sample Points and Lake Depth

Depth soundings taken at Big Moon Lake's 652 survey points revealed the bays on the lake's west side generally sloped gradually to 10ft+ of water, while the north, south, and east shorelines of the central basin tended to drop off sharply into 30ft+ of water. Within this basin, we mapped two 40ft+ holes – one on either side of the lake's midpoint. The only other topography of note was a sunken island that topped out at approximately 6ft due north of the point on the lake's southwest side (Figure 8) (Appendix IV).

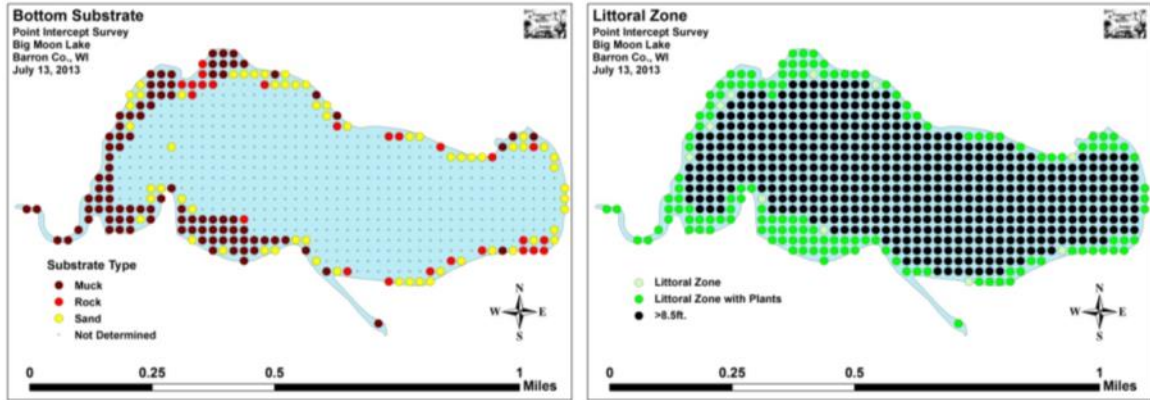
Figure 9: Bottom Substrate and Littoral Zone

Of the 183 survey points where we could determine the substrate, 53.55% were muck, 13.66% were rock, and 32.79% were pure sand. Nutrient rich organic muck dominated the lake bottom in the western and southern bays while sandy muck was common in deeper areas beyond the sandy/rocky north and eastern shorelines. Throughout the lake, most of the exposed points, bars, and islands were also sandy/rocky in nature (Figure 9). We found plants growing at 141 sites or approximately 21.63% of the entire lake bottom and in 92.76% of the littoral zone. Plant growth was slightly skewed to deeper water as the mean depth was 4.2ft while the median depth was 4.0ft. Despite a lakewide July littoral upper limit of 8.5ft, most plant growth ended in 7.0ft of water, and these plants were starting to die back due to lack of light/poor water clarity (Figure 9) (Table 2) (Appendix IV).

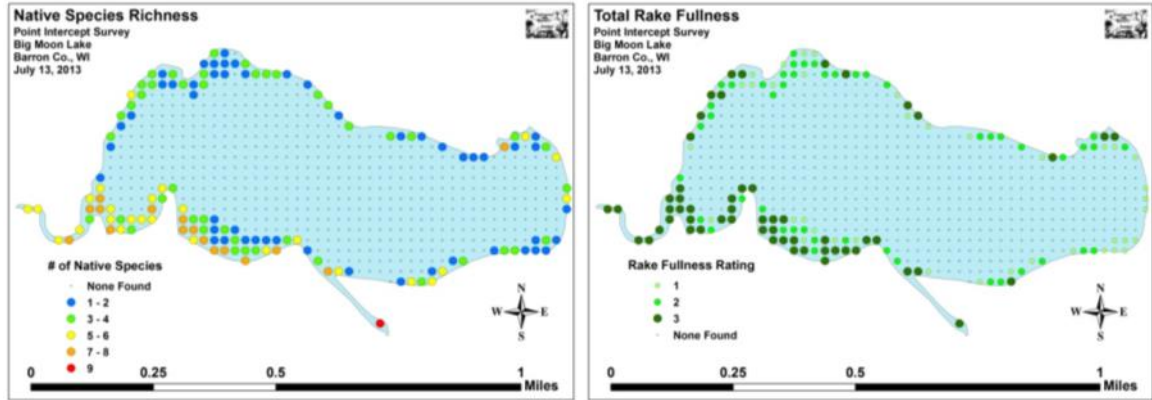
Figure 10: Native Species Richness and Total Rake Fullness

Species richness was fairly low as we found only 24 species in the rake during the survey. Visuals and boat survey species brought this total up to 38 species, but most of these were emergents rather than true aquatics. Despite this low number of species, overall diversity was very high with a Simpson Diversity Index value of 0.92. Localized richness was also high with an average of 3.65 native species per/site with native vegetation. Total rake fullness was moderate averaging 2.13 at sites with vegetation. In general, species richness, diversity and total rake biomass declined rapidly at depths beyond 5ft (Figure 10) (Appendix V).

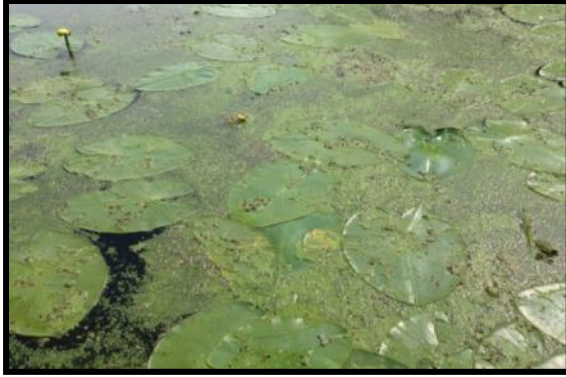
Spatterdock and “Duckweeds” near the Moon Creek Inlet (Berg 2013)

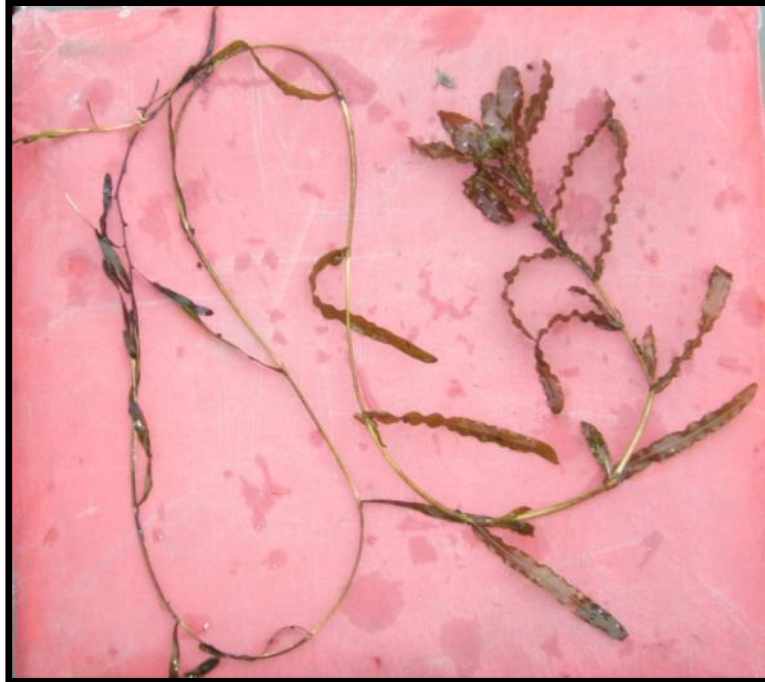
DESCRIPTION: Curly-leaf pondweed is an invasive aquatic perennial that is native to Eurasia, Africa, and Australia. It was accidentally introduced to United States waters in the mid-1880s by hobbyists who used it as an aquarium plant. The leaves are reddish-green, oblong, and about 3 inches long, with distinct wavy edges that are finely toothed. The stem of the plant is flat, reddish-brown and grows from 1 to 3 feet long. The plant usually drops to the lake bottom by early August

LIFE HISTORY AND EFFECTS OF INVASION: Curly-leaf pondweed spreads through burr-like winter buds (turions), which are moved among waterways. These plants can also reproduce by seed, but this plays a relatively small role compared to the vegetative reproduction through turions. New plants form under the ice in winter, making curly-leaf pondweed one of the first nuisance aquatic plants to emerge in the spring.

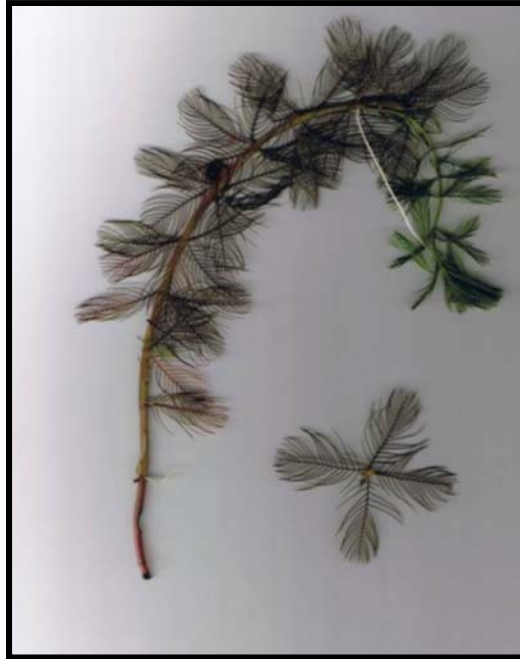
DESCRIPTION: Eurasian water milfoil is a submersed aquatic plant native to Europe, Asia, and northern Africa. It is the only non-native milfoil in Wisconsin. Like the native milfoils, the Eurasian variety has slender stems whorled by submersed feathery leaves and tiny flowers produced above the water surface. The flowers are located in the axils of the floral bracts, and are either four-petaled or without petals. The leaves are threadlike, typically uniform in diameter, and aggregated into a submersed terminal spike. The stem thickens below the inflorescence and doubles its width further down, often curving to lie parallel with the water surface. The fruits are four-jointed nut-like bodies. Without flowers or fruits, Eurasian water milfoil is nearly impossible to distinguish from Northern water milfoil. Eurasian water milfoil has 9-21 pairs of leaflets per leaf, while Northern milfoil typically has 7-11 pairs of leaflets. Coontail is often mistaken for the milfoils, but does not have individual leaflets.

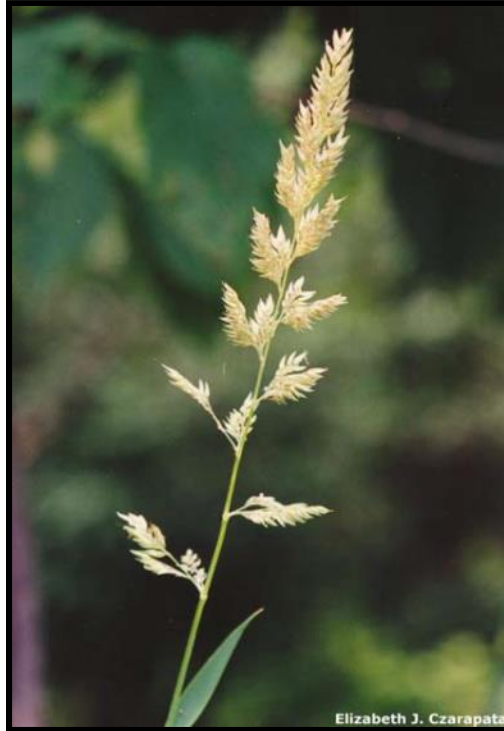
DESCRIPTION: Reed canary grass is a large, coarse grass that reaches 2 to 9 feet in height. It has an erect, hairless stem with gradually tapering leaf blades 3 1/2 to 10 inches long and 1/4 to 3/4 inch in width. Blades are flat and have a rough texture on both surfaces. The lead ligule is membranous and long. The compact panicles are erect or slightly spreading (depending on the plant's reproductive stage), and range from 3 to 16 inches long with branches 2 to 12 inches in length. Single flowers occur in dense clusters in May to mid-June. They are green to purple at first and change to beige over time. This grass is one of the first to sprout in spring, and forms a thick rhizome system that dominates the subsurface soil. Seeds are shiny brown in color.
