APPENDIX A

Public Participation Materials

**Mann Lake
Management Planning Project
Kick-off Meeting
June 21, 2014**

**Description and Summary of Lake Aeration Projects to Prevent Fish Winterkill in
Barron and Polk Counties, Wisconsin**

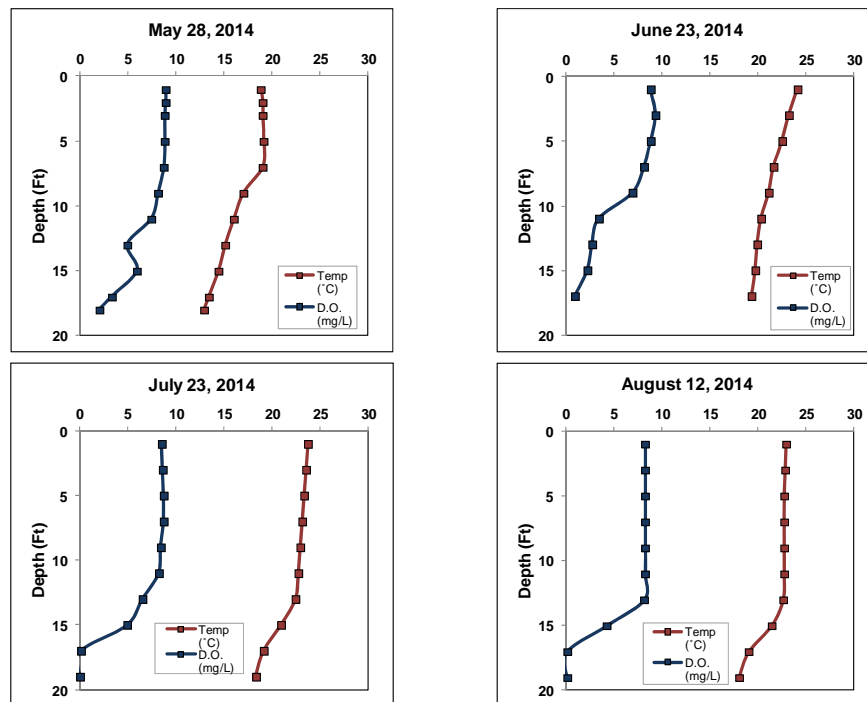
In May of 2014, Onterra staff had their first glimpse of Mann Lake with a water quality sampling visit. The lake is sampled during the spring and fall to analyze water chemistry during the lake's mixing, or *turnover* events. When a lake turns over, many physical and chemical constituents (temperature, dissolved oxygen, nutrients, etc.) are mixed within the water column. This gives ecologists an idea of what the nutrient balance is within the lake and supports computer modeling efforts of the lake's pollutant load. Water quality samples were also collected in June, July and August. These results help ecologists understand how the constituents behave if the lake *stratifies*. Stratification is when a lake develops two separate layers of water – a warmer, upper layer and a cold lower layer of water. During each water quality visit, dissolved oxygen and temperature profiles of the water column are collected. Several of these profiles are displayed in Figure 1.

Figure 1. Mann Lake dissolved oxygen and temperature profiles. Profiles collected in October and February of 2015 will indicate how these variables are fairing during fall turnover and winter ice cover.

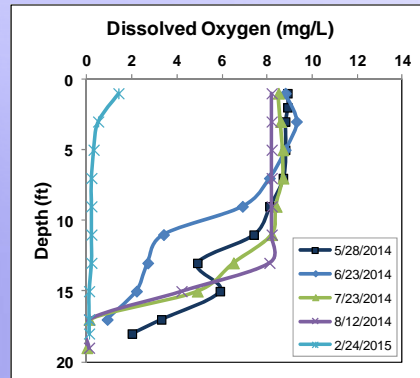
Mann Lake Fishery

- **Low winter dissolved oxygen = primary concern**
 - Trout, salmonids
~3-5 mg/L
 - Cyprinids
~1-2 mg/L
 - Pike, perch
<1 mg/L

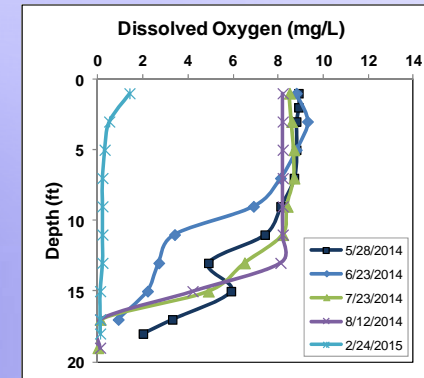
Mann Lake Fishery

- **Factors in lake dissolved oxygen content**
 - Rate of microbial degradation
 - Water volume
 - Duration of ice cover

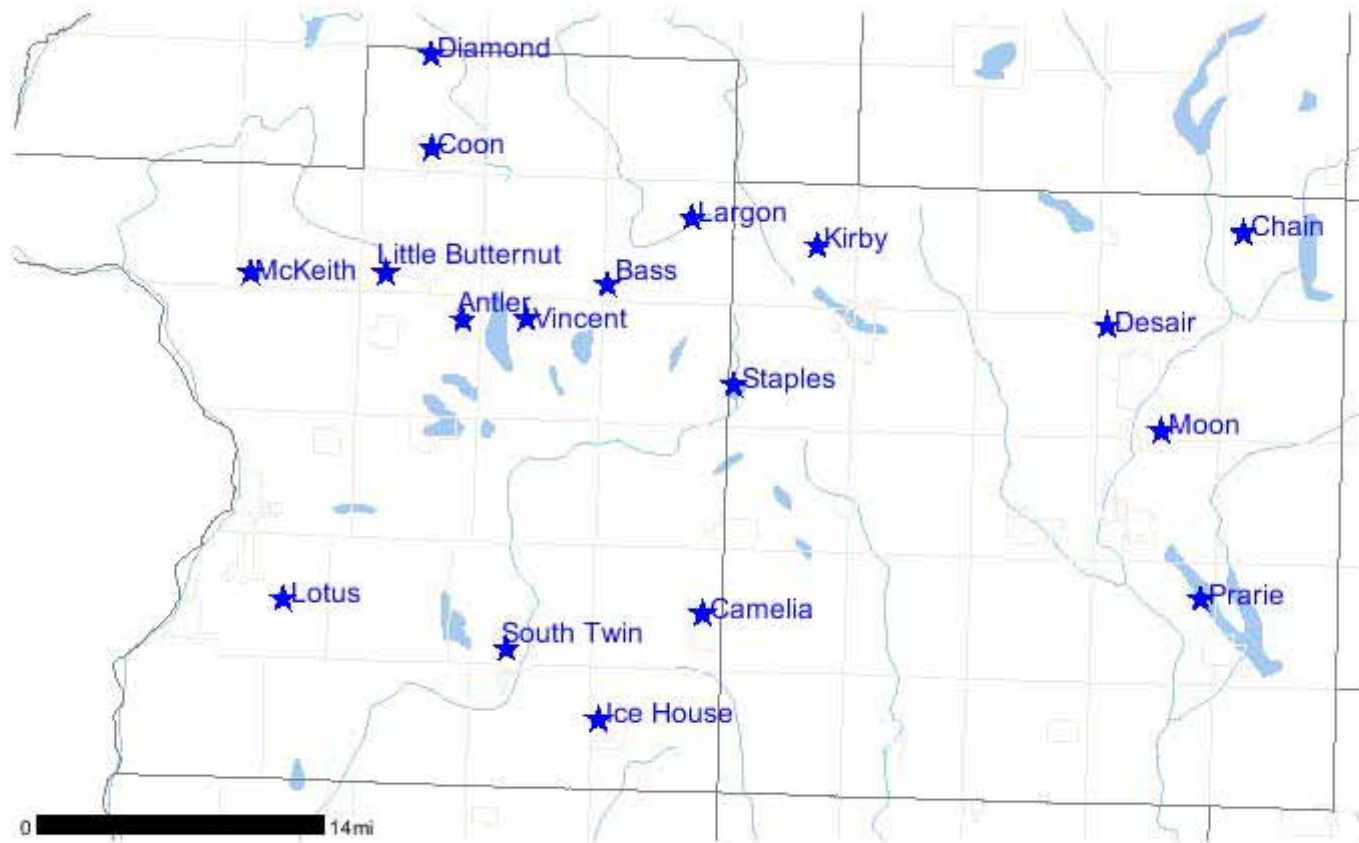
Figure 1. Barron and Polk County lake aeration projects, 1977 – 2005.

County Lake	Acres	Maximum Depth (ft)	Mean Depth (ft)	Year	Type
Barron Chain	107	19	7	1992	3 - ½ hp Air Compressors
Desair	81	33	17	1999	3 - ¾ hp Air Compressors
Kirby	92	19	8	1988	2 - ½ hp Air Compressors
Moon	84	5		2001	1 - 2 hp Aspirating Aerator
Prairie	1,534	16	9	1991	6 - 3 hp Aspirating Aerator
Staples	304	17	10	1999	4 - 2 hp Aspirating Aerator
Polk Antler	101	22	9	1988	3 - ½ hp Air Compressors
Bass	138	19	6	1998	3 - ¾ hp Air Compressors
Camelia	60	6	4	1986	3 - ½ hp Air Compressors 1 - 2 hp Aspirating Aerator
Coon	54	16	10	1981	2 - ½ hp Air Compressors
Diamond	126	15		1995	1 - ½ hp Air Compressor
East (Lotus)	246	15	7	2004	2 - ¾ hp Air Compressors
Ice House	6	35	14	1987	1 - ½ hp Air Compressor
Largon	129	10	6	1977	4 - ½ hp Air Compressors
Little Butternut	189	23	8	1998	4 - ¾ hp Air Compressors
McKeith	72	15		1998	2 - ¾ hp Air Compressors
South Twin	74	9	5	1989	2 - ⅓ hp Air Compressors
Vincent	70	15	9	1993	3 - ½ hp Air Compressors

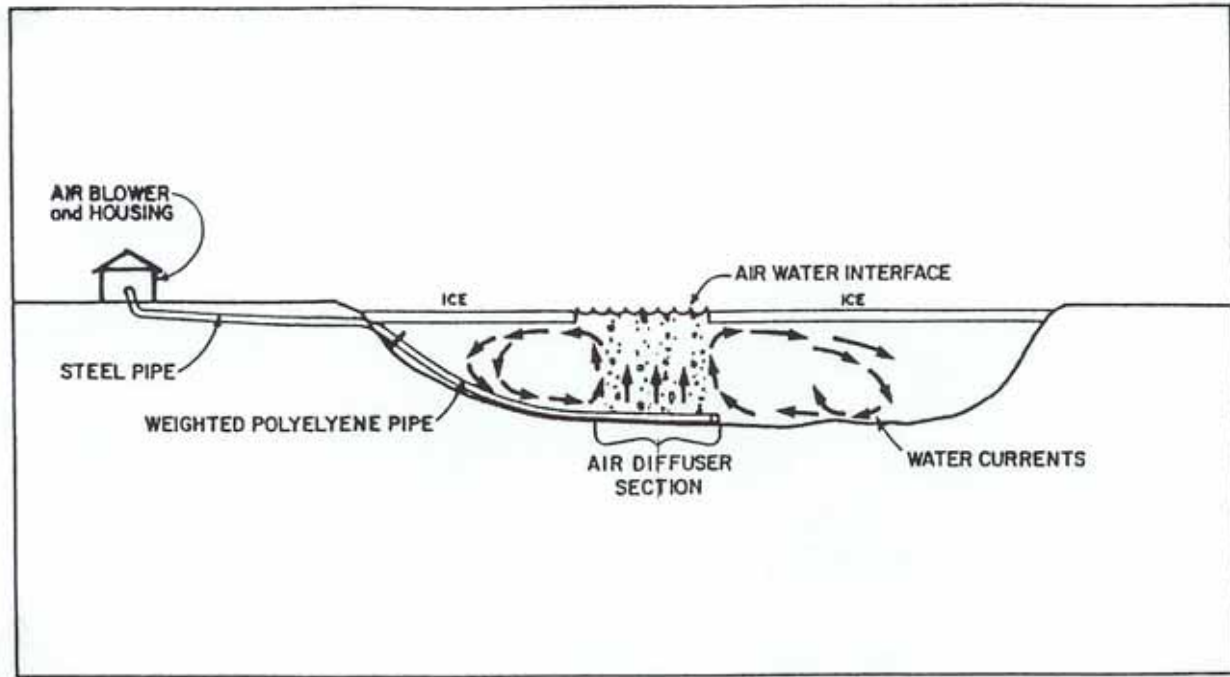
Figure 2. Compressed air aeration system.

Design, Installation and Operation of a Compressed Air Aeration System. The compressed air aeration system is permanently installed at the site. The system consists of one or more air compressors housed in a shelter on the shoreline, which push air through two or more air lines which extend along the lake bottom to the deepest part of the lake that can be reached in 400 feet or less (Figure 2). Air is released from the end of the air lines into the water where it bubbles up through the water column to the surface. This action creates a current which causes warmer water near the lake bottom to rise to the surface, creating an ice-free area which allows water to be reoxygenated. The air lines should be run inside a length of 4 inch PVC pipe from the aerator shed out into several feet of water depth to protect the lines from damage. A barricade needs to be constructed around the open water.

Because funding is often a concern when working with small groups of partners, the procedure has been to install the smallest aeration system which has a reasonable chance of preventing winterkill from occurring. If the system proves inadequate, it can be enlarged.

It is recommended that the carbon vanes in the air compressor be replaced about every nine months of operation. A vane set costs about \$85.00. Other possible maintenance concerns are muskrats *Ondatra zibethica* chewing holes in the air lines that then need repair and boat anchors catching and moving air lines that then need to be reset. If reinforcing rods are used to weigh down the air lines, they should be placed end to end to keep the air lines flat on the bottom.

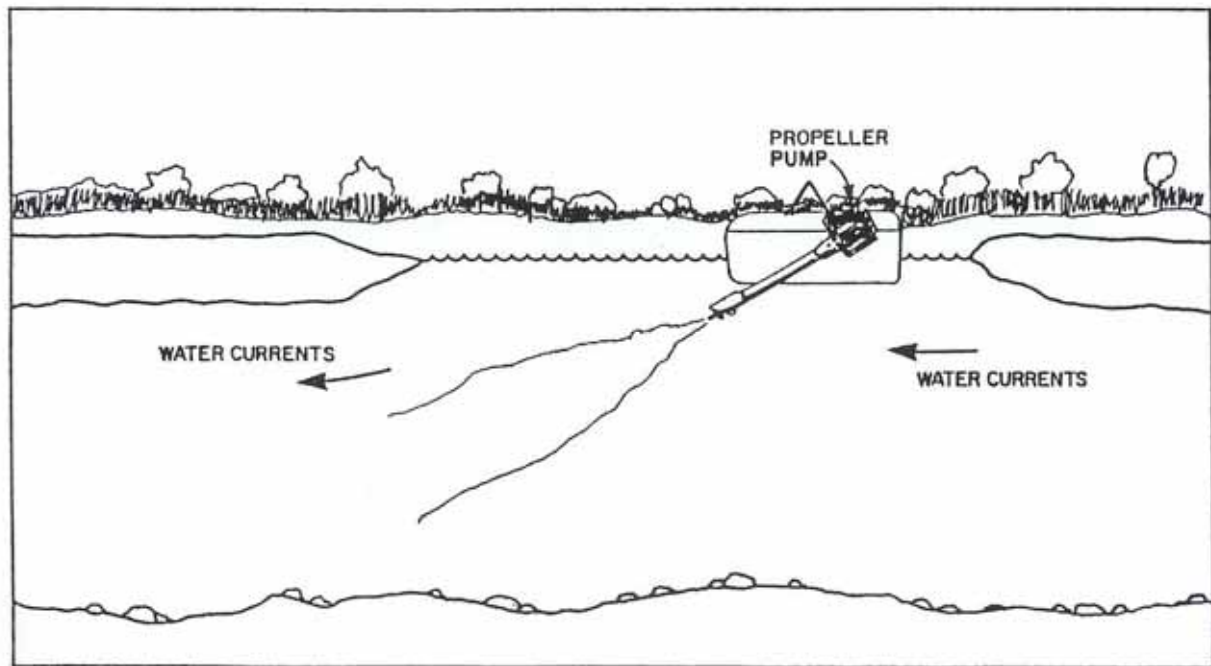
Figure 3. Surface aspirating aeration system.

Aspirating aeration systems are generally more powerful than compressed air systems, and can sustain or even elevate dissolved oxygen levels in some instances. In general, one 2 hp aspirating aerator may aerate a 75 acre lake, with an additional aerator necessary for each additional 75 acres. Dissolved oxygen levels can be monitored, and individual aerators turned on or off as the situation dictates. However, thin ice conditions can be created when aerators are turned on and off, so it is especially important to maintain a good barricade, and at least one aerator should be operating at all times to maintain some open water. The aerators must be operated until ice-out is complete to protect the aerators from being dislodged and damaged by ice push. This type of aerator damage occurred on Staples Lake one year.
