Presque Isle Wilderness Waters Program

Aquatic Plant Management Plan – Van Vliet Lake

Date: December 2015

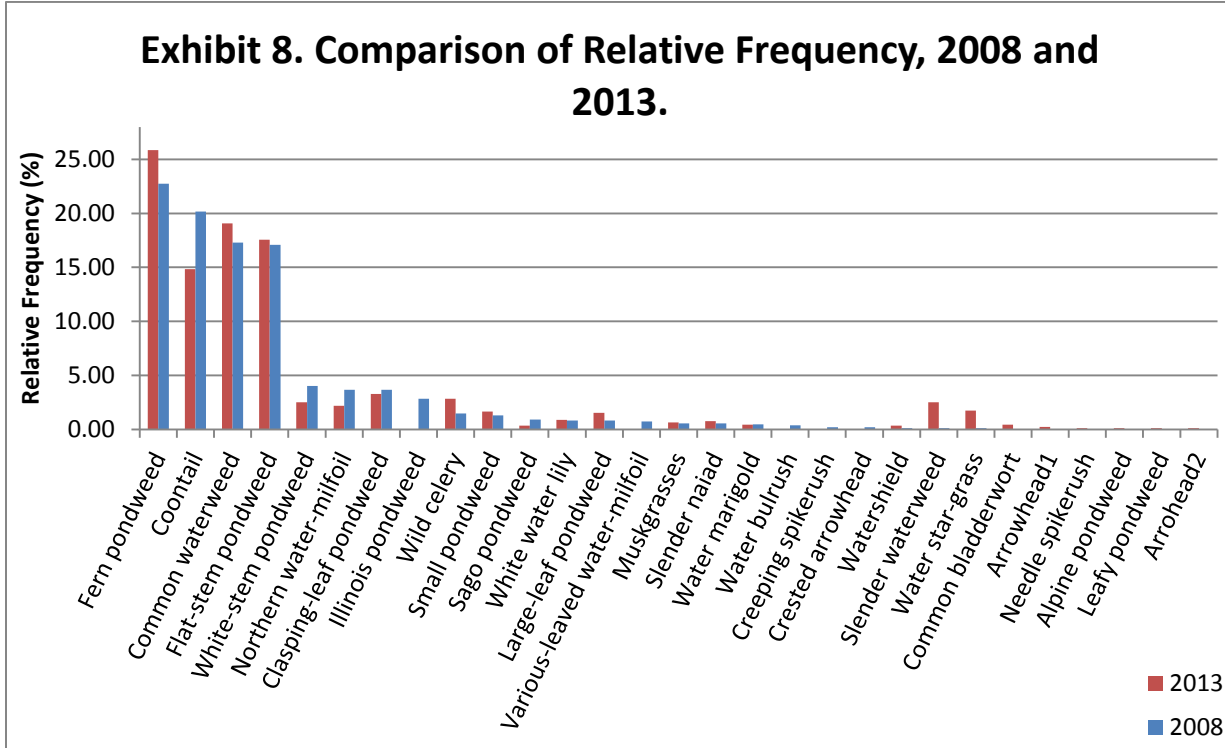
Exhibit 8. Comparison of Relative Frequency, 2008 and 2013.

Exhibit 8 displays the relative frequency of plants found in 2008 and 2013. We can see that fern pondweed was the most common plant species in both years. As seen in both survey years, fern pondweed, coontail, common waterweed, and flat-stem pondweed are the most dominant species in the Van Vliet Lake plant community. This trend is worthy of monitoring with future aquatic plant surveys.
