# **CREX MEADOWS WILDLIFE AREA WATER QUALITY ASSESSMENT**

**Wisconsin Department of Natural Resources  
2016**

**By Craig Roesler  
Rachel Peacher  
Tim Parks  
Wisconsin Department of Natural Resources,  
Spooner, WI**

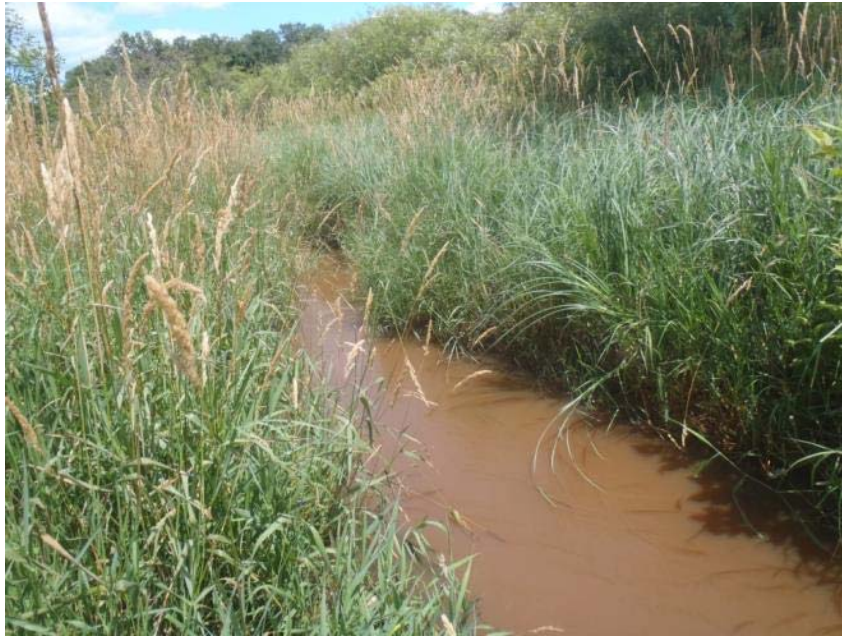
**Figure 2. Hay Creek Upstream of CTH F**

The DNR and the Burnett County Land and Water Conservation Dept. periodically receive inquiries or complaints about the water quality in the Wood River and its tributaries downstream of Crex Meadows. Frequently turbid water due to an abundance of suspended iron floc (iron hydroxide precipitate) is the reason for the concerns (figures 2-4).

Streams downstream of CMWA have high iron concentrations and are frequently turbid due to an abundance of suspended rust-colored iron floc (iron hydroxide precipitate) (figure 2-4, p. 4-5). This has generated inquiries and complaints from the public.

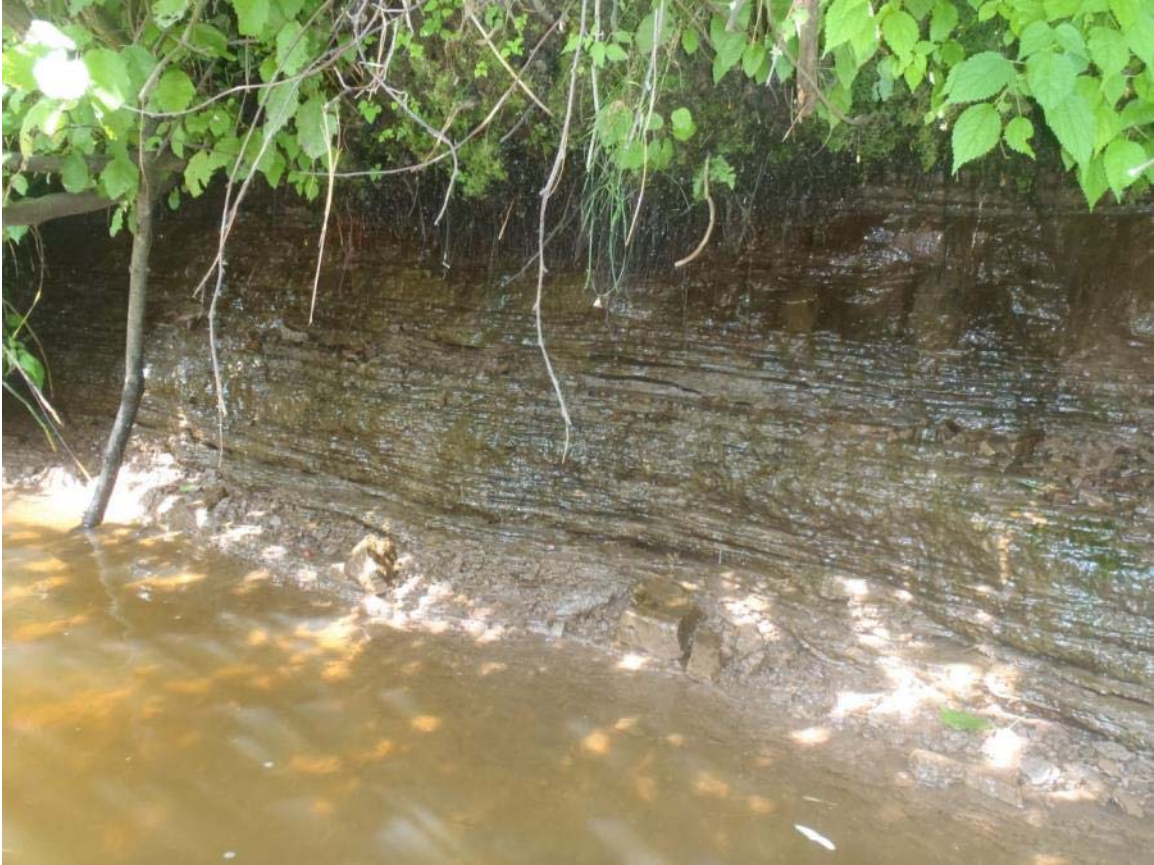
**Figure 11. Clay Layer Exposure on Wood River Upstream of Lower STH 70 Crossing**

Bedrock beneath CMWA is sandstone found at depths of 60 to 100 feet. A 20 to 25 feet layer of varved lake clay overlies the sandstone. The clay was deposited in what was Glacial Lake Grantsburg. A 40 to 75 feet layer of sandy outwash deposits overlies the clay (Patterson 1990). Sandy soils are present in upland areas. Organic soils have formed in wetland areas.

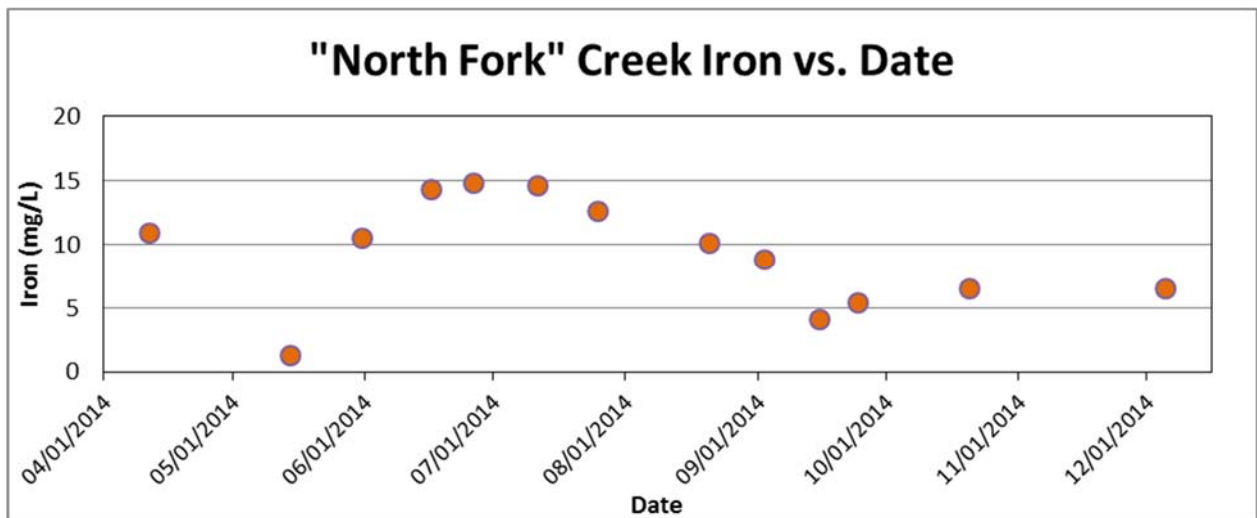
Figure 17. Iron concentrations in Hay, Whiskey, and "North Fork" Creeks

- Lowest iron concentrations occurred on May 14<sup>th</sup>, a period of high flows dominated by surface runoff. Surface runoff at CMWA has low iron concentrations while groundwater discharge often has high iron concentrations.
- A period of high iron concentrations occurred between May 31<sup>st</sup> and September 2<sup>nd</sup>.
- Lower iron concentrations (about ½ of the summer period concentrations) occurred between September 15<sup>th</sup> and December 5<sup>th</sup>. Less bacterial reduction of soil iron due to cooler soil temperatures is likely to be the primary cause of this seasonal decline.

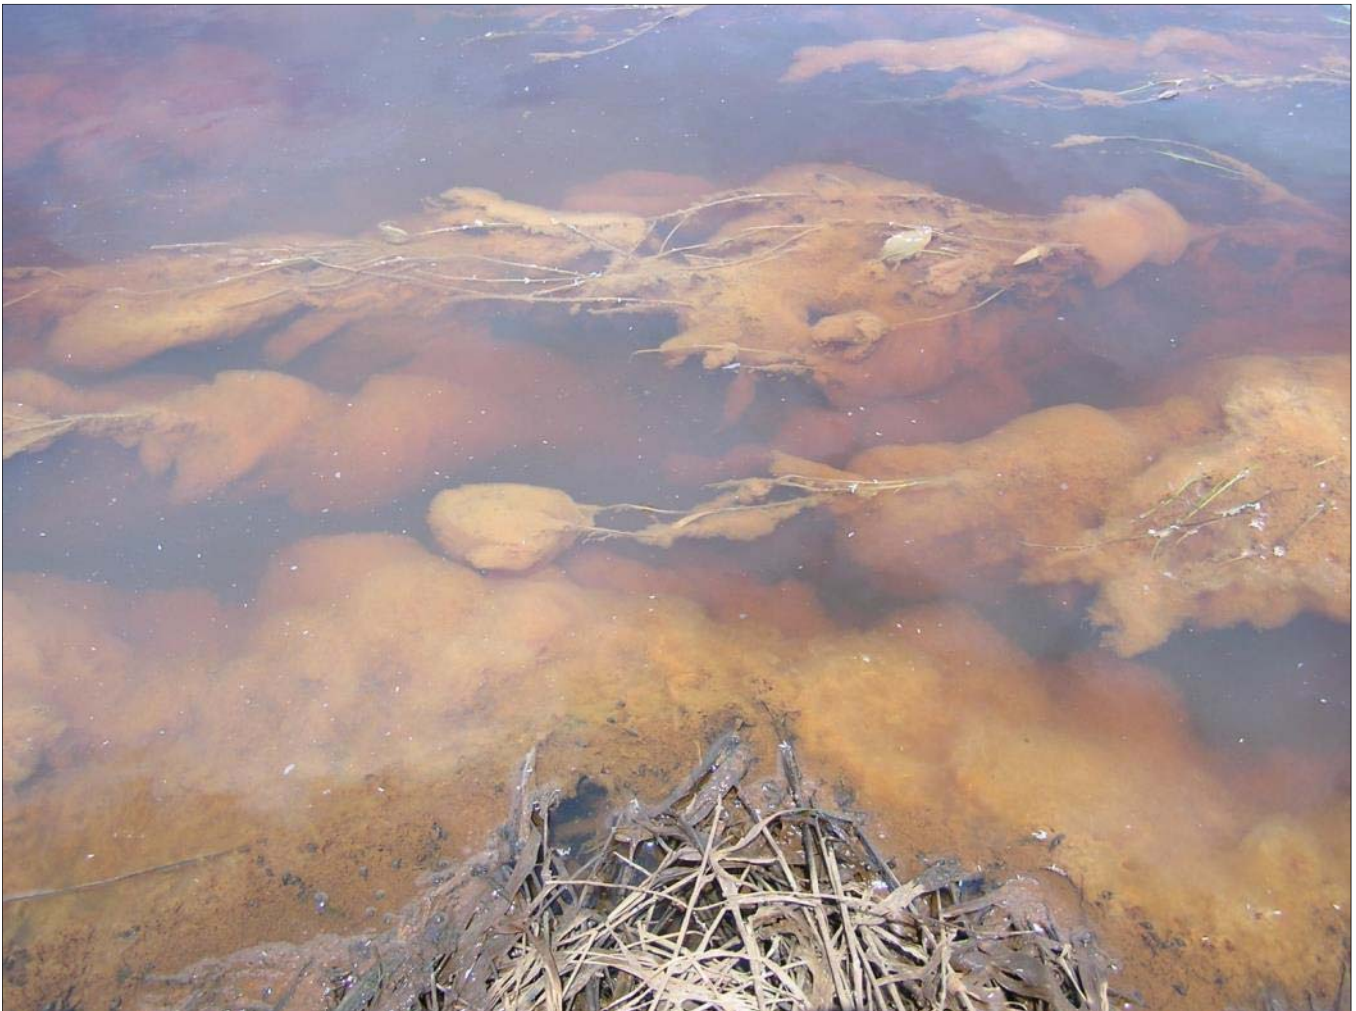
**Figure 19. Iron bacteria in East ditch along Lundquist Rd.**

Growths of iron oxidizing bacteria attached to submerged grass and other substrates were often noticeable at streams with high levels of visible iron floc turbidity (figure 19). The growths were rust colored and often had a cottony appearance due to an abundance of *Leptothrix*, which is a filamentous iron bacteria. Other types of iron bacteria produce a variety of other growth forms.

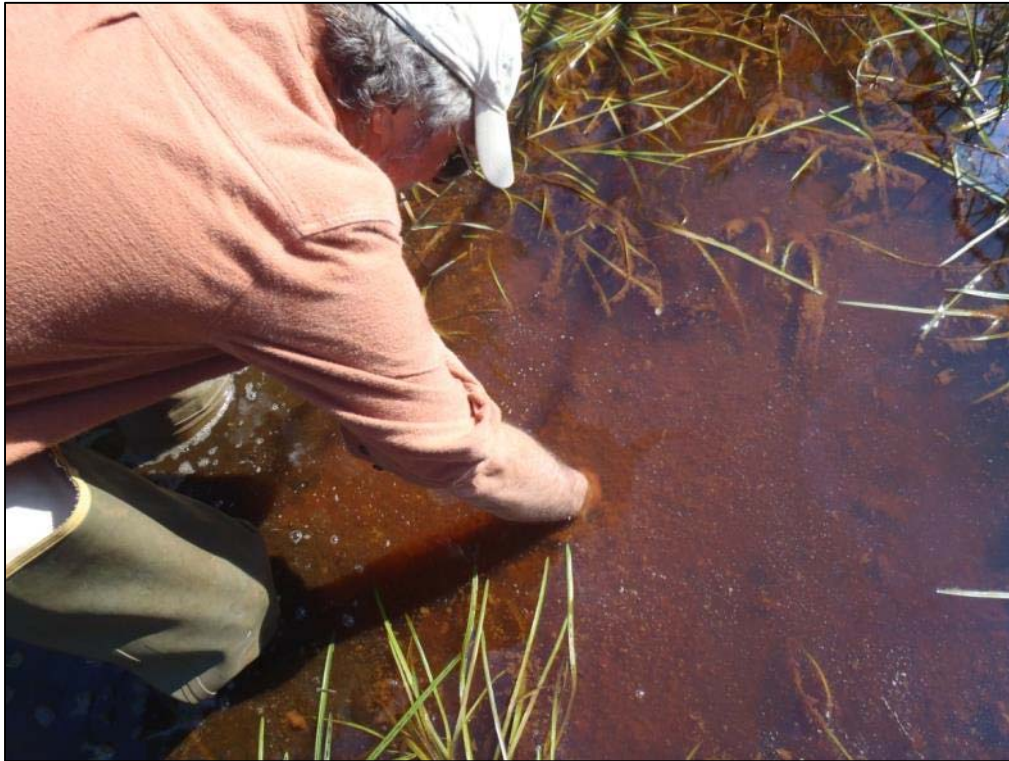
**Figure 20. Iron floc deposits on edge of Iron Creek.**

Deposits of iron floc up to several inches deep were observed at times on some stream margins (figure 20). These deposits probably contained both iron bacteria and bacterially and chemically oxidized iron.

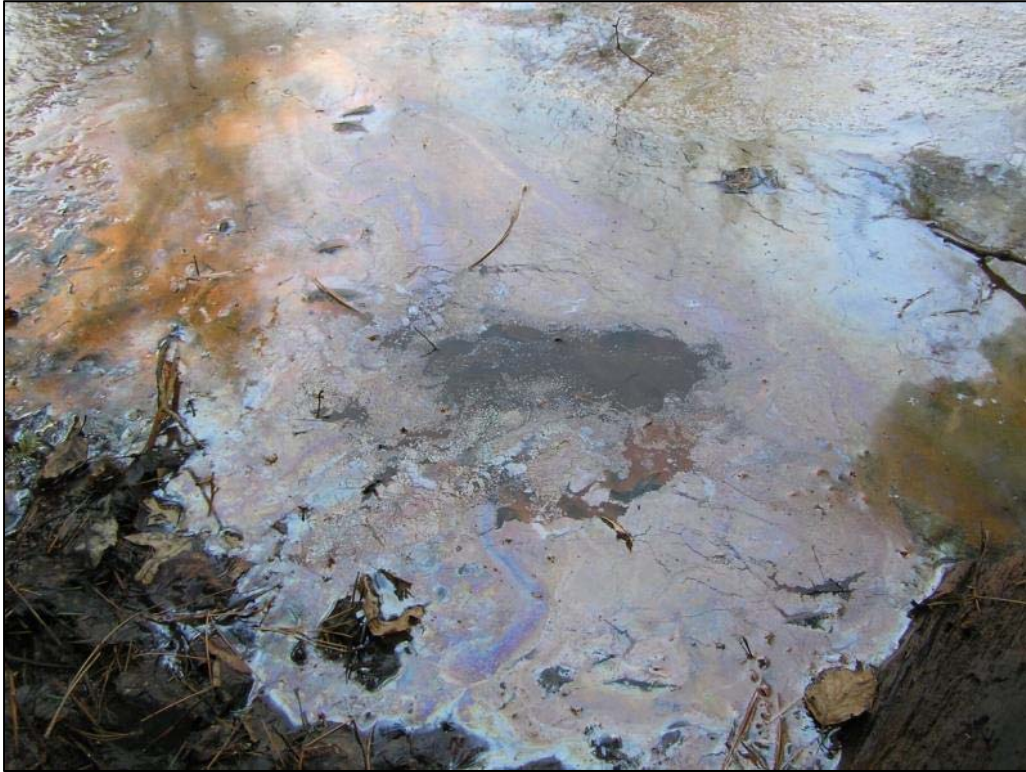
**Figure 21. Iron bacteria surface film.**

Oil-like surface films that are a by-product of iron bacteria were also observed at sites with high iron concentrations. These films have a bluish, oil-like sheen. Unlike actual oil films, these bacterial produced films will fracture and separate when disturbed (figure 21).

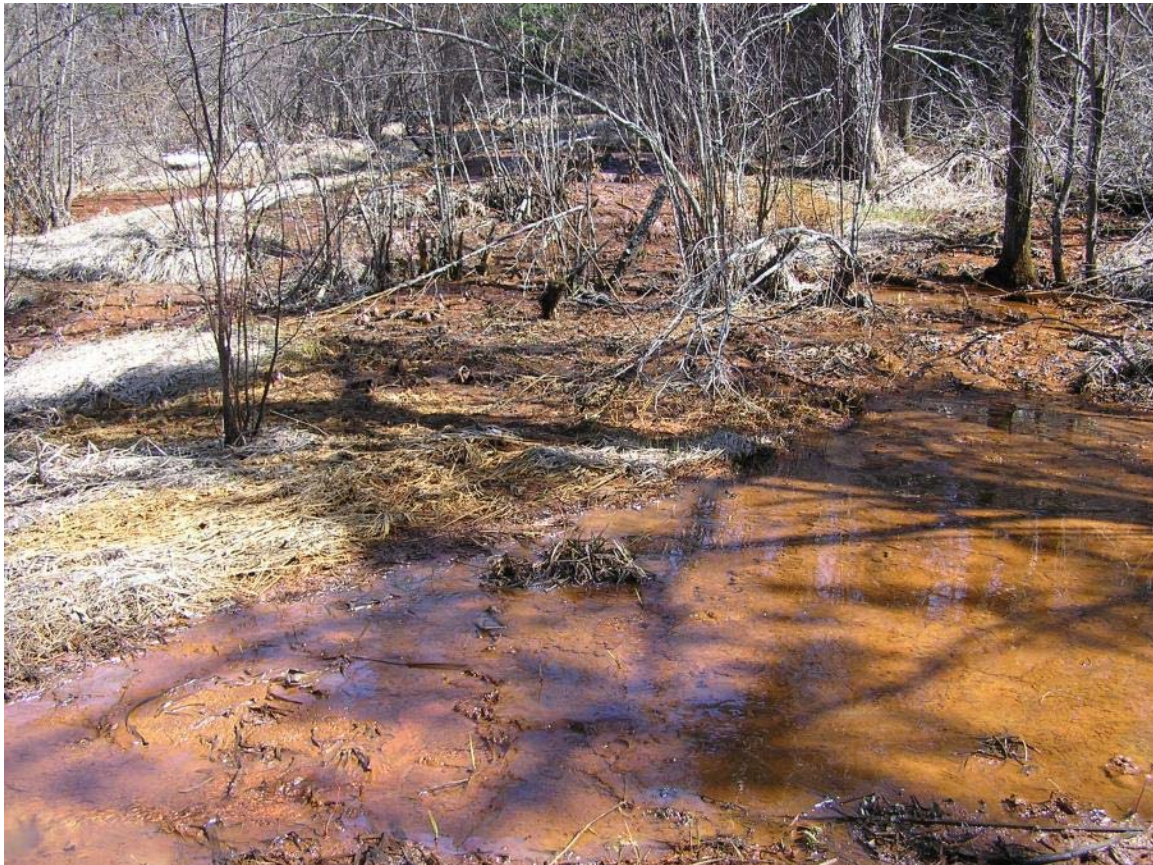
**Figure 22. Iron deposit area north of Ekdall Creek**

Probing in one area of this deposit found thicknesses of 10-15 feet. This deposit has probably been developing since the last glaciers receded.

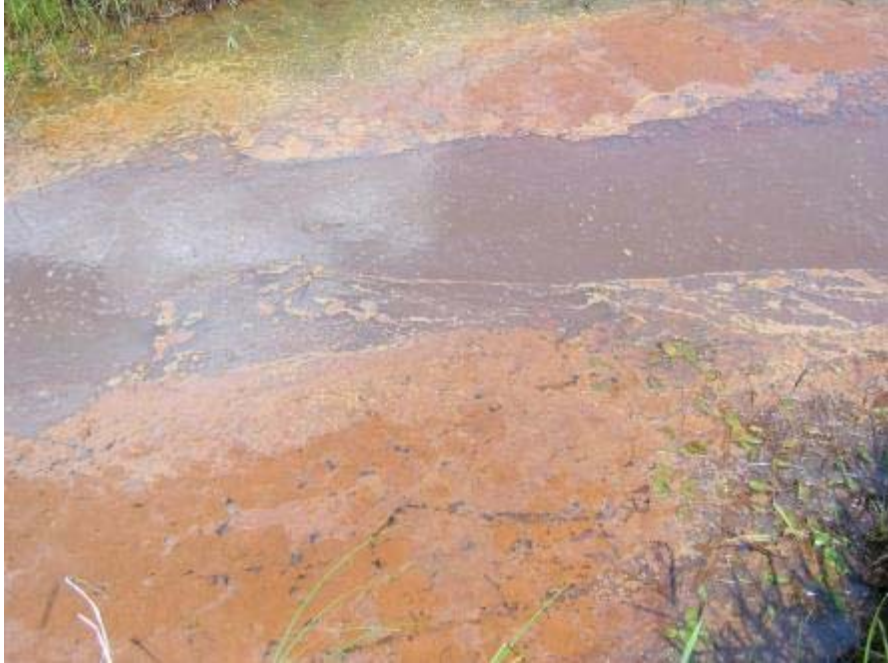
**Figure 23. East ditch along Lundquist Road**

Iron concentrations were measured in two drainage ditches along Lundquist Road ("east and west ditches along Lundquist Rd."; figure 6). Both ditches drain to "North Fork" Creek. The east ditch had a very high iron concentration of 23.3 mg/l. High amounts of visible iron floc and iron bacteria were usually noticeable in this ditch (figure 23), indicating this ditch was receiving inflow of groundwater with high iron concentrations.

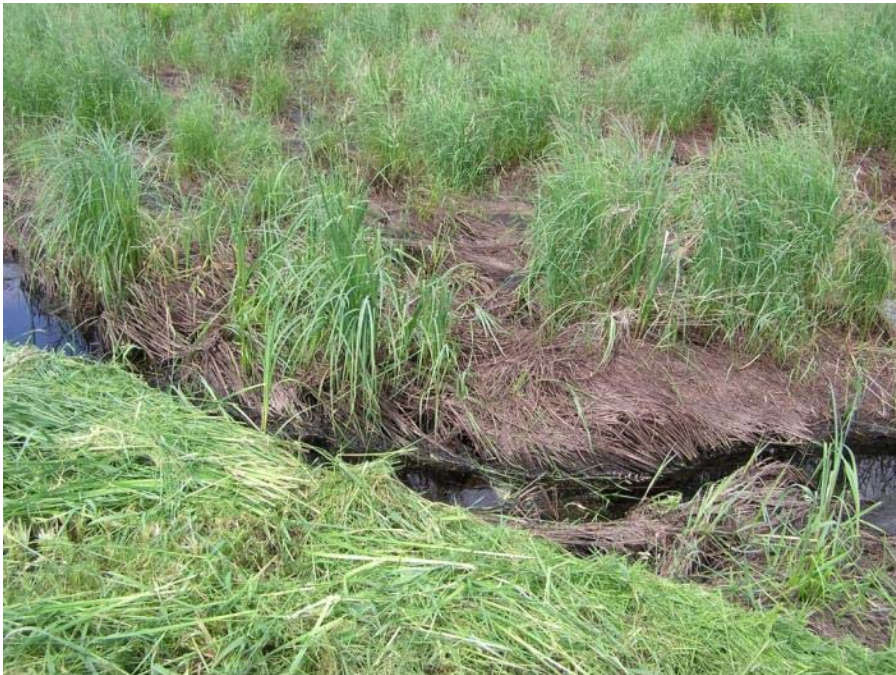
**Figure 24. West ditch along Lundquist Road**

The west ditch had a much lower iron concentration of 3.5 mg/l. The water was highly stained, but no iron floc or iron bacteria were visible (figure 24), indicating flows in this ditch were mostly surface drainage from wetlands. The high dissolved organic matter concentration was probably preventing iron hydroxide colloids from aggregating into visible floc. The wetlands draining to this ditch had been flooded earlier in the year by "North Fork" Creek water with a high iron content. Some of the iron deposited by floodwater was probably contributing to iron concentrations in the ditch. Surface water drainage from wetlands without floodwater iron deposition is likely to have lower iron concentrations.

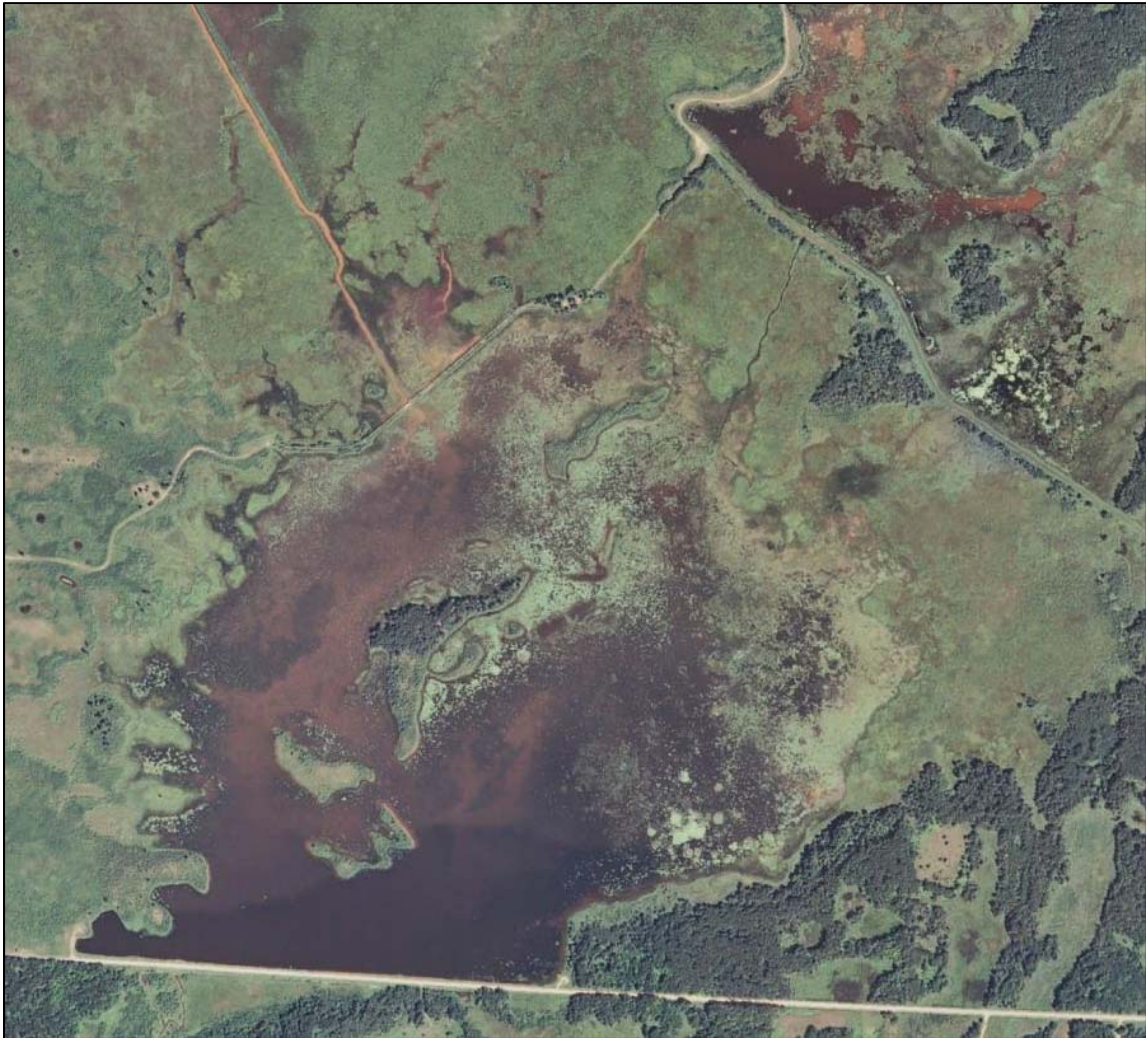
**Figure 26. North Fork Flowage summer 2008 air photo.**

Turbidity is absent at sites that are not downgradient of flowages (Upper North Fork, Sandberg, Kylingstad, Dike 6, Dike 2 Flowages; Reisinger, Reed, Monson Lakes). Turbidity is present at sites which are downgradient of flowages (Middle North Fork, North Fork, South Refuge, Dike 4, Phantom, Hay Creek, Whiskey Creek, and “L” Dike Flowages and several drainage ditches). This is further evidence that iron reduction in soils inundated by flowages is the major source of iron in surface waters at CMWA.

The air photos also show that turbidity is not uniformly distributed in areas downgradient of flowages. The turbidity will occur where groundwater inflow is a substantial water source. Where surface drainage from wetlands is the major water source, turbidity is minimal. Wetland drainage has high concentrations of dissolved organic matter, which gives the water a stained “tea

The early spring 2010 air photos show far less turbidity than the summer 2008 air photos. Many flowages that are turbid in 2008 are clear in 2010. This is consistent with the seasonal variation in the activity of iron reducing bacteria. Little soil iron is being reduced during the winter due to inactivity of iron reducing bacteria in cold soil temperatures. Increased iron concentrations were observed in some flowages in March of 2015 (see next section). This may also contribute to early spring turbidity in some locations.

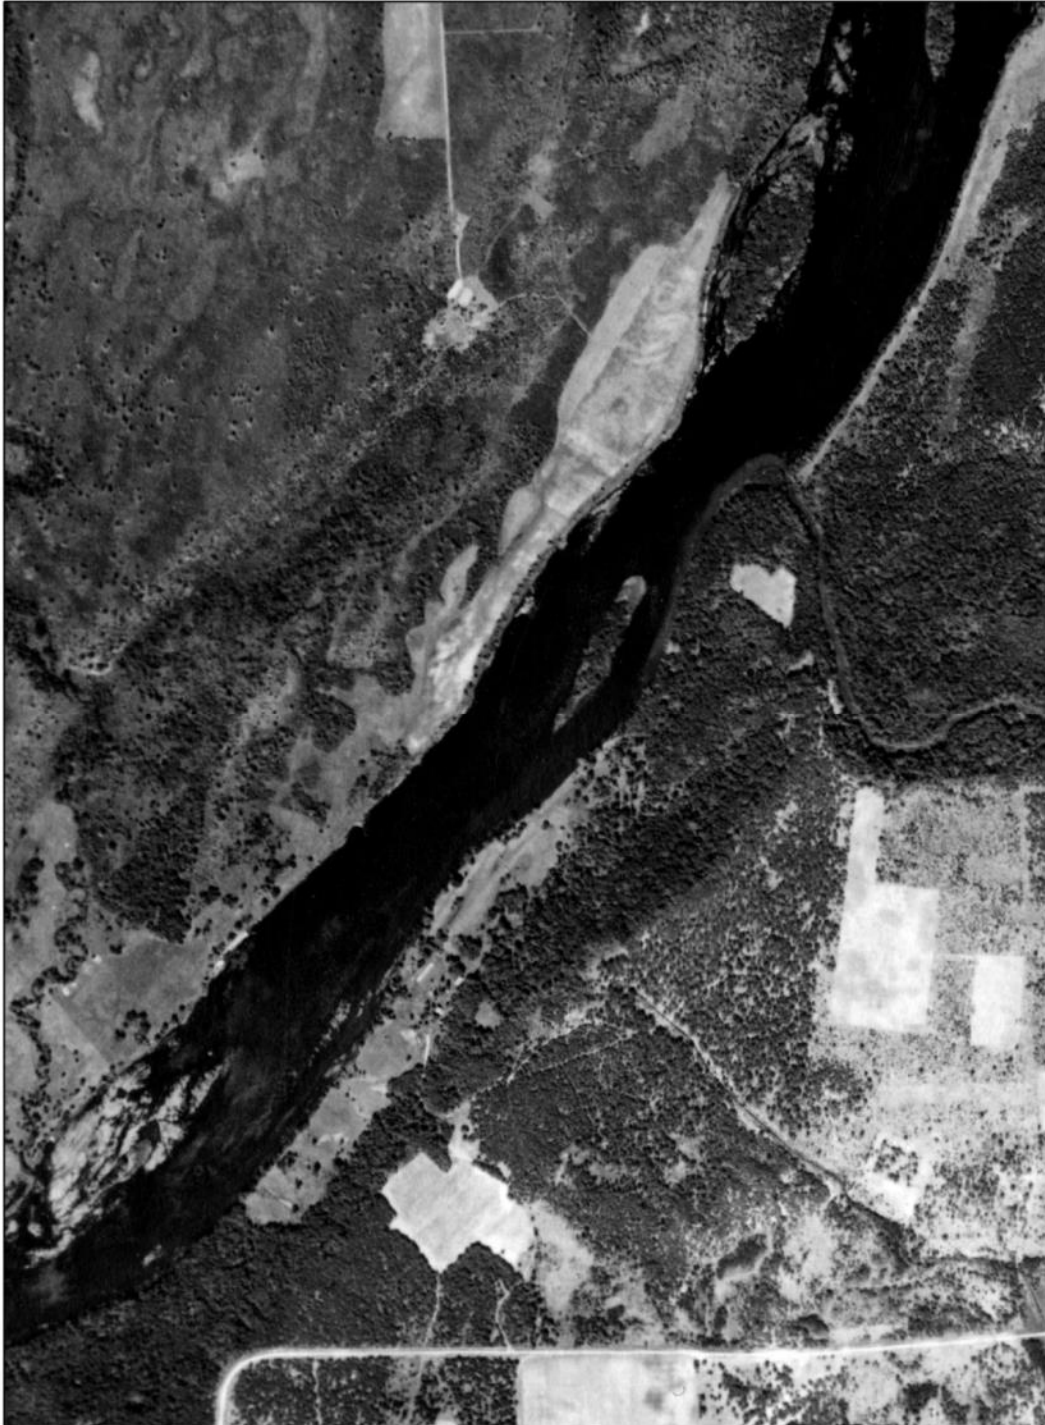
**Figure 28. Wood River Mouth, August 18, 1938**

The 1938 black and white air photo was taken on August 18<sup>th</sup> (figure 28 and 29). There was no heavy precipitation shortly before that date, so Wood River flows were probably at baseflow levels and not influenced by a runoff event. There appears to be iron deposition on the bottom of the Wood River and along the bank of the St. Croix River for a distance of about 1,400 feet below the Wood River mouth. The distinctively shaded area that is visible in the 1938 photo appears likely to be bottom deposition rather than turbidity since there is no evidence of a mixing zone, as seen in the later photos. Coatings of iron deposits on stream bottoms are seen today in the small spring-fed streams on the north side of CMWA (Ekdall, “Nordstrum”, and “Bang” Creeks; figure 8). This indicates some level of iron deposition was occurring downstream of the CMWA area prior to flowage construction. Naturally occurring rates of soil iron release were probably adequate to produce iron deposition in some surface waters.

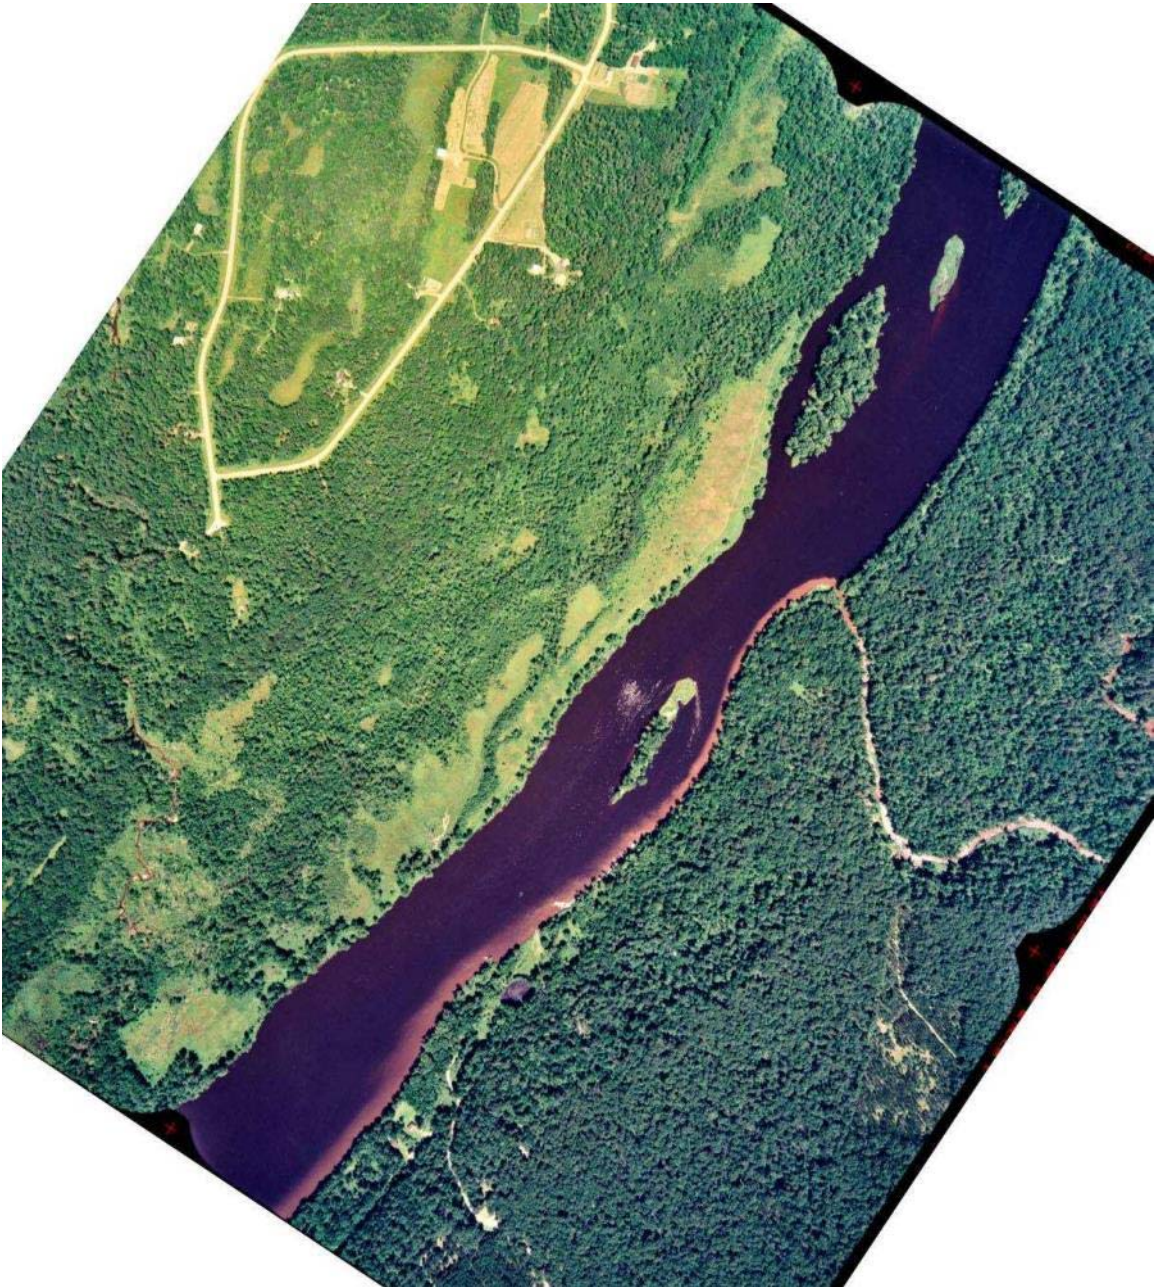
**Figure 30. Wood River Mouth, Summer 1995**

A summer 1995 air photo (figure 30) (date unknown) shows a very distinct turbidity plume extending from the river mouth to the edge of the photo (4,400 feet). It seems likely the plume extended a considerable distance further. Since the date is unknown, the conditions that produced this distinctive plume can't be determined.
