## INTRODUCTION

This report describes monitoring and control efforts that took place in 2015 on Virgin Lake, the Burnt Rollways channel and Townline Lake, with guidance for 2016 actions.

Map 1 - Virgin Lake  
 Three Lakes Chain  
 Oneida County, Wisconsin  
**2015 EWM Final Control Strategy**

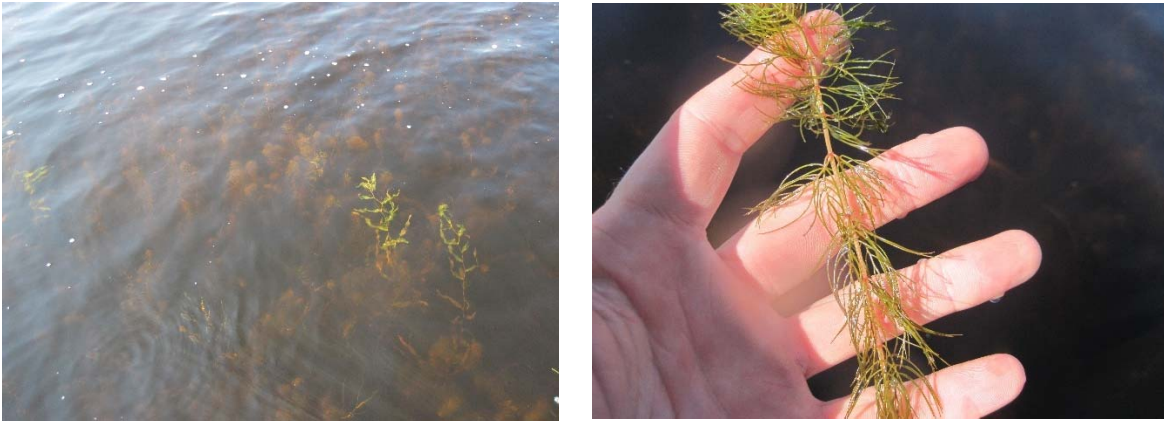
**Photograph 1 & 2. Northern water milfoil colony, Virgin Lake.** Photos display a dense northern water milfoil colony within Site A-15 of Virgin Lake, and a close-up of a single northern water milfoil stem with leaflets. Photos collected during a late summer EWM survey.

During the September 22 visit, Site A-15 was visited first. Only several EWM plants were observed within the treatment area – likely new growth following the treatment. The aquatic plant community here was dominated by native pondweeds, however there were stands of very healthy northern water milfoil as well – almost to the point that driving through them was troublesome for the boat motor (Photographs 1 & 2). This of course can be interpreted as a good sign, as northern water milfoil is a close relative of EWM and thus believed to be susceptible to herbicide treatments. However, conducting herbicide treatments in the early spring is thought to reduce exposure of the herbicide to some native plant species, northern water milfoil being included.

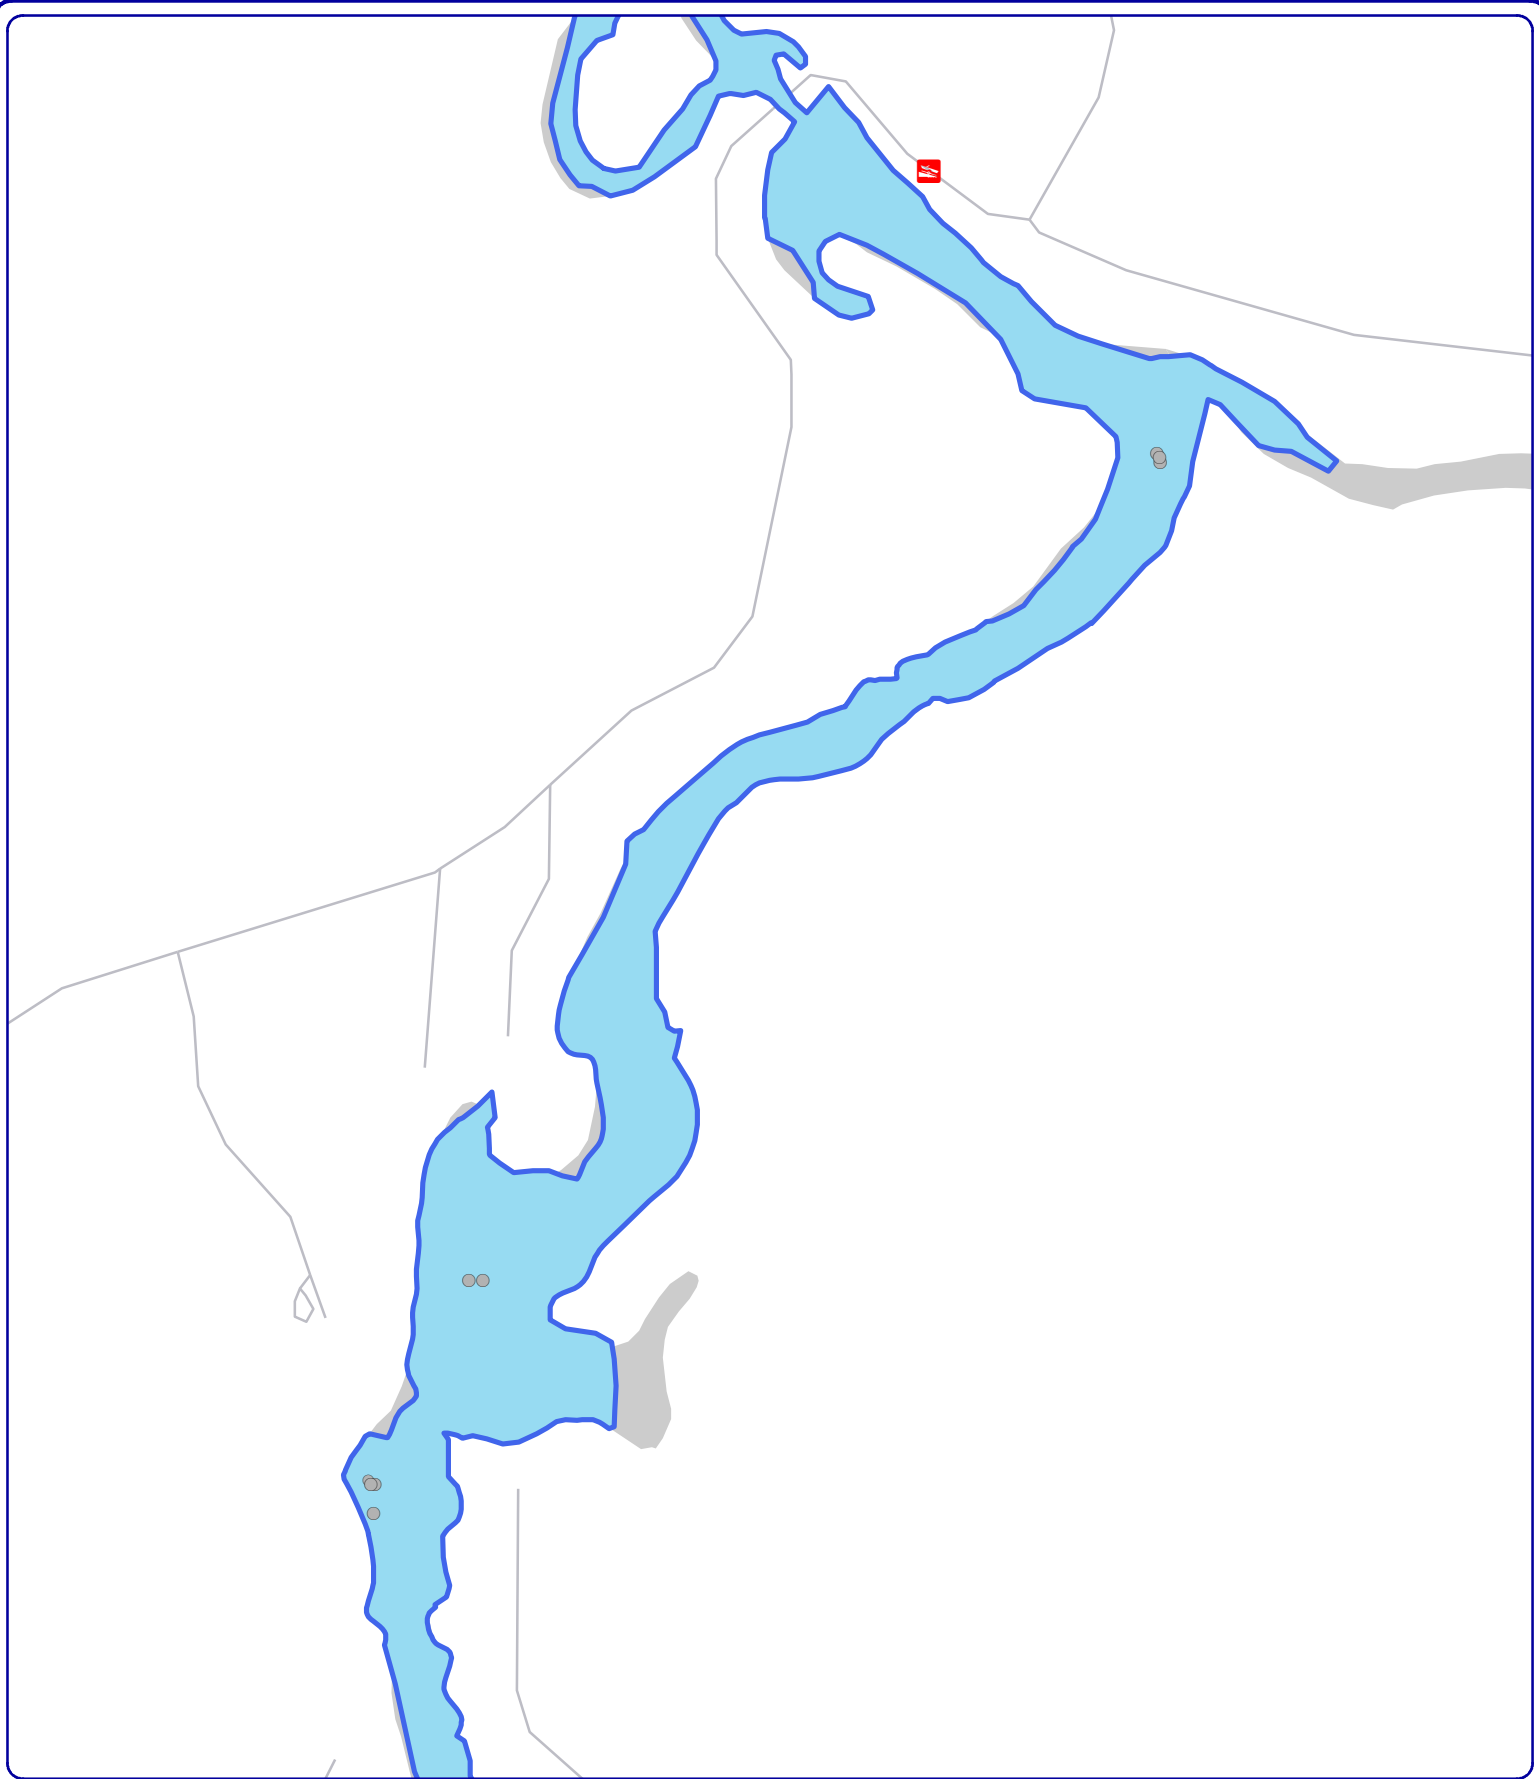
Map 3 - Long Lake  
 Burnt Rollways Channel  
 Three Lakes Chain of Lakes  
 Oneida County, Wisconsin  
**September 2015**  
**EWM Survey Results**

On September 30, 2015, Onterra staff visited the Burnt Rollways Channel to complete an EWM Peak-Biomass survey. It was a very brisk morning, with air temperatures in the mid 50's but with no wind and a very sun-filled sky. In three separate areas of the channel, only several EWM plants were observed, along with a healthy assortment of native pondweeds, native milfoils, floating-leaf lily pads and bur-reeds, and other native vegetation. Onterra staff navigated their boat outside of the channel, into Long Lake for a coarse survey of the surrounding channel area. No EWM was observed in this area.

As there is still a minimal EWM population within the Burnt Rollways Channel, no professional control actions (herbicide treatments, professional hand-harvesting, etc.) are recommended for 2016. Continued monitoring of the channel should be completed by volunteers during the mid-summer timeframe (mid-June). Should volunteers observe EWM that has increased in density from that which is pictured on Map 3, then a call should be placed to Onterra staff to visit the channel. The current level of EWM in the channel may be addressed by volunteer hand-removal. However, if this level is observed to have increased, the potential to line-up summer professional hand-harvesters would still exist if the colonies are spotted early enough. During the late summer season, Onterra would again complete an EWM Peak-Biomass survey to determine the level of EWM in the channel at that time and collect data for 2017 decision-making and planning. Funding for these surveys is available through a previously acquired grant, which expires in late 2016.
