FEDERAL ENERGY
REGULATORY COMMISSION**Subject: Water Quality Monitoring Report
Badger-Rapide Croche Hydroelectric Project, FERC No. 2677-030**

2015 Water Quality Monitoring Report

Submitted by:
GEI Consultants, Inc.
3159 Voyager Drive
Green Bay, Wisconsin 54311

January 26, 2016
Project No. 1506460

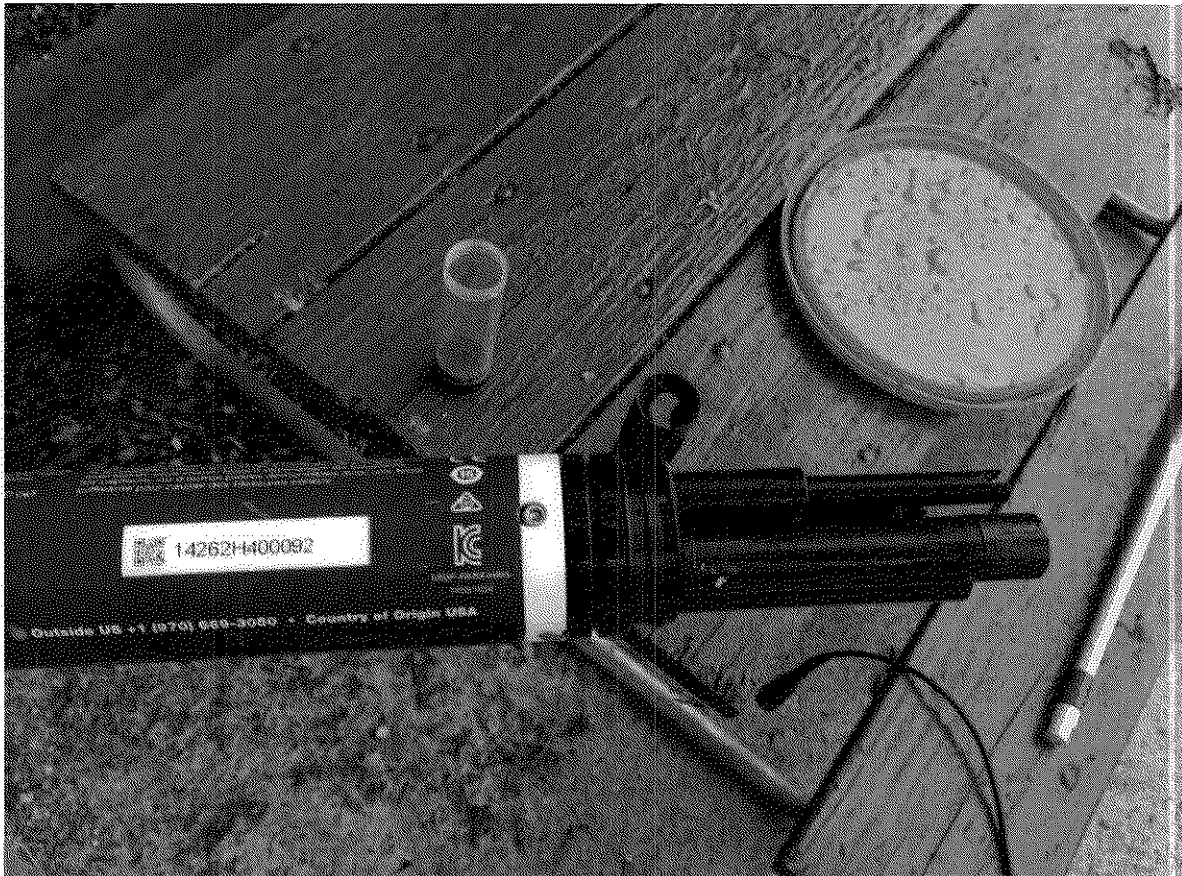
Photo No. 1 Example of relatively clean sonde at Rapide Croche Downstream. Photo taken 6/11/15.

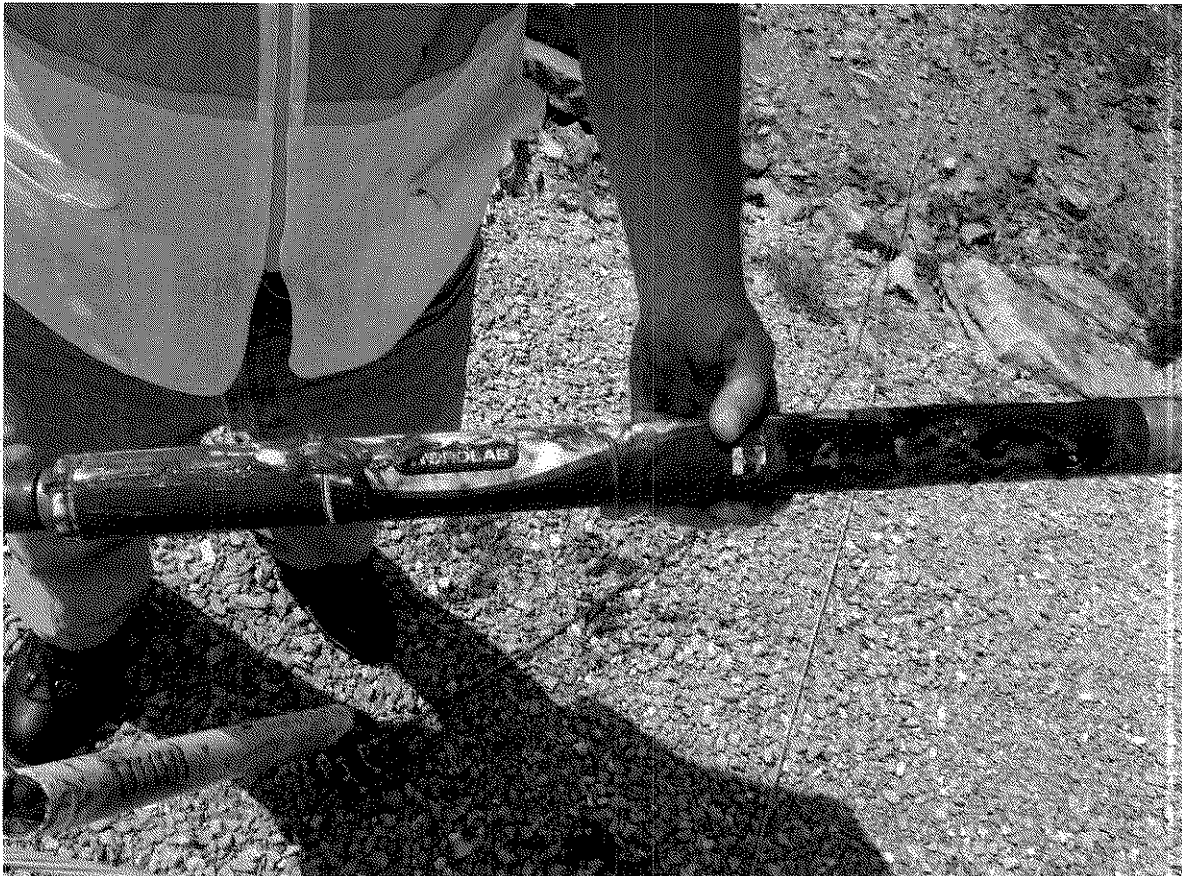
Poor DO data quality in the downstream probe from approximately June 29 to July 28 was caused by sedimentation. Malfunction of the sonde, due to sonde/computer interface communication issues, resulted in no data collection from the downstream sonde from July 28 to August 10. The sonde was replaced with a different sonde from August 10 to August 20. Following repair by the manufacturer, the original sonde was restored at the downstream location

Photo No. 2 Example of sedimentation that occurred at Badger Downstream. Photo taken 6/29/15.

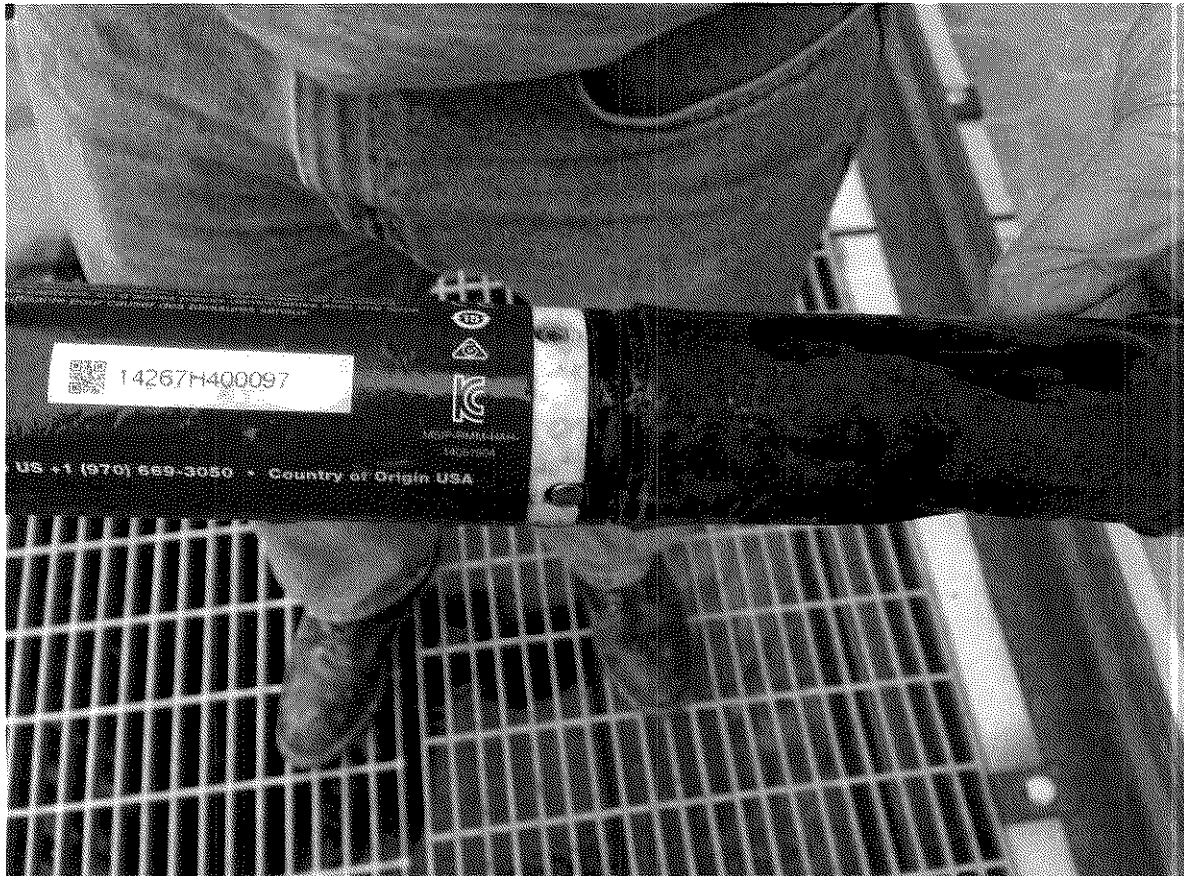
Photo No. 3 Example of biofouling that occurred at Rapide Croche Upstream. Photo taken 8/28/15.

In 2014, biofouling caused parameter drift of DO and pH at Rapide Croche and Badger downstream stations. We recommended and implemented a more frequent cleaning and probe calibration interval of 7-10 days in 2015. This led to a better data set in 2015. We made improvements from the data losses in 2014 by eliminating vandalism and reducing the effects of biofouling with more frequent calibrations.

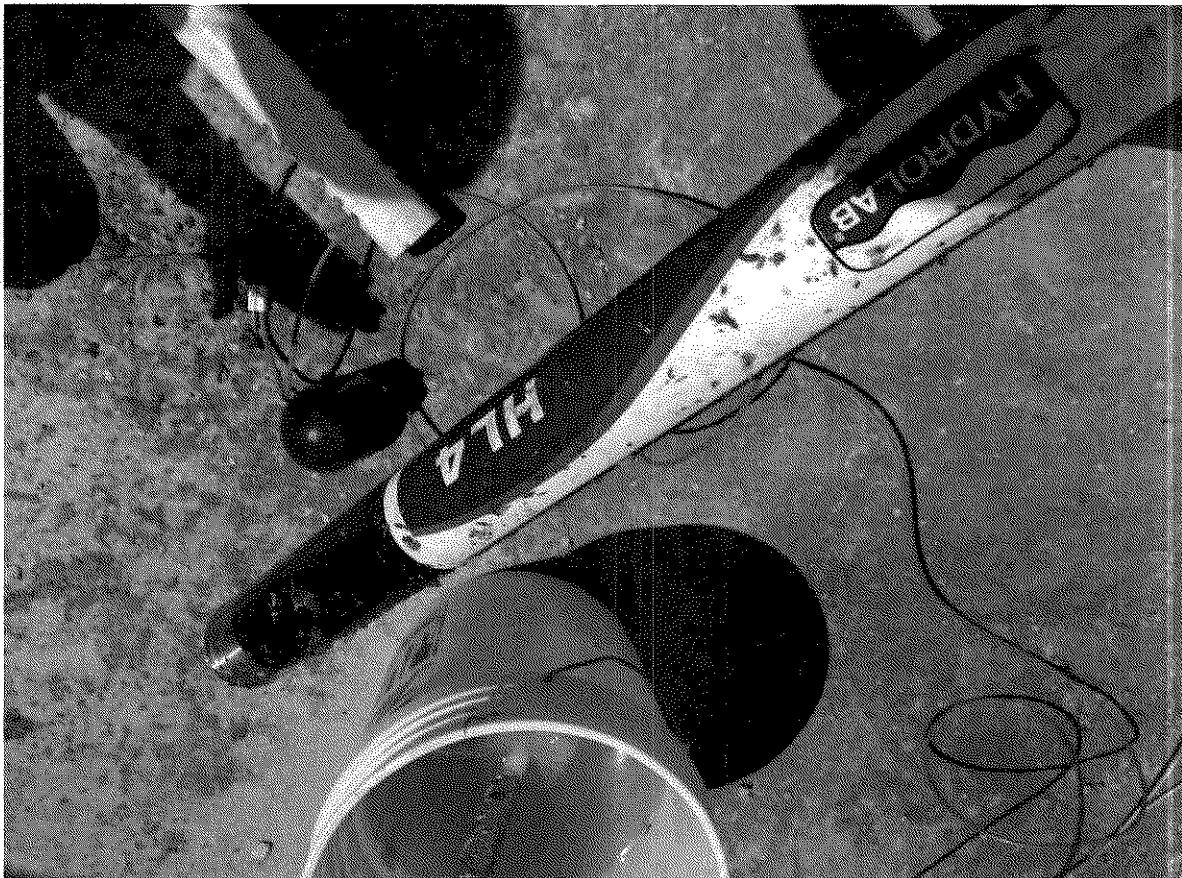
Photo No. 4 Example of mechanical problems that occurred due to aquatic organisms with hard shells becoming lodged in battery housing at Rapide Croche Downstream. Photo taken 7/28/15.
