# **The Bearskin Lake Adaptive Management Plan**

## **(Oneida County, Wisconsin)**

**Date: April 2016**

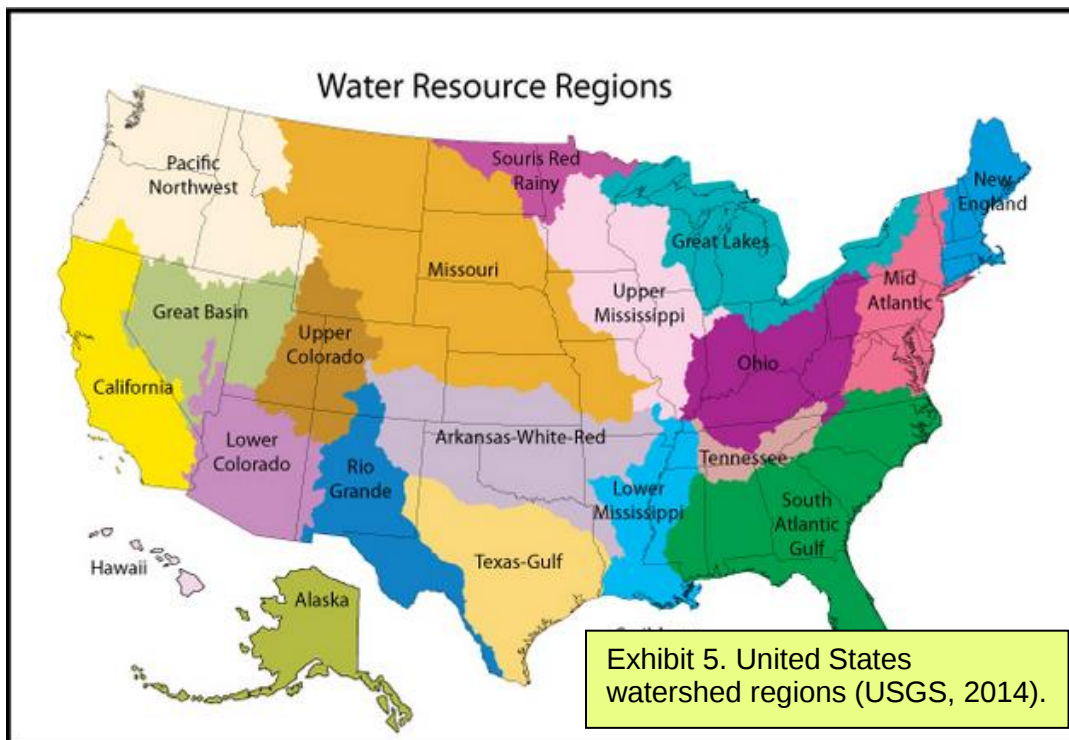
Exhibit 6. Wisconsin River basin (HUC#070700) (green). The Upper Wisconsin sub-basin is also visible (USEPA, 2009).

Bearskin Lake and its watershed are very small components of a large-scale watershed landscape. The continental United States is divided into 18 watershed regions (Exhibit 5). Two watershed regions lie within Wisconsin: the Upper Mississippi and Great Lakes regions. Bearskin Lake is located in the Upper Mississippi region, but is very close to the Great Lakes regional border. The Upper Mississippi region is made up of many sub-regions and basins. The Wisconsin sub-region (HUC#0707), and the Wisconsin River basin (HUC#070700) (Exhibit 6) contain Bearskin Lake. Within the Wisconsin River basin is the Upper Wisconsin sub-basin (HUC#07070001) (Exhibit 7), which can be further divided into watersheds and sub-watersheds. Bearskin Lake is located in the Middle Tomahawk River watershed (HUC#0707000109). Finally, the Middle Tomahawk River watershed is divided into federal hydrologic sub-watersheds, designated by 12-digit HUC codes. Bearskin Lake is located in the Bearskin Creek Sub-watershed (HUC#070700010906), which can be seen in Exhibit 8. Exhibit 9 shows the watershed boundary for Bearskin Lake.

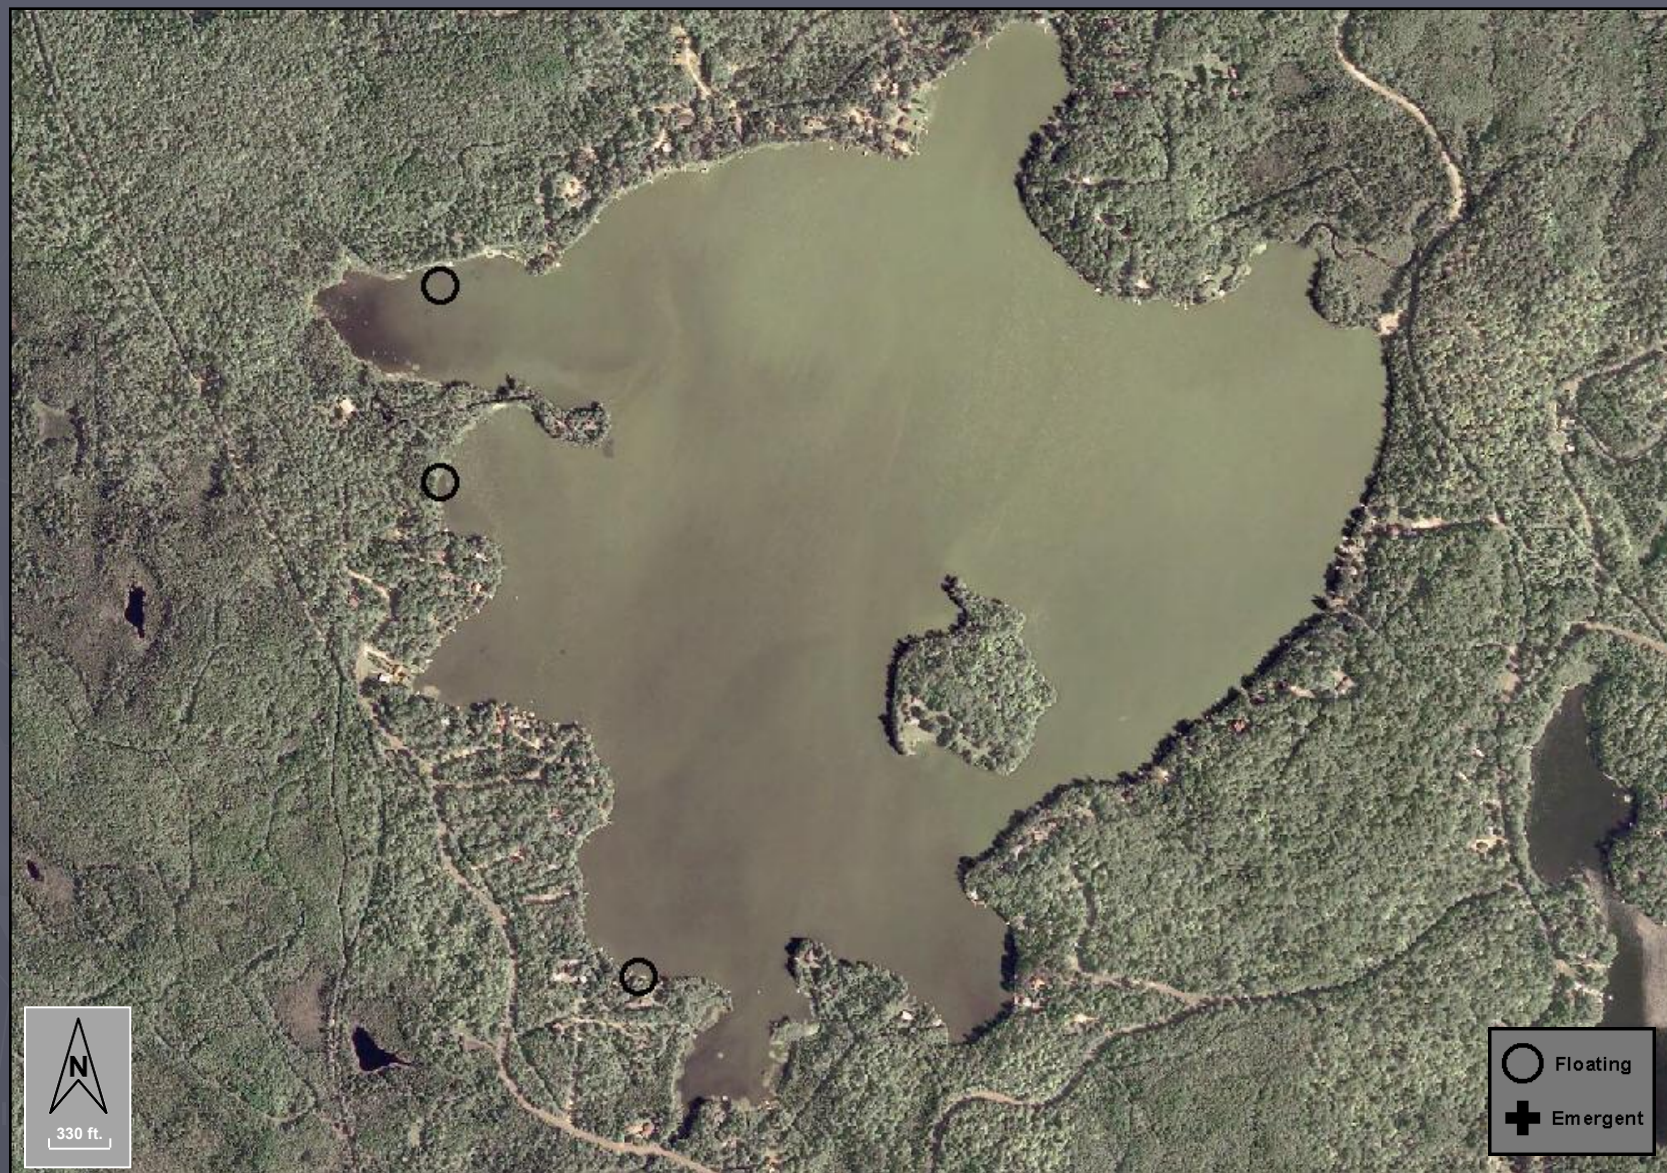
Figure 7. Bearskin Lake point-intercept plant sampling sites with emergent and floating aquatic plants (2012).

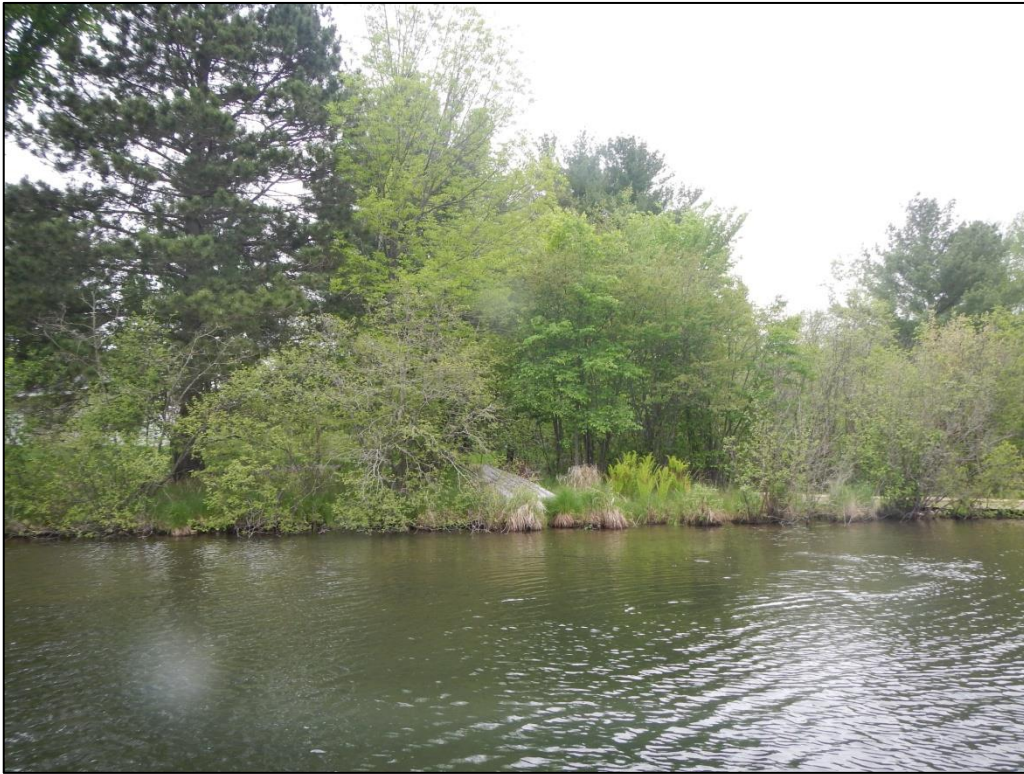
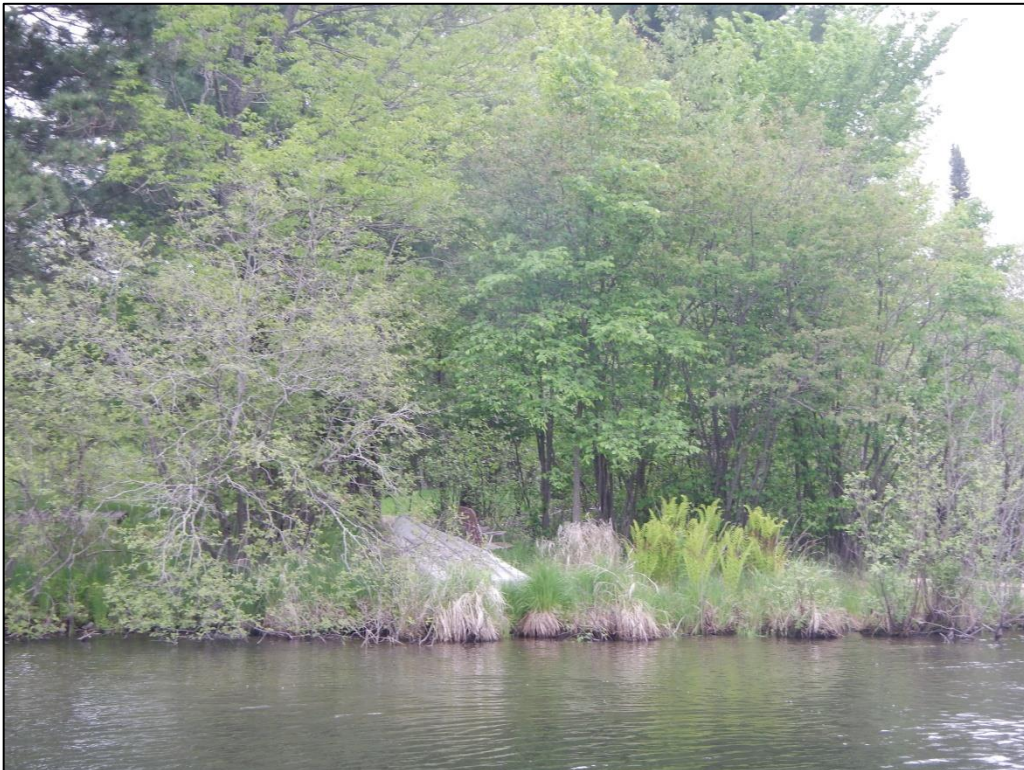
## Station A – Bearskin Lake

USEPA & WDNR Physical Habitat Assessment  
Photograph taken 6/4/2013, White Water Associates, Inc.

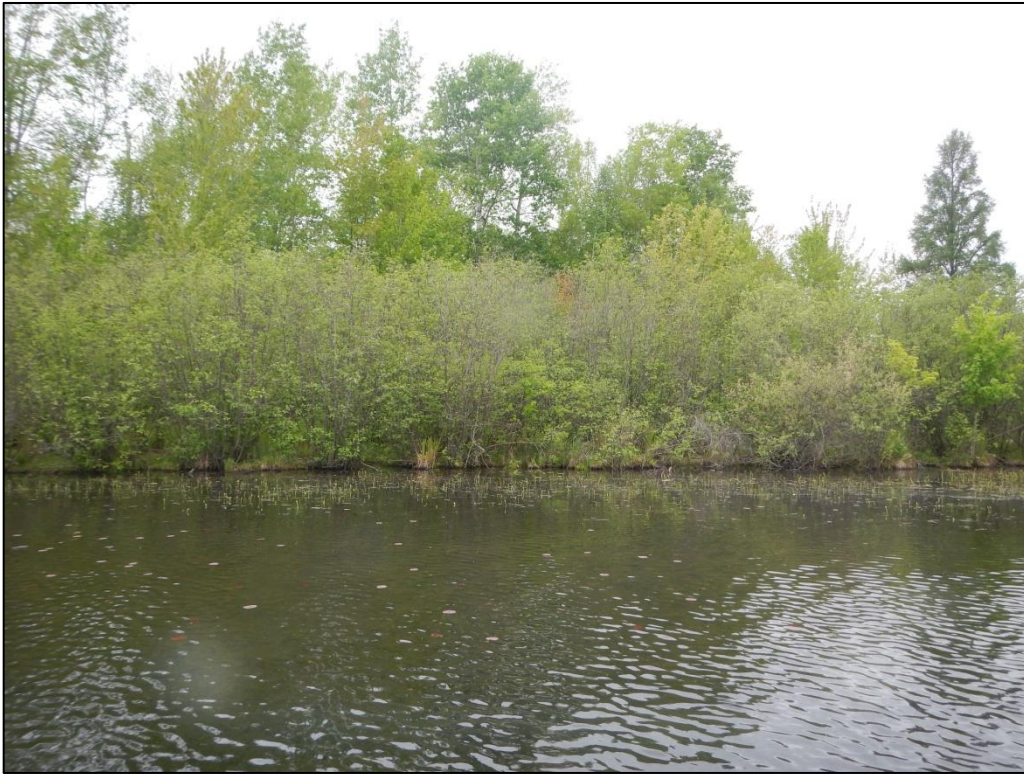
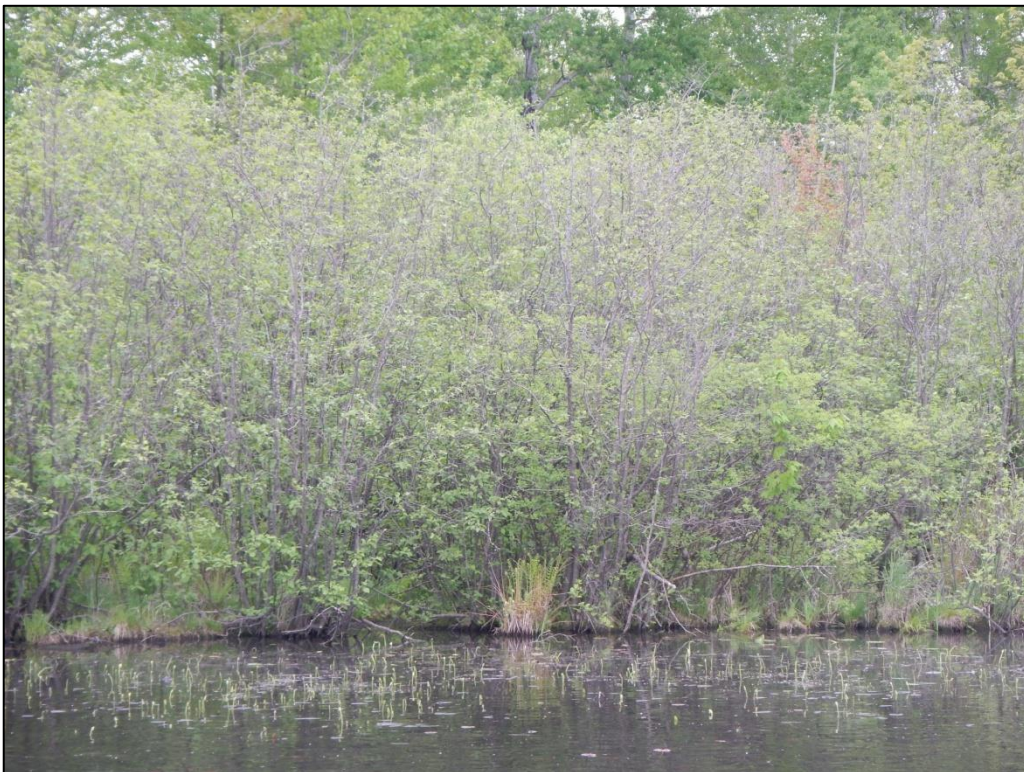
## **Station B – Bearskin Lake**

USEPA & WDNR Physical Habitat Assessment  
Photograph taken 6/4/2013, White Water Associates, Inc.

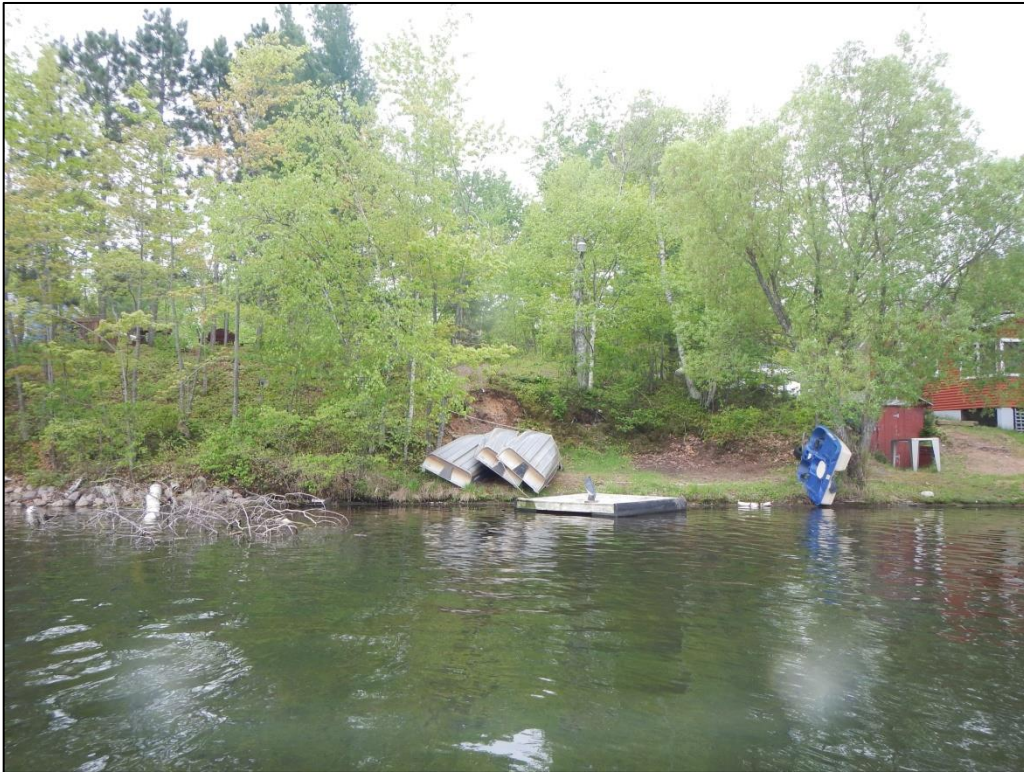
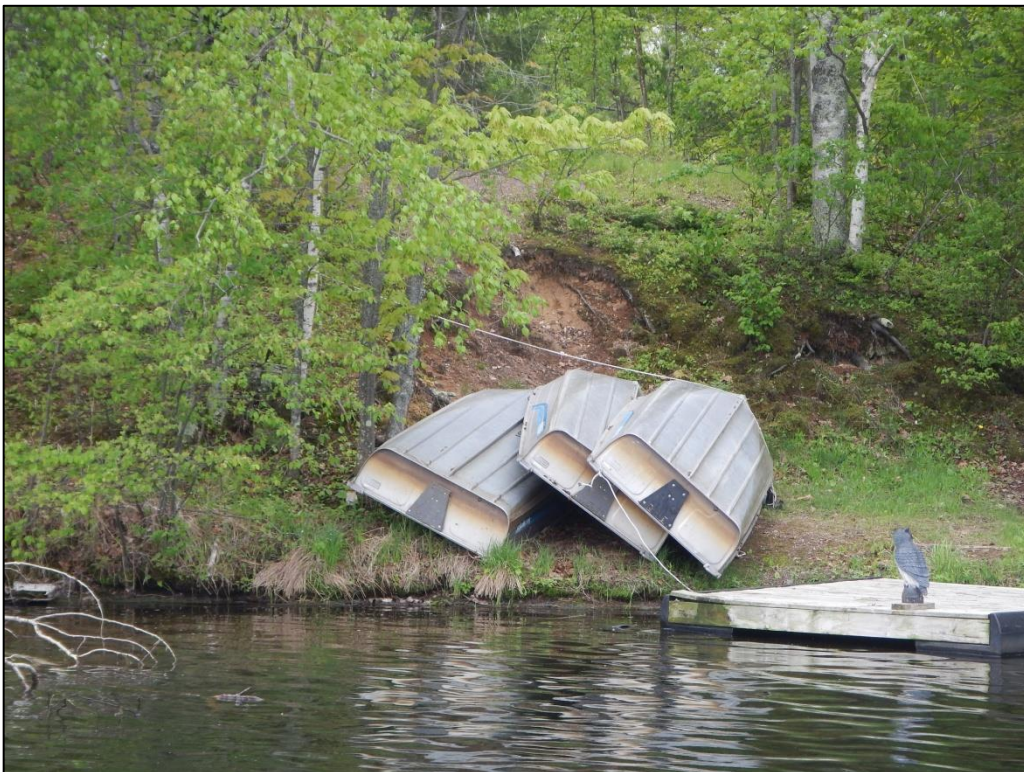
## Station C – Bearskin Lake

USEPA & WDNR Physical Habitat Assessment  
Photograph taken 6/4/2013, White Water Associates, Inc.

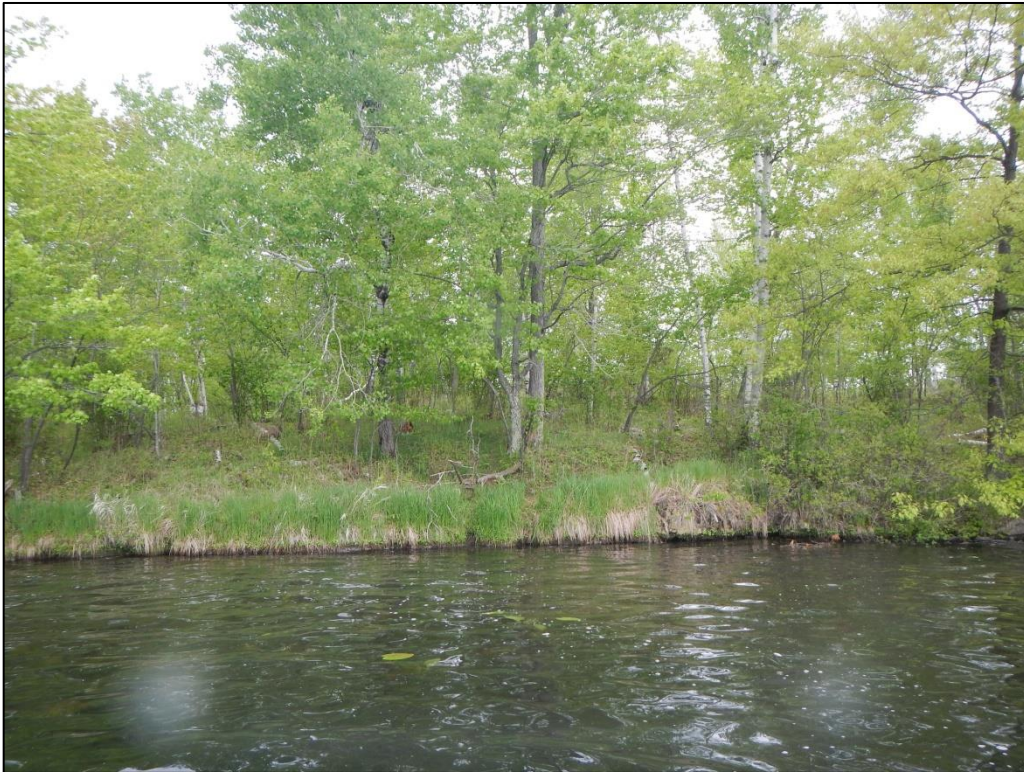
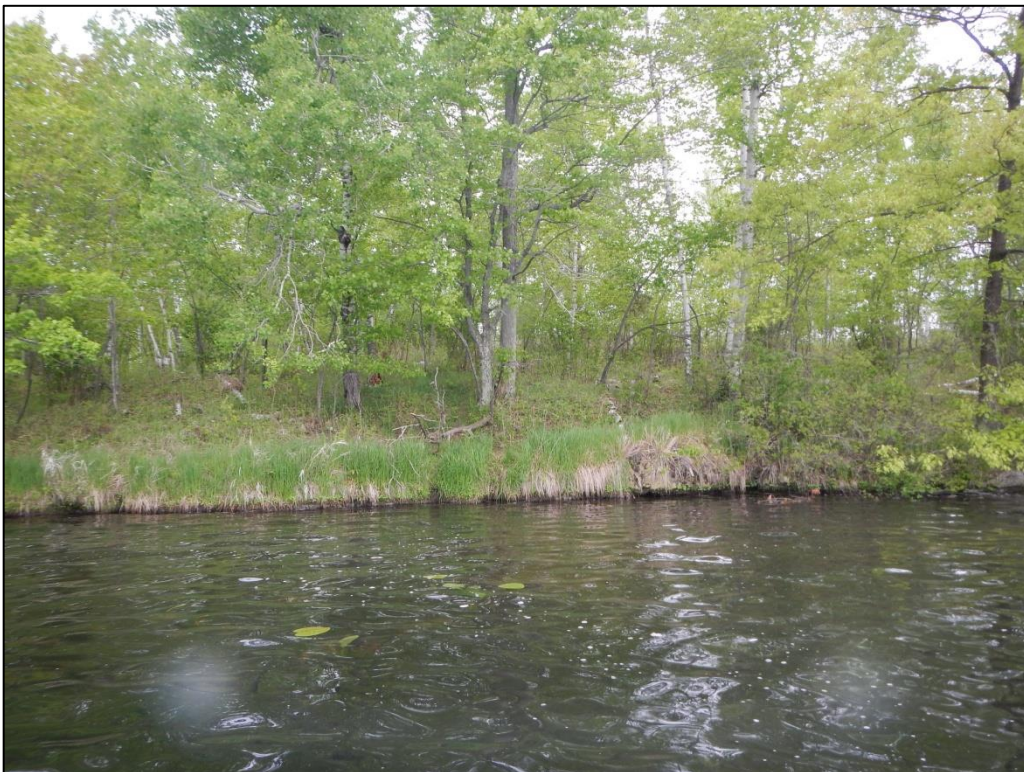
## Station D – Bearskin Lake

USEPA & WDNR Physical Habitat Assessment  
Photograph taken 6/4/2013, White Water Associates, Inc.

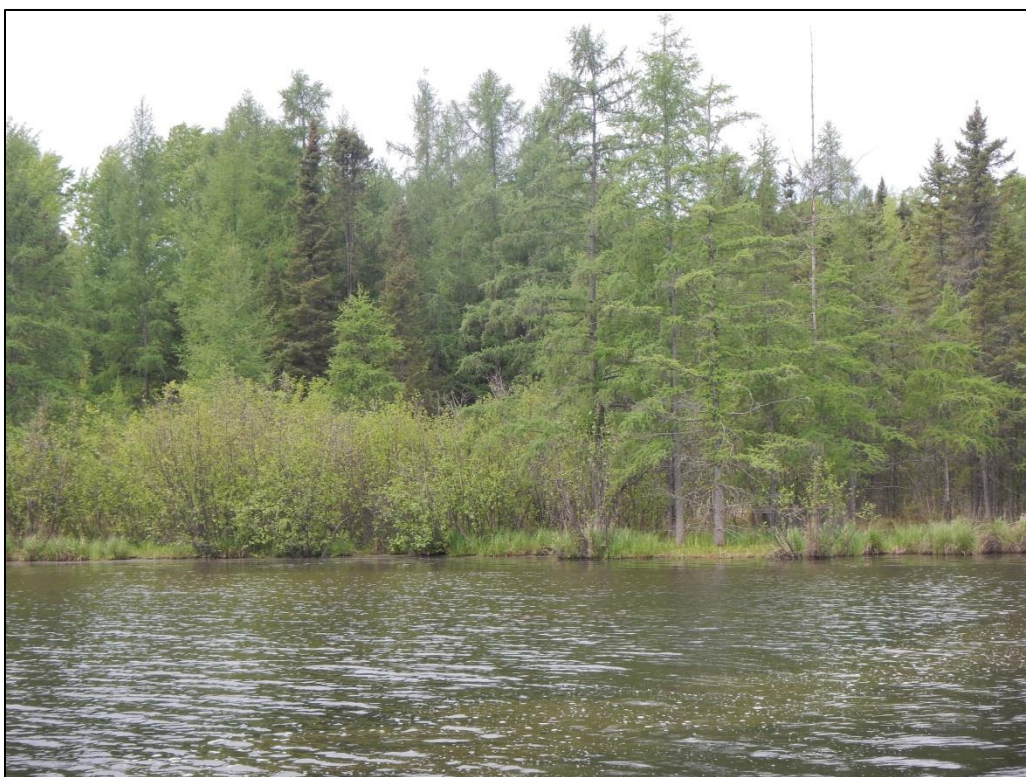
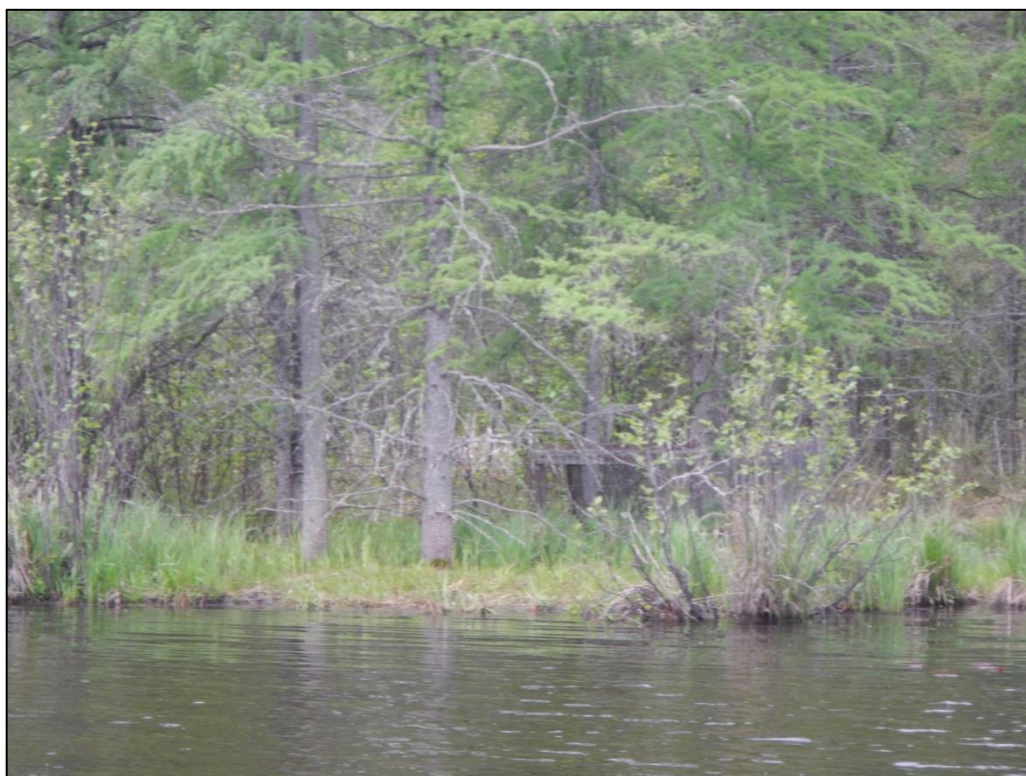
## Station E – Bearskin Lake

USEPA & WDNR Physical Habitat Assessment  
Photograph taken 6/4/2013, White Water Associates, Inc.

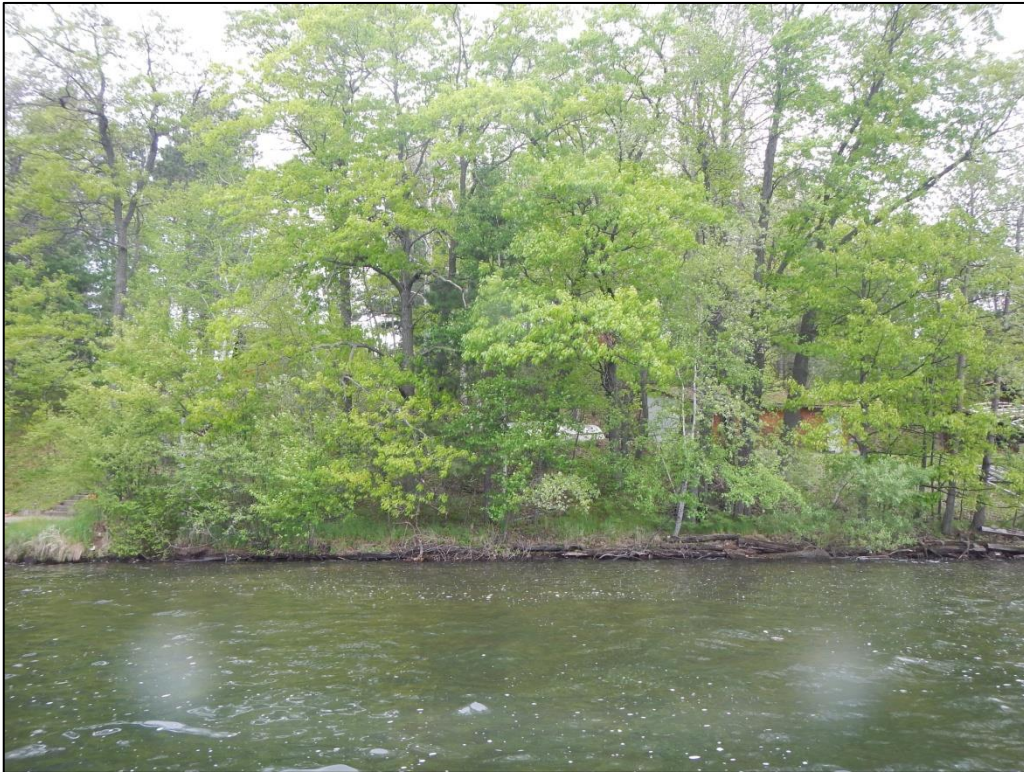
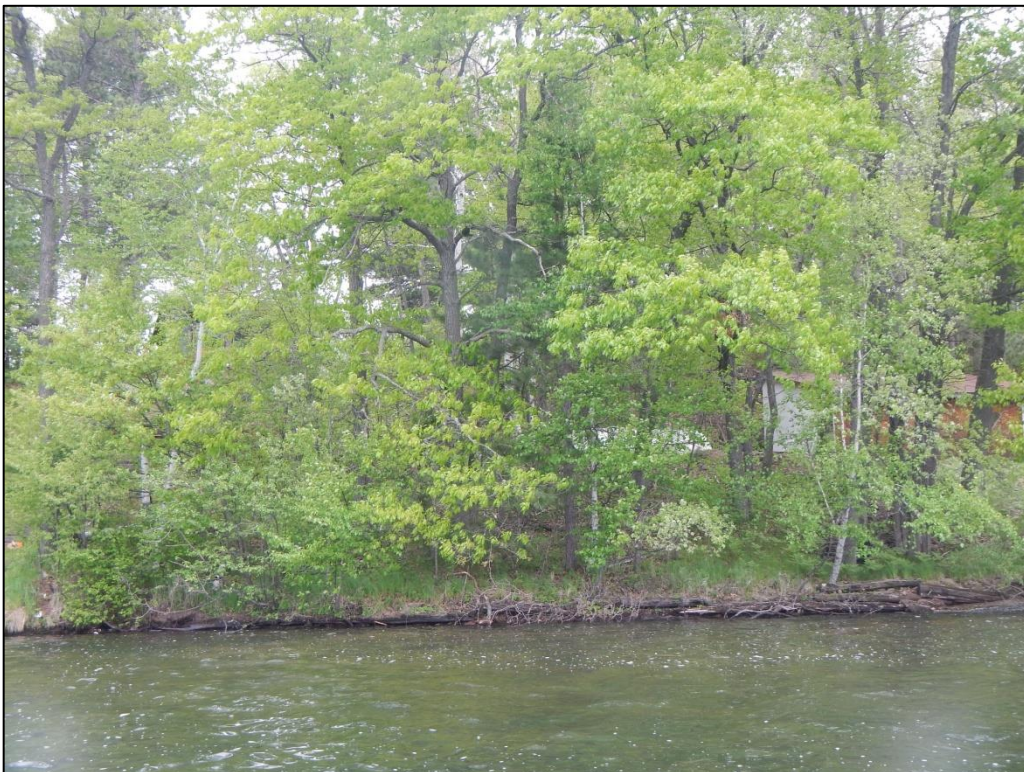
## Station F – Bearskin Lake

USEPA & WDNR Physical Habitat Assessment  
Photograph taken 6/4/2013, White Water Associates, Inc.

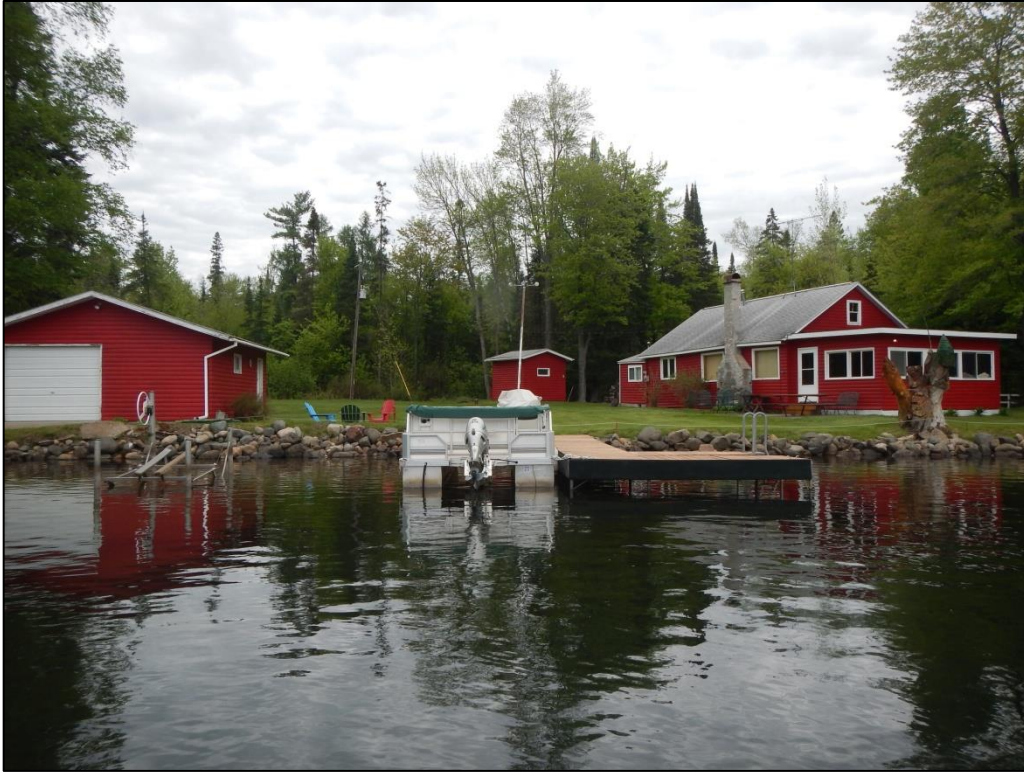
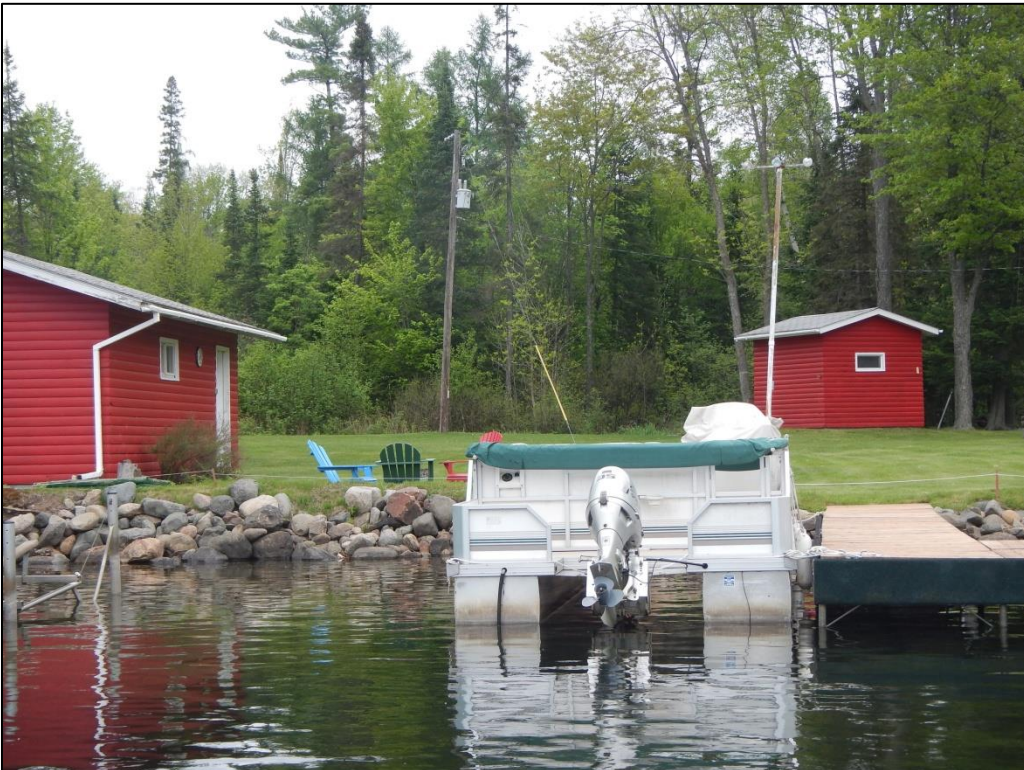
## Station G – Bearskin Lake

USEPA & WDNR Physical Habitat Assessment  
Photograph taken 6/4/2013, White Water Associates, Inc.

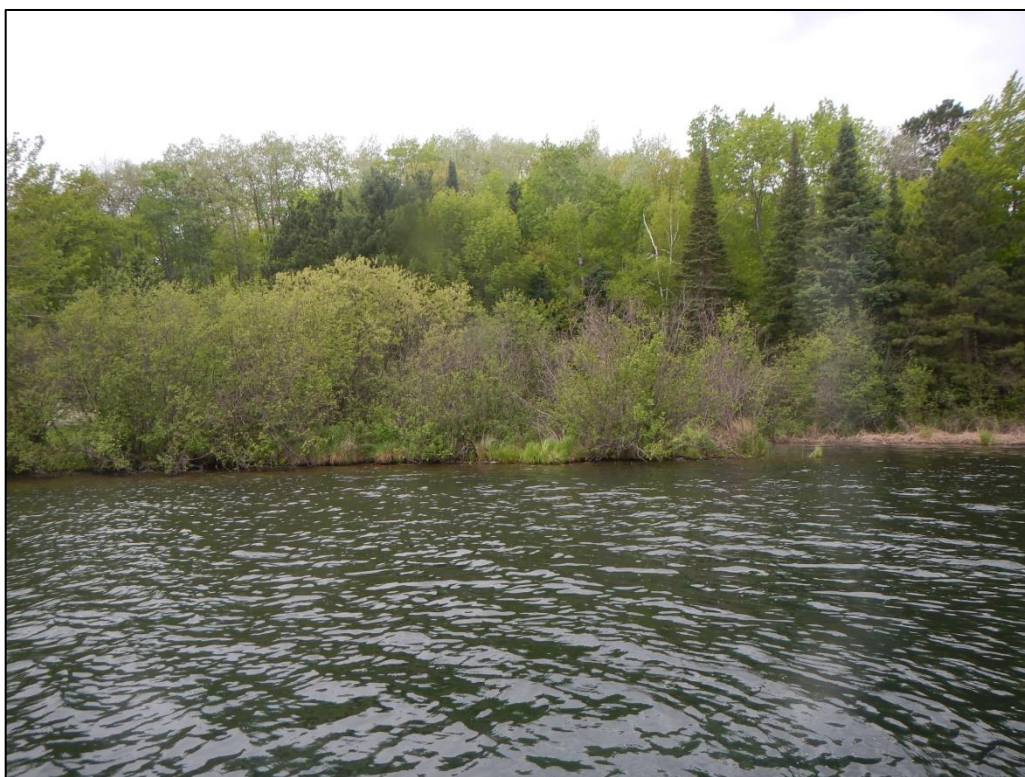
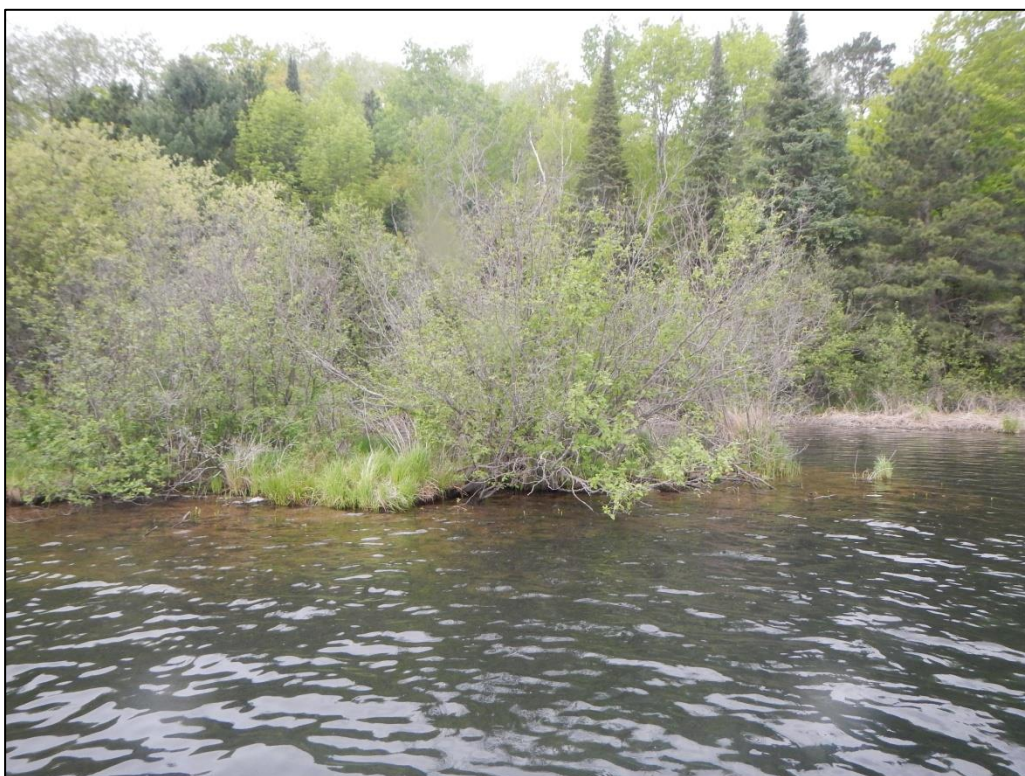
## Station H – Bearskin Lake

USEPA & WDNR Physical Habitat Assessment  
Photograph taken 6/4/2013, White Water Associates, Inc.

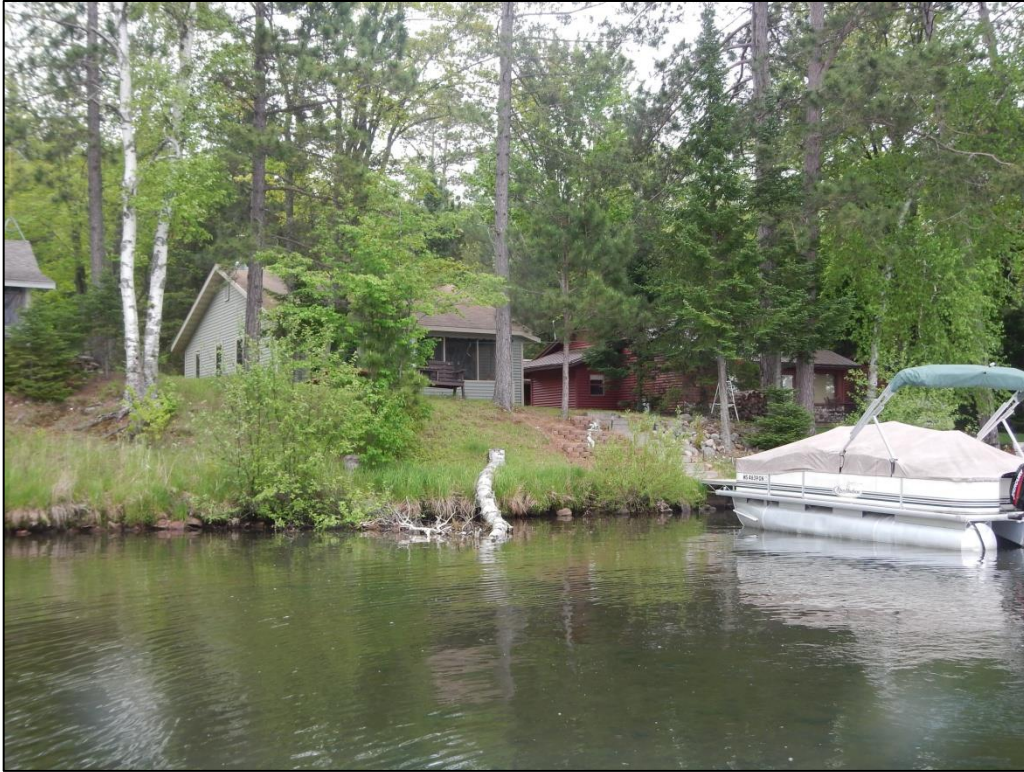
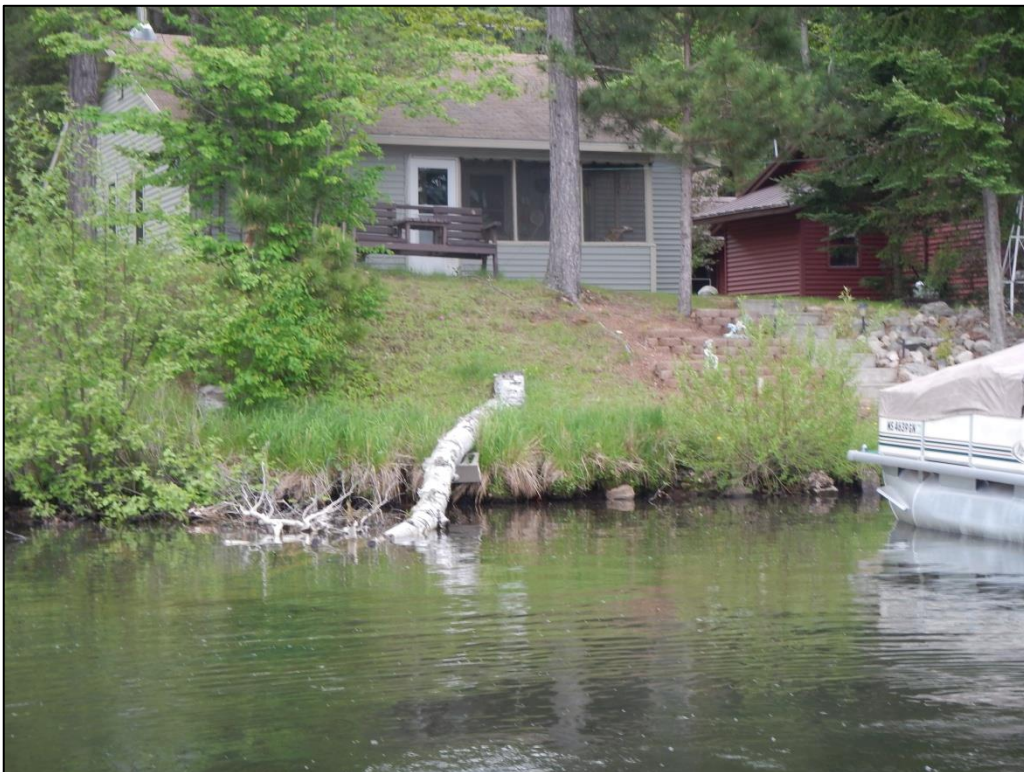
## Station I – Bearskin Lake

USEPA & WDNR Physical Habitat Assessment  
Photograph taken 6/4/2013, White Water Associates, Inc.

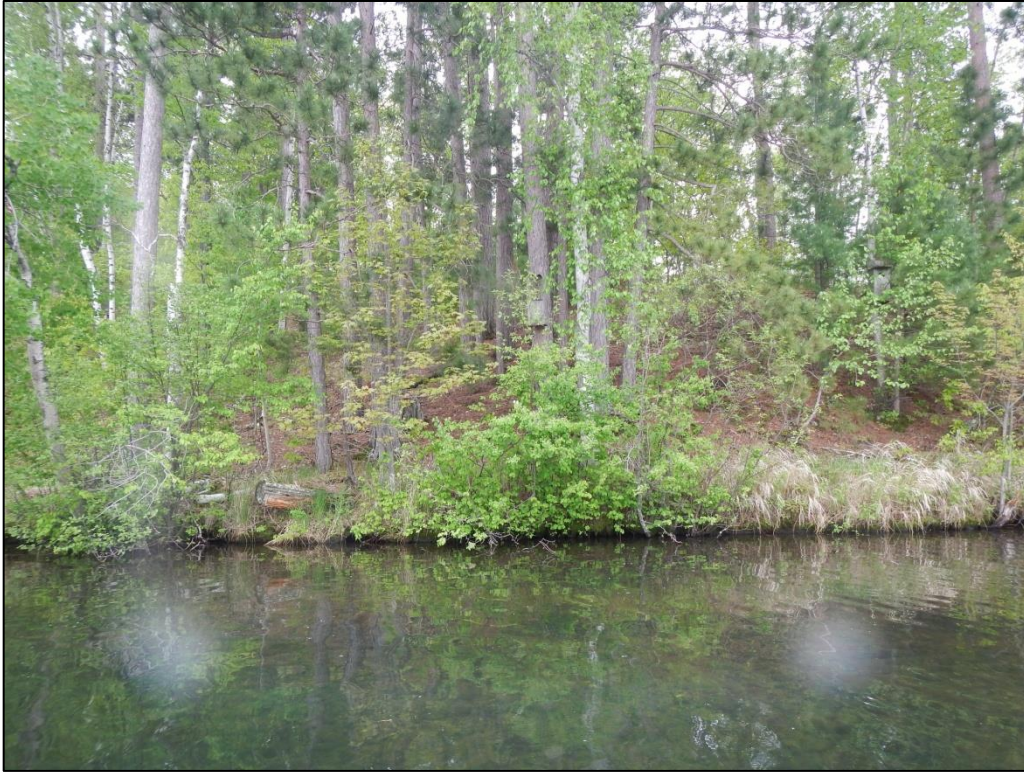
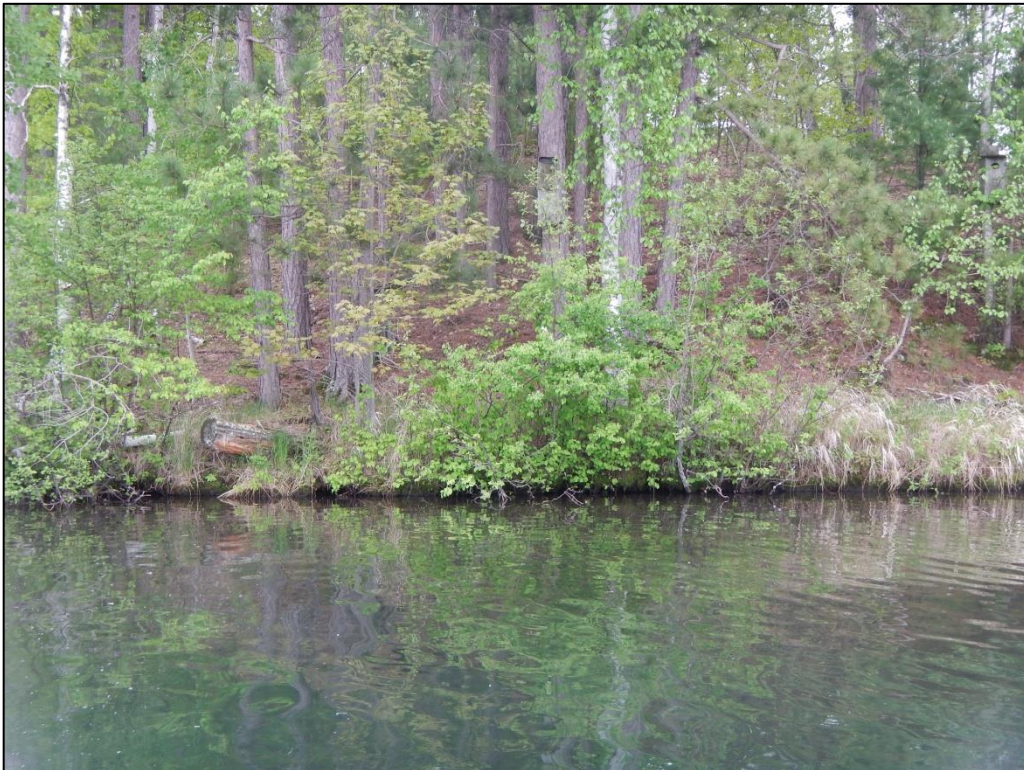
## Station J – Bearskin Lake

USEPA & WDNR Physical Habitat Assessment  
Photograph taken 6/4/2013, White Water Associates, Inc.

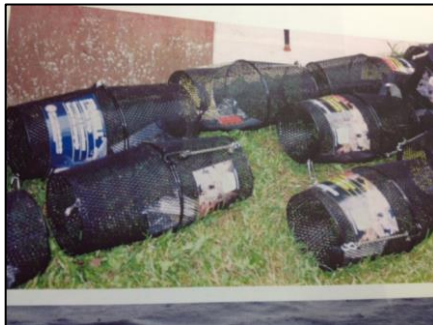
Frabill traps used for trapping rusty crayfish.

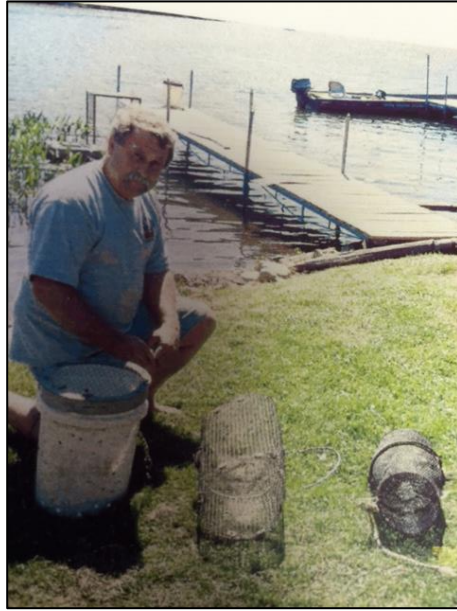
**Exhibit 3. Roger Soletske with the three different trap styles (McComas 2006).**

The first trap style was a purchased trap that was approximately 8x18 inches with a funnel at each end and was emptied by splitting in the middle (Exhibit 3, right). The average count for this trap was 25.9 crayfish per 24 hour period (Soletske 2006). This trap had the highest loss due to many crayfish being able to escape. The second trap was one that Soletske made out of hardware cloth, measuring 12x14 inches with a funnel on each end (Exhibit 3, middle). This trap averaged 35 crayfish per 24 hour period. The third trap style was a plastic 5 gallon pail with perforated holes and one mesh funnel end formed into the pail top (Exhibit 3, left). This style of trap averaged 43.5 crayfish per trap. Figure 3 displays the number of rusty crayfish captured/day by trap type.

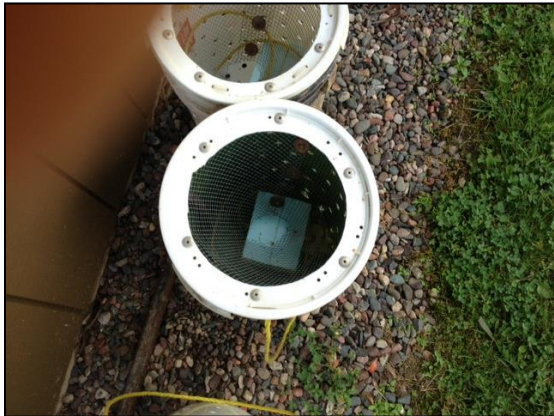
5 gallon pails used by Soletske to trap.

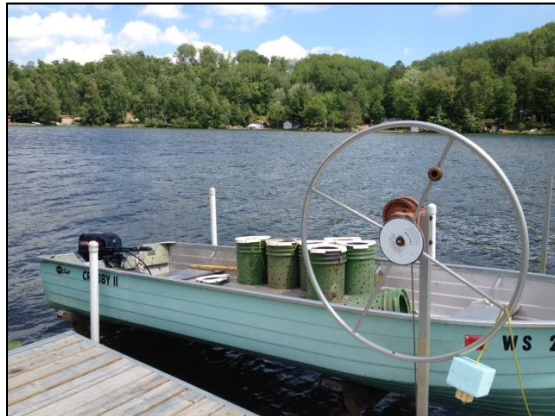
Boat with green 5 gallon traps.

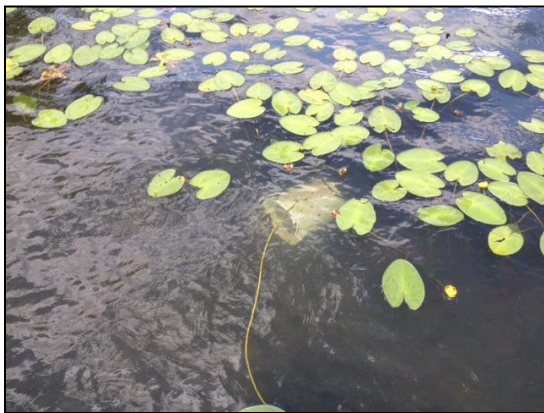
5 gallon trap located on the bottom near dock.

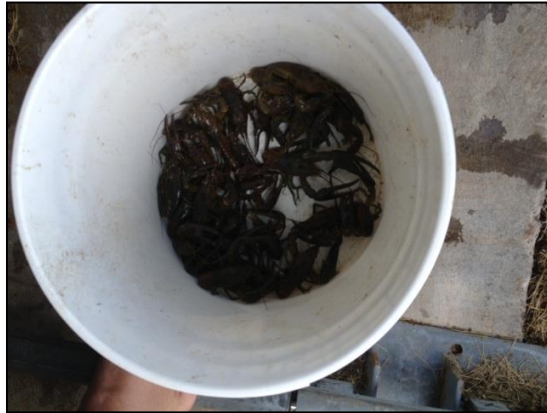
5 gallon pail with rusty crayfish.

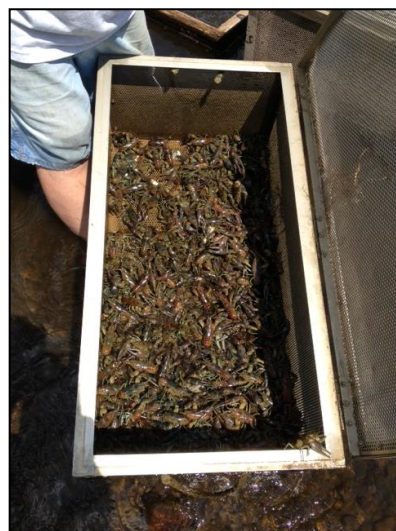
Rusty crayfish storage bin located by dock.
