Big Chetac Chain Lakes Association
Aquatic Invasive Species Grant ACEI 133 13
2013 through 2015 Summary Progress Report
Dated: February 22, 2016

Prepared by: BCCLA Board of Directors

As Required by: AIS Grant 133 13

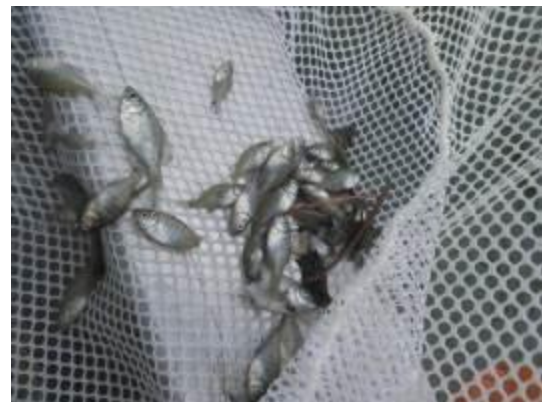
Young-of-year panfish from a mini-fyke net set in the herbicide treatment area in Lake Chetac during August 2014.

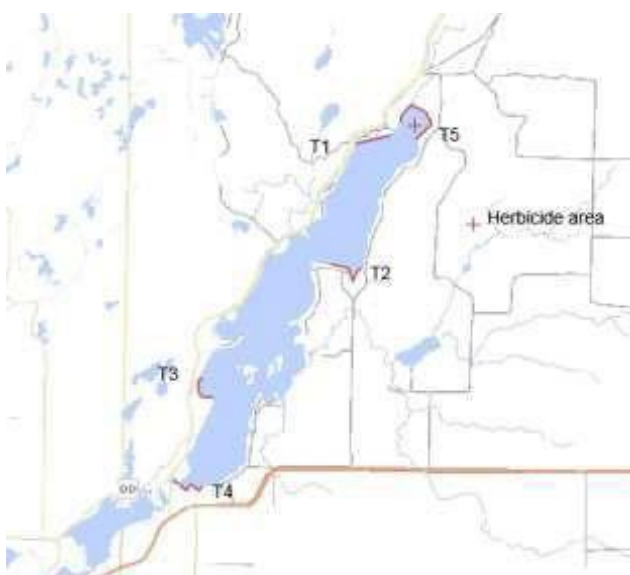
Fishery survey data presented in this section is from boom electrofishing surveys conducted in the spring of the year. In 2009 only one transect was surveyed (approximate location of T4 in Figure 1). In 2013 locations T1, T2, T3, and T4 were surveyed. In 2014 locations T1 and T2 were surveyed again and T5 was added to provide a sample from the immediate vicinity of the herbicide treatment.

Figure 1. Map of Lake Chetac showing the herbicide treatment area and the fishery survey locations in spring of 2013 and 2014.

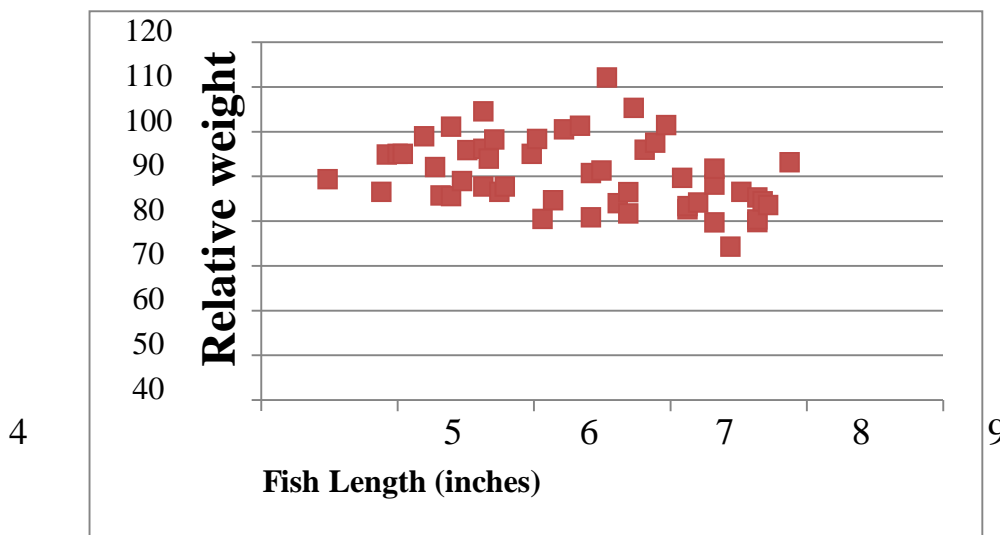
Figure 2. Relative weight of bluegill in Lake Chetac, August 2014.

Conclusions on Question 2. There is no indication that bluegill in Lake Chetac are in poor condition or are skinnier than a normal bluegill population. Relative weight can be used as an indicator that these fish have access to enough food to maintain normal body condition.

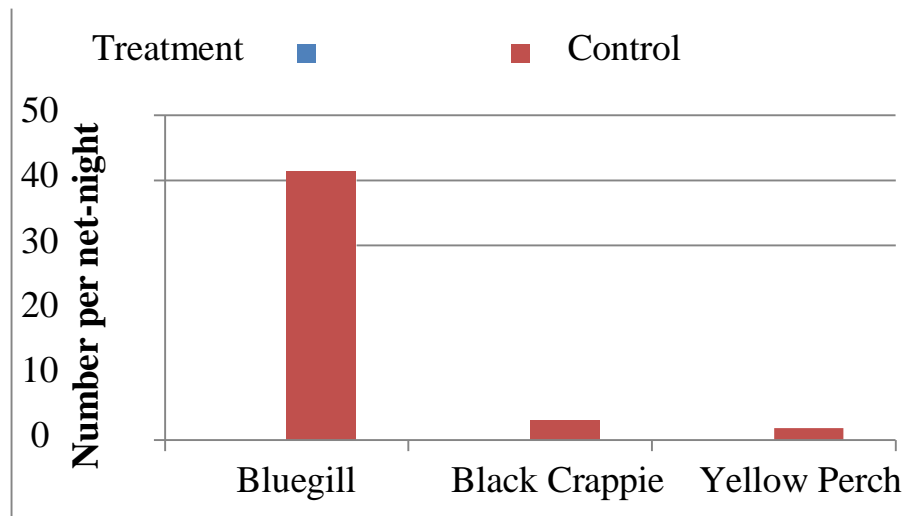
We used mini-fyke net catch rates as a measure of relative abundance of young-of-year panfish (i.e. fish born earlier that same year, 2014). Catch rates for bluegill were high in both the treatment and control areas with averages of 29.7 and 41.3 respectively (Figure 4). Catch rates for black crappie and yellow perch were both considerably higher in the treatment area.

Figure 4. Capture rates of three species of young-of-year panfish captured with mini-nets in Lake Chetac, August 2014. Young-of-year panfish were considered to be fish less than 3 inches in length.

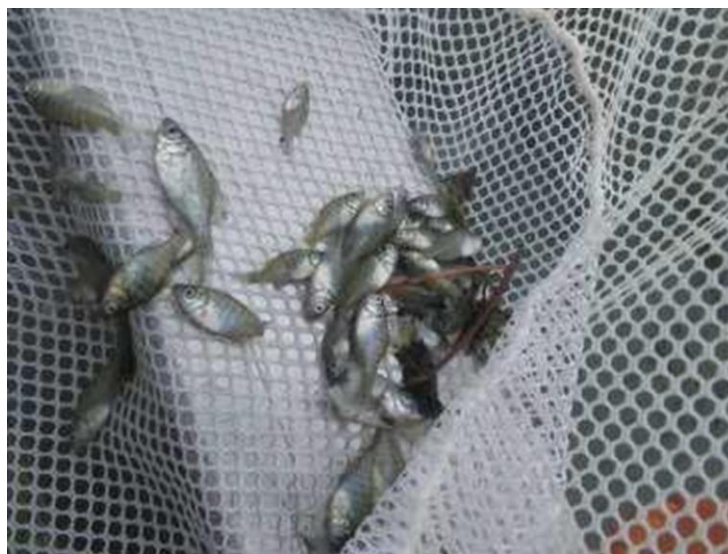
Figure 5. Photograph of young-of-year panfish from a mini-fyke net in Lake Chetac, August 2014.
