Grant Type		
Select Grant Type Notice of Discharge		
Project Name & Location		
Project Name Smits Bros. Heavy Use Protection & Manure Storage		
Grant Number UF10-24000-N15	Governmental Unit Name Green Lake County	
County Green Lake	Watershed Name Buffalo & Puckaway Lakes	12-Digit HUC 040302010605
Project Contact Name Todd Morris	Phone Number (920) 294-4051	E-mail Address tmorris@co.green-lake.wi.us
<input type="checkbox"/> For a project with multiple site locations, an aerial photo map is attached with each site location labeled.

Compliance Report – Medium Size Farm (11-20-12)

Inspection Report – Medium Size Farm (June 8, 2016)

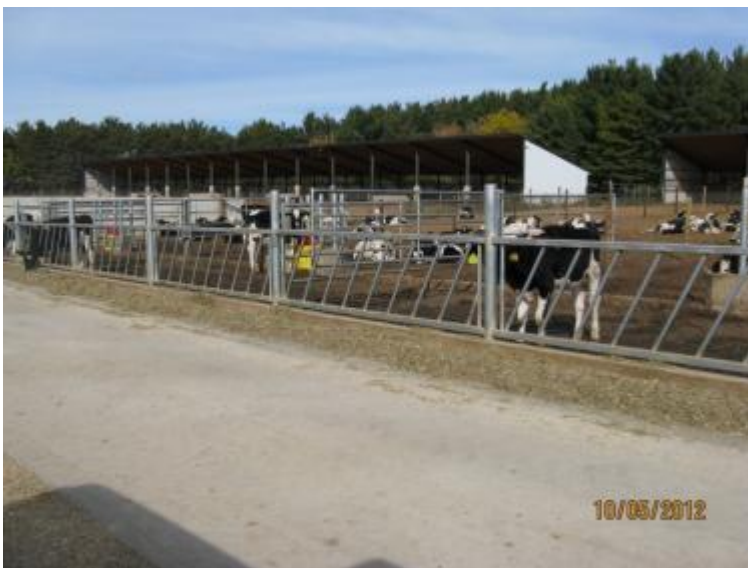
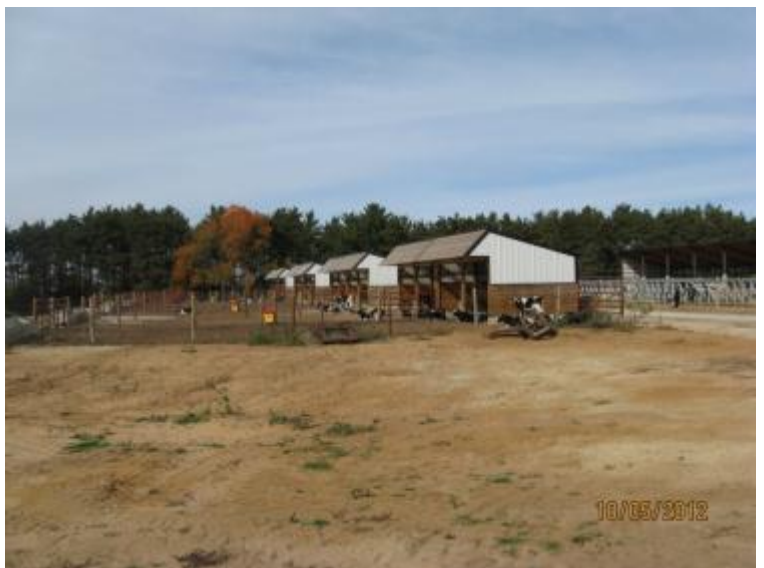
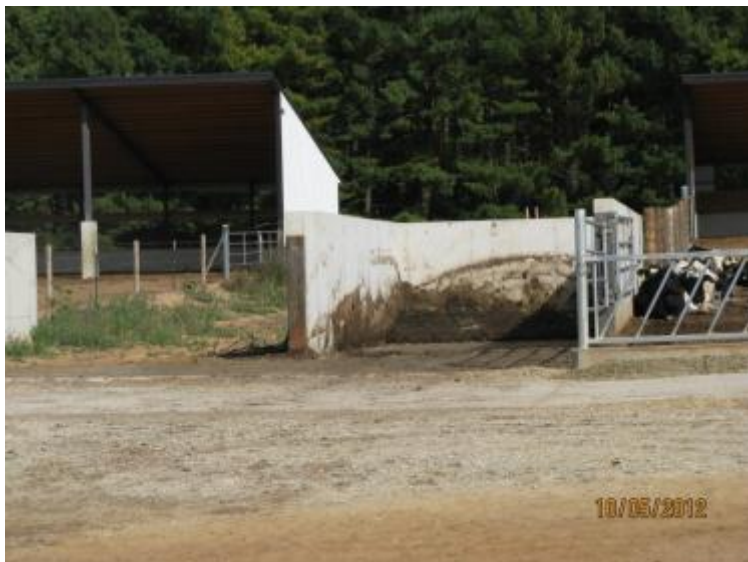
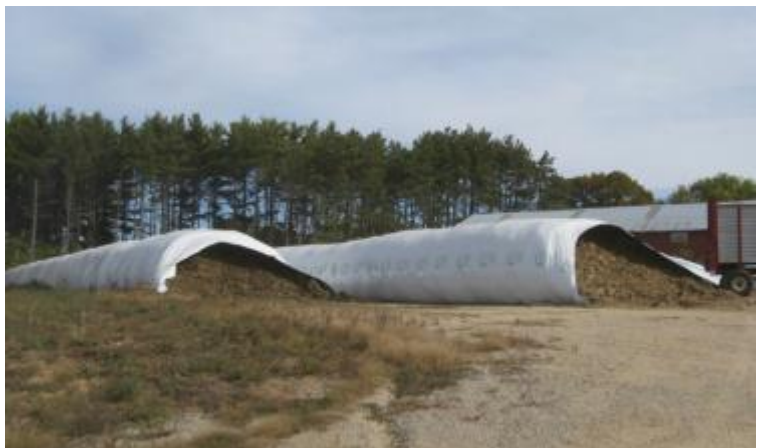
The location referred to as “Gus’s Farm” was purchased by Smits in 2006. This facility has some open sided heifer barns and drive-by feeding lanes, but heifers are primarily kept on earthen lot areas. The northern side of the farm has a small staging area for manure scraped from feed lanes. The private well onsite is upgradient of all outdoor lot areas. Photos shown below are the northern area of this farm.

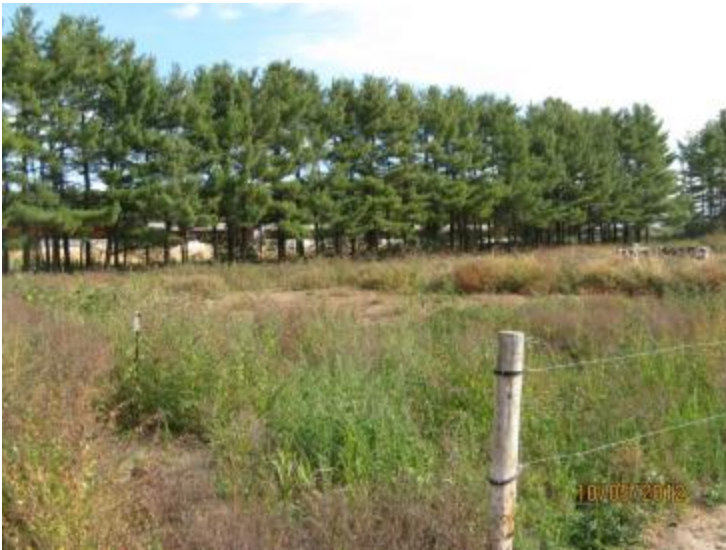
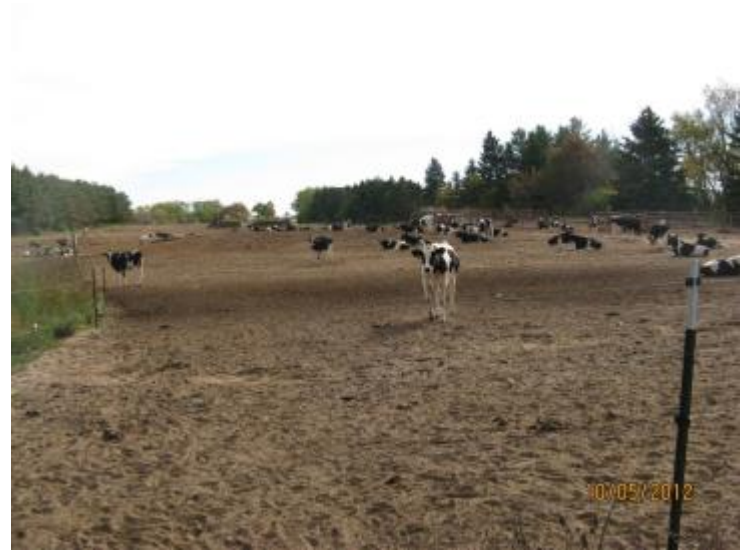
South of the area with buildings are two large open earthen lots where cows are kept year round and fed with feed wagons. These lots have sparse to no vegetation present and soils are well drained and sandy. Surface drainage flows toward west; there is an intermittent stream west of lots.

Photos above show the smaller of the two lots. Left photo is low area where runoff ponds and some solids settle out; cows are fenced out of this area. Smits said it is scraped out each fall. Photo right is looking east at lot.

Management of lot areas needs to be modified to adequately handle the nutrients being deposited by the cattle. Some options include: 1) Lots must be managed in pasture where vegetation can uptake nutrients and prevent erosion problems that can result in surface water discharges; 2) Manure should be scraped from heavy use areas where vegetation cannot be maintained and applied to cropland under a nutrient management plan; 3) Animals removed from lots and housed under roof.

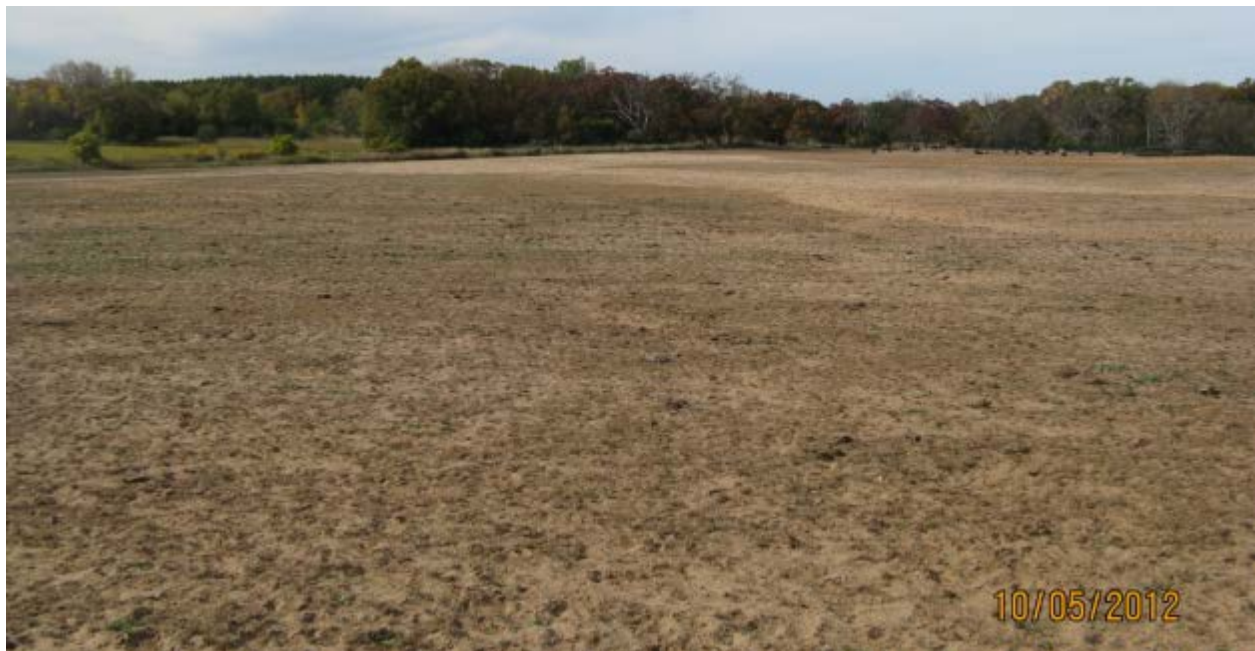
Photo above looking toward west from Hwy 73 at second larger lot at site.

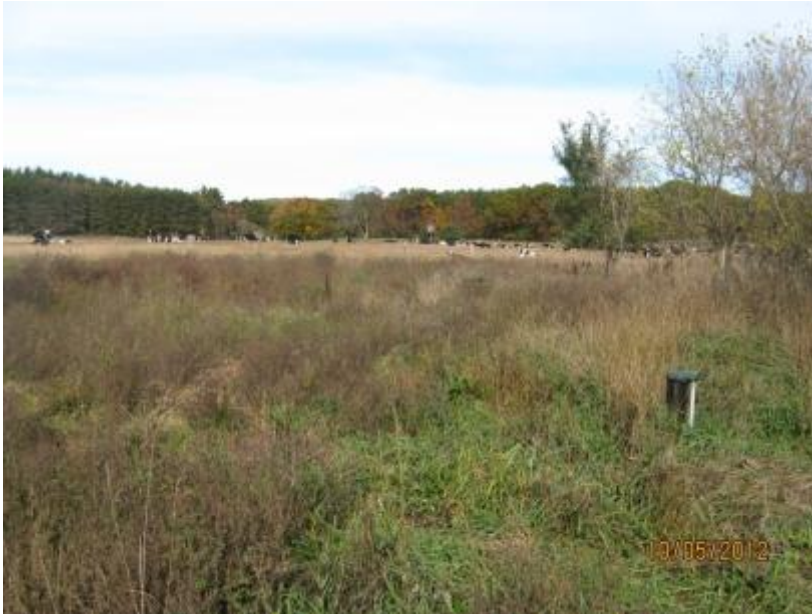
Looking northwest towards lot; well in foreground.

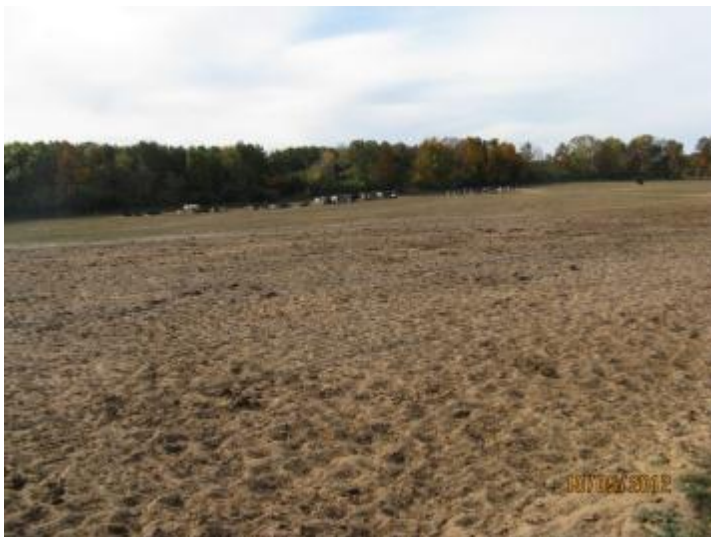
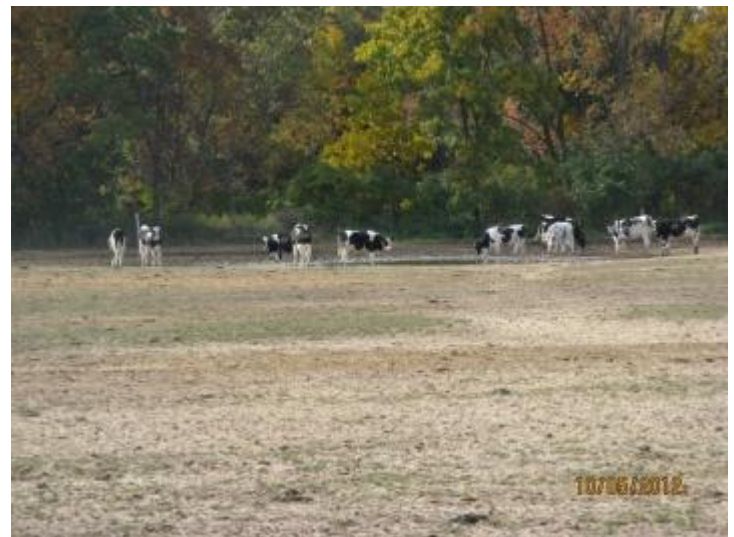
Photos above show views of lot areas; some areas had sparse vegetation but most areas were bare soil. Photo on right shows areas with some standing water present.

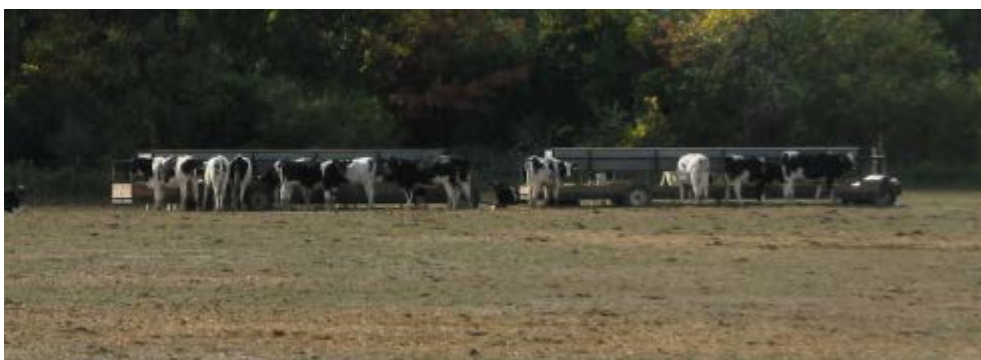
Photo left showing cows eating at feeder wagons. Smits said these are moved around to different locations regularly.

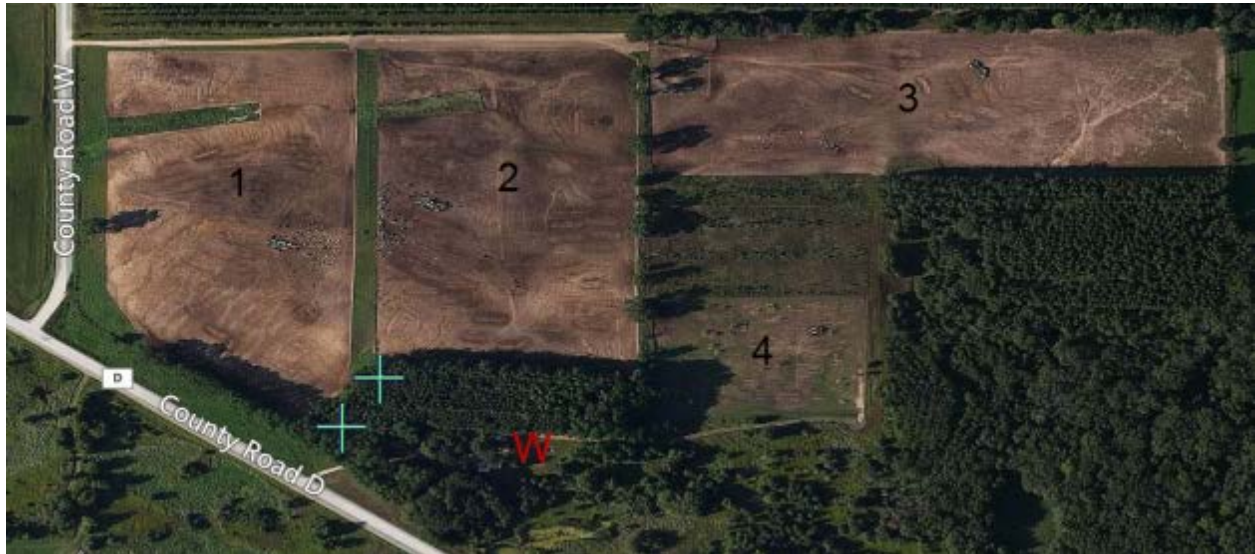
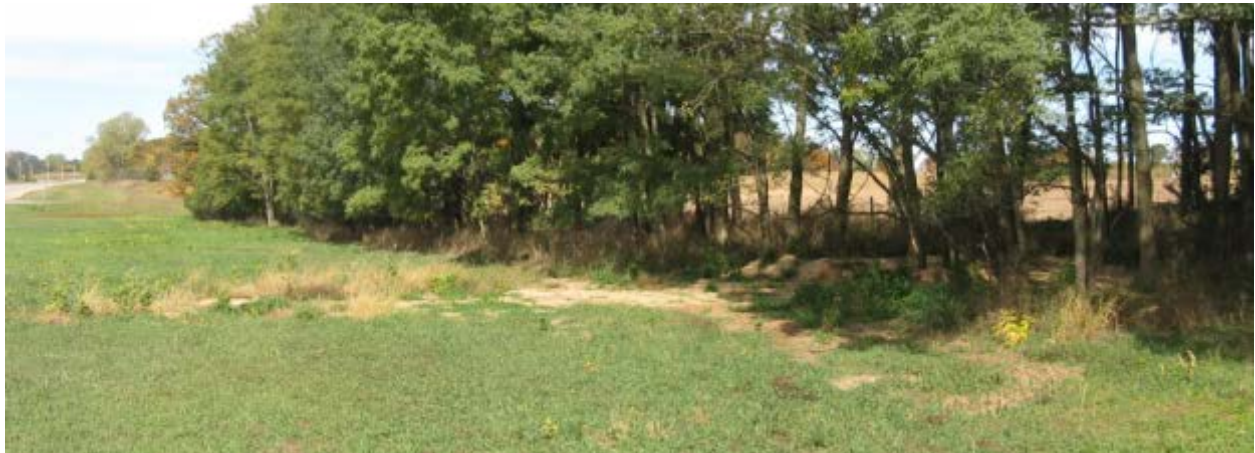
Looking northwest at accumulated sand that had ran off lots earlier in the year. Area is between southern edge of lot and Hwy D.

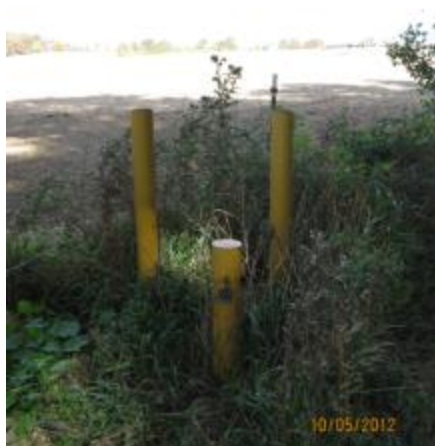
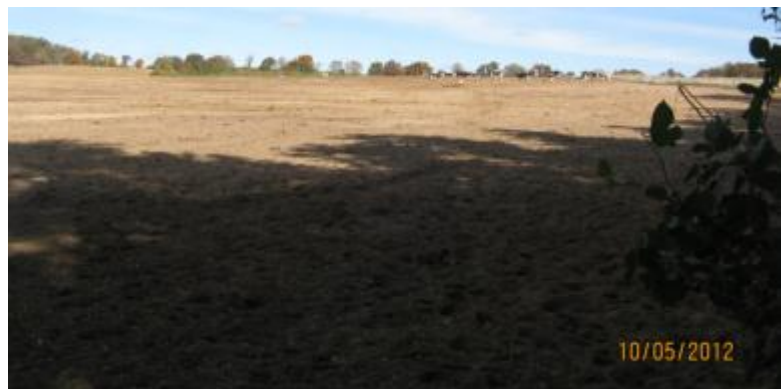
Photo left is monitoring well GL1-2. Photo above is looking northwest at earthen lot area 1 from well location.

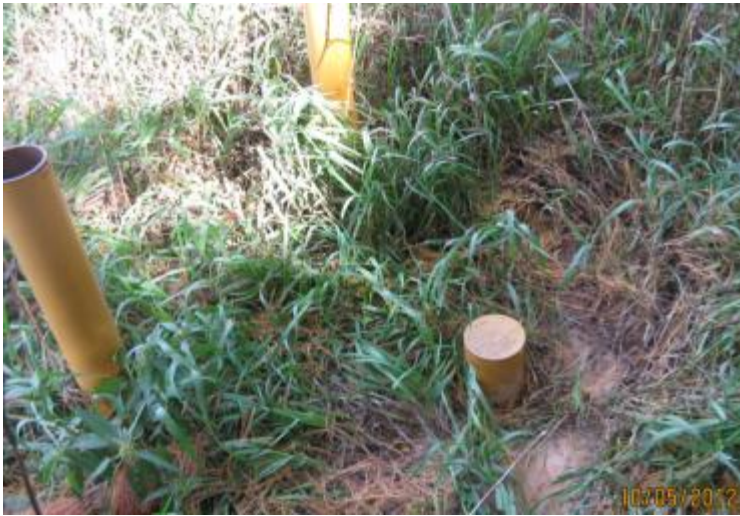
Photo above well GL1-1, either well has settled or runoff from lot shown on right has filled in ground around well. Photo right is looking northeast at lot 2.

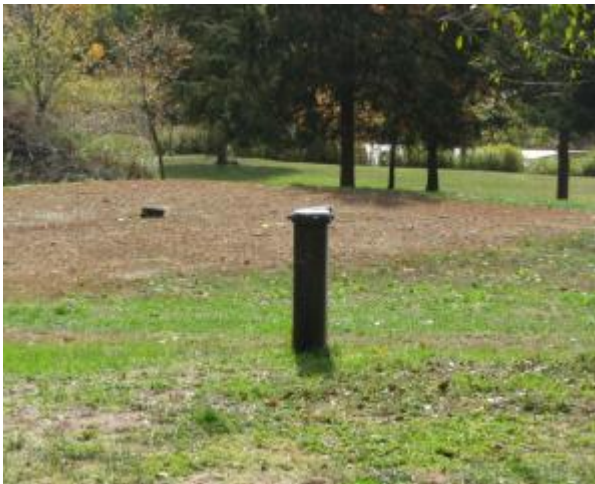
Photo left looking south at private well onsite for residence and to service watering cattle.

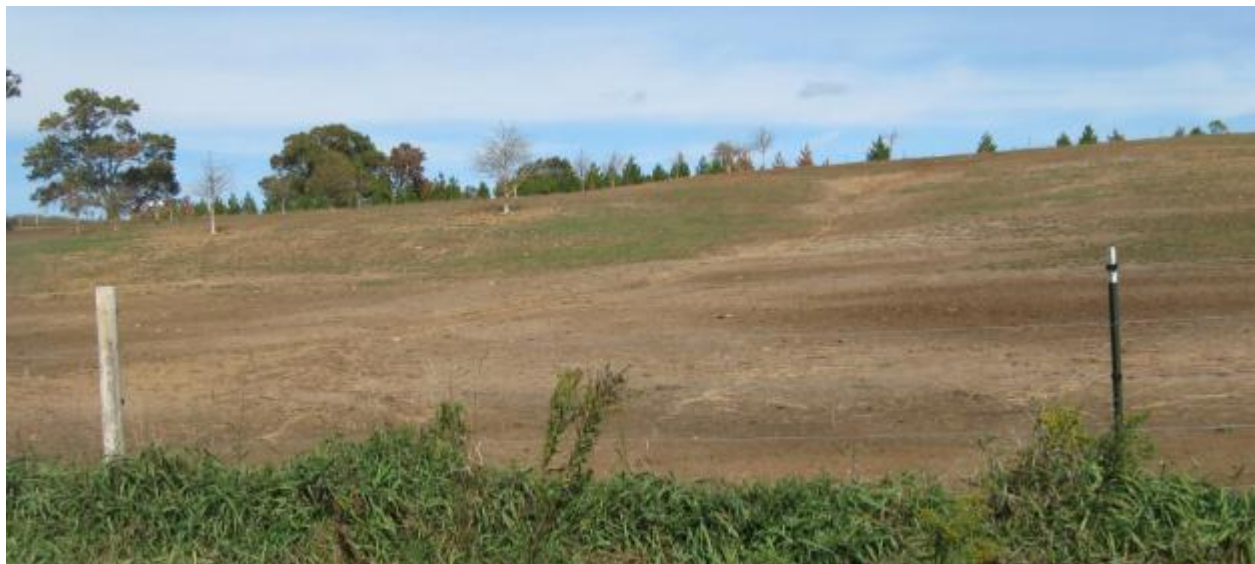
Looking north at lot labeled as number 4 on air photo overview. Smits said this is an overflow area but cows are not typically kept on this lot. Surface flow of this lot would drain south toward wetland area.

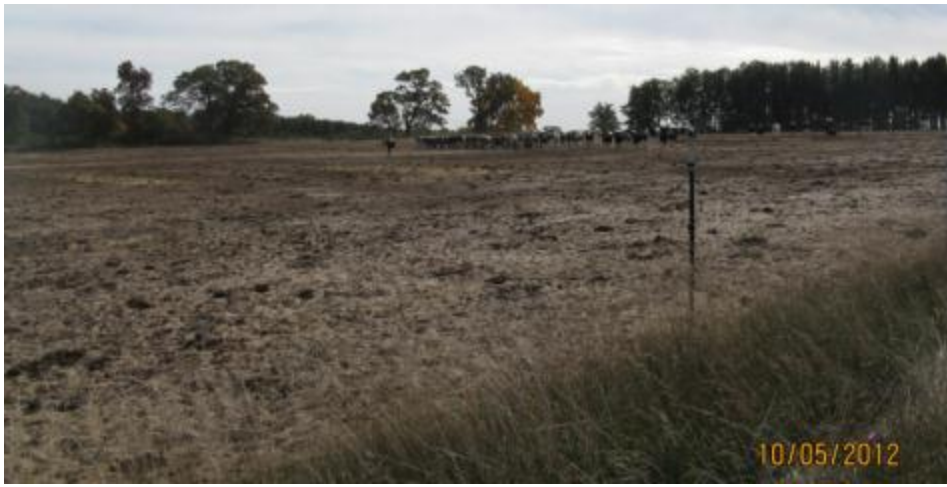
Looking southeast at Lot 2. No vegetation present on lot.

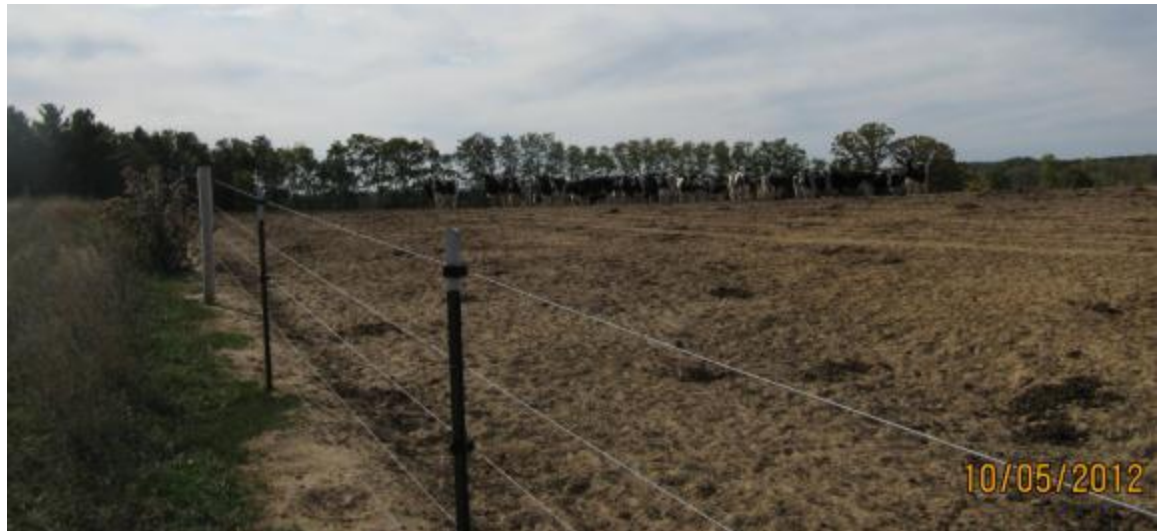
Looking southwest at Lot 1. No vegetation present on lot.

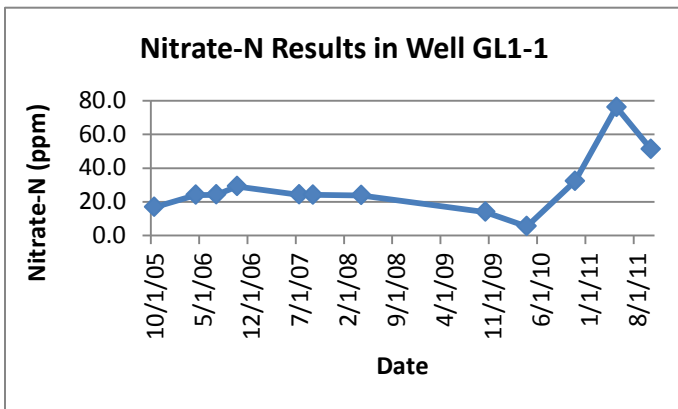
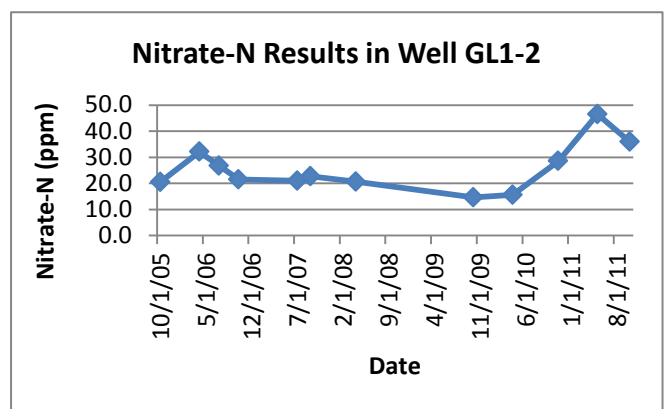
Based on site inspection conditions and monitoring well results, the Department concludes that the feedlots are unlawfully discharging to groundwater which is considered waters of the state.

A summary of well results are shown in tables below for each well. Trends show increase in nitrate levels after cattle were added to lot areas.

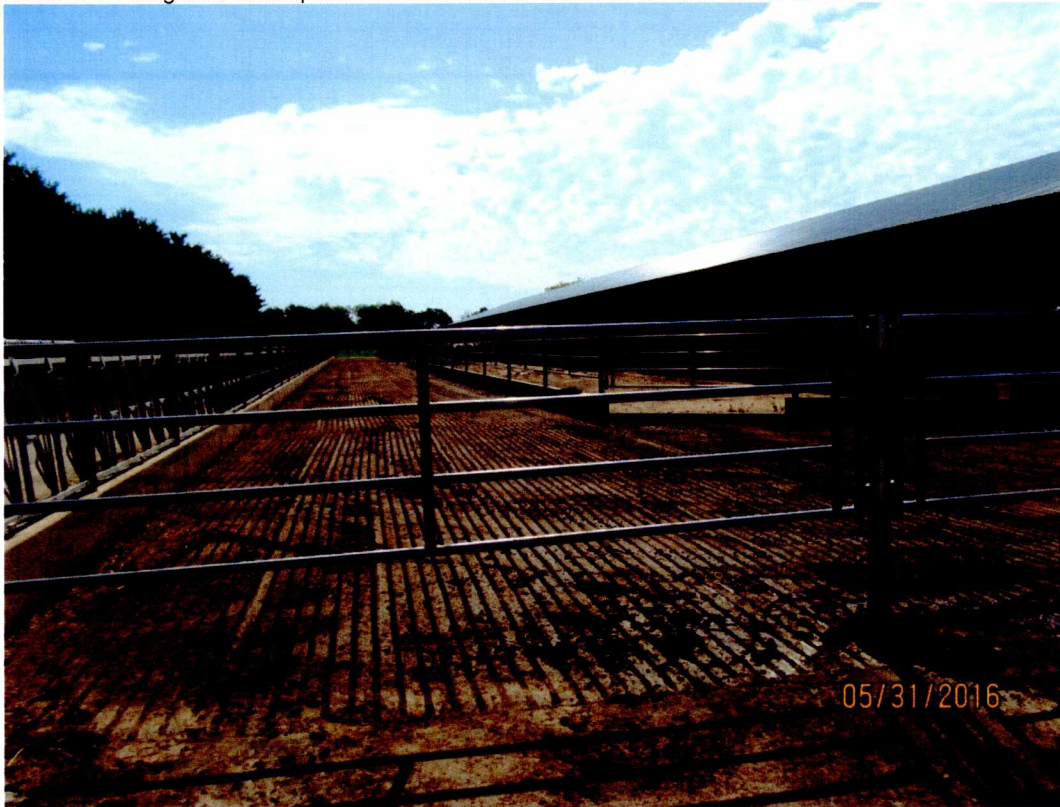
Photo 1: Looking east at completed concrete feed lanes in the former Pen 26 at Gus’ farm.

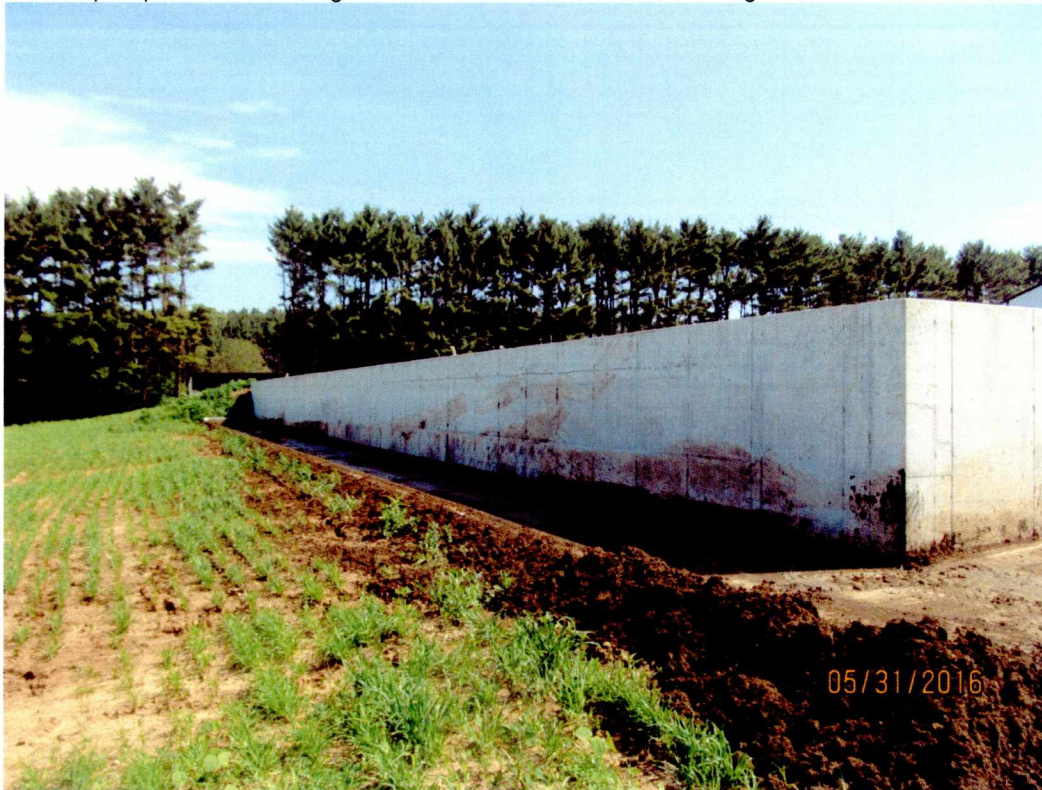
Photo 2: Manure storage and vegetated treatment area on west end of former Pen 26 at Gus' farm. Smits will continue to monitor vegetation growth and ensure the area remains fully vegetated without channelized flow paths. Brief animal use is allowed following the O&M plan provided it is during suitable times and the area remains vegetated.

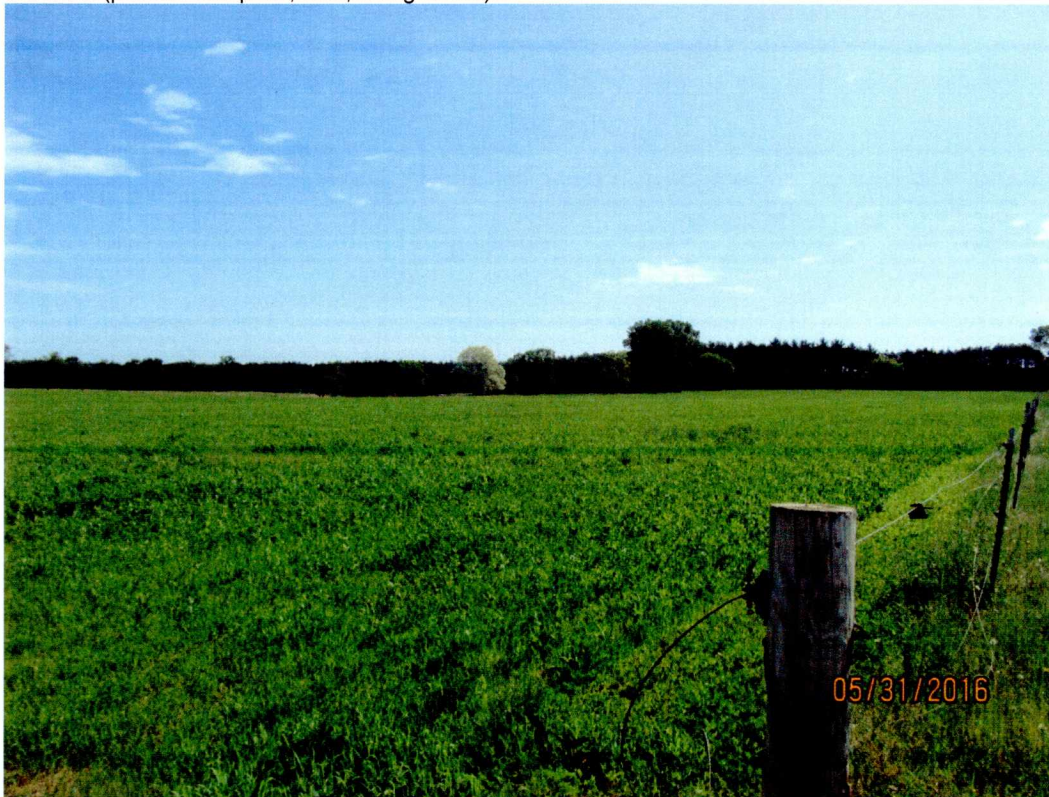
Photo 3: View of one of the lots at Tony's farm. All former earthen lots at George's, Tony's, and Gus's farm were in similar vegetated condition (planted with peas, oats, and grasses).
