An Evaluation of Water Quality in Wilson Lake, Waushara County, Wisconsin

**Wisconsin
Lake & Pond Resource LLC**

September 5, 2006

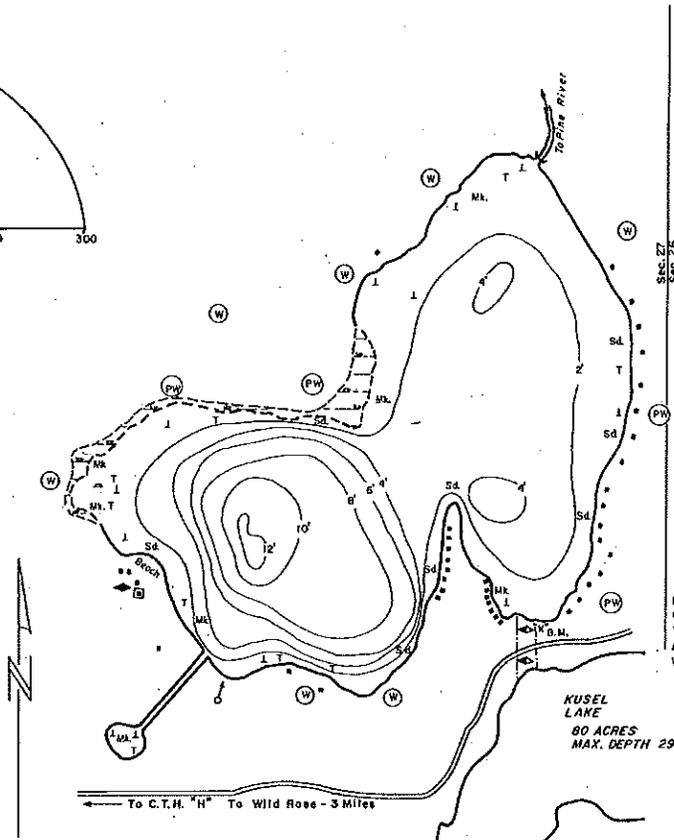
Figure 2. Wilson Lake, Waushara County Wisconsin

WILSON LAKE WAUSHARA COUNTY
 SEC. 27 T. 20 - N. R. 11 - E.

- INSTRUMENT ECHO SOUNDER MAPPED AUGUST 1964
 MO. VA.
 TOPOGRAPHIC SYMBOLS
 Brush Steep slope
 Partially wooded Indefinite shoreline
 Woods Marsh
 Cleared Spring
 Pastured Intermittent stream
 Agricultural Permanent inlet
 Bench Mark Permanent outlet
 Dwelling Dam
 Resort
- LAKE BOTTOM SYMBOLS
 P. Peat G. Gravel Stumps B Snags
 M. Muck R. Rubble
 C. Clay Br. Bedrock
 M. Mud T Submerged vegetation
 Sd. Sand I Emergent vegetation
 S1. Silt A Flooding vegetation

AREA 80.75 ACRES
 UNDER 3 FT. 50 %
 OVER 20 FT. 0 %
 VOLUME 300.72 ACRE FT.
 TOTAL ALK. 118 P.P.M.
 SHORELINE 2.08 MILES
 MAX. DEPTH 12 FEET

Wilson Lake is located in the forested hills near the town of Wild Rose in Waushara County (**Figures 1 and 2**). It is an 81-acre seepage lake comprised of two basins. The west basin has a maximum depth of 16 feet and an average depth of 6 feet. The east basin has a maximum depth of 5 feet and an average depth of 3 feet. There is a small outlet creek on the north end of the lake, which eventually drains into the Pine River. Wilson Lake supports a fishery of northern pike, largemouth bass, walleye and panfish (WDNR, 2005).

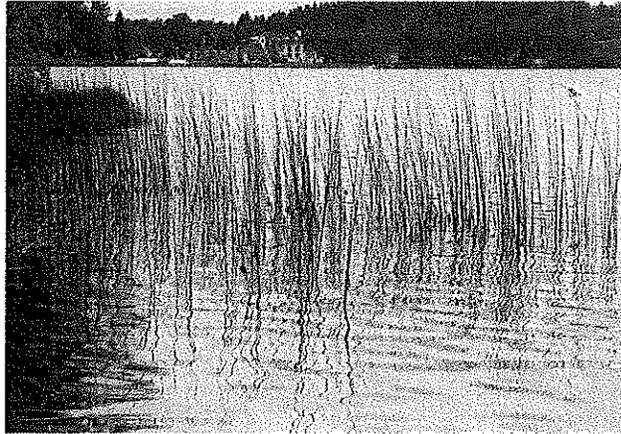
A recommended buffer zone consists of native vegetation that may extend from 25 – 100 feet or more from the water's edge onto land, and 25 – 50 feet into the water. A buffer should cover at least 50%, and preferably 75% of the shoreline frontage (Henderson et al., 1998). In most cases this still allows plenty of room for a dock, swimming area, and lawn. Buffer zones are made up of a mixture of native trees, shrubs, and other upland and aquatic plants.

Shoreline vegetation serves as an important filter against nutrient loading and trapping loose sediment. A buffer provides excellent fish and wildlife habitat, including nesting sites for birds, and spawning habitat for fish. Properly vegetated shorelines also play a key role in bank stabilization. A number of resources are available to assist
