Adaptive Lake Management Plan

Black Otter Lake District
Hortonville, Wisconsin

STS Project No. 200800520

LPL-1190-08 June 2008

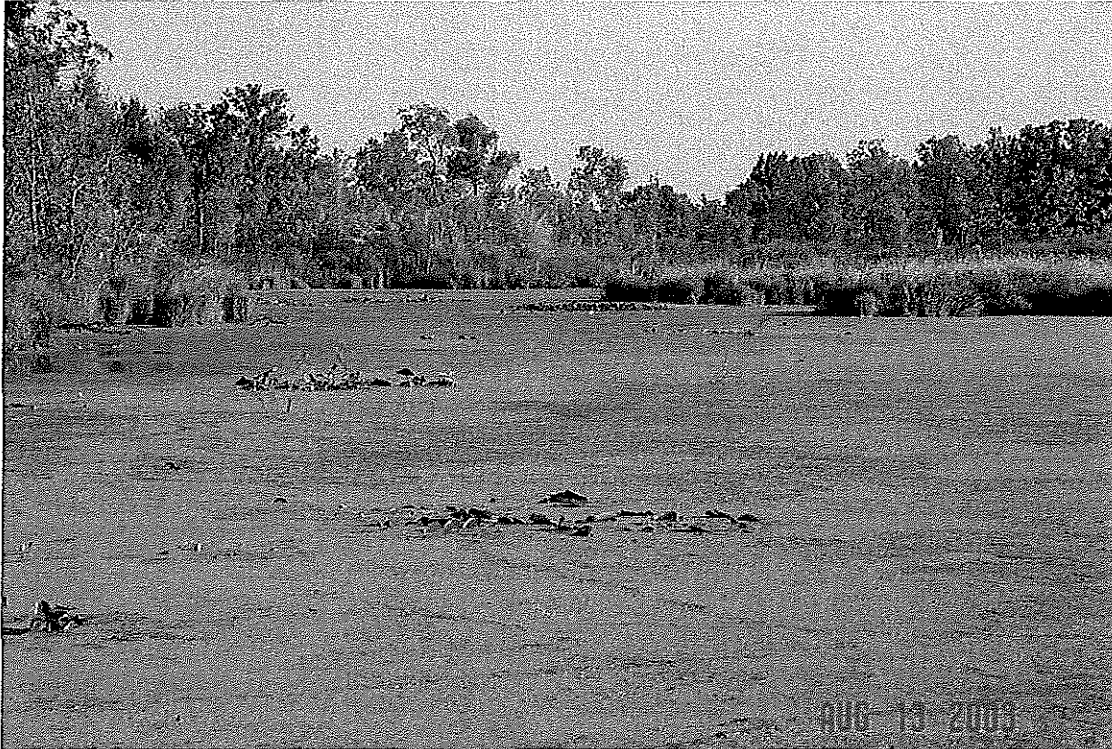
Figure 30 – A view of the upper reaches of Black Otter Lake. An area that was once dominated by emergent plant beds is now dominated by duckweed, algae, Eurasian Watermilfoil and curly-leaf pondweed.

The greatest advantage of drawing down Black Otter Lake could be the restoration of emergent plant beds that once dominated the upper ends of the impoundment. Since most emergent species require fluctuating water levels to regenerate, these plant beds have gradually disappeared as a result of the high and constant water levels that have been maintained. The restoration of emergent plant beds would reduce areas where exotic submergent species can grow. Additionally the emergent plant beds would help to improve lake water quality and fishery habitat. For drawdowns to be effective in restoring native vegetation however, they would likely need to be repeated periodically (i.e. every few years).
