# **Gilbert Lake Aquatic Plant Management Plan 2006-2009**

*Prepared for:*  
**The Gilbert Lake Advancement Association, Inc.**

**Brad Roost and Chad Cason**

**December 8, 2005**

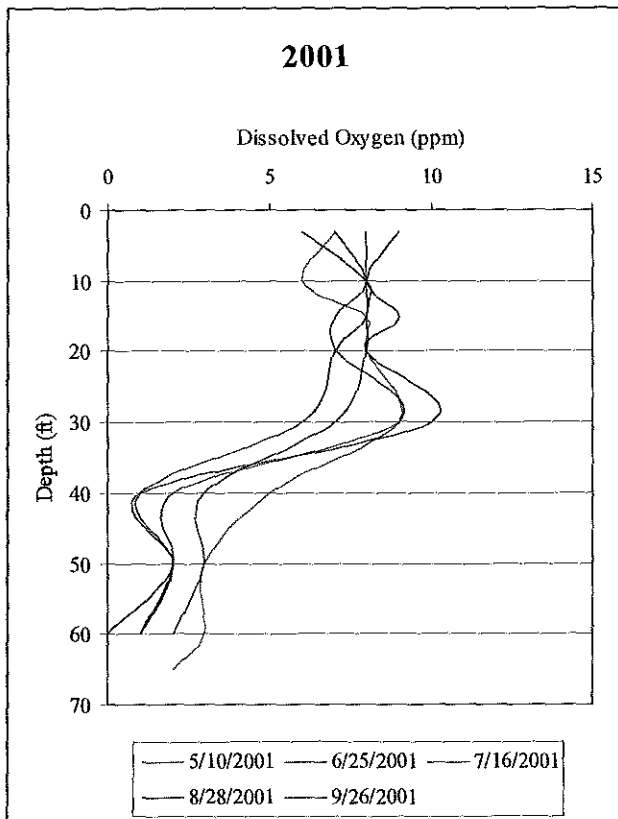
Dissolved oxygen data collected since 1993 for Gilbert Lake were used to develop annual profile graphs (**Figure 3**). Surface oxygen levels have been consistently between 5 and 10 ppm. As is evident in the profile graphs, the levels of oxygen start to decline at a depth of approximately 30 feet. This decline is often dramatic. This point, at which oxygen levels drop off, is referred to as the oxycline. Below the oxycline there is insufficient oxygen to support many fish species. The threshold level of oxygen needed for fish such as bass, perch, and sunfish to survive and grow is 5 mg/L. However, the lack of any significant fluctuations in oxygen content, both within a given year and from one year to the next, indicates a relatively stable lake environment.

**Figure 3. Dissolved oxygen concentrations found in Gilbert Lake.**

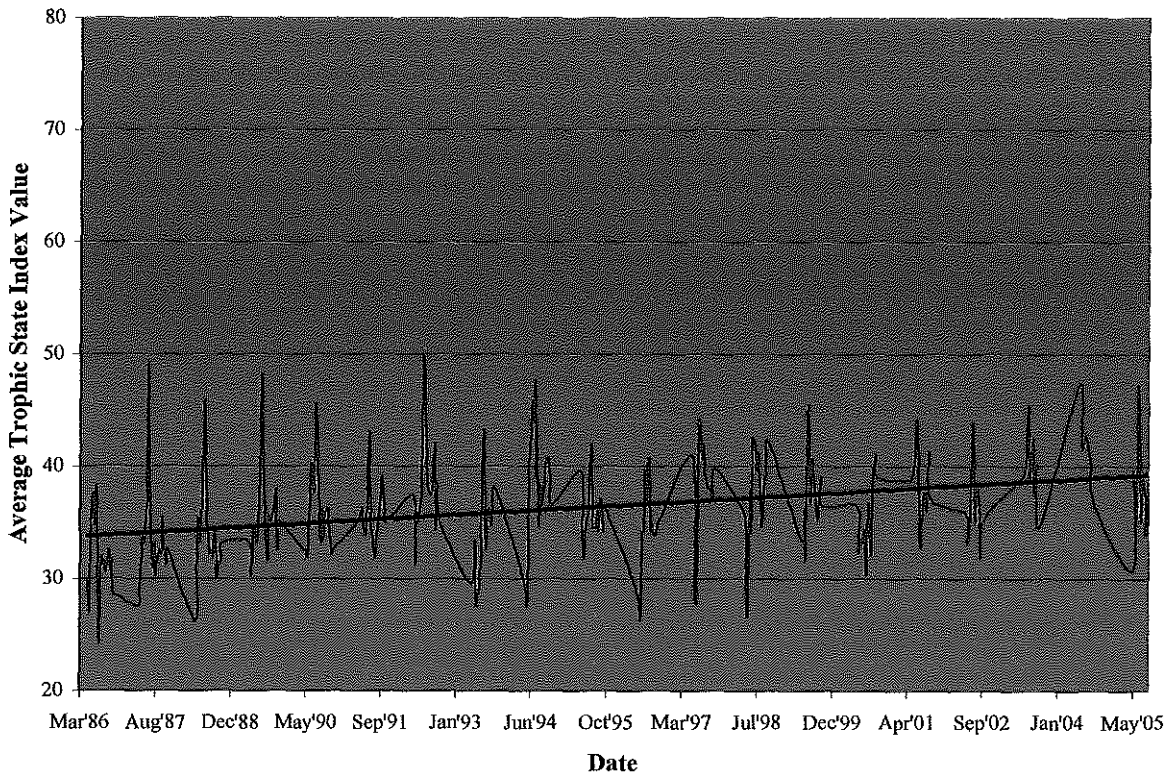
### Trophic State of Gilbert Lake 1986-2005

**Figure 6** shows the Trophic State Indices (TSI) calculated from the Self-Help monitoring data collected from 1986 through 2005. Throughout this time period, TSI values have steadily increased – reflecting a steady decrease in Gilbert Lake's water quality. This relatively rapid decline in water quality is a result of cultural eutrophication, or accelerated nutrient loading due to human activities. If this trend is not reversed the declining water quality will result in changes to the fish community and changes to the aquatic plant community – specifically, a shift from rooted plants to algae.

Figure 6. TSI values calculated from Self-Help monitoring data.

The twenty-one years of Self-Help monitoring data presented in this report reveal a trend of declining water quality in Gilbert Lake. Although water quality is still good in Gilbert Lake, water quality issues may be the primary concern for the Gilbert Lake Advancement Association if this trend continues. This first step in remedying this situation will be to identify sources of nutrient loading, and then to determine which of those sources has increased in recent years. In order to answer these questions, the Lake Association is advised to commission a detailed water quality study of Gilbert Lake. Regardless of survey findings, individual property owners should adhere to the recommendations presented in **Appendix 1: Protecting Lake Water Quality**. The Lake Association should make this information available to all lakefront property owners.

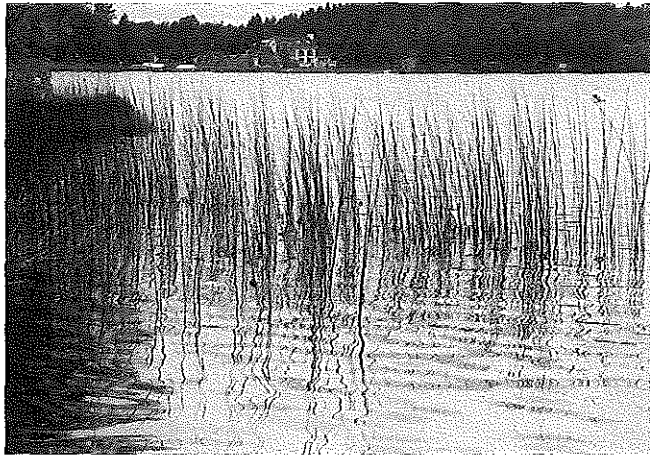
A recommended buffer zone consists of native vegetation that may extend from 25 – 100 feet or more from the water's edge onto land, and 25 – 50 feet into the water. A buffer should cover at least 50%, and preferably 75% of the shoreline frontage (Henderson et al., 1998). In most cases this still allows plenty of room for a dock, swimming area, and lawn. Buffer zones are made up of a mixture of native trees, shrubs, upland plants, and aquatic plants.

There are beneficial alternatives to the traditional mowed lawn. The best alternative is to protect the natural shoreline and leave it undisturbed. If clearing is necessary to access and view the lake, consider very selective removal of vegetation. Restoring a vegetative buffer zone is also an important alternative.

Shoreline vegetation serves as an important filter against nutrient and sediment loading. The buffer provides excellent fish and wildlife habitat, including nesting sites for birds, and spawning habitat for fish. Properly vegetated shorelines also play a key role in bank stabilization.
