**Subject: 2016 Purple Loosestrife Monitoring Report  
White River (P-2444), Superior Falls (P-2587), Hayward (P-2417), Big Falls (P-2390-01), and Thornapple (P-2475)**

**2016 Purple Loosestrife Monitoring Report for Superior Falls  
Flowage, White River Flowage, Lake Hayward, Big Falls Flowage  
and Thornapple Flowage**

**2016 Purple Loosestrife Survey Maps for  
Lake Hayward and Thornapple Flowage**

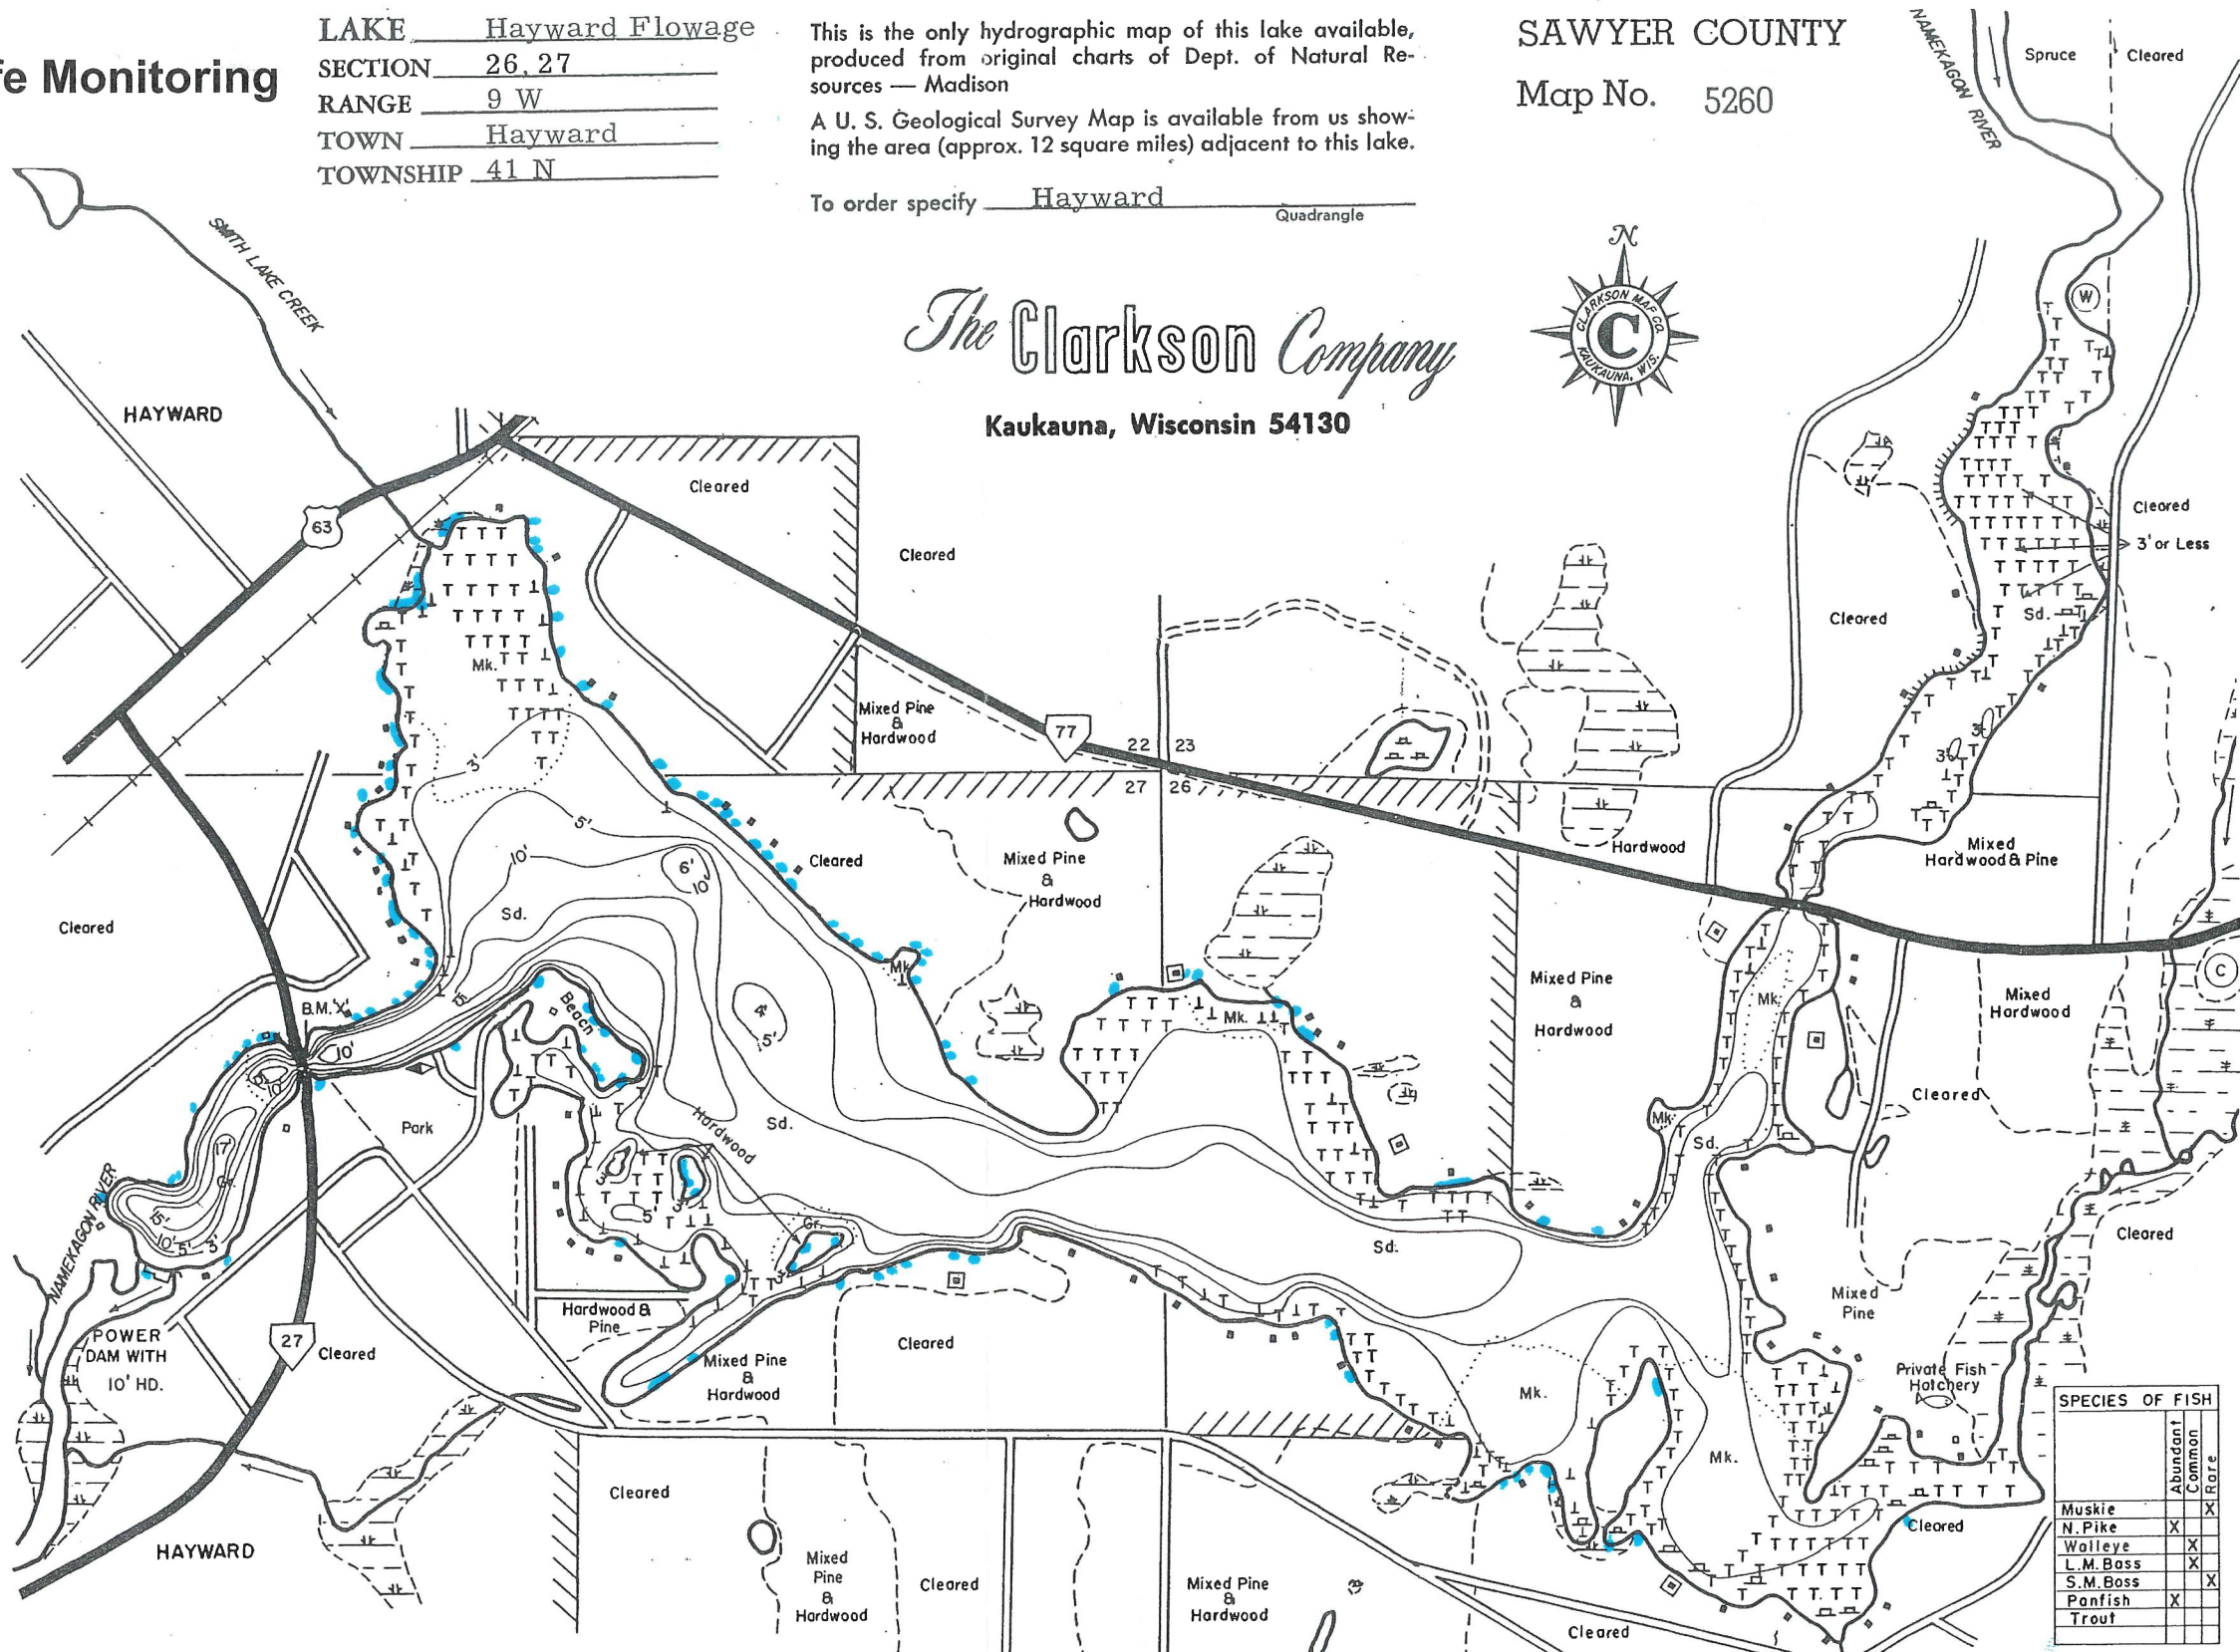
LAKE Hayward Flowage  
SECTION 26, 27  
RANGE 9 W  
TOWN Hayward  
TOWNSHIP 41 N

## Areas of loosestrife present or common

$$\frac{7.2 \text{ CLICKS}}{1 \text{ MILE}} = \frac{4.1 \text{ CLICKS}}{X}$$

$$X = 0.57 \text{ MILES} = 3010 \text{ FT}$$

OR 6.6% OF SHORELINE

## Areas of loosestrife abundant

0 FT. - NO AREAS CLASSIFIED AS ABUNDANT

3.3 Lake Hayward. The presence of purple loosestrife on Lake Hayward has been relatively stable over the last several years. Appendix A includes a survey map of Lake Hayward depicting this year’s loosestrife coverage. This year’s survey indicated a slight increase in areas categorized as present or common. There were no areas classified as abundant this year.

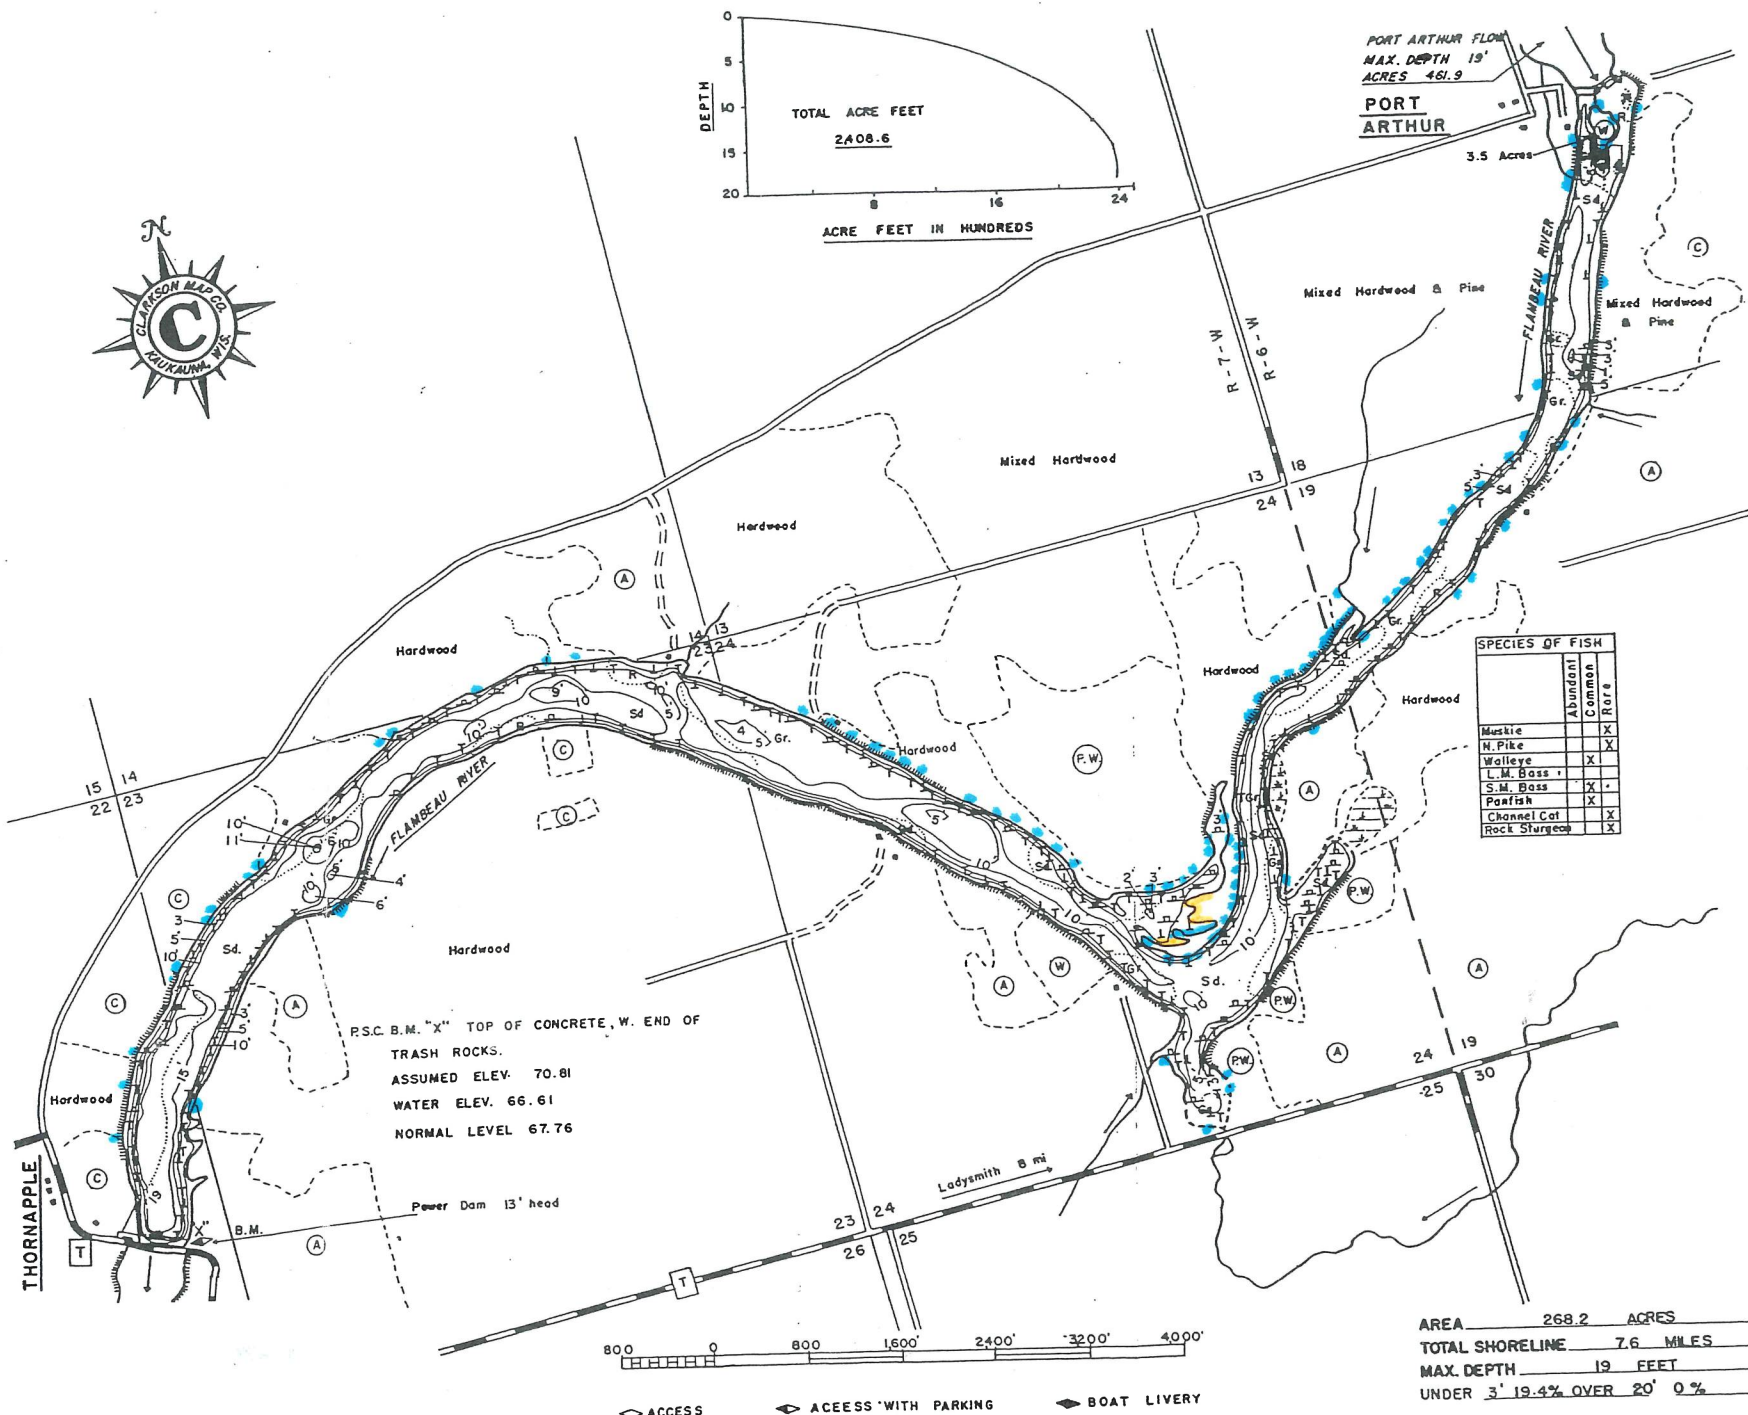
LAKE Thornapple Flow  
 SECTION 18, 19, 22, 23, 24  
 RANGE 6, 7 W  
 TOWN Thornapple  
 TOWNSHIP 34 N

AREAS OF PURPLE LOOSESTRIFE COMMON

$$\frac{2.5 \text{ CLICKS}}{4000 \text{ FT}} = \frac{3.5 \text{ CLICKS}}{X \text{ FT.}}$$

$$X = 5600 \text{ FT} = 1.06 \text{ MILES}$$

OR 13.9% OF SHORELINE

AREAS OF PURPLE LOOSESTRIFE

ABUNDANT

$$\frac{2.5 \text{ CLICKS}}{4000 \text{ FT}} = \frac{0.4 \text{ CLICKS}}{X \text{ FT.}}$$

$$X = 640 \text{ FT.} = 0.12 \text{ MILES}$$

OR 1.6% OF SHORELINE

along 1.06 miles of shoreline compared to 1.45 miles in 2015. Approximately 0.12 miles of shoreline was categorized as abundant this year which is the same as last year. The wetland areas near the middle of the flowage continue to account for the greatest concentration of loosestrife plants. See Appendix A for a survey map of Thornapple Flowage depicting the results of this year's monitoring.
