# **Invasive Species Monitoring and Control Report**

## **Badger-Rapide Croche Hydroelectric Project**

**FERC Project No. 2677**

**Lower Fox River  
Outagamie County, Wisconsin**

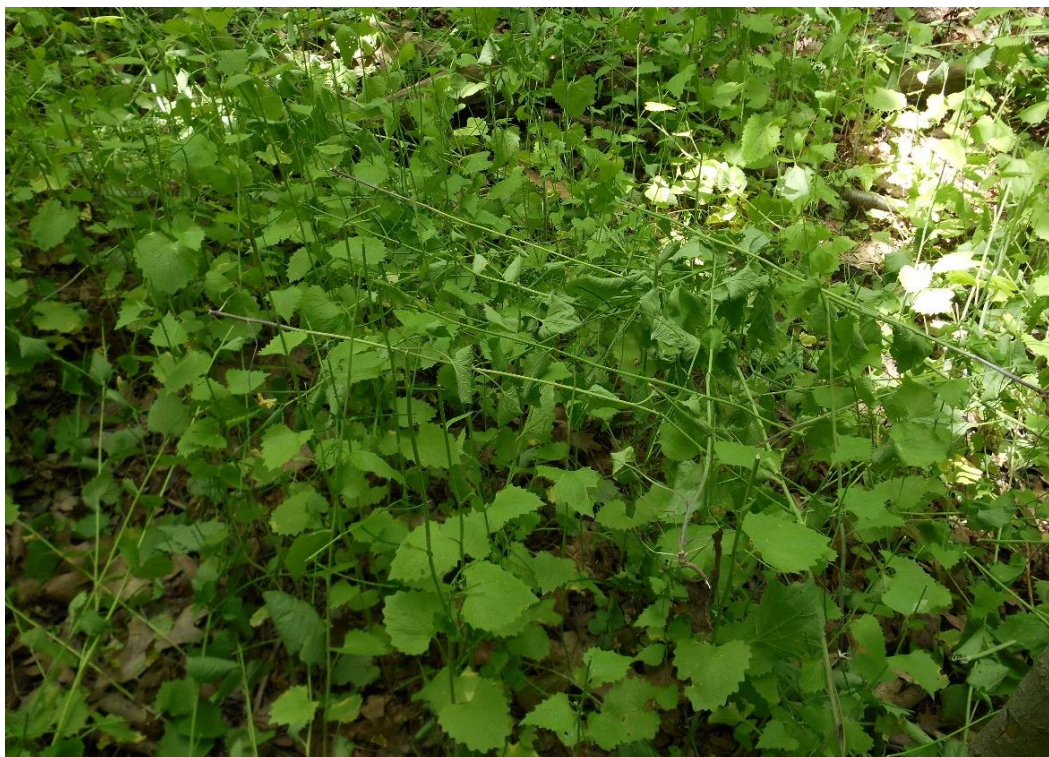
Prairie Nursery's management strategy for controlling garlic mustard involves cutting off the pre-mature seed stalks just after flowering is complete in early June (see Figure 1). This prevents maturation of the seed while starving the rootstock. This cost-effective strategy also offers significant advantages over pulling, which disturbs the soil and stimulates germination of dormant mustard seed. It is also safer than spraying herbicides, which can lead to unacceptable collateral damage to desirable native vegetation. When repeated annually, this strategy offers a cost-effective control that also encourages recovery of adjacent native ground layer vegetation.

*Figure 1. Example of cut-over garlic mustard infested area, June 6, 2014.*

As a result of identifying a garlic mustard infestation on approximately 2.5 acres of Rapide Croche Park woodlands, KU retained Prairie Nursery of Westfield, Wisconsin, to perform garlic mustard control and evaluate the ecological health of the park's woodlands. An initial site visit on November 14, 2013, revealed a small remnant of rare Fox Valley oak savanna habitat within the park, with healthy mature white oaks and a partially intact native herb community. In light of this discovery, KU requested Prairie Nursery to identify restoration and management strategies for this habitat, as well as perform garlic mustard control. Prairie Nursery's management report is being provided to KU under separate cover as it is outside the scope of FERC license compliance.

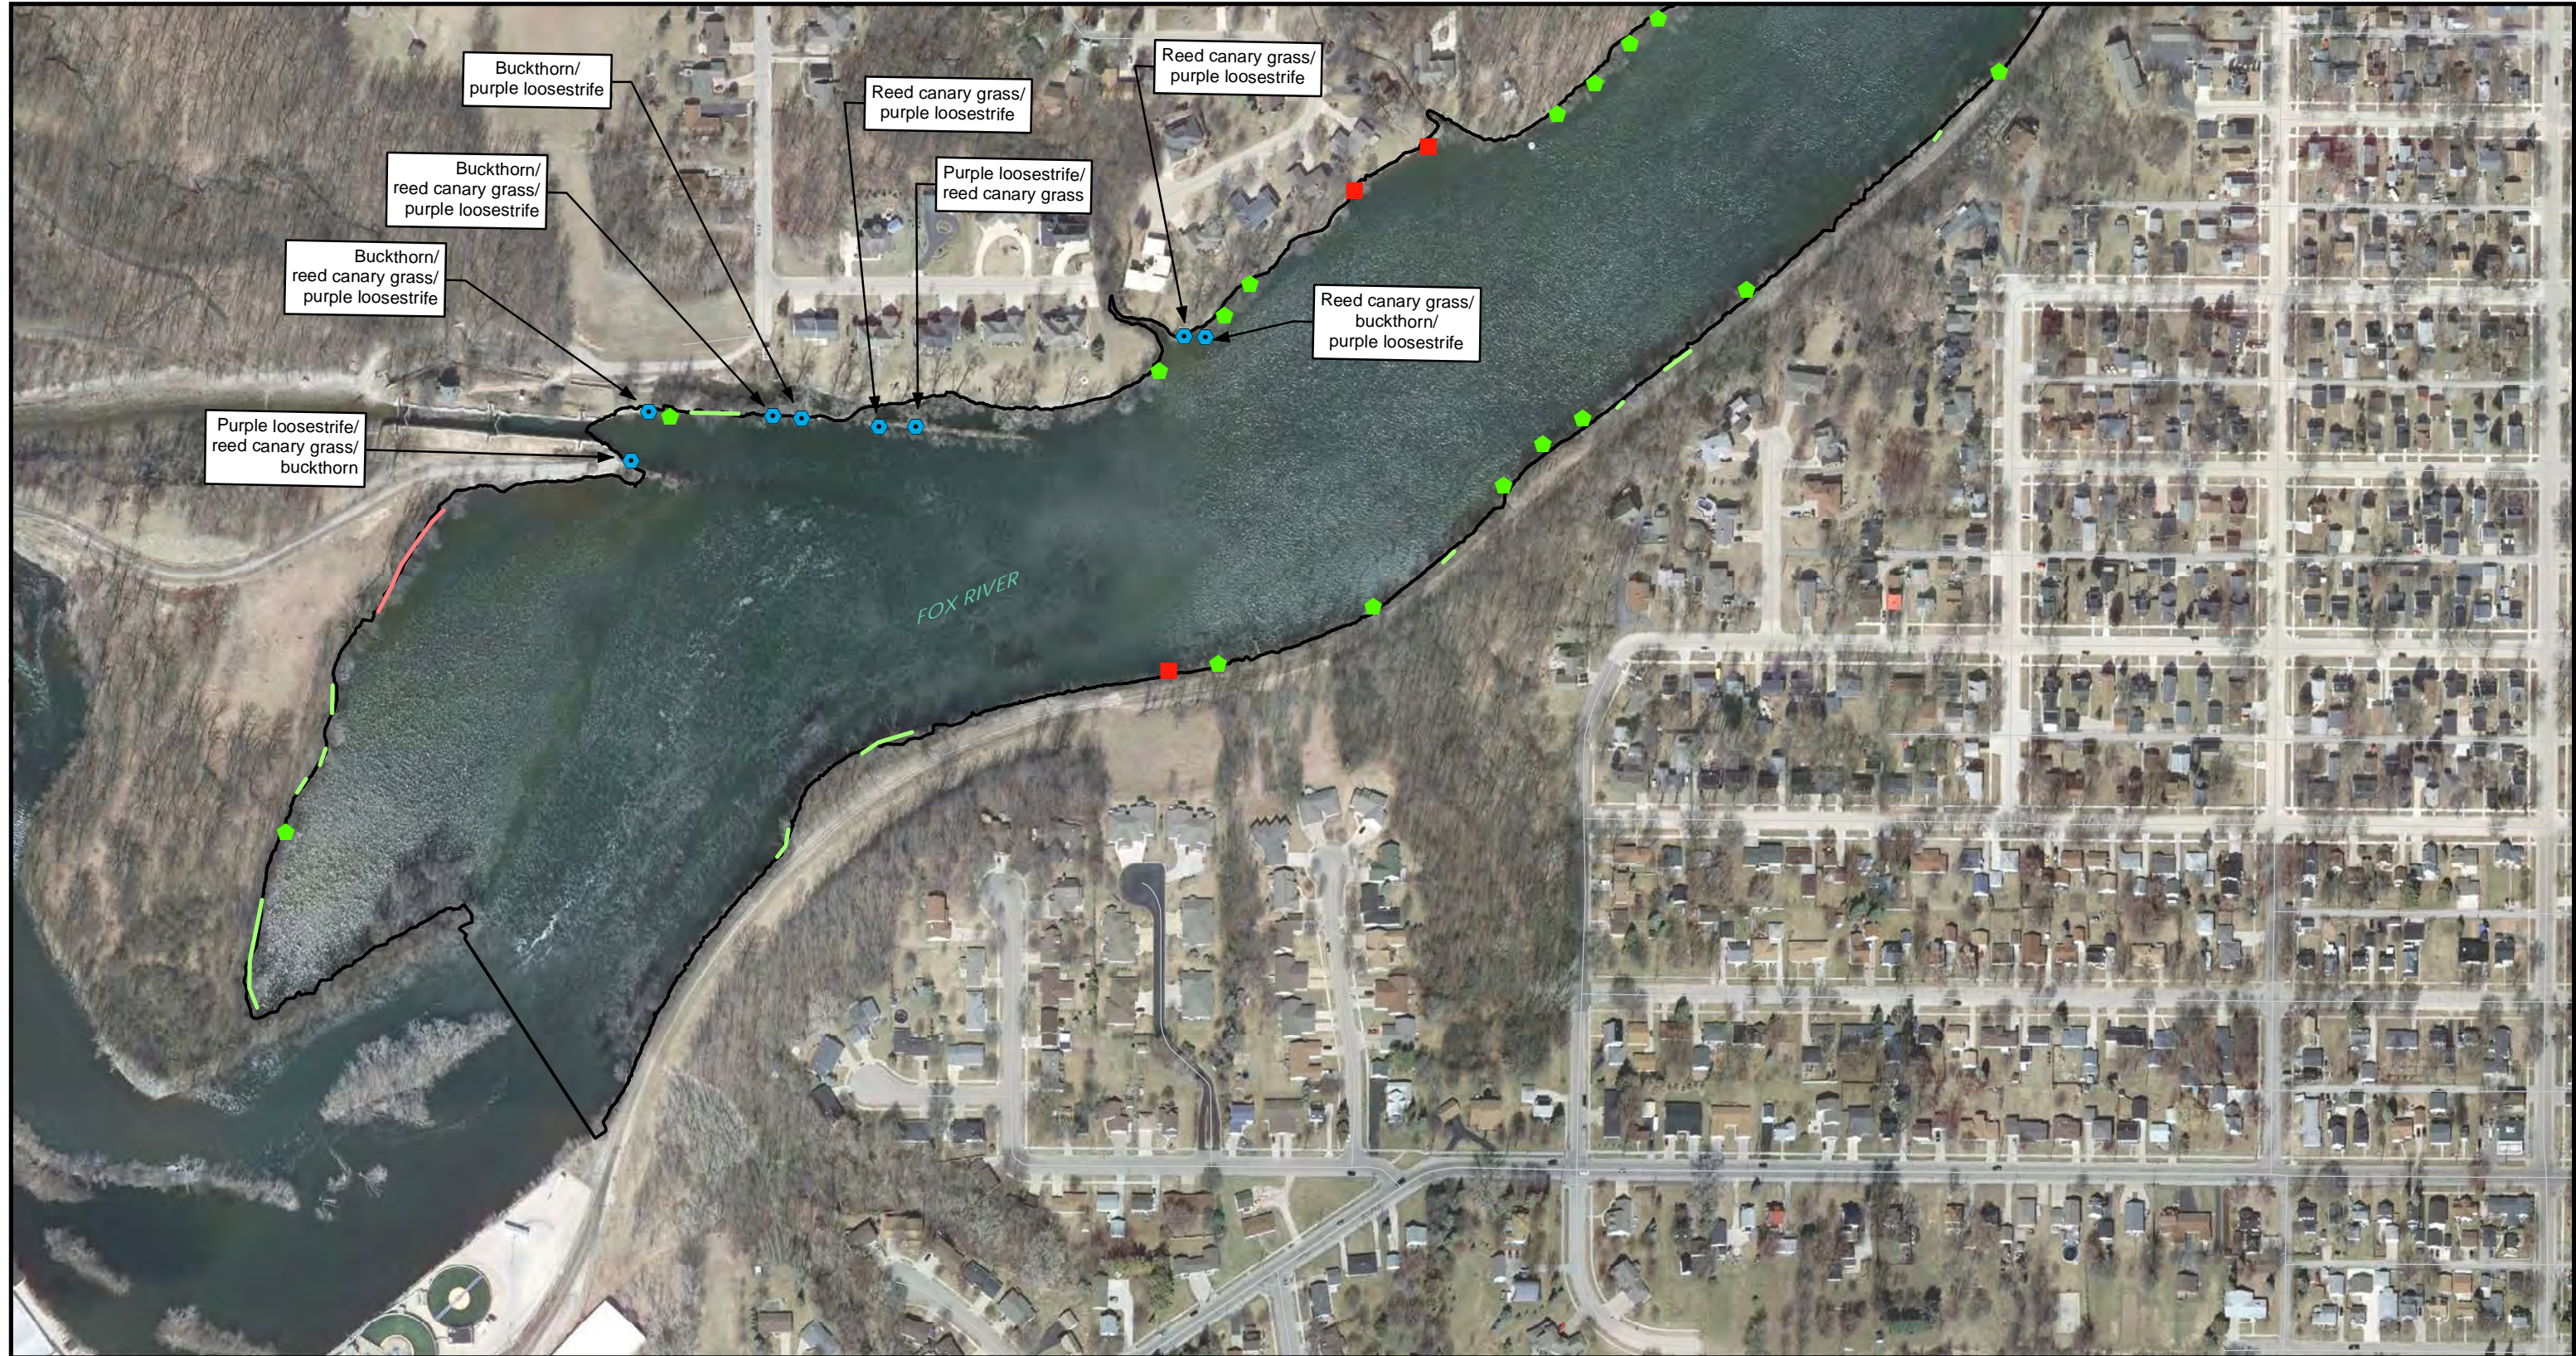
Of the invasive plants in Table 1, garlic mustard, buckthorn, reed canary grass, and purple loosestrife were documented within the monitoring limits. As in 2013, no Japanese knotweed or common reed was found. The most prevalent species was buckthorn, which occurred along northern and southern river banks throughout the project. Spot occurrences of one to several mature shrubs remained common, interspersed with naturalized Eurasian honeysuckle (*Lonicera x bella*) and red osier dogwood. These two species of brush appeared to be competitively excluding buckthorn by overgrowing it in many locations. In other riverbank areas, however, continuous, narrow populations of mature buckthorn were noted along the shoreline and are mapped as lines in Appendix A.
