Dane County Water Quality Plan

Appendix B Update

Surface Water Quality Conditions

Prepared by the Staff of the Capital Area Regional Planning Commission

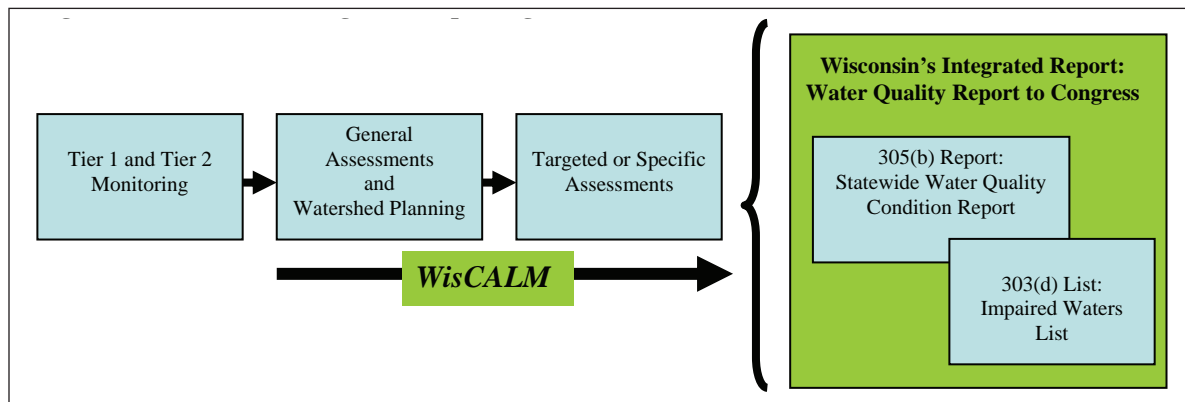
Figure 8. Wisconsin’s Integrated Reporting Process

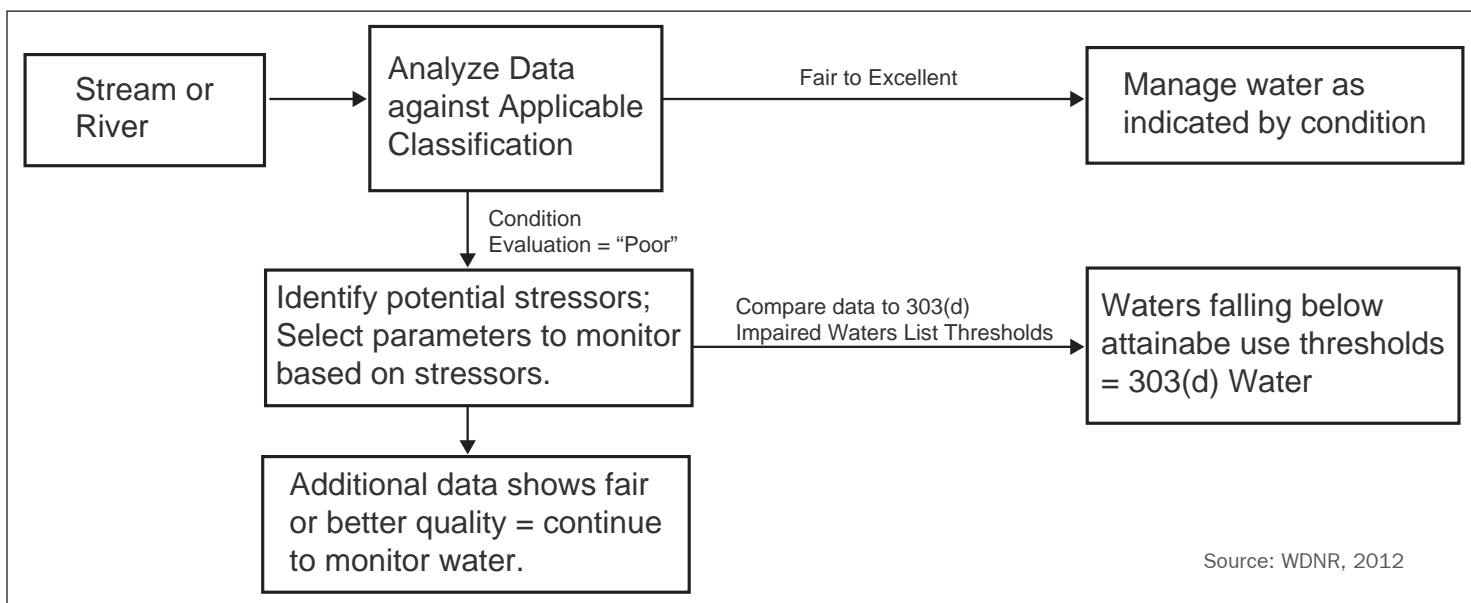
Figure 10. Overview of Assessment Process for Streams, Rivers – General and Specific Assessments

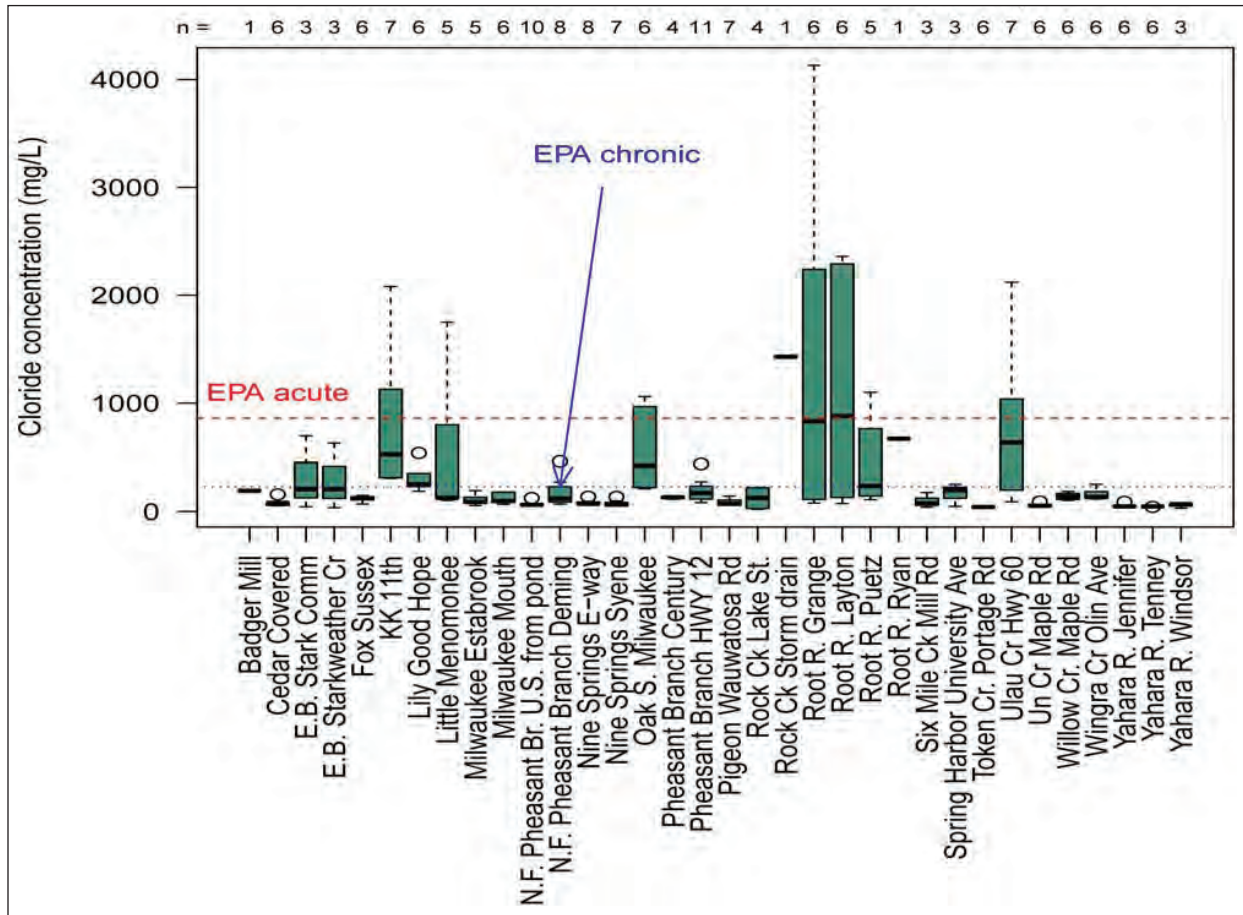
Figure 12. Chloride in Southern Wisconsin Streams, 2011

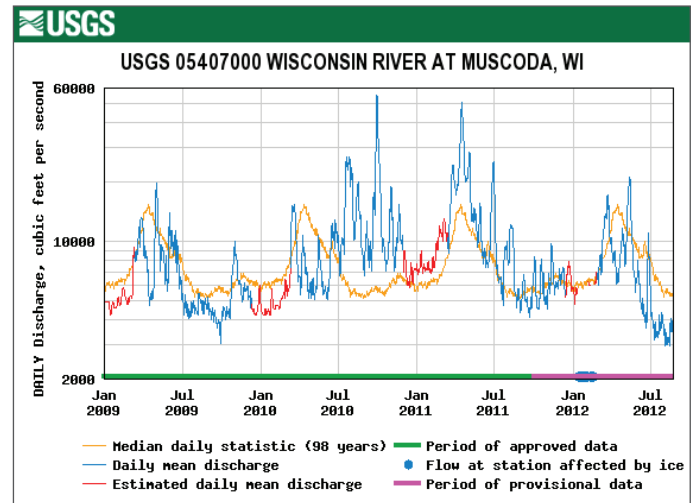
Figure 24. Lower Wisconsin River Flow Rates in 2009-10 demonstrate variable conditions within the river floodplain

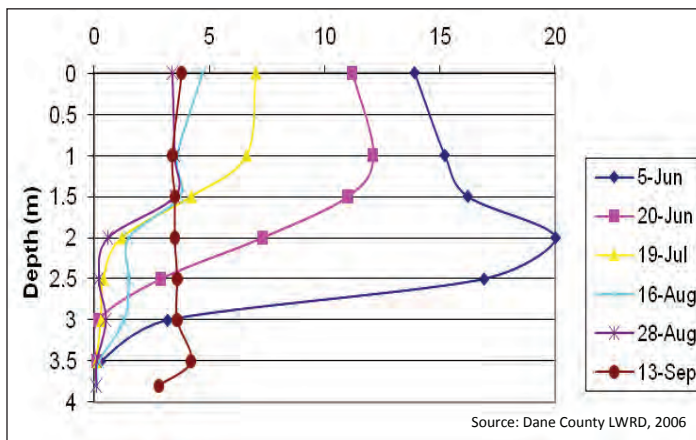
Figure 31. 2006 Dissolved Oxygen Profiles in Stewart Lake (ppm)

The ecological effects of the dense rooted aquatic plants found in 2006 included undermining fish predator-prey relationships. Abundant very small bluegills were easily observed near the surface during the 2006 study, particularly when dissolved oxygen levels were low. The dense plant canopy likely created a refuge, resulting in large numbers of stunted panfish.

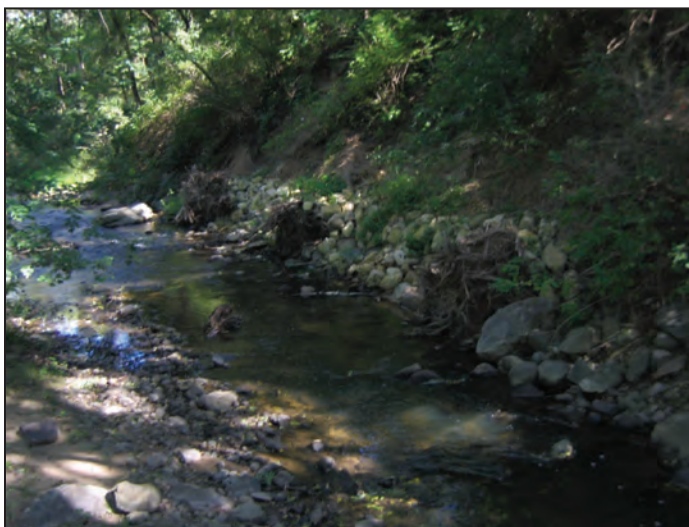
Failing Bank Stabilization Along Pheasant Branch in 2010
