Re-evaluation of Bone Lake Phosphorus Reduction Goal and Objectives

The Bone Lake phosphorus reduction goal was established in the Bone Lake Comprehensive Lake Management Plan 2009. Goals and objectives from the plan are shown in the text box below. The plan calls for gathering additional information to clarify sources of phosphorus to Bone Lake. Objectives were to be reassessed once this information is gathered.

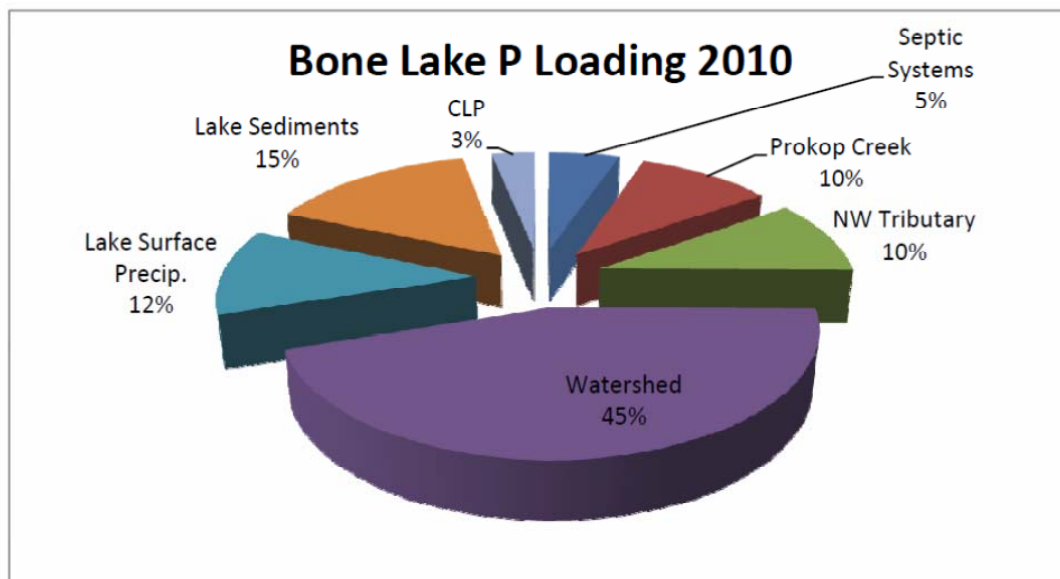
Figure 1. Phosphorus Sources to Bone Lake 2010

This is the best estimate that we currently have for managing phosphorus to reduce nuisance algae growth in Bone Lake. It shows a higher tributary load than the 2008 estimate. This is simply because there was more precipitation in 2010 than in 2008. Watershed and lake surface loads decreased in importance as the internal sediment and CLP loads were added.

Source	Kg/Year	Percent of P Load
Septic Systems	67	5
Prokop Creek	124.8	10
NW Tributary	122.7	10
Watershed	557	45
Lake Surface Precipitation	143	12
Lake Sediments	192	15
CLP	40	3
Total	1246.5

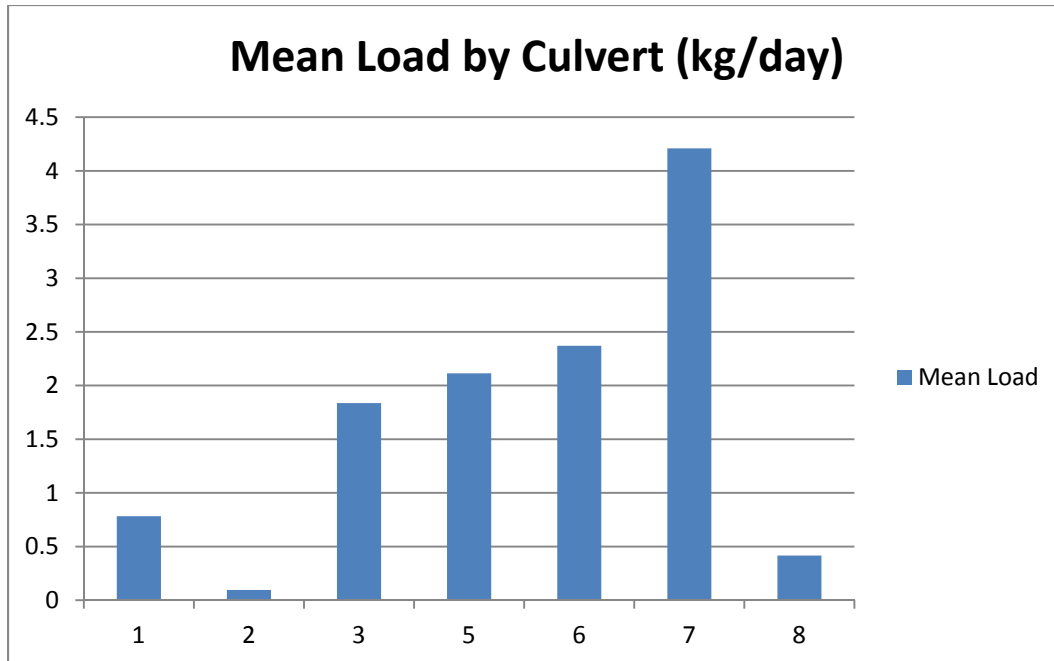
Figure 3. Mean phosphorus load (kg/day) for sampled culverts

Figure 3 compares overall phosphorus loading from the culverts on the days when sampling occurred. Figure 4 shows the loading of phosphorus (kg/day) each time sampling occurred.

Culvert 7a/7 Much of this area that flows to this culvert is undeveloped. Water below the culvert flows through extensive wetlands before entering the lake. Some streambank erosion was identified in wooded areas above the culvert. Specific locations were not recorded. Data reported for 6 in Figures 3 and 4 is actually from a new culvert (7a) installed next to 7 when the previous single culvert blew out after a large storm event (over 3 inches in 24 hours) on July 14, 2010.

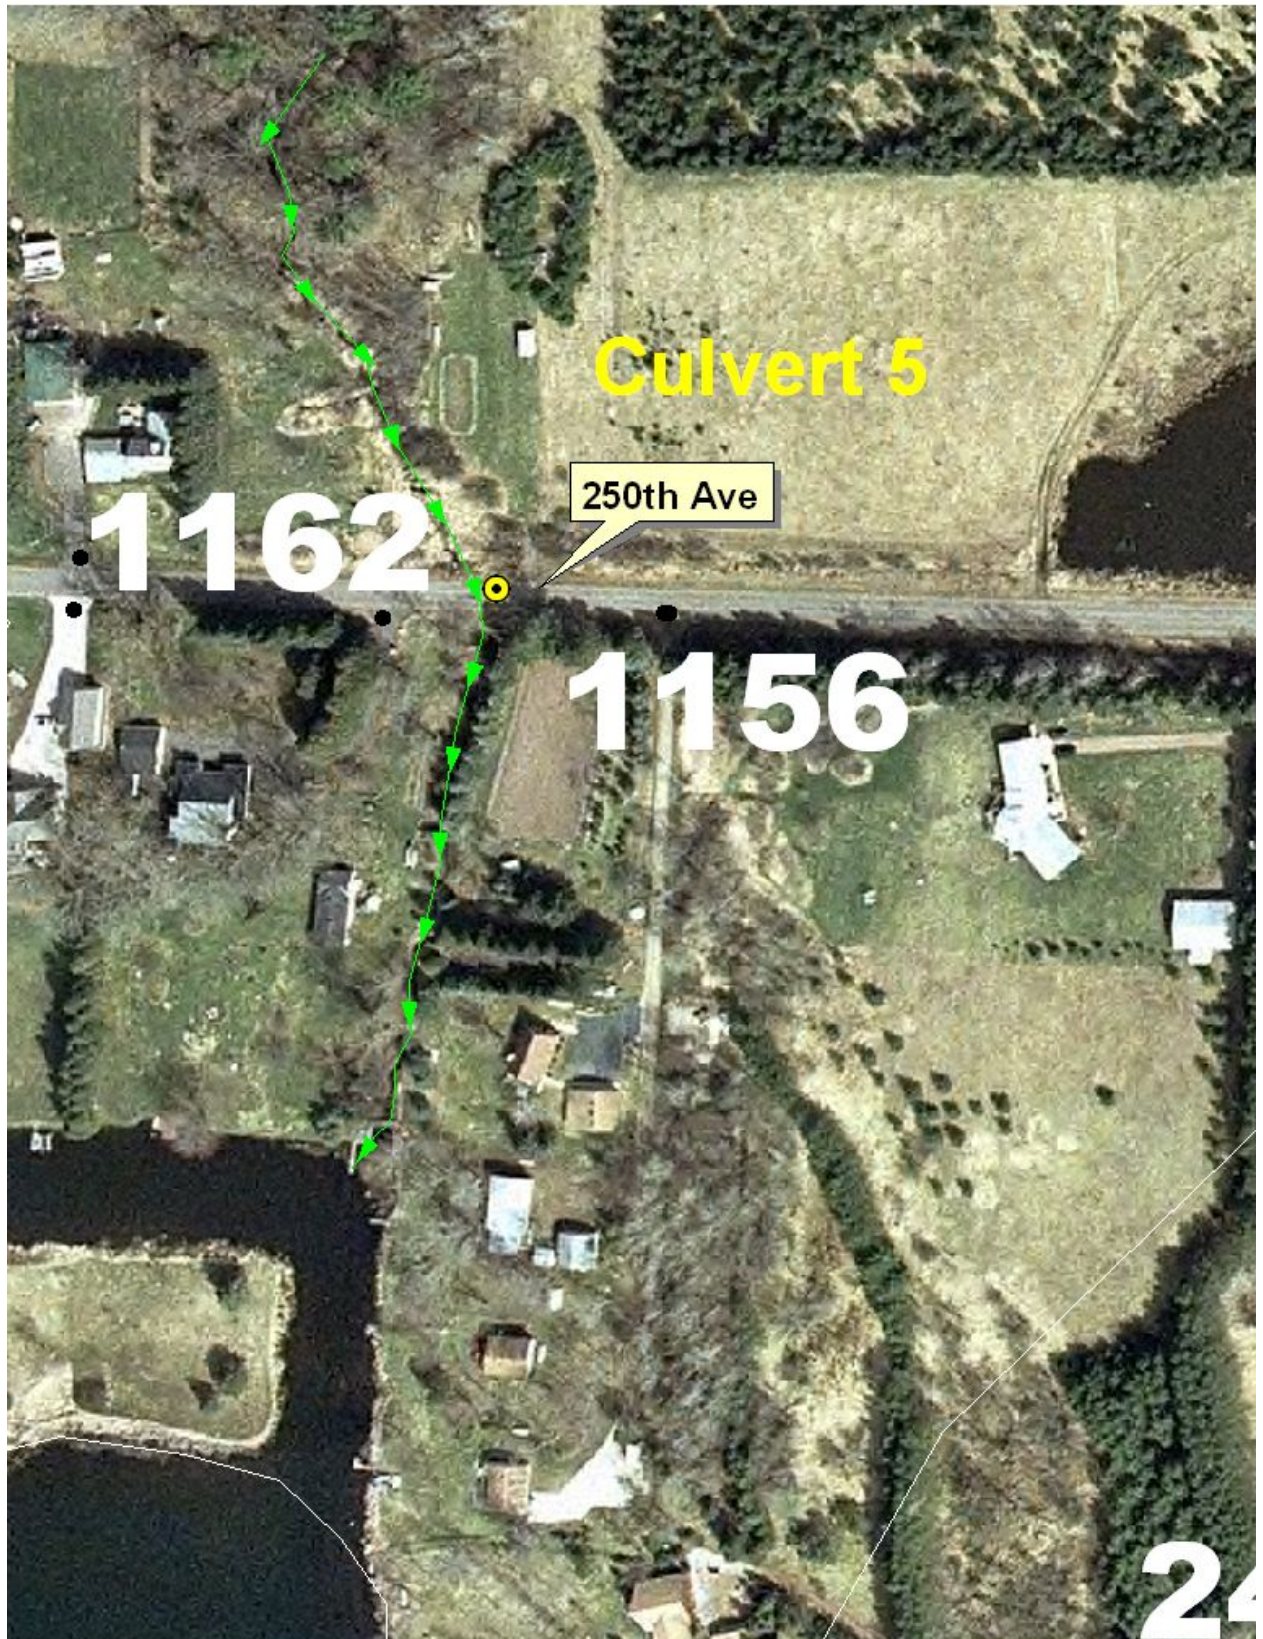
Figure 5. Culvert 5 drainage

Culvert 5 This is only the portion of the Station 1 NW watershed that flows to the Lagoon. High flows were reported by residents and streambank erosion is evident below this culvert.

A pond designed to capture water from this watershed is estimated to reduce 7 kg of phosphorus annually at a cost of \$25,000. This is the best potential for a high level of phosphorus reduction identified to date. The owner is willing to install the practice. However, DNR permitting and grant staff are concerned about placement of the pond in an existing wetland and the impact of the practice for phosphorus reduction.

The owner along the streambank below culvert 5 is willing to consider efforts for stream stabilization. Polk County LWRD is authorized to proceed with a survey of this area and to propose solutions for erosion.

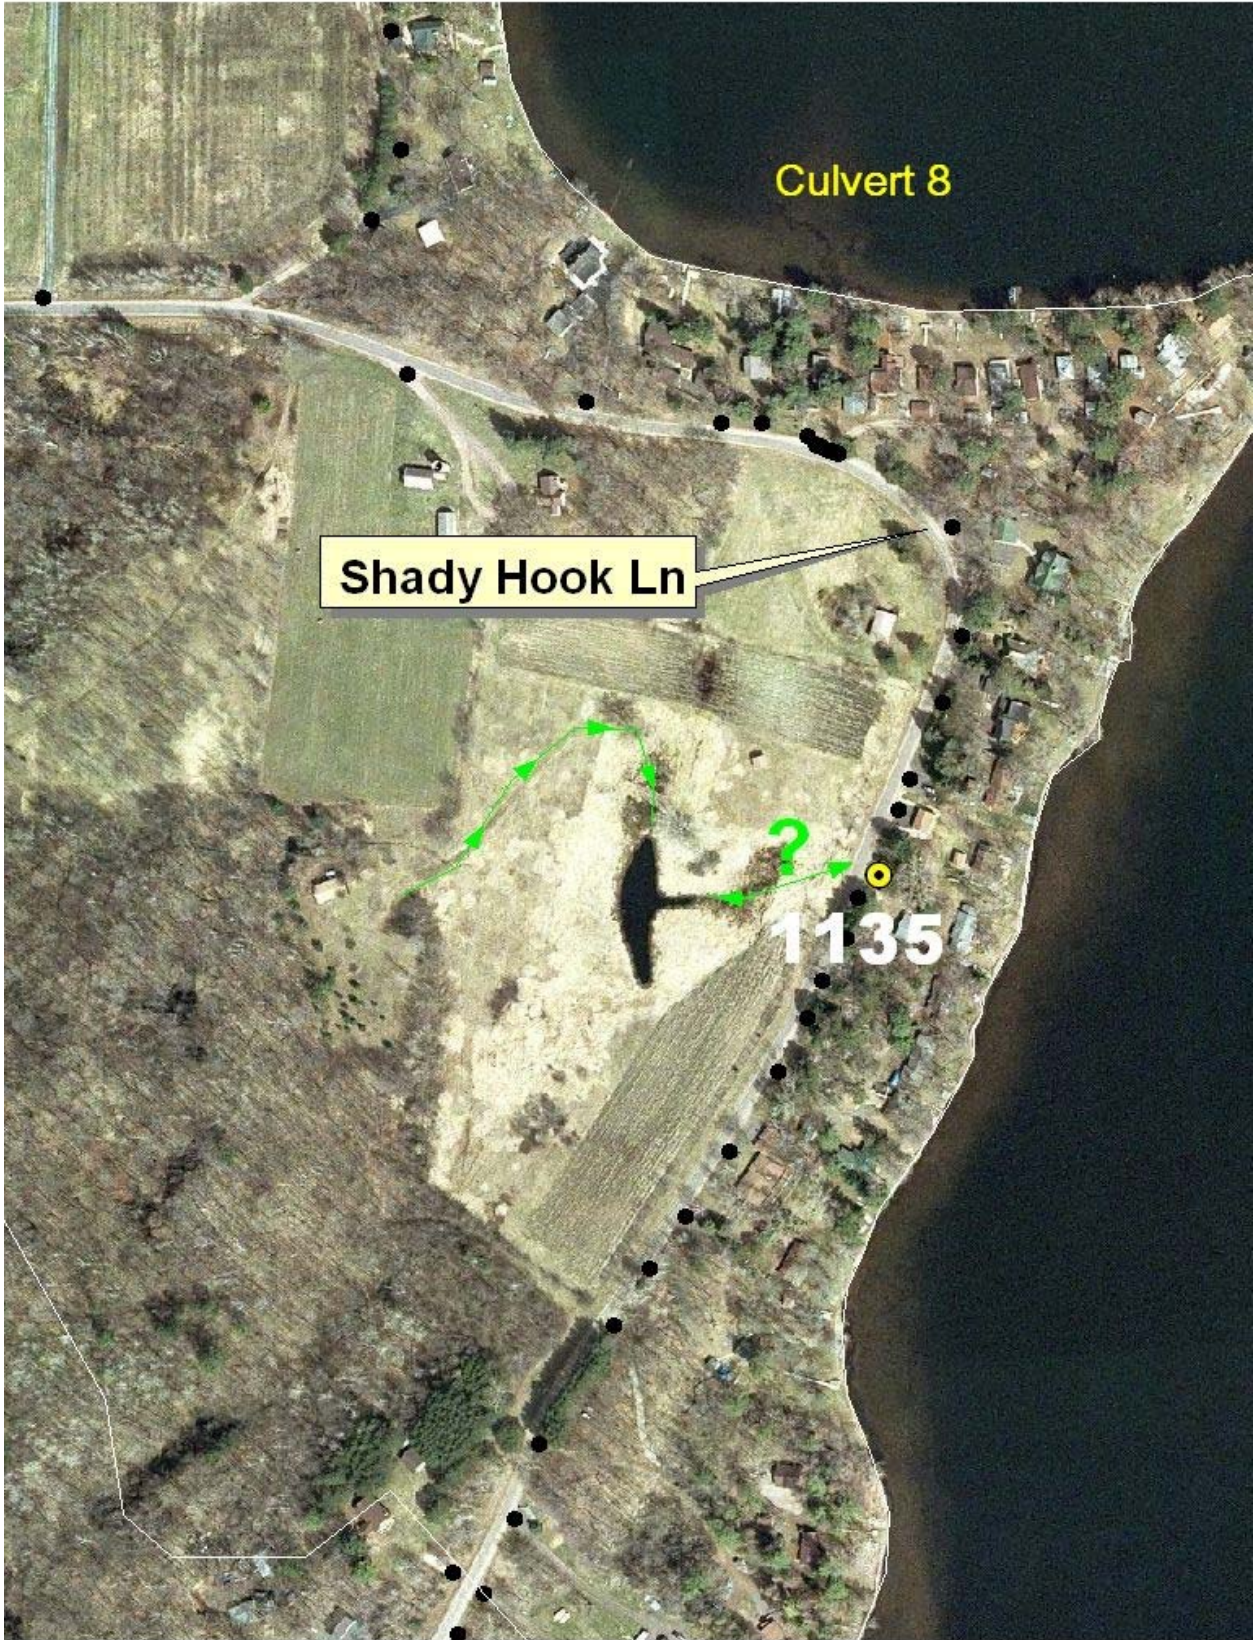
Figure 8. Culvert 8 flow

Culvert 8 Crop field and farmstead (may not be active, check with owner) are very close to the culvert. Working with this farm should be a priority. Channelized flow comes from a wetland area which will present challenges for practice installation.
