# Three Lakes Chain

Oneida County, Wisconsin

## Phases I – IV Comprehensive Management Plan

April 2016

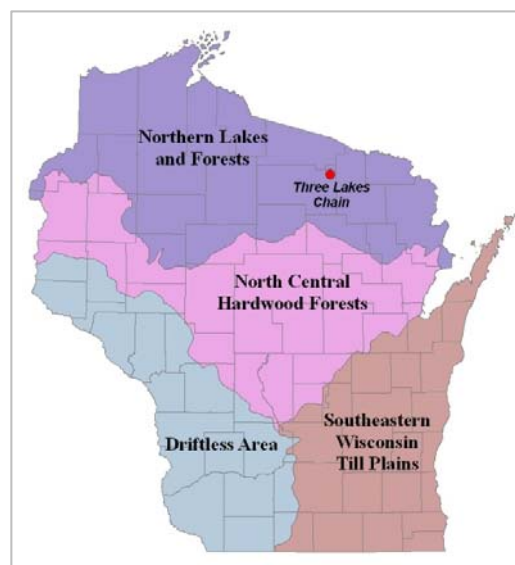
**Figure 3.1-2. Location of Three Lakes Chain within the ecoregions of Wisconsin.** After Nichols 1999.

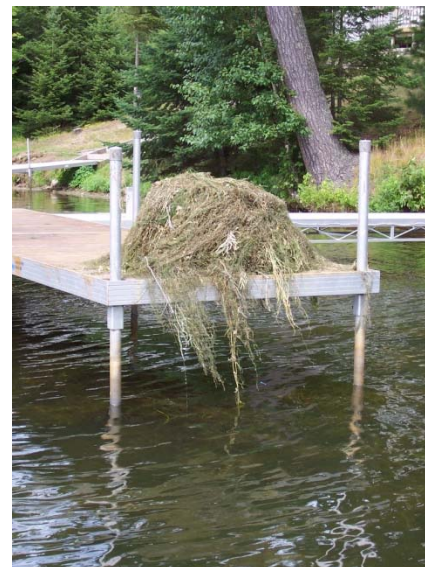
Manual removal methods include hand-pulling, raking, and hand-cutting. Hand-pulling involves the manual removal of whole plants, including roots, from the area of concern and disposing them out of the waterbody. Raking entails the removal of partial and whole plants from the lake by dragging a rake with a rope tied to it through plant beds. Specially designed rakes are available from commercial sources or an asphalt rake can be used. Hand-cutting differs from the other two manual methods because the entire plant is not removed, rather the plants are cut similar to mowing a lawn; however Wisconsin law states that all plant fragments must be removed. One manual cutting technique involves throwing a specialized “V” shaped cutter into the plant bed and retrieving it with a rope. The raking method entails the use of a two-sided straight blade on a telescoping pole that is swiped back and forth at the base of the undesired plants.

In addition to the hand-cutting methods described above, powered cutters are now available for mounting on boats. Some are mounted in a similar fashion to electric trolling motors and offer a 4-foot cutting width, while larger models require complicated mounting procedures, but offer an 8-foot cutting width. Please note that the use of powered cutters may require a mechanical harvesting permit to be issued by the WDNR.

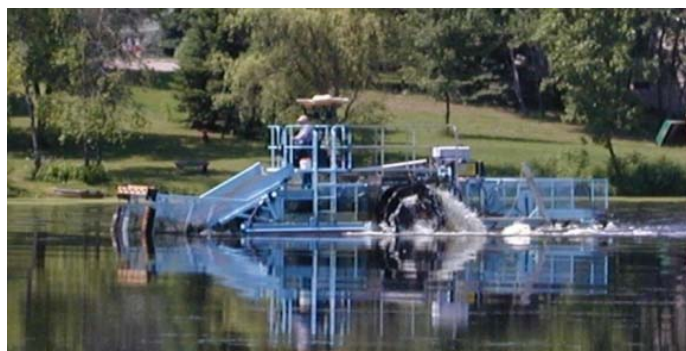
Aquatic plant harvesting is frequently used in Wisconsin and involves the cutting and removal of plants much like mowing and bagging a lawn. Harvesters are produced in many sizes that can cut to depths ranging from 3 to 6 feet with cutting widths of 4 to 10 feet. Plant harvesting speeds vary with the size of the harvester, density and types of plants, and the distance to the off-loading area. Equipment requirements do not end with the harvester. In addition to the harvester, a shore-conveyor would be required to transfer plant material from the harvester to a dump truck for transport to a landfill or compost site. Furthermore, if off-loading sites are limited and/or the lake is large, a transport barge may be needed to move the harvested plants from the harvester to the shore in order to cut back on the time that the harvester spends traveling to the shore conveyor. Some lake organizations contract to have nuisance plants harvested, while others choose to purchase their own equipment. If the latter route is chosen, it is especially important for the lake group to be very organized and realize that there is a great deal of work and expense involved with the purchase, operation, maintenance, and storage of an aquatic plant harvester. In either case, planning is very important to minimize environmental effects and maximize benefits.

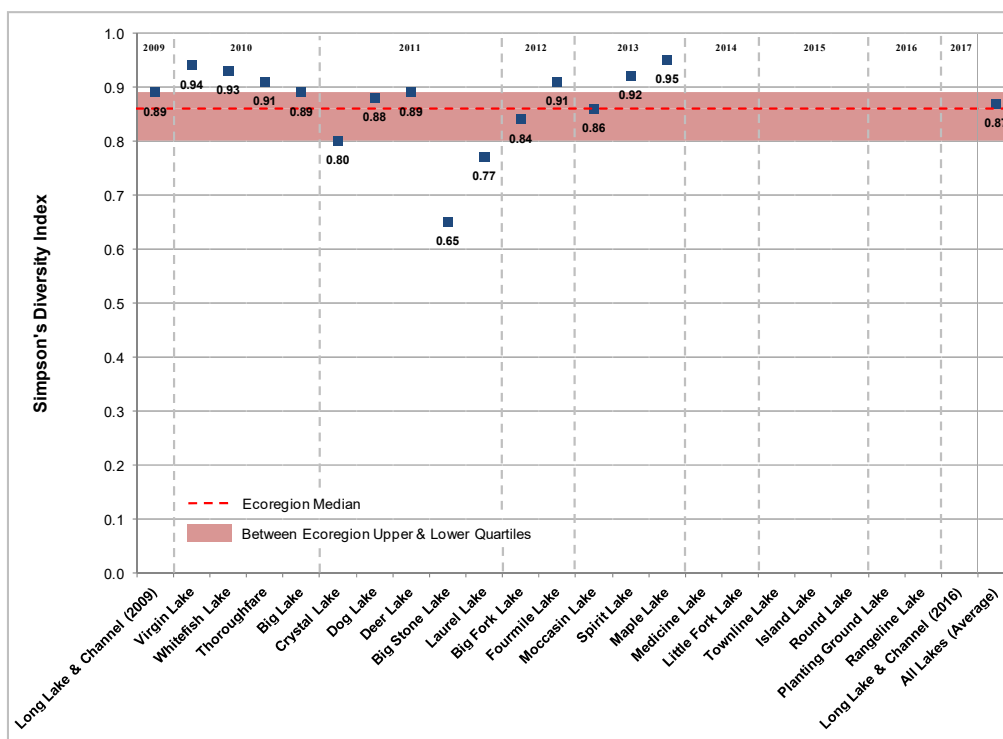
**Figure 3.4-6 Three Lakes Chain species diversity index.** Created using data from summer point-intercept surveys. Ecoregion data provided by WDNR Science Services.

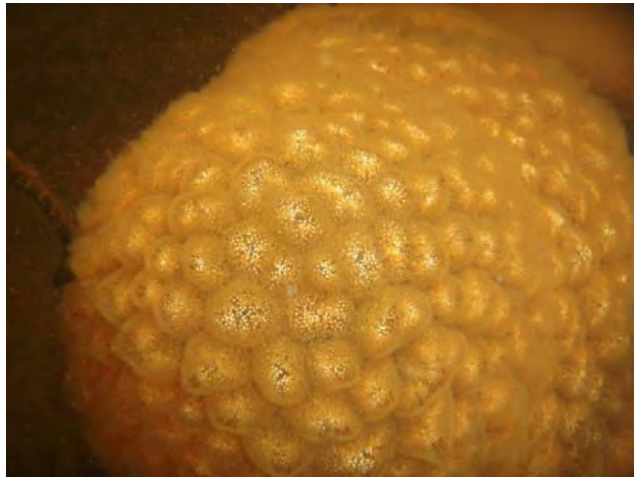
*Many species observed during aquatic plant surveys. Several bryozoans (aquatic invertebrates consisting of colonies of microscopic organisms called “zooids” – pictured to the right), some relatively large in size, spotted as well.*

**Photo 8.1 Bryozoan from Virgin Lake, Oneida County**

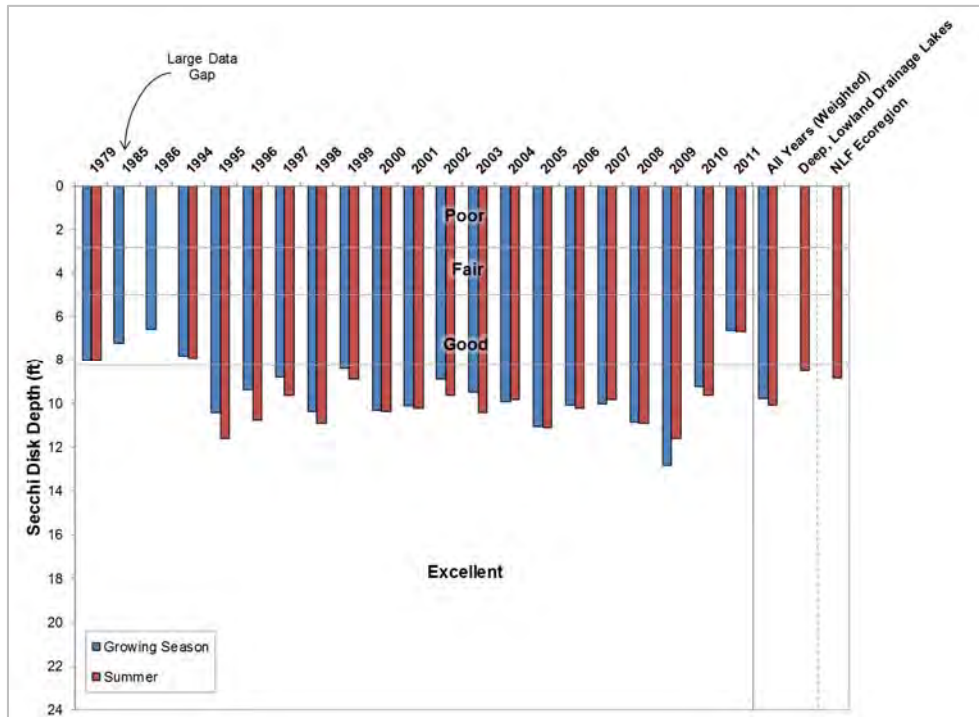
**Figure 8.1.1-1. Virgin Lake, state-wide deep, lowland drainage lakes, and regional Secchi disk clarity values.** Mean values calculated with summer and growing season surface sample data. Water Quality Index values adapted from WDNR 2013.

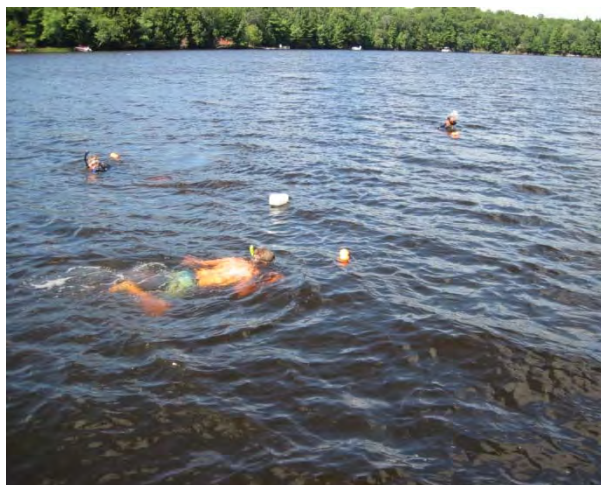
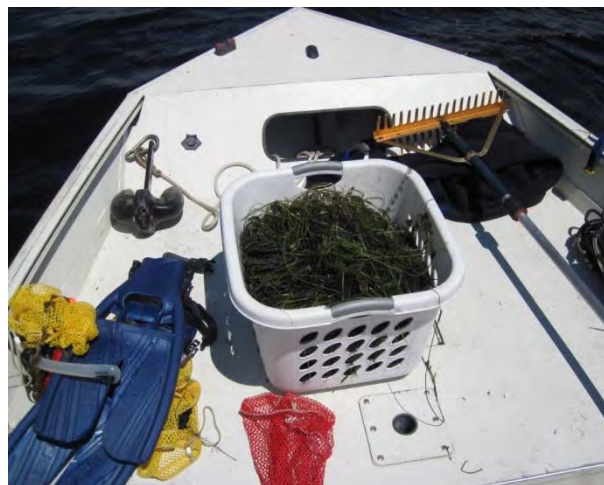
Following reports from TLWA members that more Eurasian water milfoil existed within the previously marked colony, Onterra staff members revisited the lake on September 8<sup>th</sup> to conduct plant removal again. This time, three staff slipped on donned snorkeling gear while a fourth staff

member emptied mesh bags and scooped plant fragments from the surface with a pool skimmer on an extendable pole. About 35 plants were pulled during this time, though stained water was again an issue the snorkelers faced and some single plants were likely left behind.

**Photo 8.1.4-1 a) Virgin Lake Eurasian water milfoil hand harvesting, and b) Hand harvesting results.** Hand harvesting occurred in July and September of 2011.

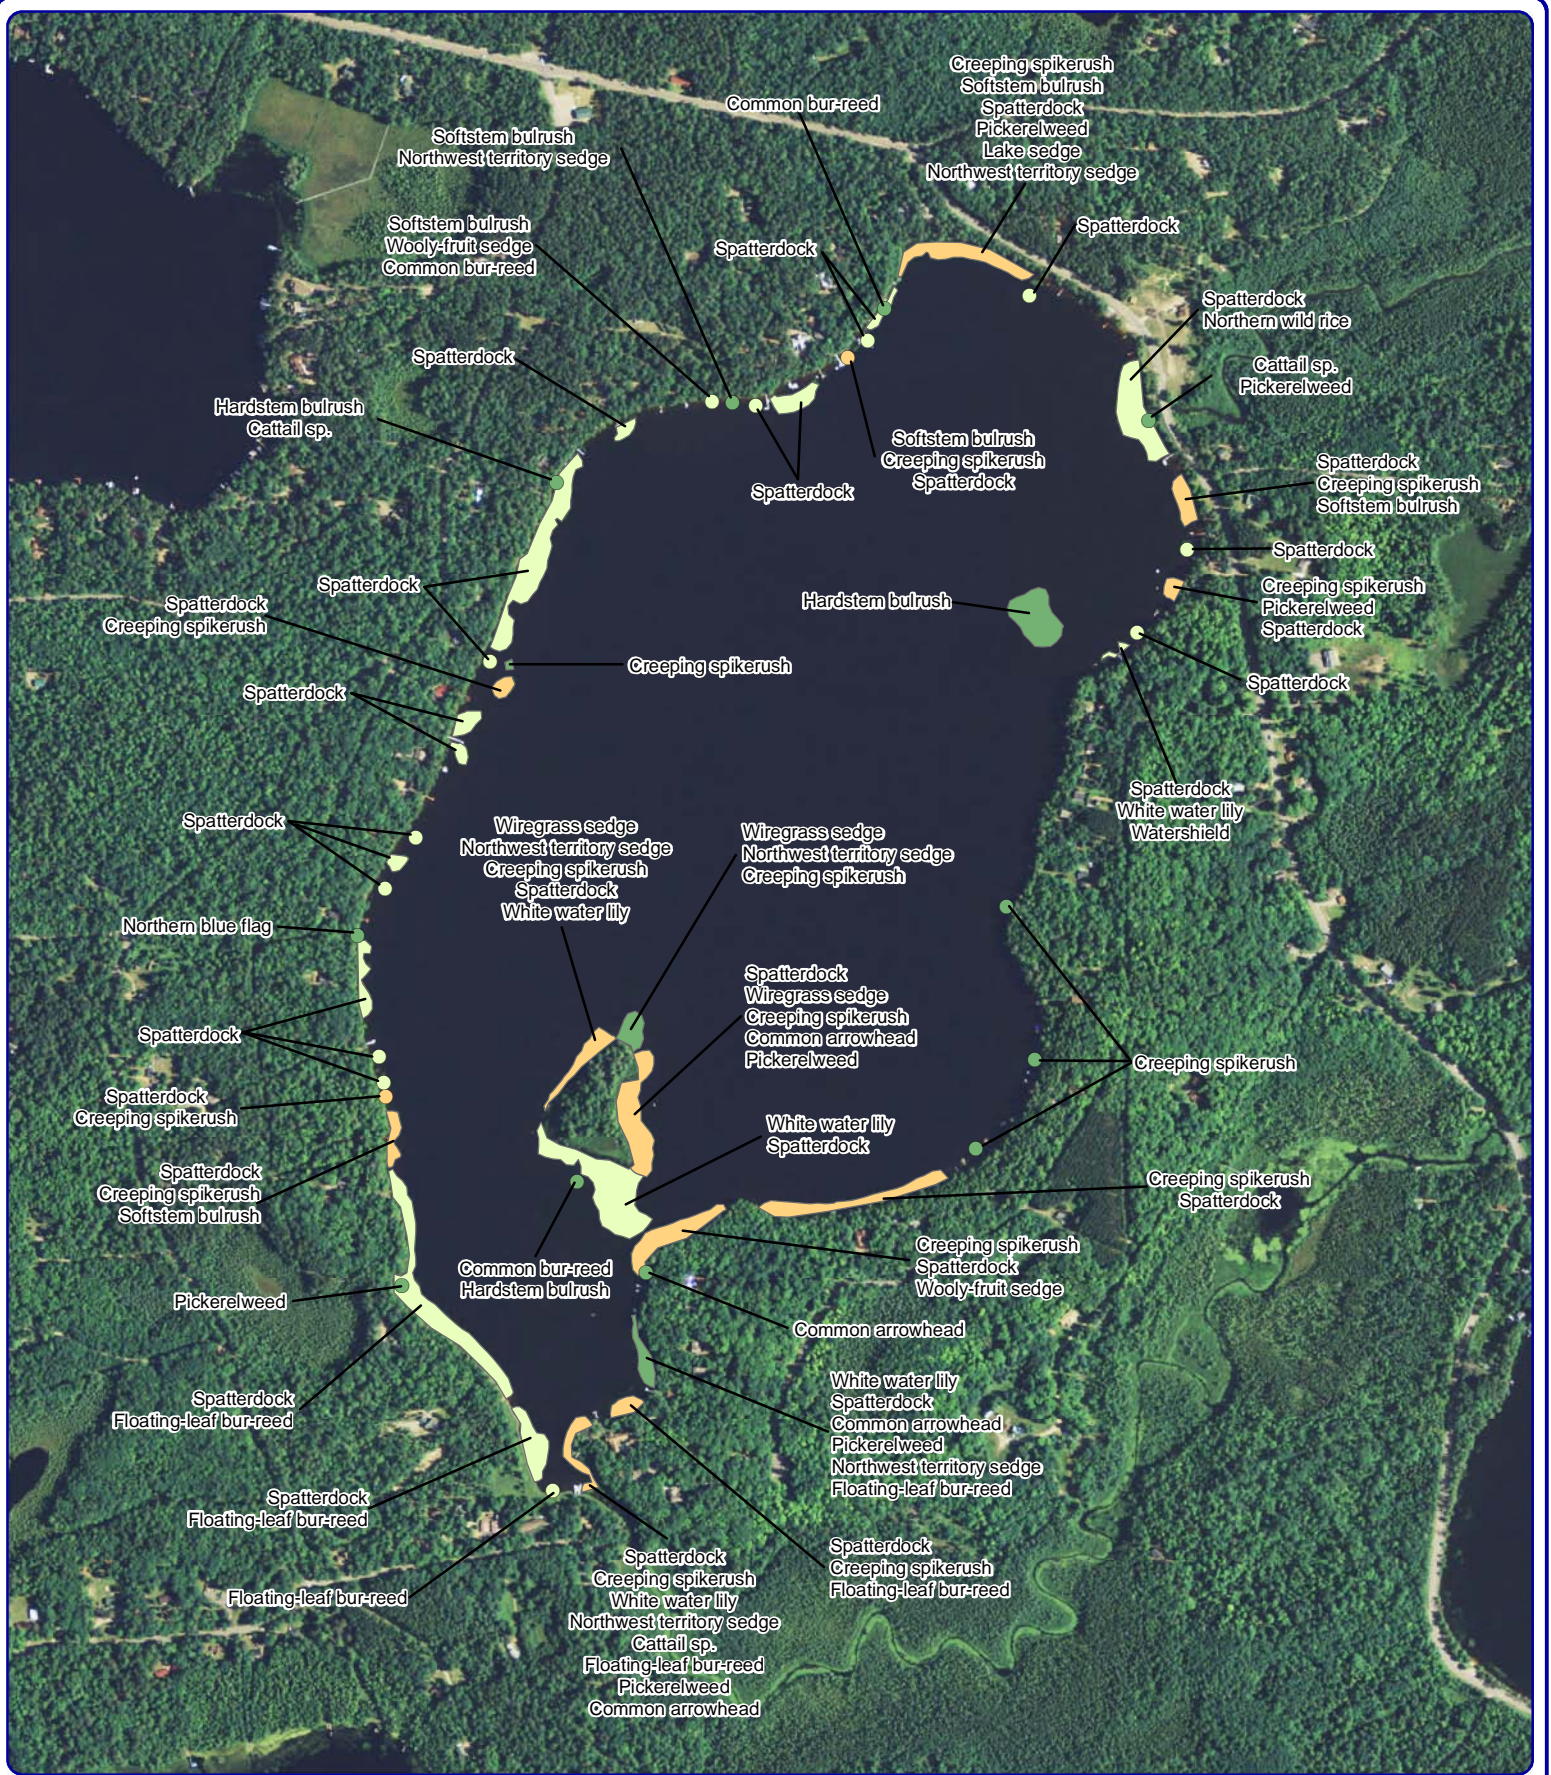
Virgin Lake - Map 2  
 Three Lakes Chain  
 Oneida County, Wisconsin  
**2014 Coarse  
 Woody Habitat**

Sources:  
 Aquatic Plants: Onterra, 2010  
 Orthophotography: NAIP, 2010  
 Map Date: March 7, 2012  
 File Name: Virgin\_Comm\_2010.mxd

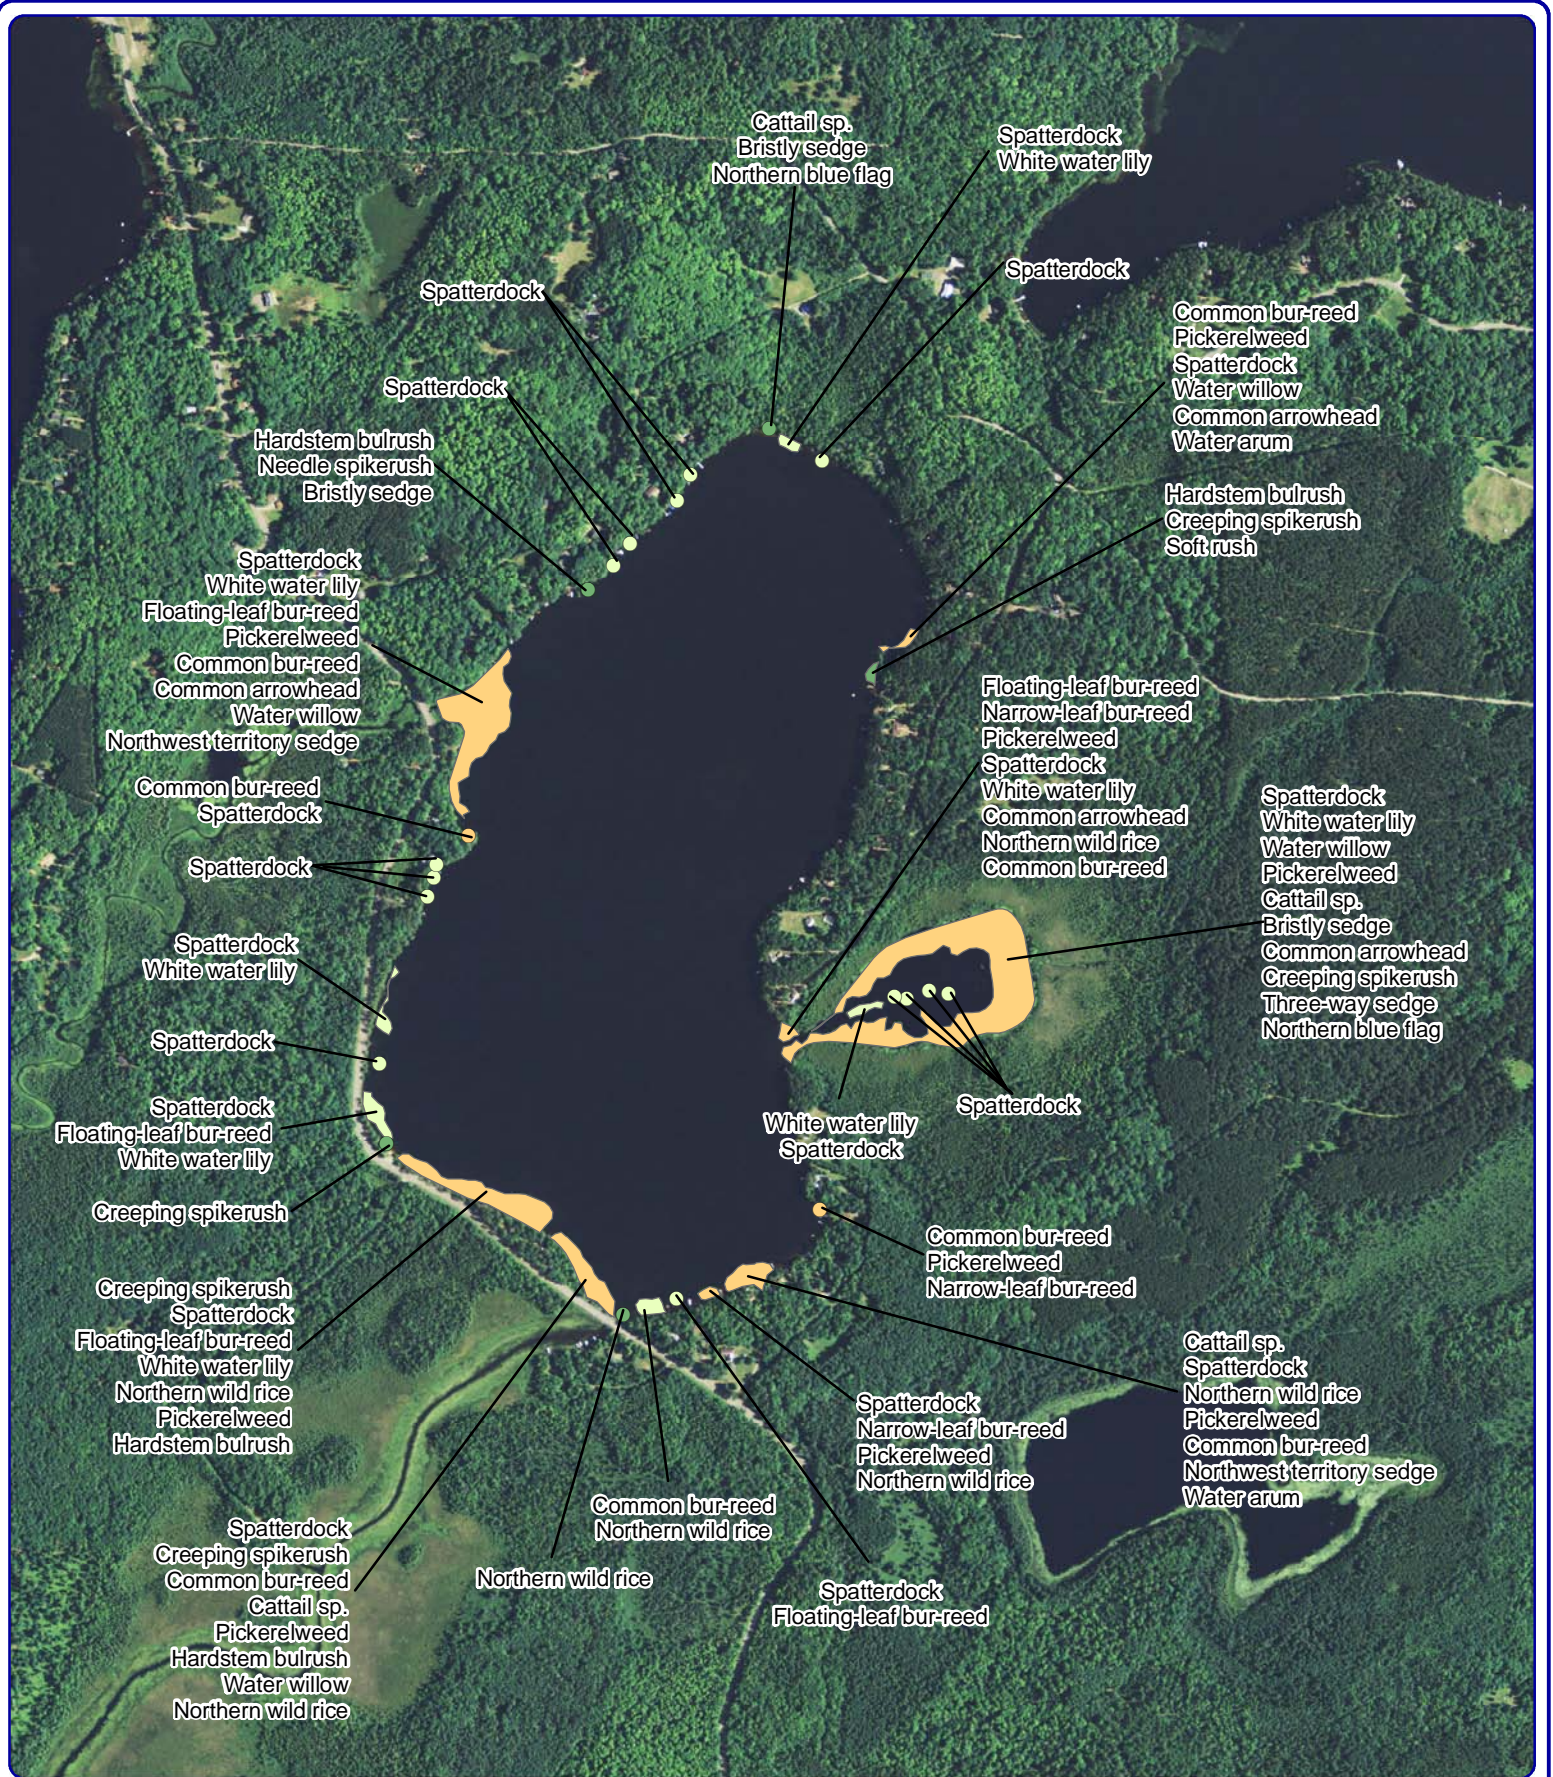
Sources:  
 Aquatic Plants: Onterra, 2010  
 Orthophotography: NAIP, 2010  
 Map Date: March 7, 2012  
 File Name: Whitefish\_Comm\_2010.mxd

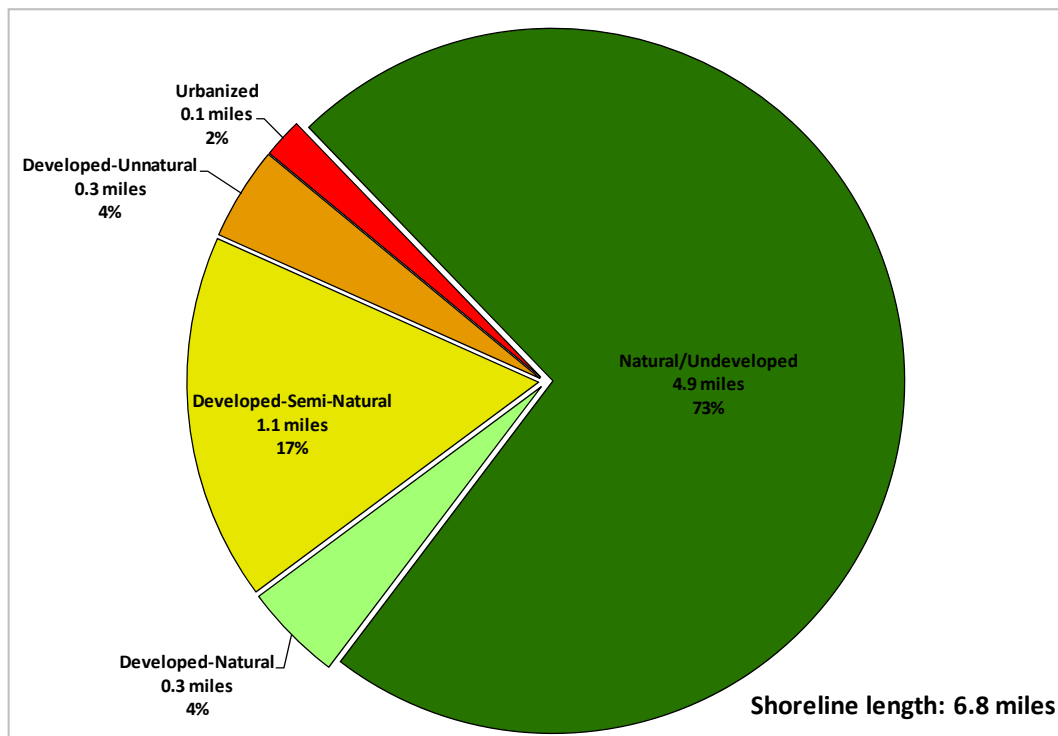
**Figure 8.3.3-1. The Thoroughfare shoreland categories and total lengths.** Based upon a late summer 2010 survey. Locations of these categorized shorelands can be found on the Thoroughfare Map 1.

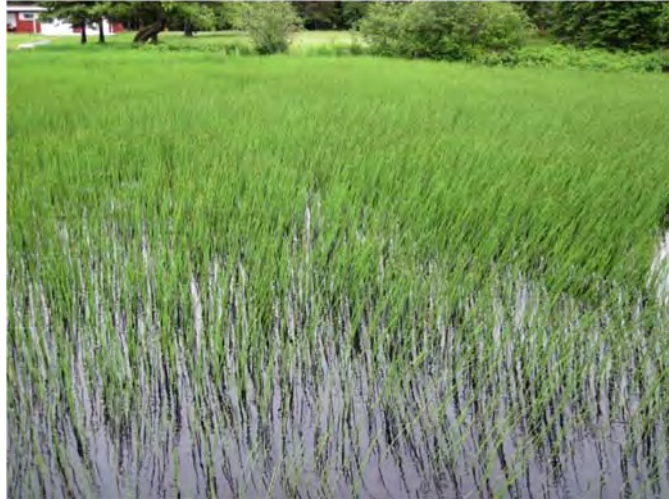
Photo 8.5.1 Dog Lake, Oneida County

Unusually large community of water horsetail (*Equisetum fluviatile*) encountered during aquatic plant surveys (pictured at right).

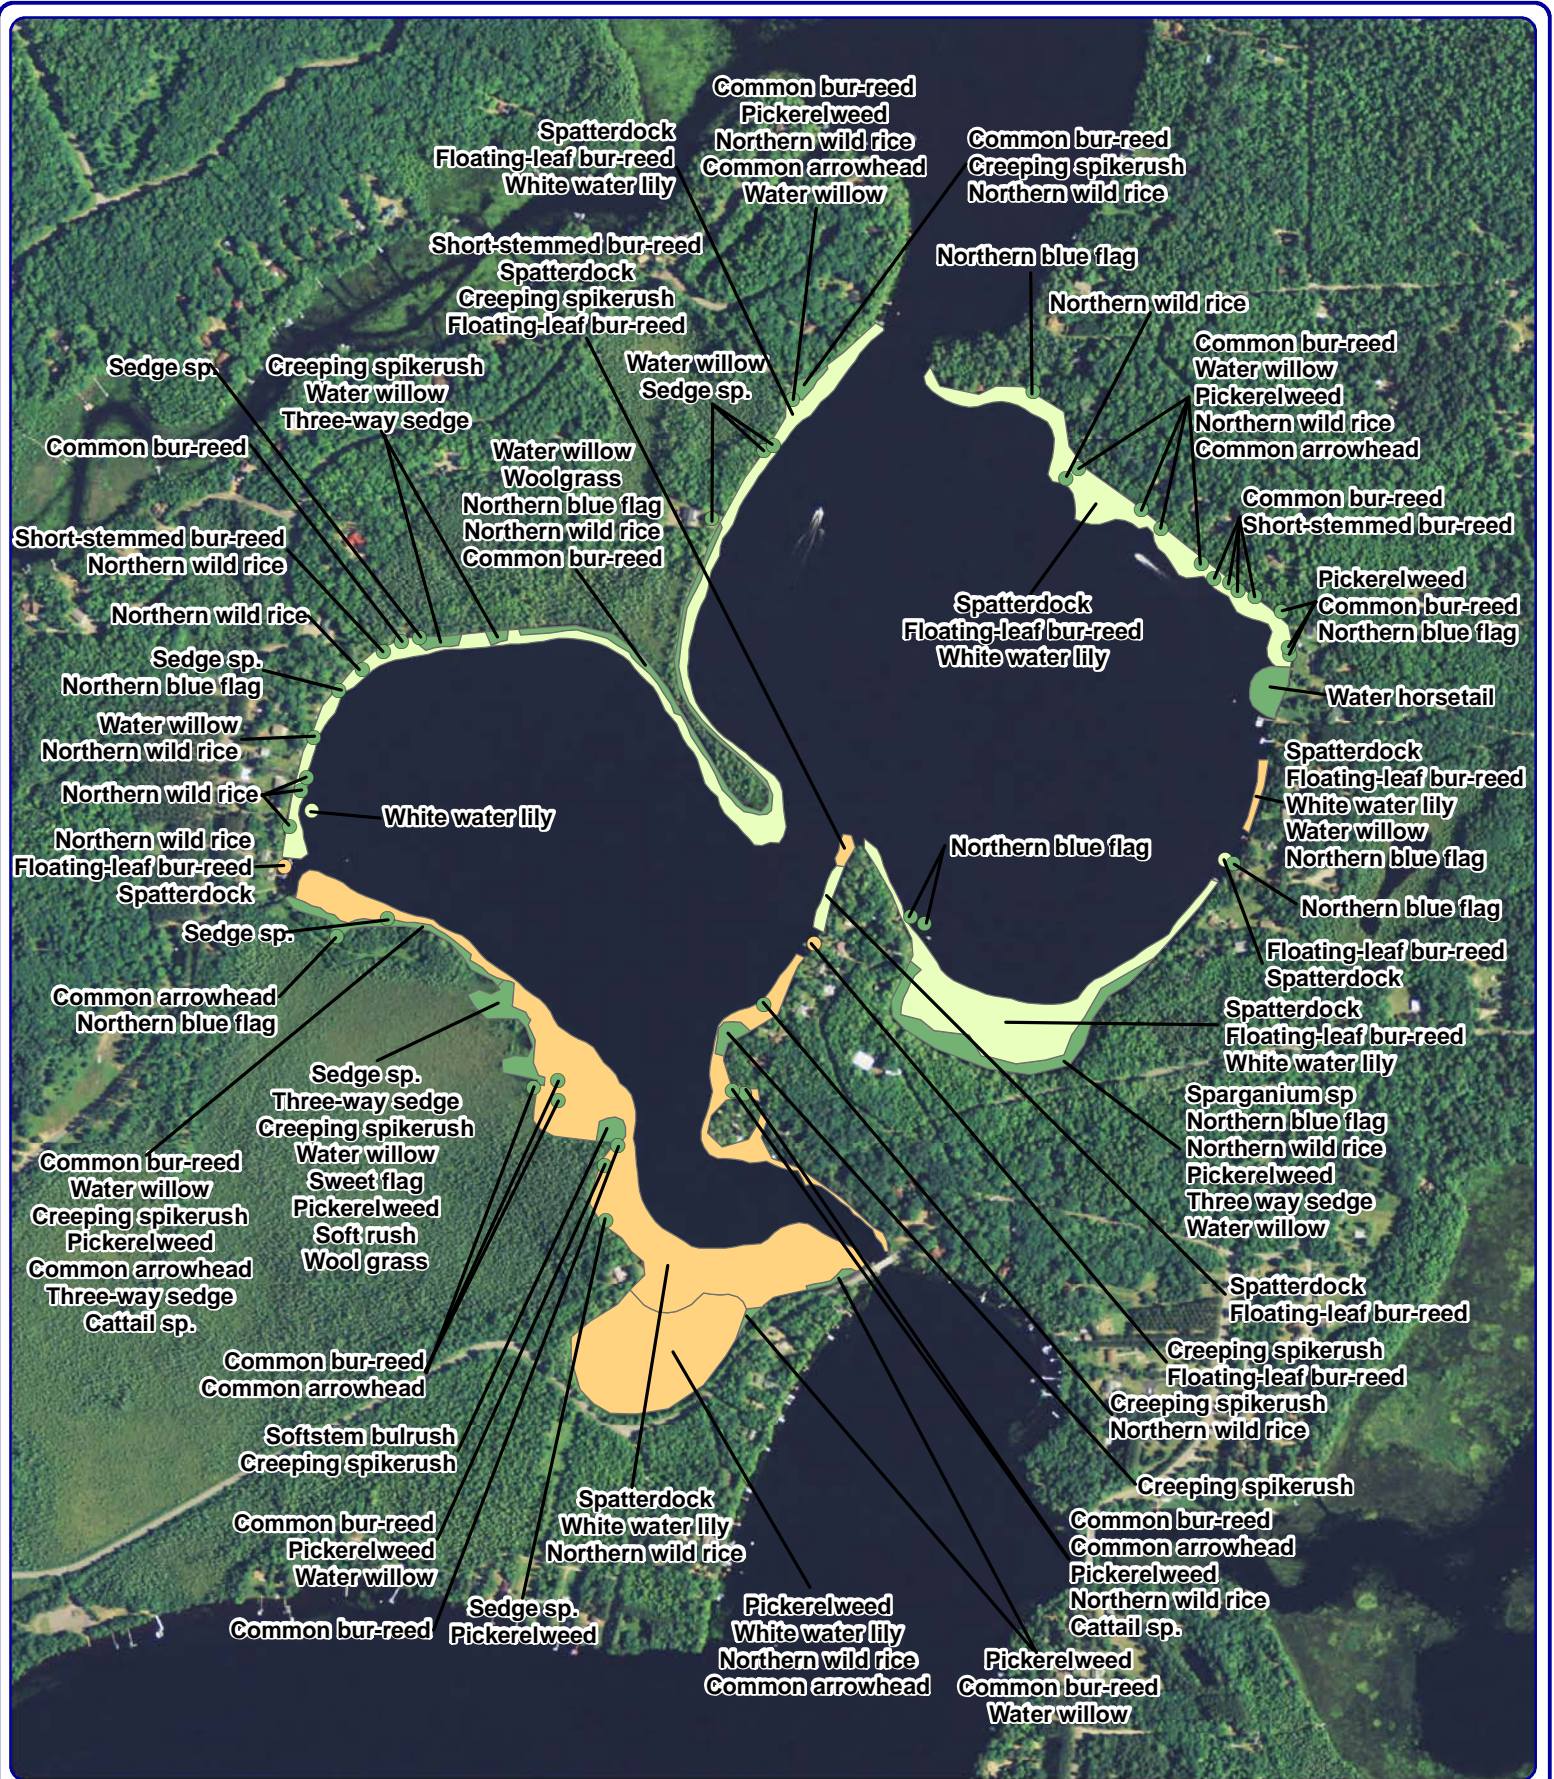
**Dog Lake - Map 2**  
**Three Lakes Chain**  
 Oneida County, Wisconsin  
**2014 Coarse**  
**Woody Habitat**

- No Branches
- Minimal Branches (none)
- Moderate Branches (none)
- Full Canopy (none)

During this survey, a total of 63 pieces of coarse woody habitat were observed along 3.7 miles of shoreline, which gives Dog Lake a coarse woody habitat to shoreline mile ratio of 17:1. Trees falling into the lake are natural and are an important component of lake ecology, providing valuable structural habitat for fish and other wildlife. Fallen trees should be left in place unless they impact access to the lake or recreational safety. Locations of coarse woody habitat are displayed on Dog Lake Map 2.

**Figure 8.5.3-2. Dog Lake coarse woody habitat survey results.** Based upon a Fall 2014 survey. Locations of Dog Lake coarse woody habitat can be found on Dog Lake Map 2.

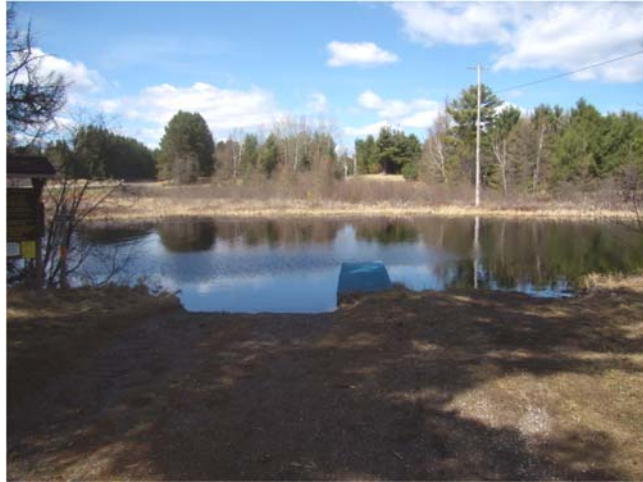
Photo 8.6.1 Crystal (Mud) Lake, Oneida County

*A shallow, dark lake consisting primarily of mucky substrate. Few sampling locations held aquatic plants. No exotic aquatic plant species observed during 2011 field work.*

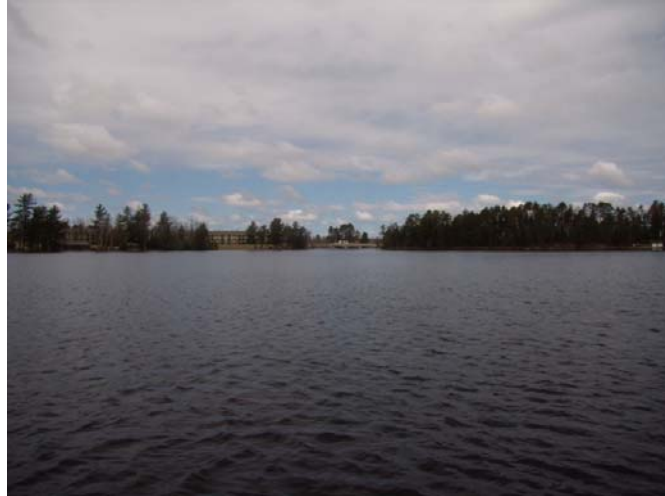
Photo 8.7.1 Deer Lake, Oneida County

*Navigation tricky on west side of lake, where shallow water and thick floating-leaf aquatic plants were commonly encountered. Dark, stained water observed during surveys.*

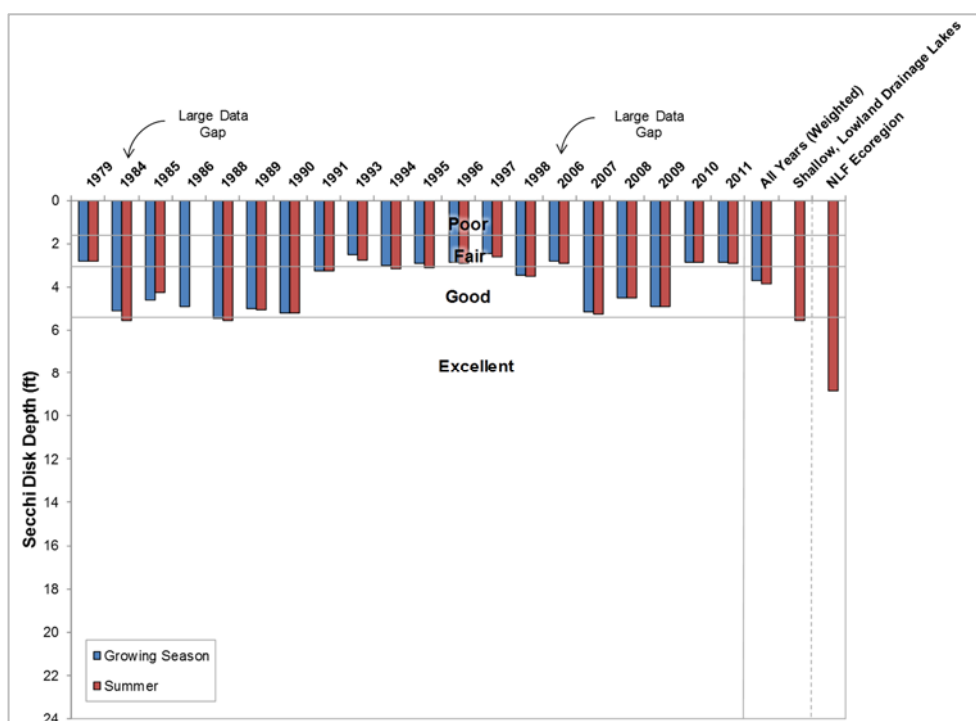
**Figure 8.7.1-2. Deer Lake, state-wide shallow, lowland drainage lakes, and regional Secchi disk clarity values.** Mean values calculated with summer and growing season surface sample data. Water Quality Index values adapted from WDNR 2013.

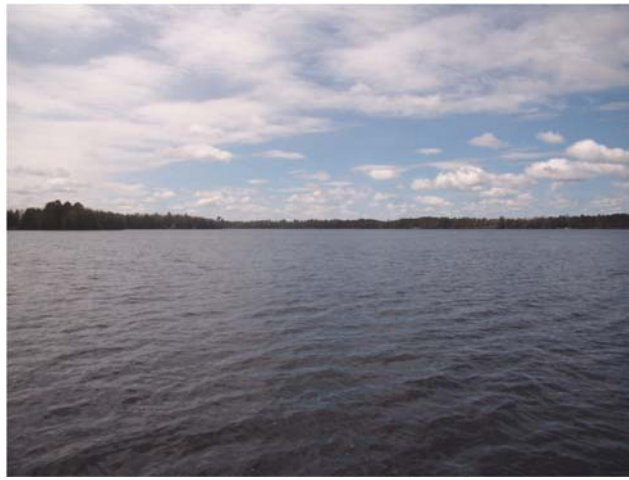
Photo 8.8.1 Big Stone Lake, Oneida County

*Much purple loosestrife observed in the southeastern wetland area of lake. Another colony spotted near Hwy 32.*

*Lake is quite deep. The littoral region is dominated by a sandy substrate. Primary plant species appears to be wild celery. Much unnatural shoreline observed during surveys.*

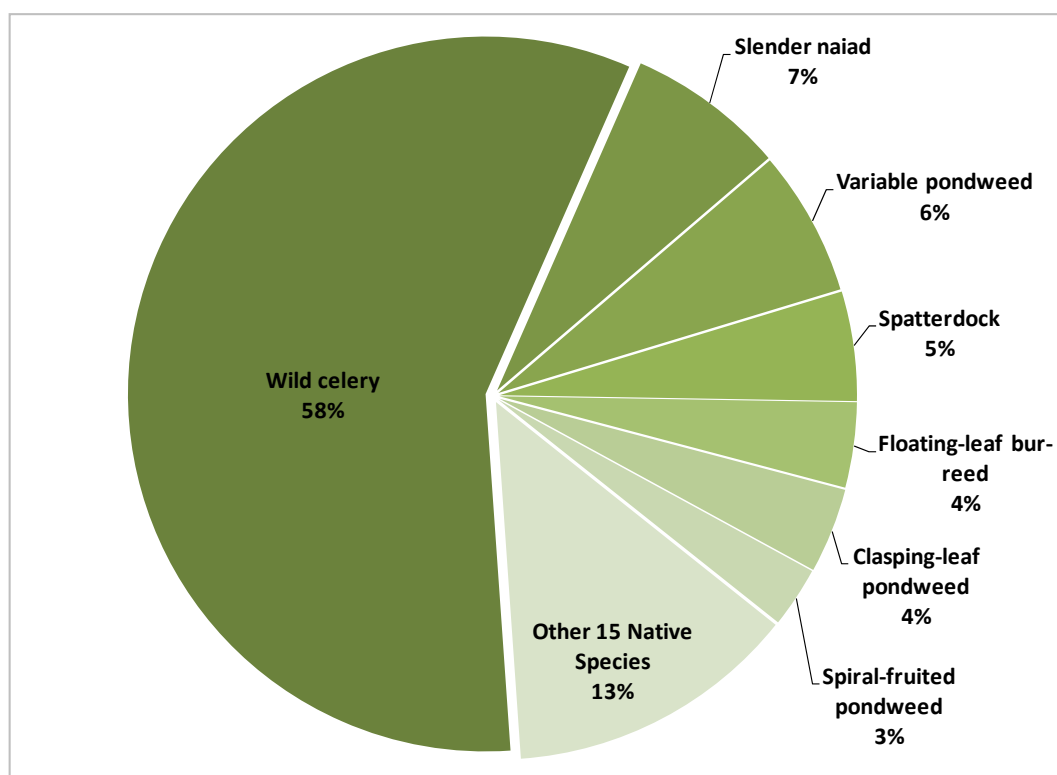
**Figure 8.8.4-2 Big Stone Lake aquatic plant relative frequency of occurrence analysis.**  
Created using data from 2011 point-intercept survey.

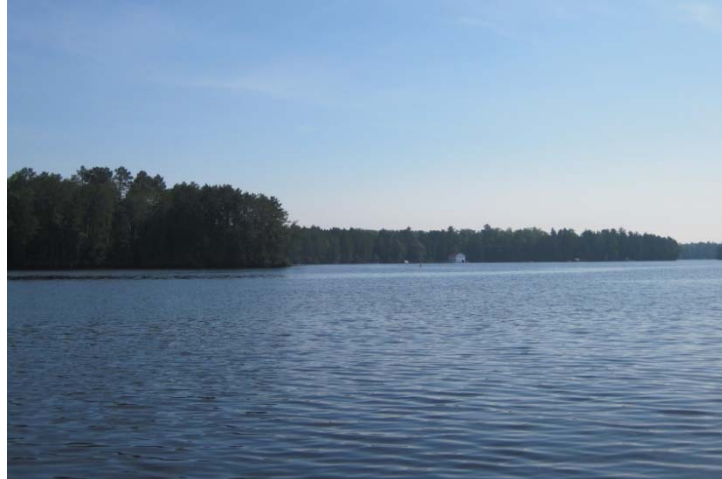
Photo 8.9.1 Laurel Lake, Oneida County

*Many emergent and floating-leaf plants as well as islands located in north-eastern section of lake – very diverse habitat, great for wildlife!*

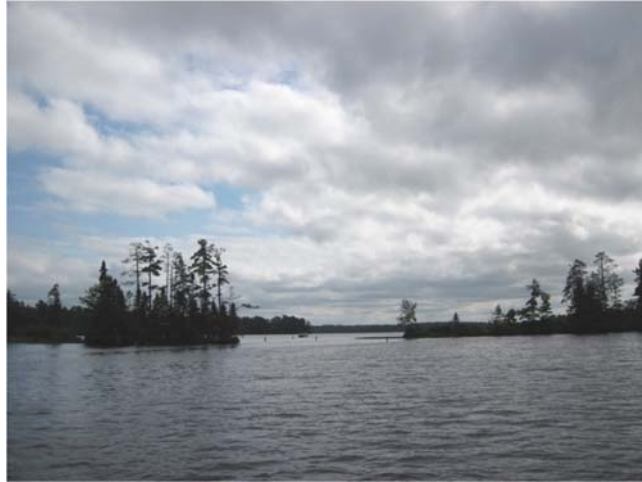
Photo 8.10.1-1 Fourmile Lake, Oneida County

*Abundant wild rice observed during aquatic plant surveys. Lake has much natural shoreline surrounding it – great wildlife habitat! Pale yellow iris spotted several times during the early season AIS survey.*

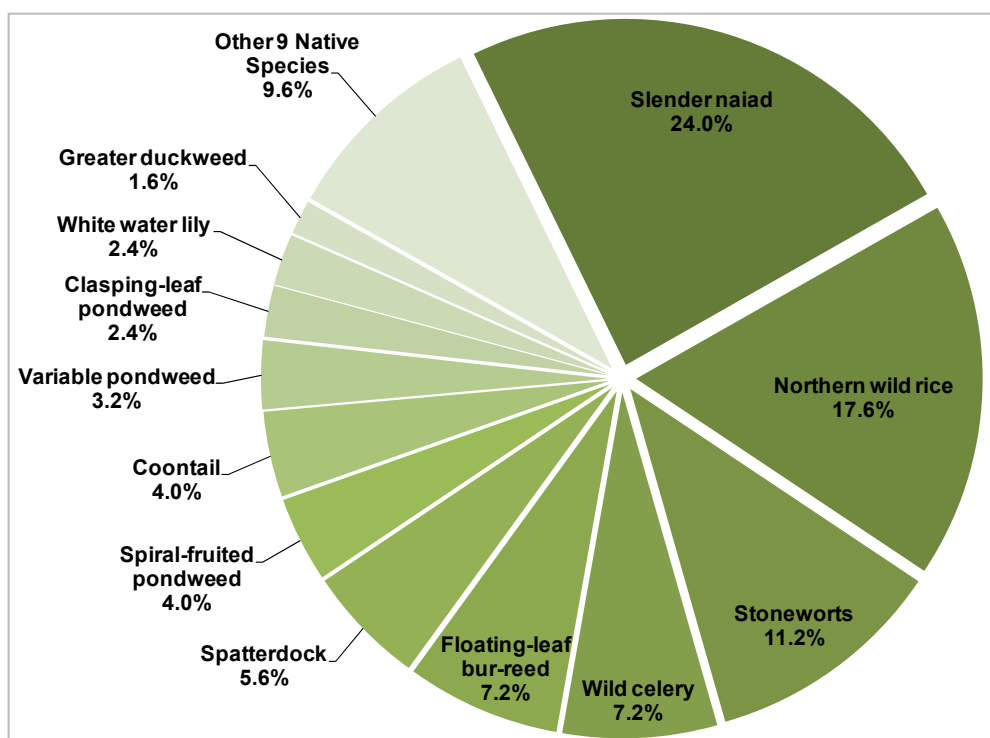
**Figure 8.10.4-2 Fourmile Lake aquatic plant relative frequency of occurrence analysis.**  
Created using data from 2012 point-intercept survey.

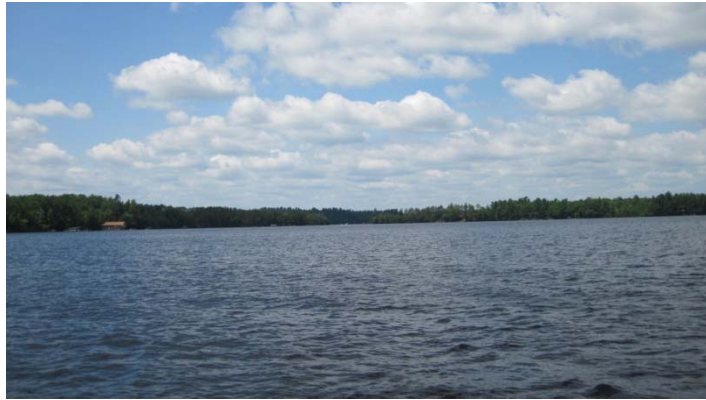
Photo 8.11.1-1 Big Fork Lake, Oneida County

*A fair amount of development observed on the lake. Vasey's pondweed found in two point-intercept locations. Shoreline was dotted with much pale yellow iris during early-season AIS survey.*

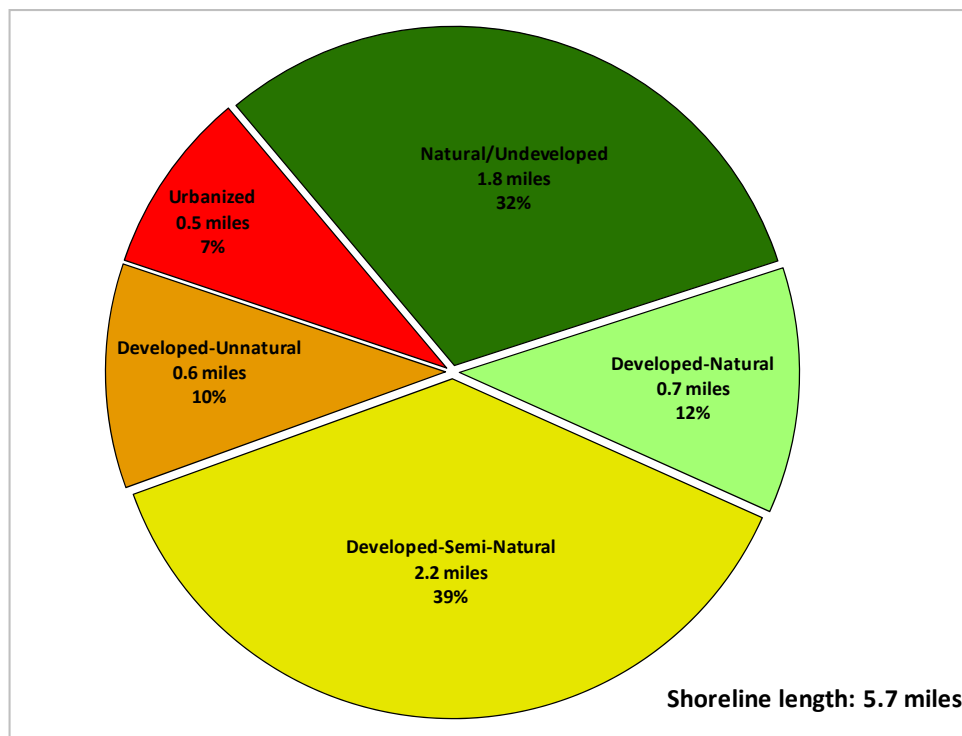
**Figure 8.11.3-1. Big Fork Lake shoreland categories and total lengths.** Based upon a late summer 2012 survey. Locations of these categorized shorelands can be found on Big Fork Lake Map 1.

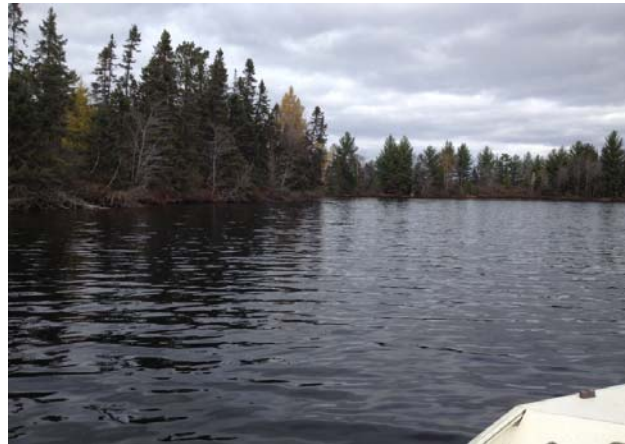
Photo 8.12.1-1 Moccasin Lake, Oneida County

*Pink water lily observed in one location of the lake.*

*Connecting waters from Moccasin to Spirit Lake were low in the late summer, but still navigable for smaller watercraft.*

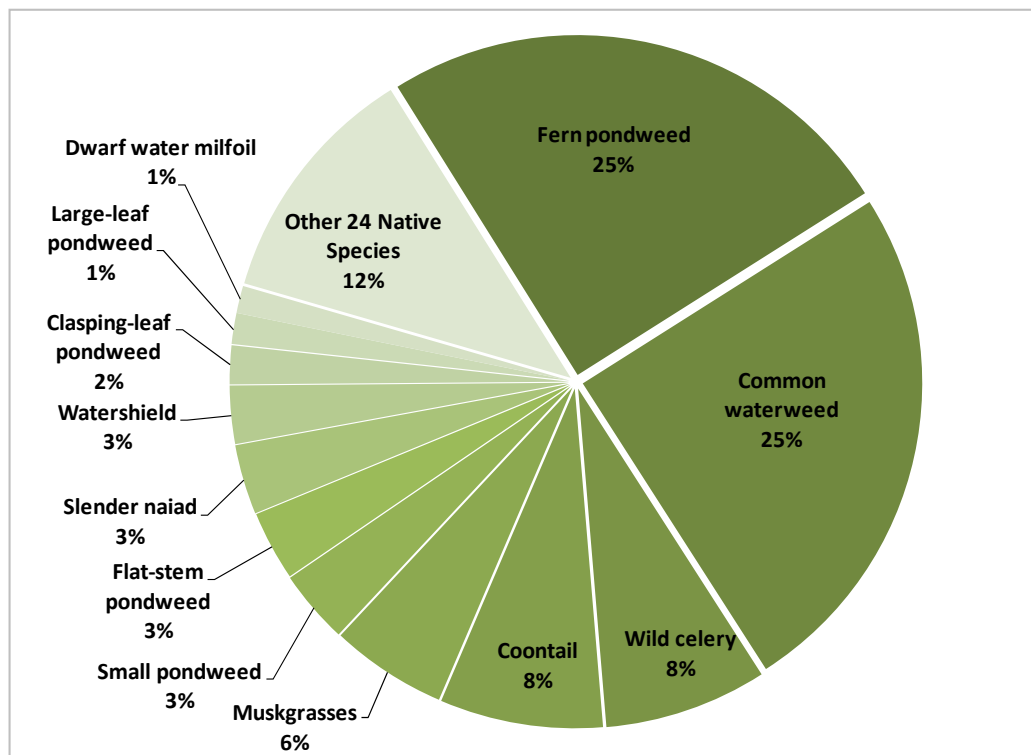
**Figure 8.12.4-2 Moccasin Lake aquatic plant relative frequency of occurrence analysis.**  
Created using data from 2013 point-intercept survey.

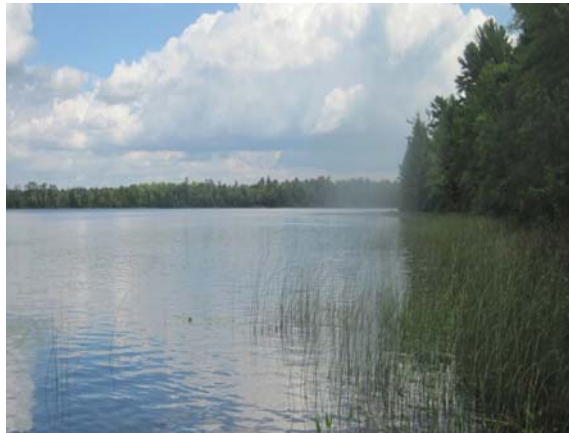
Photo 8.13.1-1 Spirit Lake, Oneida County

*Incredible diversity of native aquatic plants species found during the comprehensive plant surveys. A large amount of the shoreline is undeveloped.*

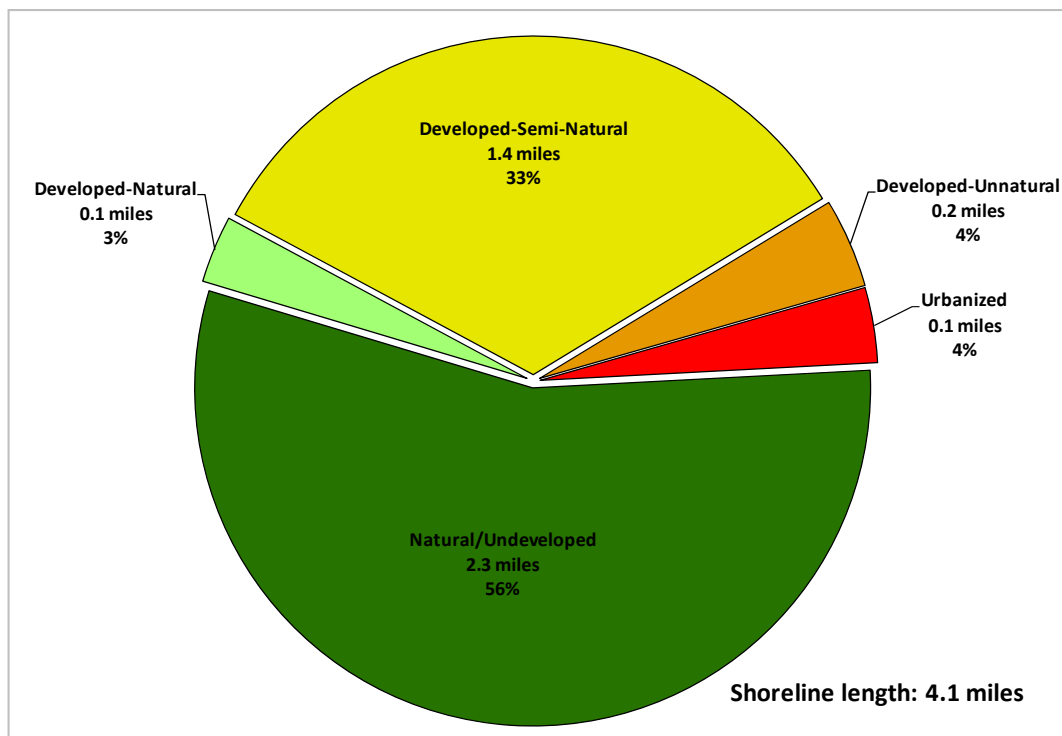
**Figure 8.13.3-1. Spirit Lake shoreland categories and total lengths.** Based upon a fall 2013 survey. Locations of these categorized shorelands can be found on Spirit Lake Map 1.

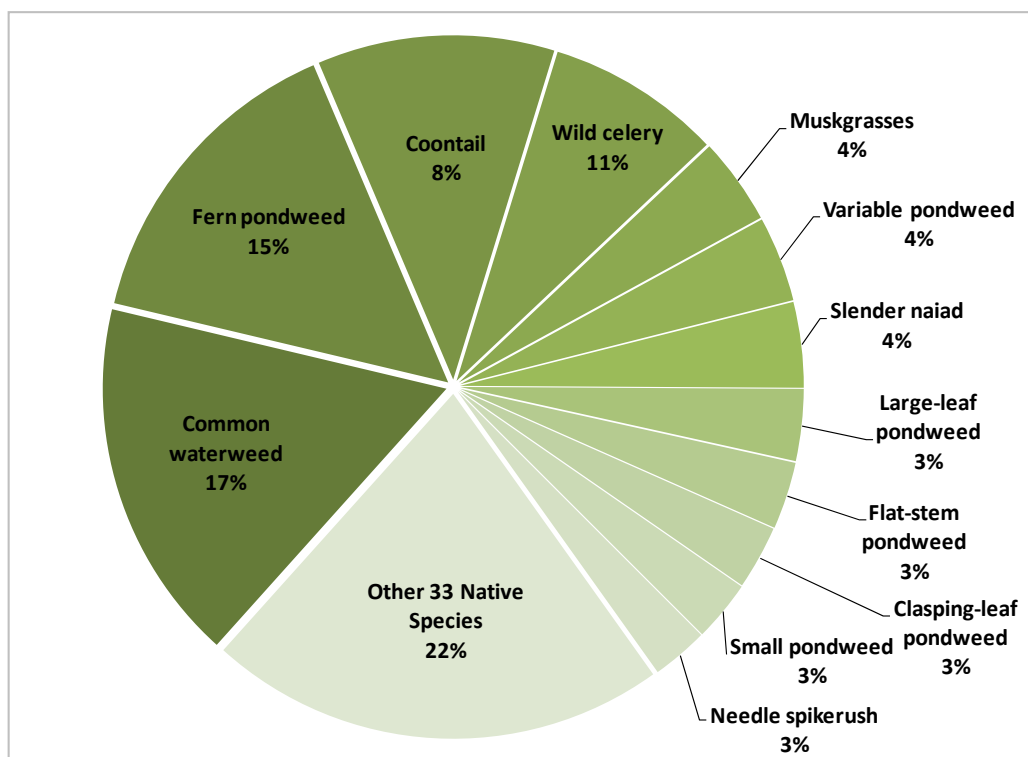
**Figure 8.13.4-2 Spirit Lake aquatic plant relative frequency of occurrence analysis.**  
Created using data from 2013 point-intercept survey.

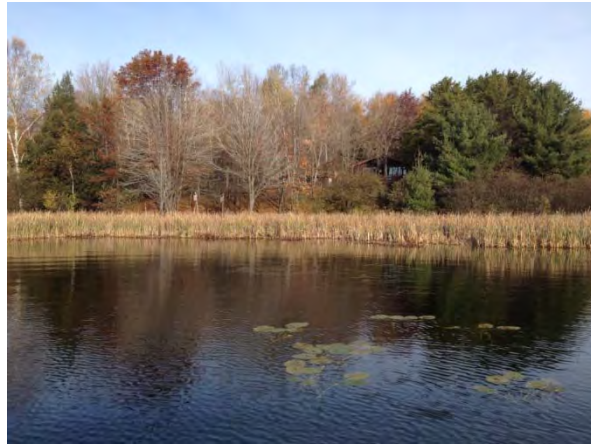
Photo 8.14.1-1 Maple Lake, Oneida County

*Much of the lake holds native plants, including many pondweed species. No aquatic invasive species found during 2013 surveys.*
