# Three Lakes Chain

Oneida County, Wisconsin

## Phases I – IV Comprehensive Management Plan

April 2016

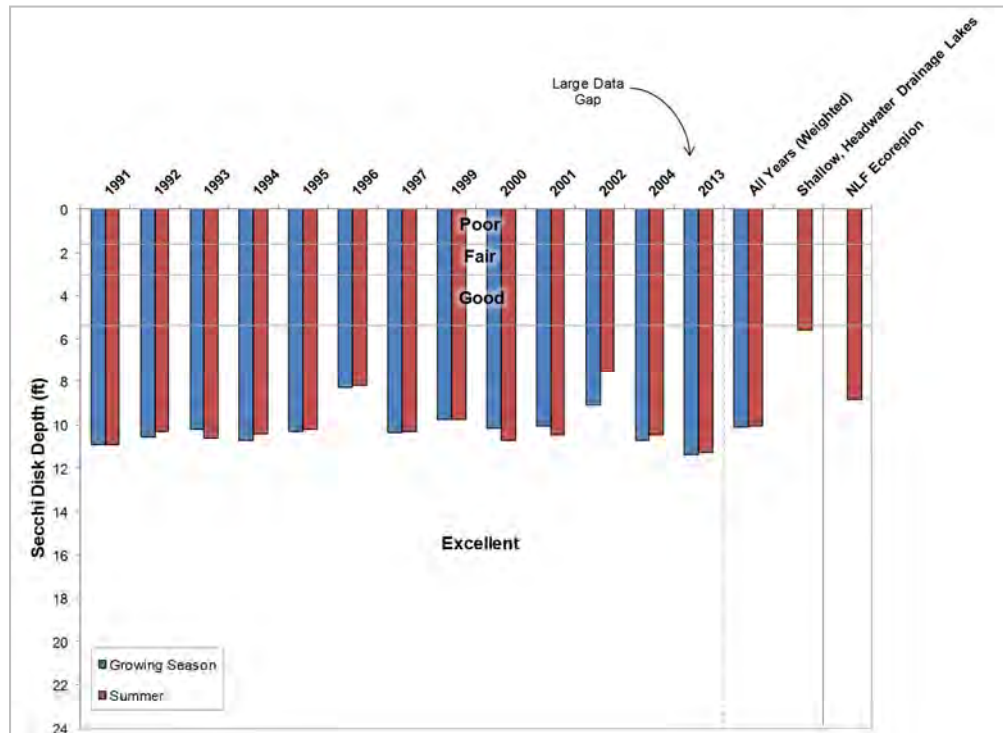
**Figure 8.14.1-3. Maple Lake, state-wide shallow, headwater drainage lakes, and regional Secchi disk clarity values.** Mean values calculated with summer month surface sample data. Water Quality Index values adapted from WDNR 2013.

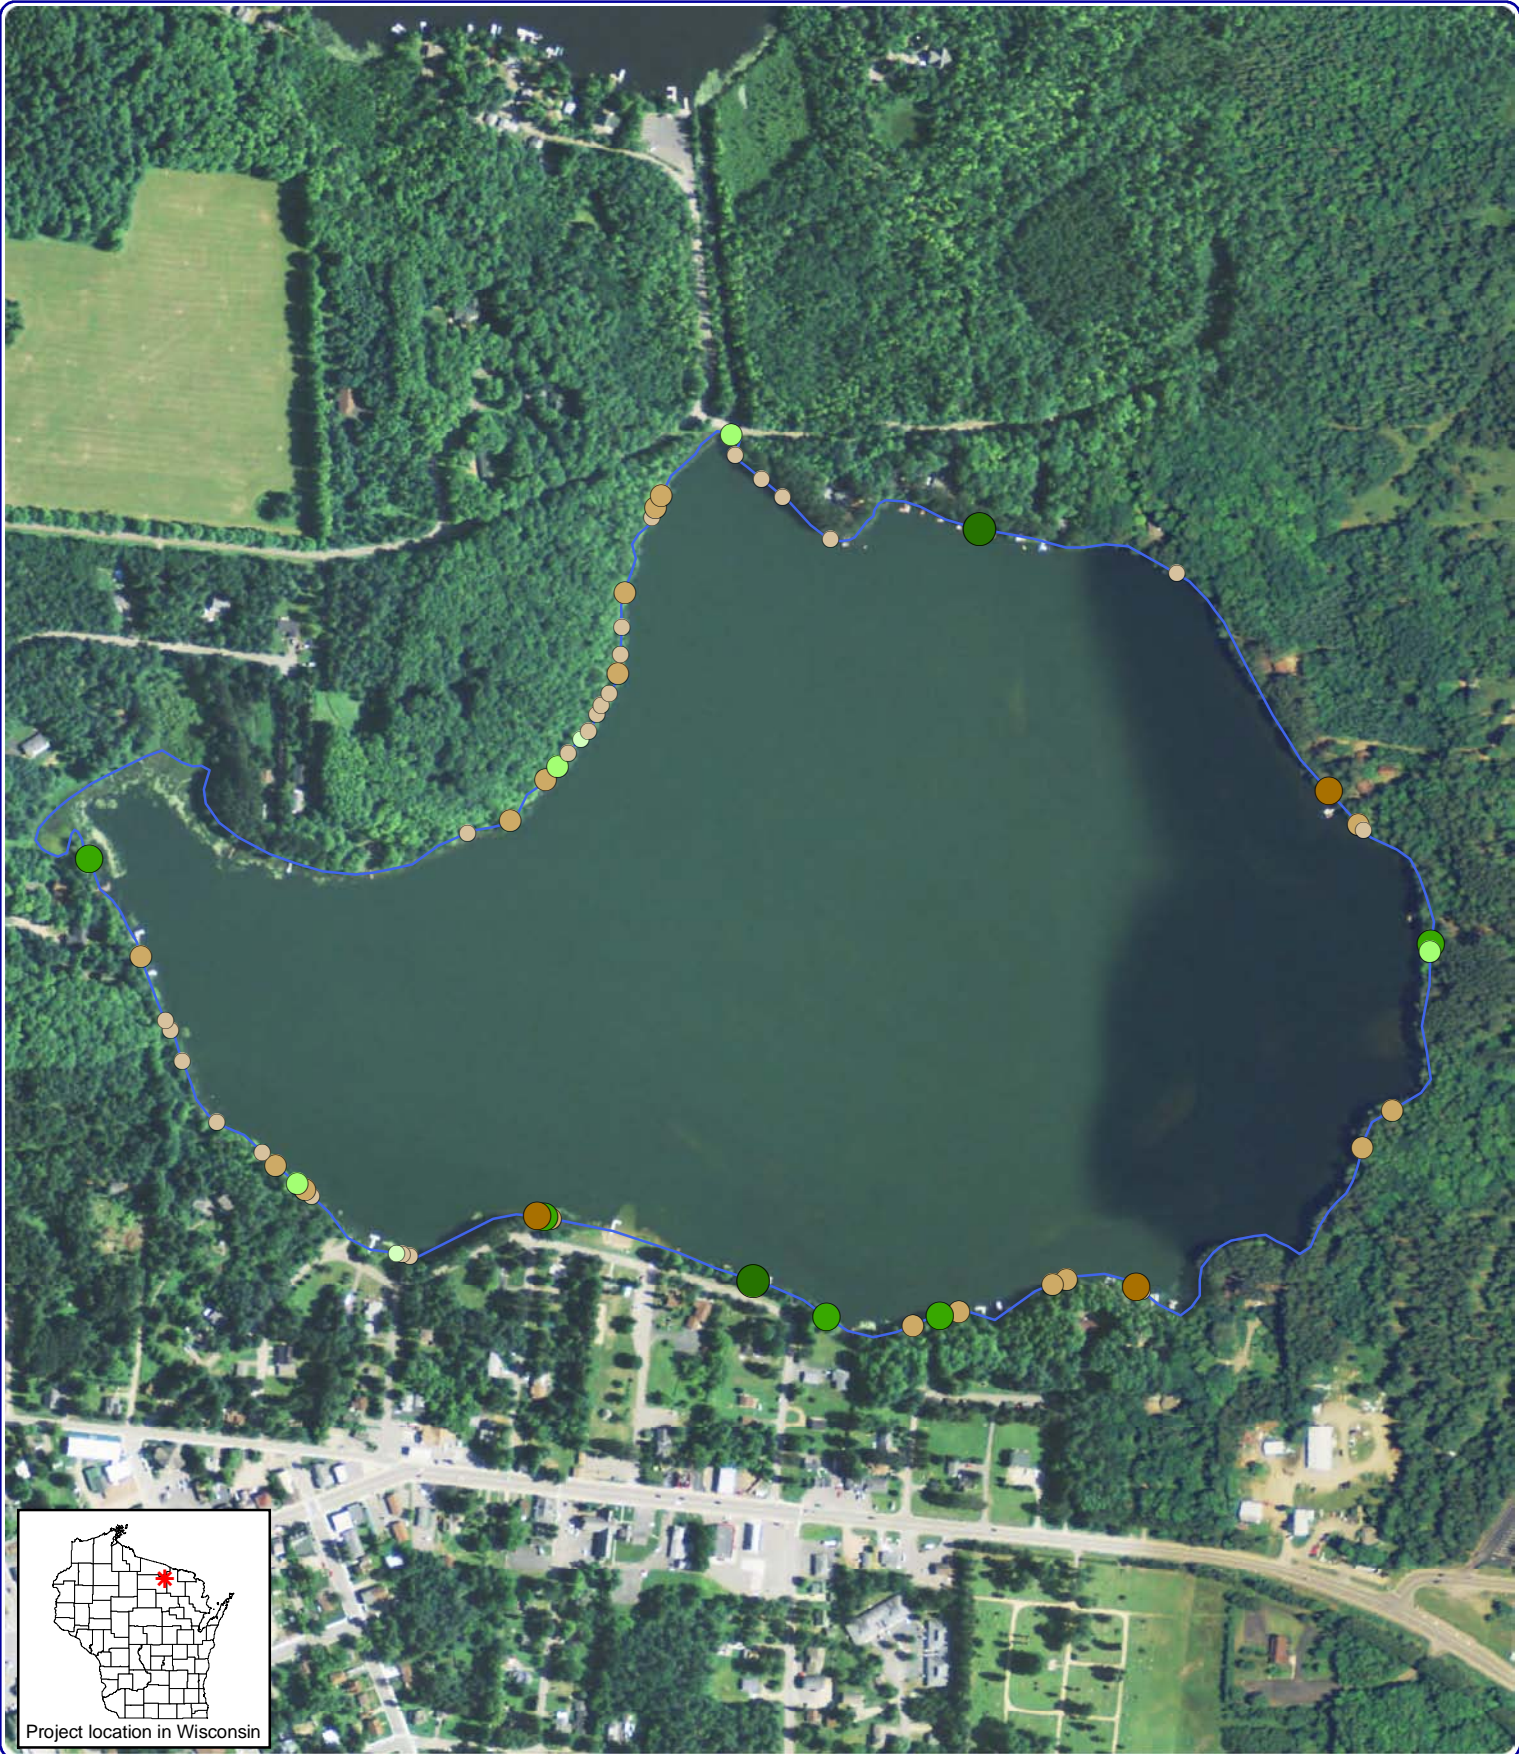
Maple Lake - Map 1  
 Three Lakes Chain  
 Oneida County, Wisconsin  
**Shoreland Condition  
 Assessment**

- Natural/Undeveloped
- Developed-Natural
- Developed-Semi-Natural
- Developed-Unnatural
- Urbanized
- Seawall
- Masonary/Wood
- Rip-Rap
