Lower Menominee River South Channel Ogden Street Bridge Sediment Assessment Results

January 27, 2016

Office of the Great Lakes Sediment Management Section
Wisconsin Department of Natural Resources - Green Bay & Madison

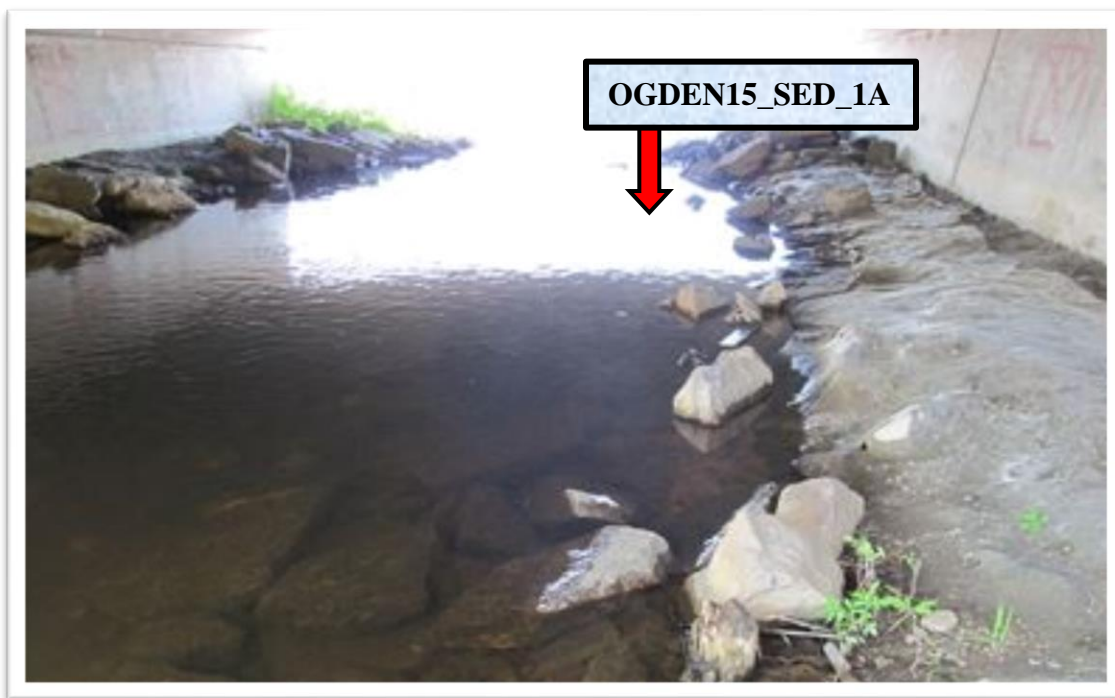
Photo 2. Ogden Street Bridge South Channel Menominee River Sediment Sampling Location – Facing East (WDNR, 2015)

Field staff made many attempts at locating measurable deposits of soft sediment under the bridge. Large riprap was moved to locate the streambed. A metal sounding pole was used to determine substrate type and water depths. Water levels were elevated due to seiche from the Bay of Green Bay, making it difficult to manually remove some riprap. Once the riprap was removed, coarse sand and gravel could be detected. The sounding pole was used to advance through the top layer of material; however, full penetration was unsuccessful as the material was highly compacted. As evident in Photo 2 (below), material compaction along both stream banks was likely caused by bridge reconstruction activities and placement of large pieces of broken concrete from deconstruction of the former bridge in 1993. Compaction and coarse sand and gravel consistency made retrieval of a representative sample difficult. Once retrieved, the sample was composited and placed in appropriate sample containers provided by the Wisconsin State Laboratory of Hygiene (SLOH) for chemical and physical analysis. The samples were labeled *OGDEN15_SED_1A*, then placed in a cooler with ice and personally delivered to the SLOH for analysis. The sample was analyzed for arsenic, copper, lead, mercury, grain size, and percent solids.

The Global Positioning System (GPS) Trimble Pro-XRS-RTD© unit could not receive a signal under the concrete bridge, therefore, latitude and longitude readings were taken at all four bridge corners along with taped measurements in feet from each near corner to the sampling point. Computed geographic coordinates of the sample location are: Latitude 45.092052°N, Longitude -87.598238°W, WRS84 Datum

Stream flow direction is generally west to east from the South Channel Menominee River into Menekaunee Harbor. However, seiche effect was also observed on the surface of the water where floating debris (plastic water bottle) flowed east to west at times. Seiche effect is common on the Menominee River due to changes in wind direction pushing the surface water to the east into the river and harbor areas. Note that the surface flow in the channel can be reversed at times resulting in water elevations to change (usually increase). Floating debris can also be transported into other areas and deposited during seiche periods.

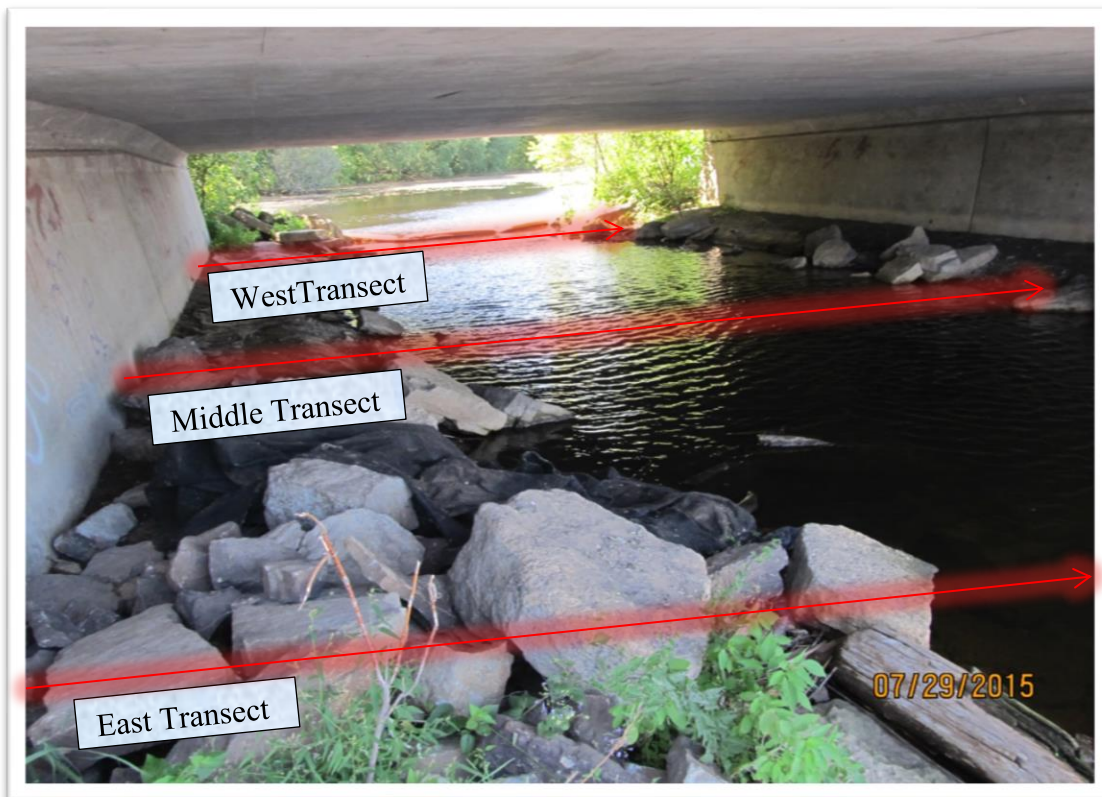
Photo 3. Ogden Street Bridge River Transects – Facing West (WDNR, 2015)

Three river transects were selected at Ogden Street Bridge to record water depth and distance from the south wall of the bridge to north shoreline (shown in Photo 3 below). This information was transformed into cross section diagrams to be used for debris removal as part of the South Channel Habitat Restoration Specifications and Drawings (Anderson, 2015). The restoration goal is to remove streambed material to the 577' (NAVD 88) elevation to improve flow, fish passage and overall water quality. Refer to Figure 2 for the transect streambed elevations on Page 5.
