Mable Lake Stewardship Program

Aquatic Plant Management Plan – Mable Lake

Date: December 2016

Cite as: Premo, Dean, Angie Stine, Caitlin Hoenig and Kent Premo. 2016. Mable Lake Stewardship Program: Mable Lake Aquatic Plant Management Plan. White Water Associates, Inc.

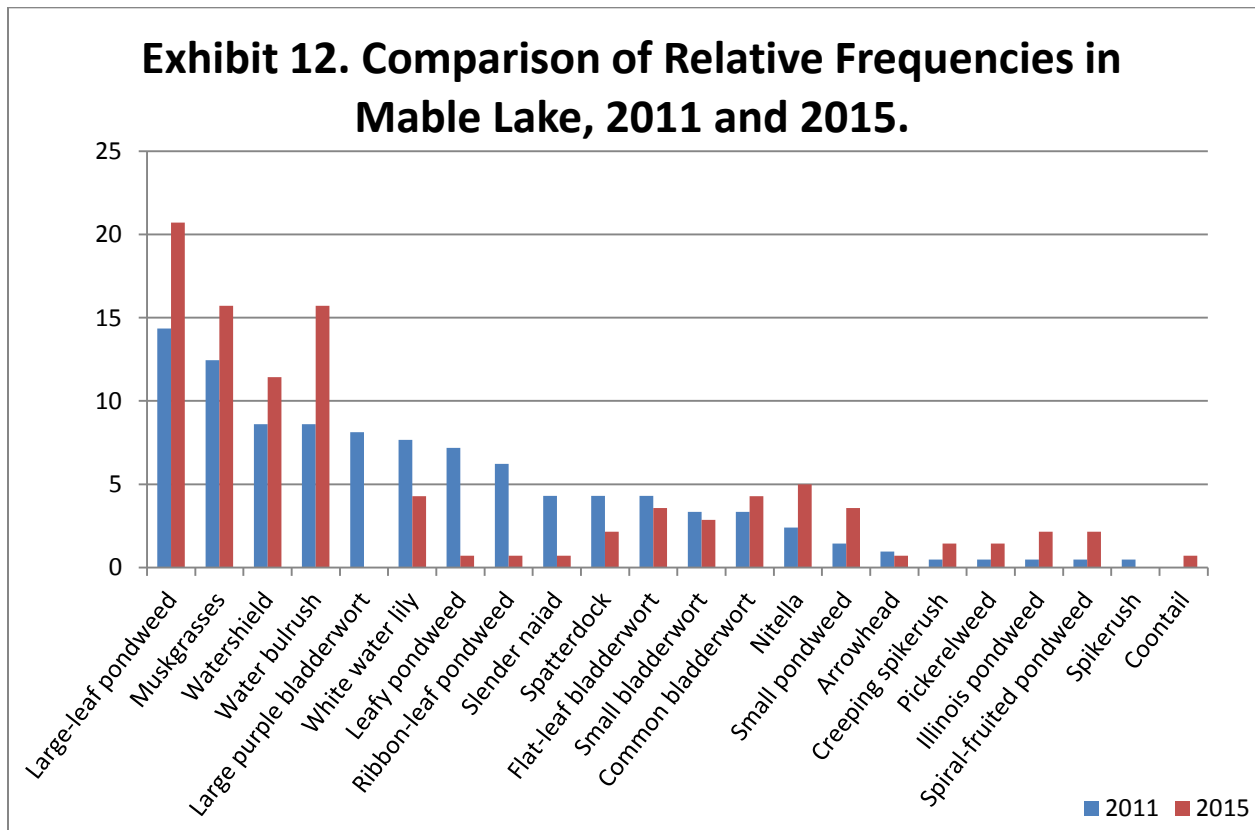
Exhibit 12 displays the relative frequency of plants found in 2011 and 2015. We can see that the relative frequency of the first four species increased from 2011 to 2015.

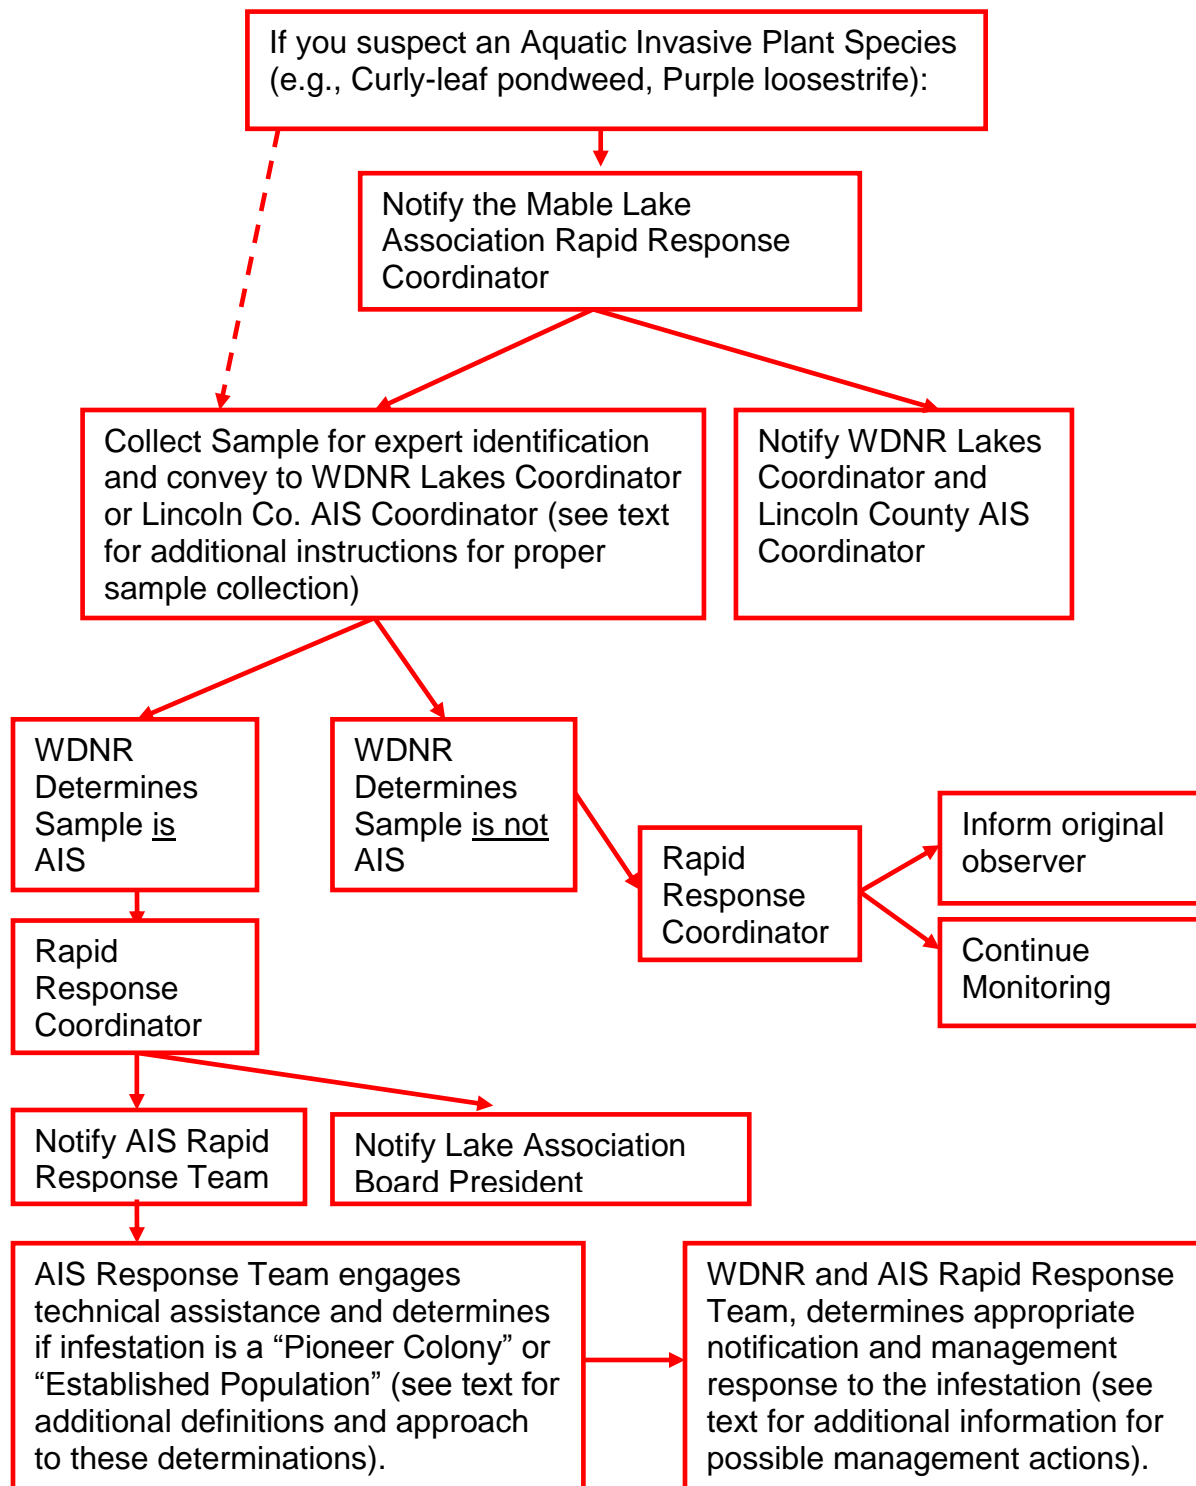
Exhibit 15. Aquatic Invasive Plant Species Rapid Response

When a suspect aquatic invasive plant species is found, either the original observer or a member of the Rapid Response Team (likely the coordinator) should collect an entire plant specimen including roots, stems, and flowers (if present). The sample should be placed in a sealable bag with a small amount of water to keep it moist. Place a label in the bag written in pencil with date, time, collector’s name, lake name, location, town, and county. Attach a lake map to the bag that has the location of the suspect AIS marked and GPS coordinates recorded (if GPS is available). The sample should be placed on ice in a cooler or in a refrigerator. Deliver

Once the Rapid Response Team is organized, one of its first tasks is to develop a list of contacts and associated contact information (phone numbers and email addresses). At a minimum, this contact list should include: the Rapid Response Coordinator, members of the Rapid Response Team, County AIS Coordinator, WDNR Lakes Management Coordinator, Lake Association Presidents (or other points of contact), local WDNR warden, local government official(s), other experts, chemical treatment contractors, and consultant(s).

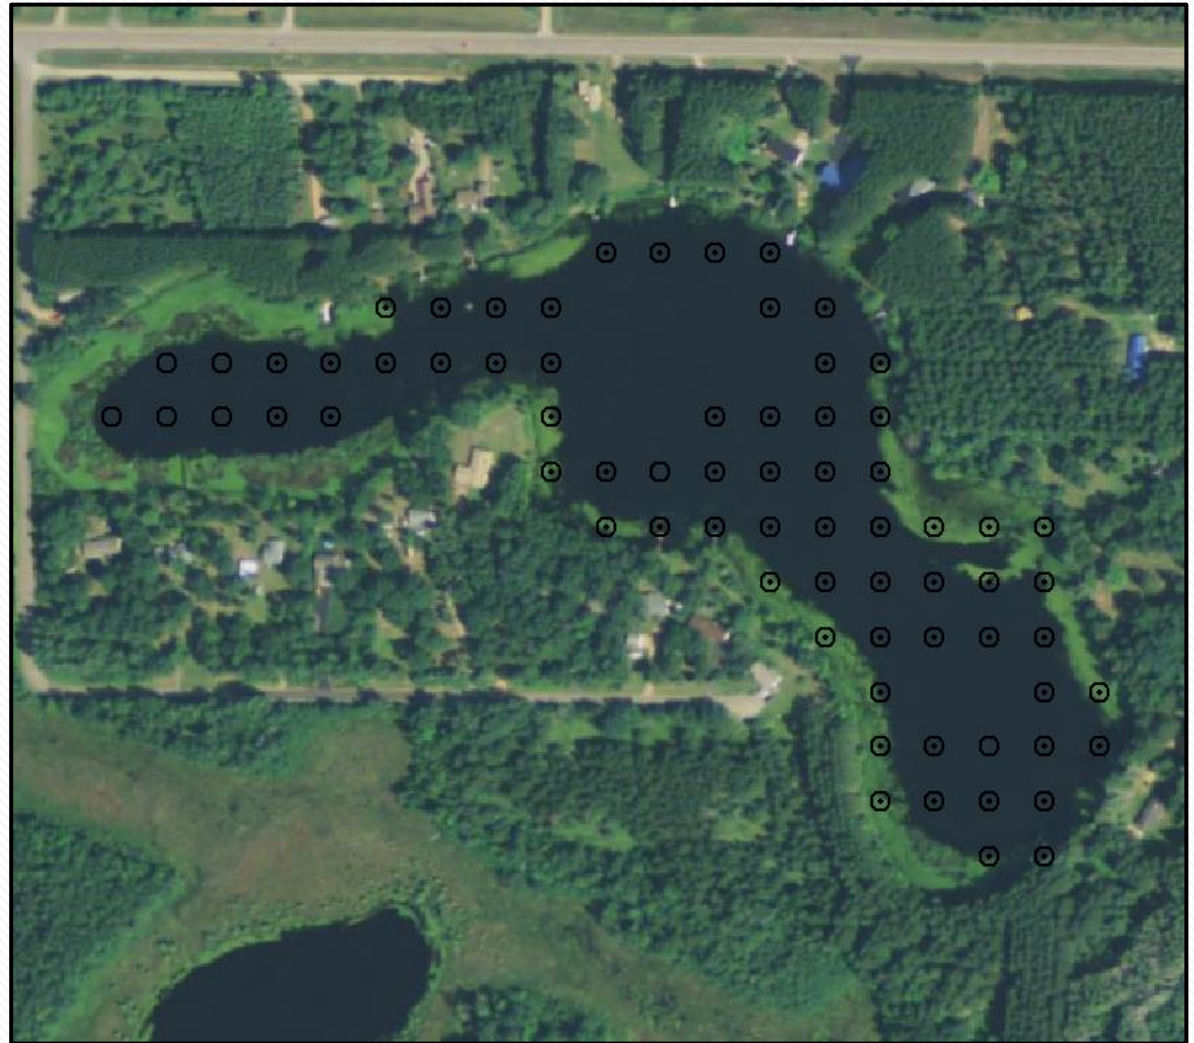
Figure 4. Mable Lake
sampling sites less than or
equal to maximum depth of
rooted vegetation (2015).

- Sites less than or equal to maximum depth of plant colonization (MDC)
- ⊙ Plant find(s) at sites less than or equal to MDC

The maximum depth of plant colonization in 2015 was 18.5 feet (Table 1 and Figure 3). Rooted vegetation was found at 63 of the 71 sample sites with depth \leq the maximum depth of plant colonization (88.7% of sites). These sites are displayed as a black dot within a circle on Figure 4 (2015 data). This indicates that although availability of appropriate depth may limit the distribution of plants, it is not the only habitat factor involved. Substrate is another feature that influences plant distribution (e.g., soft substrate often harbors more plants than hard substrate). Figure 5 presents the substrates encountered during the 2015 aquatic plant survey (mud, sand, or rock). Figure 6 displays distribution of emergent and floating aquatic plants in 2015. Corresponding data for the 2011 survey are illustrated in Figures 16, 17, 18, and 19.

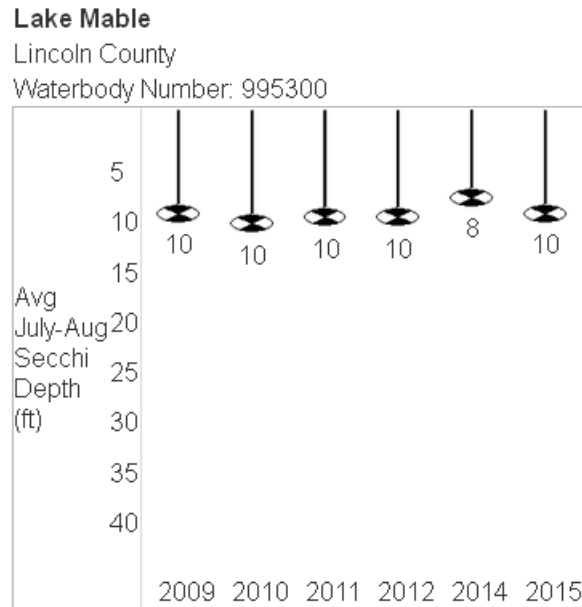
Figure 2. Mable Lake Secchi depth averages (July and August only).

Past secchi averages in feet (July and August only).

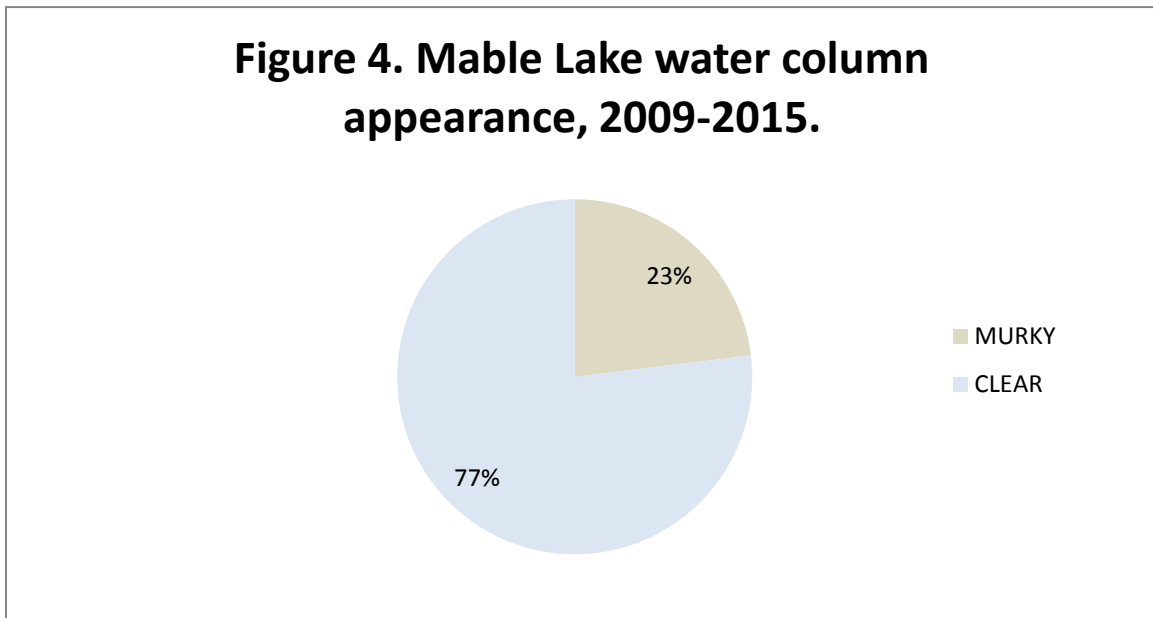
CLMN volunteers rated water clarity and described the water as “clear” or “murky.” Since 2009, 77% of volunteers described the water as “clear” (Figure 4).
