{ 2013 Centerville Creek Stream Assessment

Centerville Creek, Summer 2013

- Student Intern: Ethan Poling
- Baseline Assessment
- Ten sampling points along stream
- Weekly measurements of physical, chemical, and biological characteristics
 - pH, temperature, stream flow, turbidity, conductivity, dissolved oxygen, ammonia, phosphorus, *E. coli* (*Escherichia coli*)

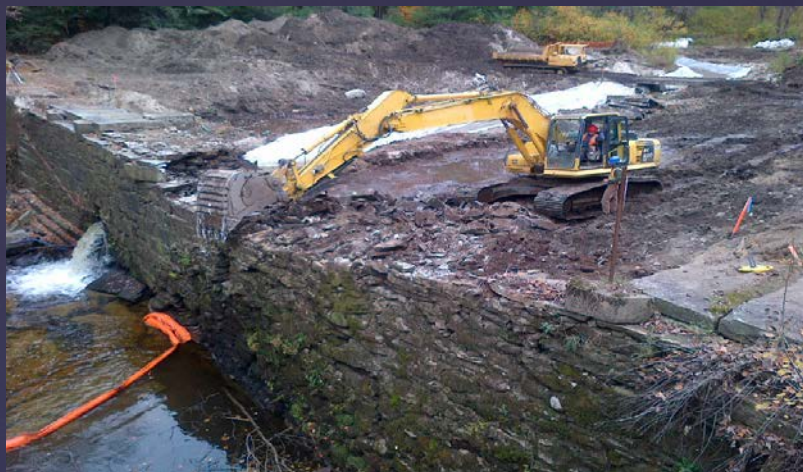
Site of Removed Dam on Centerville Creek

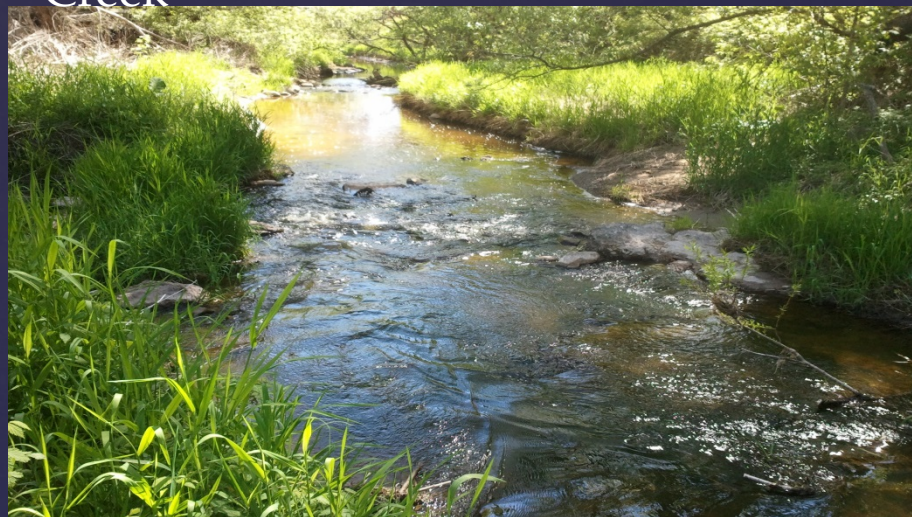
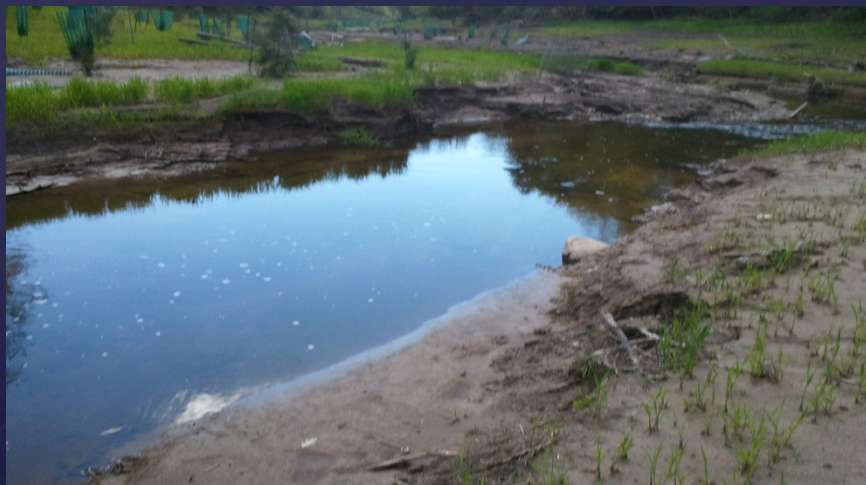
Site of the Mid-Point sample site within the former Mill pond after restoration

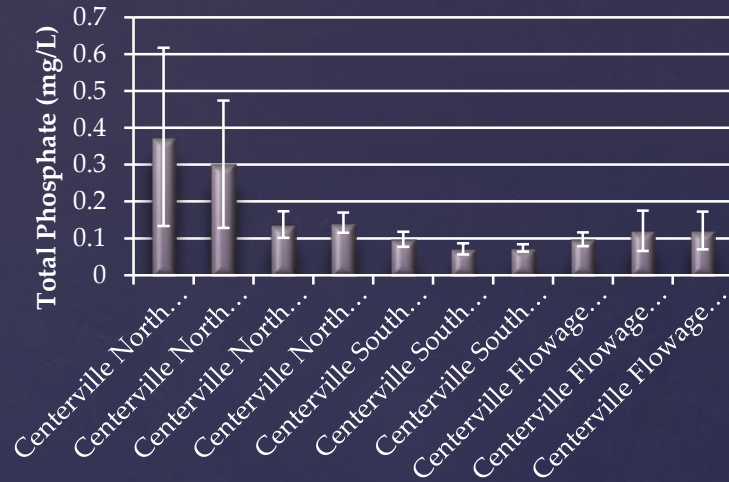
❖ As seen in summer, 2012. Phosphates did not seem to increase at Mid-point within the mill pond in the sampling season of 2013.

➤ This may be attributed to the lack of rainfall throughout summers 2012, and 2013

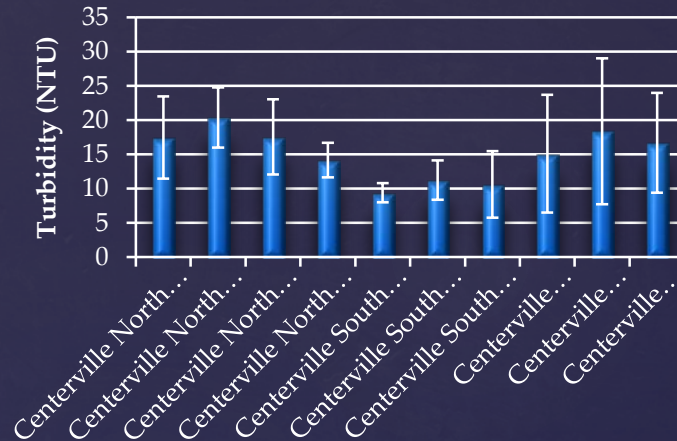
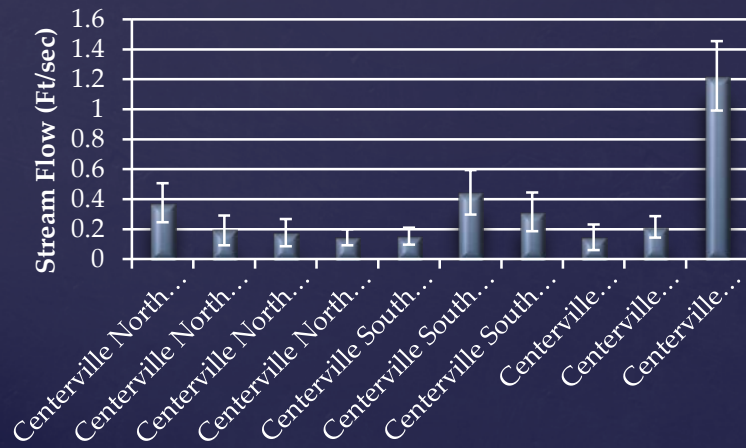
Stream flow was typically higher along the South Branch than the North Branch of Centerville Creek, and highest at the Dam barrier (Consistent throughout all three summers)

- ⌘ Stream flow was typically higher along the South Branch than the North Branch of Centerville Creek, and highest at the Dam barrier (Consistent throughout all three summers)

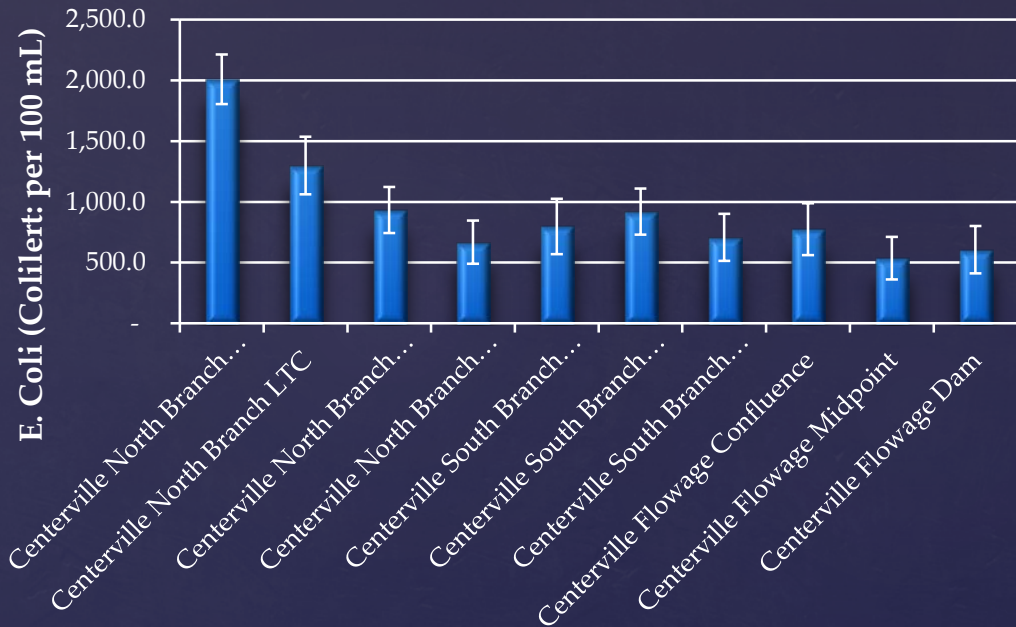
E. Coli Summer 2013

North Branch
Centerville Creek
appears to be a
significant contributor
to *E. coli* (Consistent
with both previous
summer's data)
