2013 Stream Assessment-Centerville Creek

Final Report

Ethan Poling, Student Intern, UW-Manitowoc

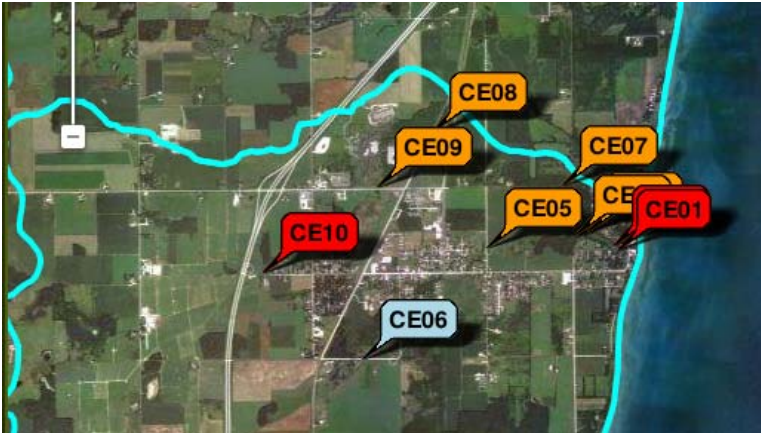
Figure 3: Satellite image depicting, the sites sampled in summer 2013.

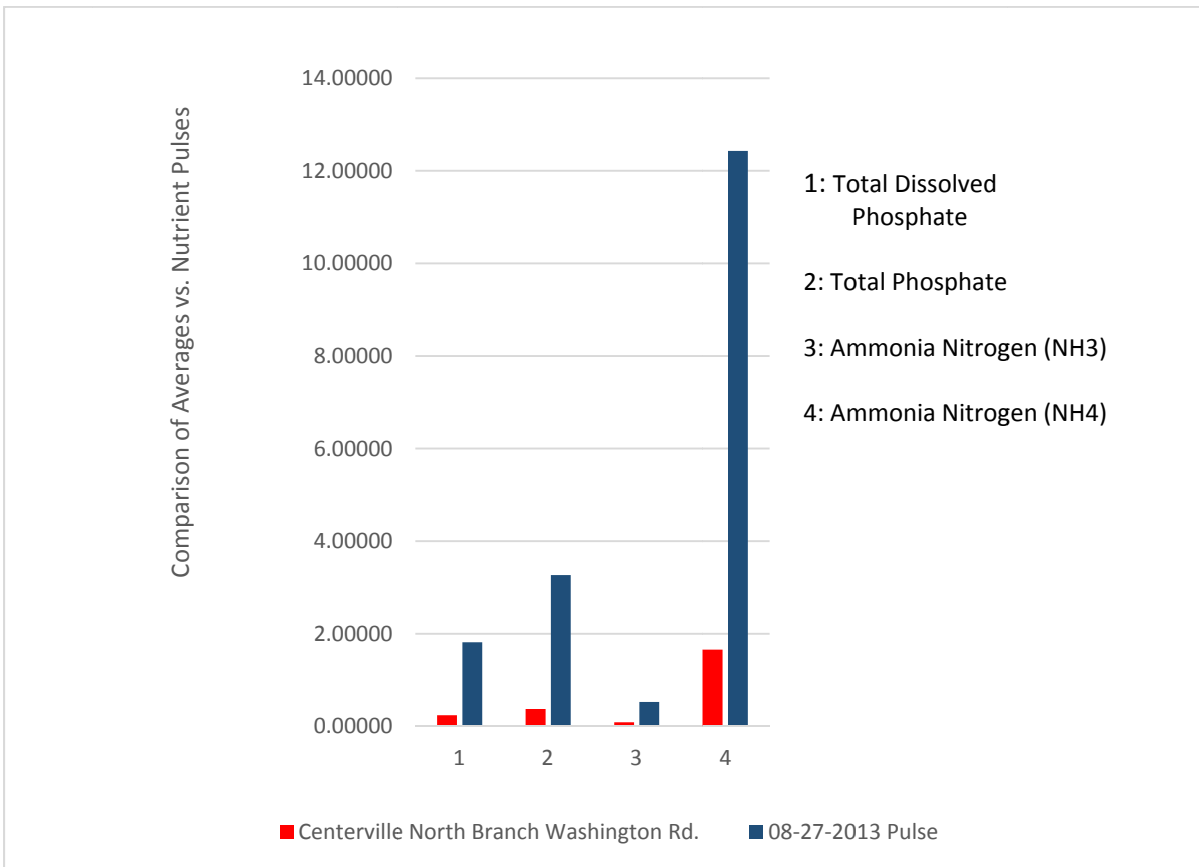
Appendix C:

Comparison of summer 2013 Average vs. August 27th, 2013 nutrient data spike for CE10 sample site:

In the sampling season of 2013, a single, isolated spike in both ammonia nitrogen, as well as *E. coli* data was noticed that raised some further concern in regards to the north branch Washington St. sample site. On August 27th, 2013, samples were routinely collected from all sampling locations and the results that came back from most of the sites were typical of those seen in the dry conditions of late august. However, one site in particular CE10 (north branch Washington) returned results exceedingly

higher than those of any other site that day in both ammonia nitrogen and *E. coli*. The results from these samples on August 27th, 2013 were higher than that of even the average of the summer for this site in relation to ammonia nitrogen and *E. coli*. (Appendix C.) To better understand what would cause a spike so severe, further investigation into north branch contribution is needed.

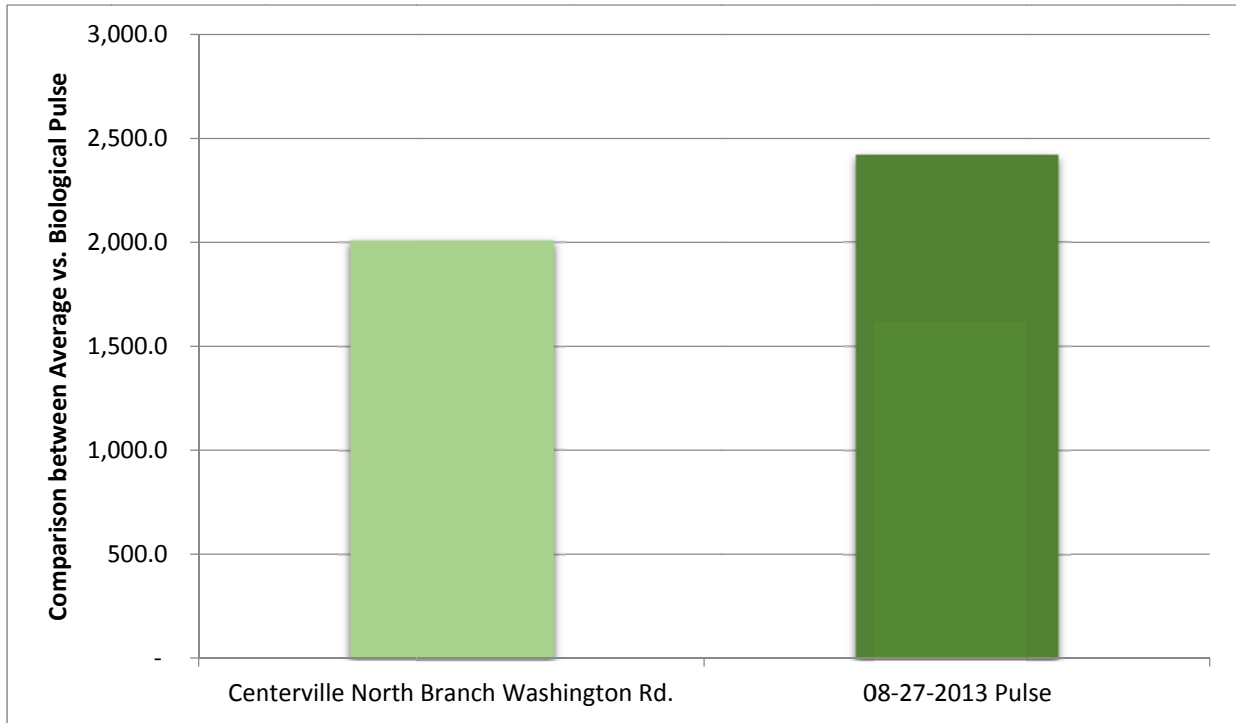
Appendix C, continued:

Comparison of summer 2013 Average vs. August 27th, 2013 Biological data spike for CE10 sample site:
