Re: Mosinee Hydroelectric Project, FERC Project No. 2207
Invasive Species Survey Report - 2009

2009
INVASIVE SPECIES REPORT
FOR THE
MOSINEE HYDROELECTRIC PROJECT
MARATHON COUNTY, WISCONSIN
FERC Project No. 2207

Submitted By
Mosinee Paper Corporation

December 2009

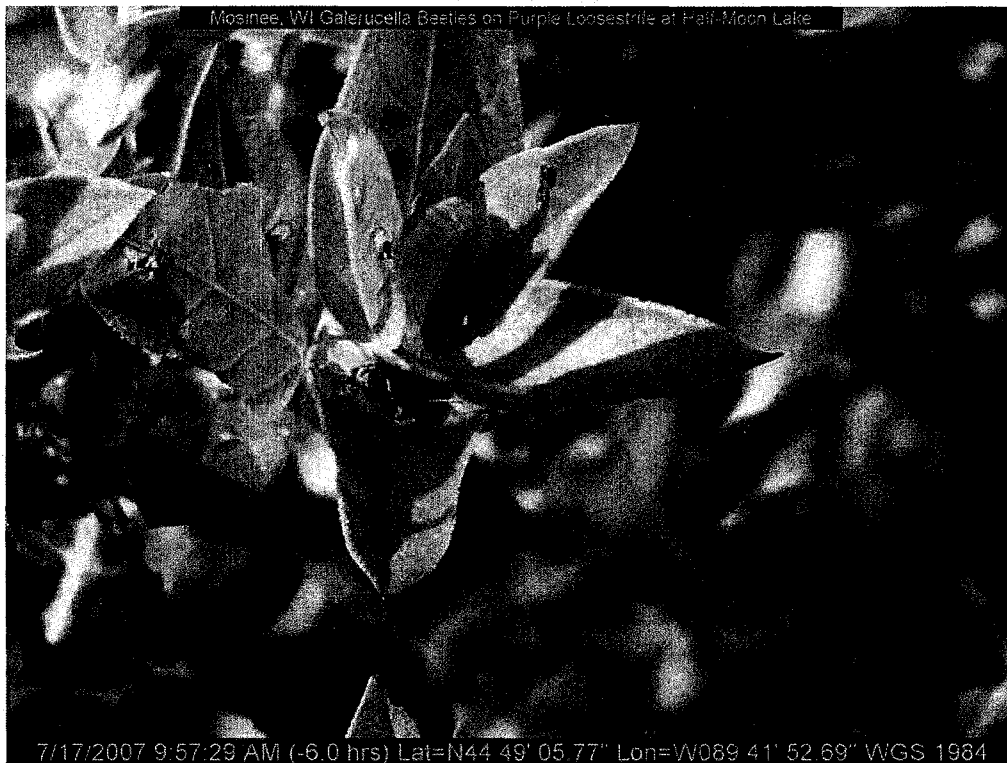
Galerucella Beetles on Purple Loosestrife (2007)

During the baseline survey in 2007, Cella beetles were discovered to be present at a quite a number of PL occurrences. Upon closer inspection, it was noted that the beetles were partially defoliating and stunting the growth of a large amount of PL plants to the point where the flowers were not developing. At that point, the crew found it necessary to slow down, stay closer to shore, and look for additional plants by color and texture rather than just looking for the flowering seed heads. Damaged plants took on a yellow/green or brown color and were readily identified against the darker green surrounding vegetation. These conditions were found to be similar in the 2008 and 2009 surveys.

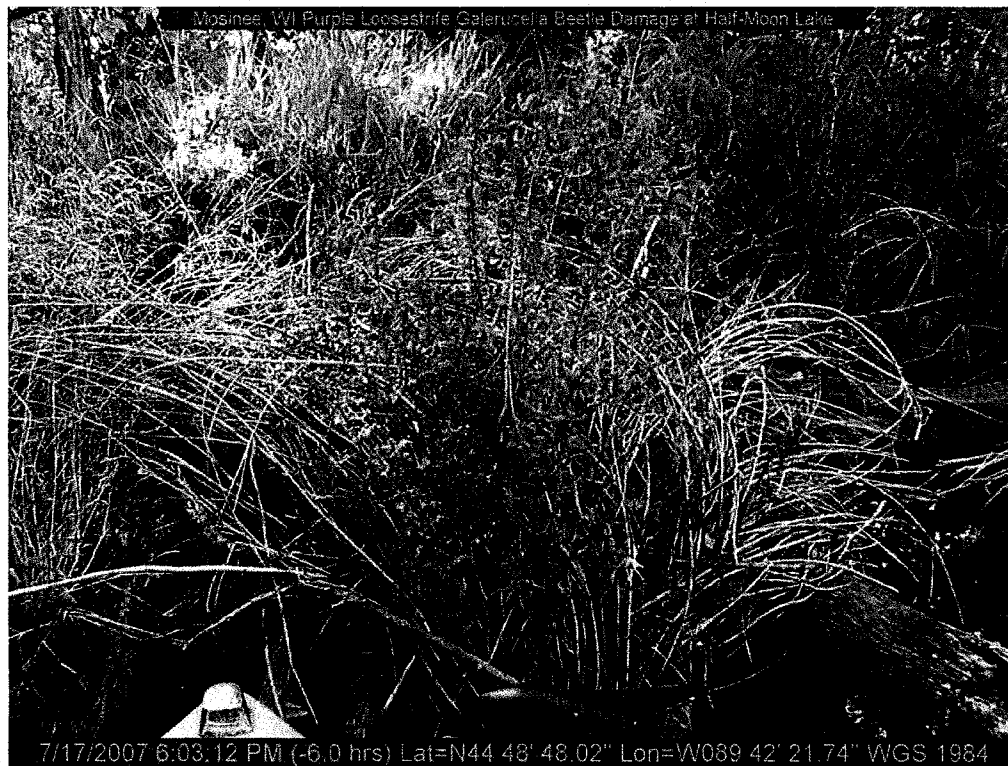
Beetle Damage on Purple Loosestrife Against Darker Green Surrounding Vegetation (2007)

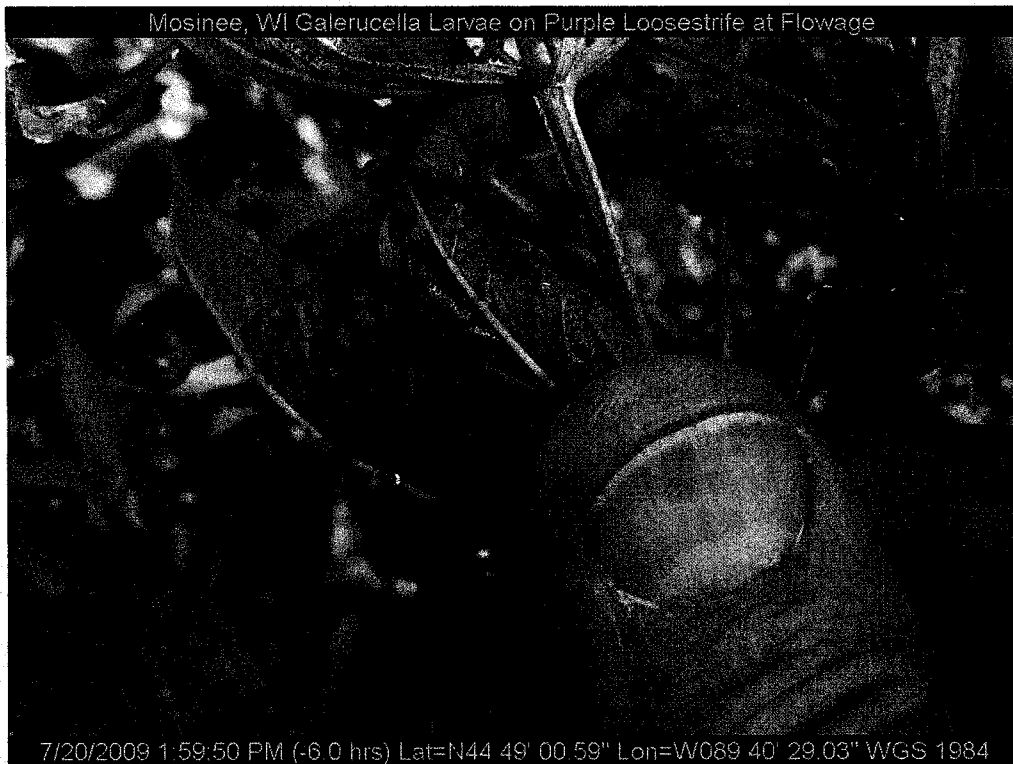
Beetle Larvae on Purple Loosestrife at Mosinee Flowage (2009)

Cella beetle larvae were found on PL plants in a slough in the northeastern area of the Mosinee Flowage (N44° 49' 00.59" W89° 40' 29.03"). In the 2008 survey, larvae had been found on plants at this location. Larvae were observed at a number of other locations throughout the project during the 2009 survey.

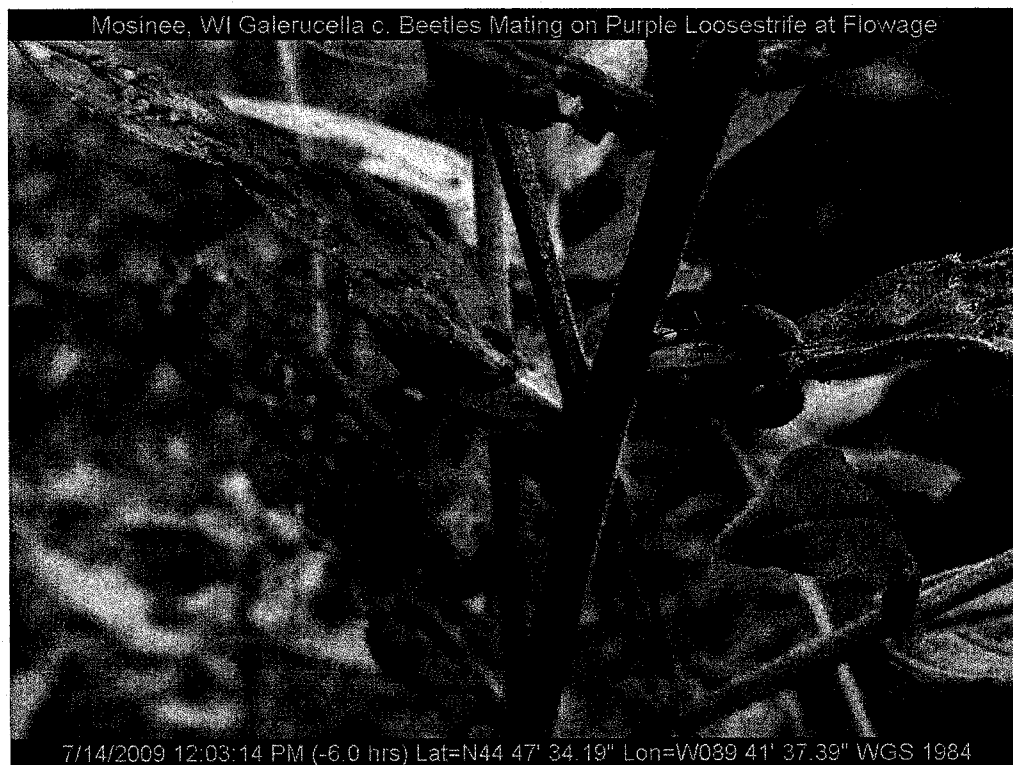
Galerucella Calmariensis Beetles Mating on Purple Loosestrife at Mosinee Flowage (2009)

In 2009, two species of beetles (*Galerucella pusilla* and *Galerucella californiensis*) were detected at the project. On 7/14/09, *Galerucella c.* beetles were observed mating at MOSN PL0155 (N44° 47' 34.19" W89° 41' 37.39"), and, the following day, new eggs were detected on the plants. Eggs were found on PL at a number of other locations during the survey.

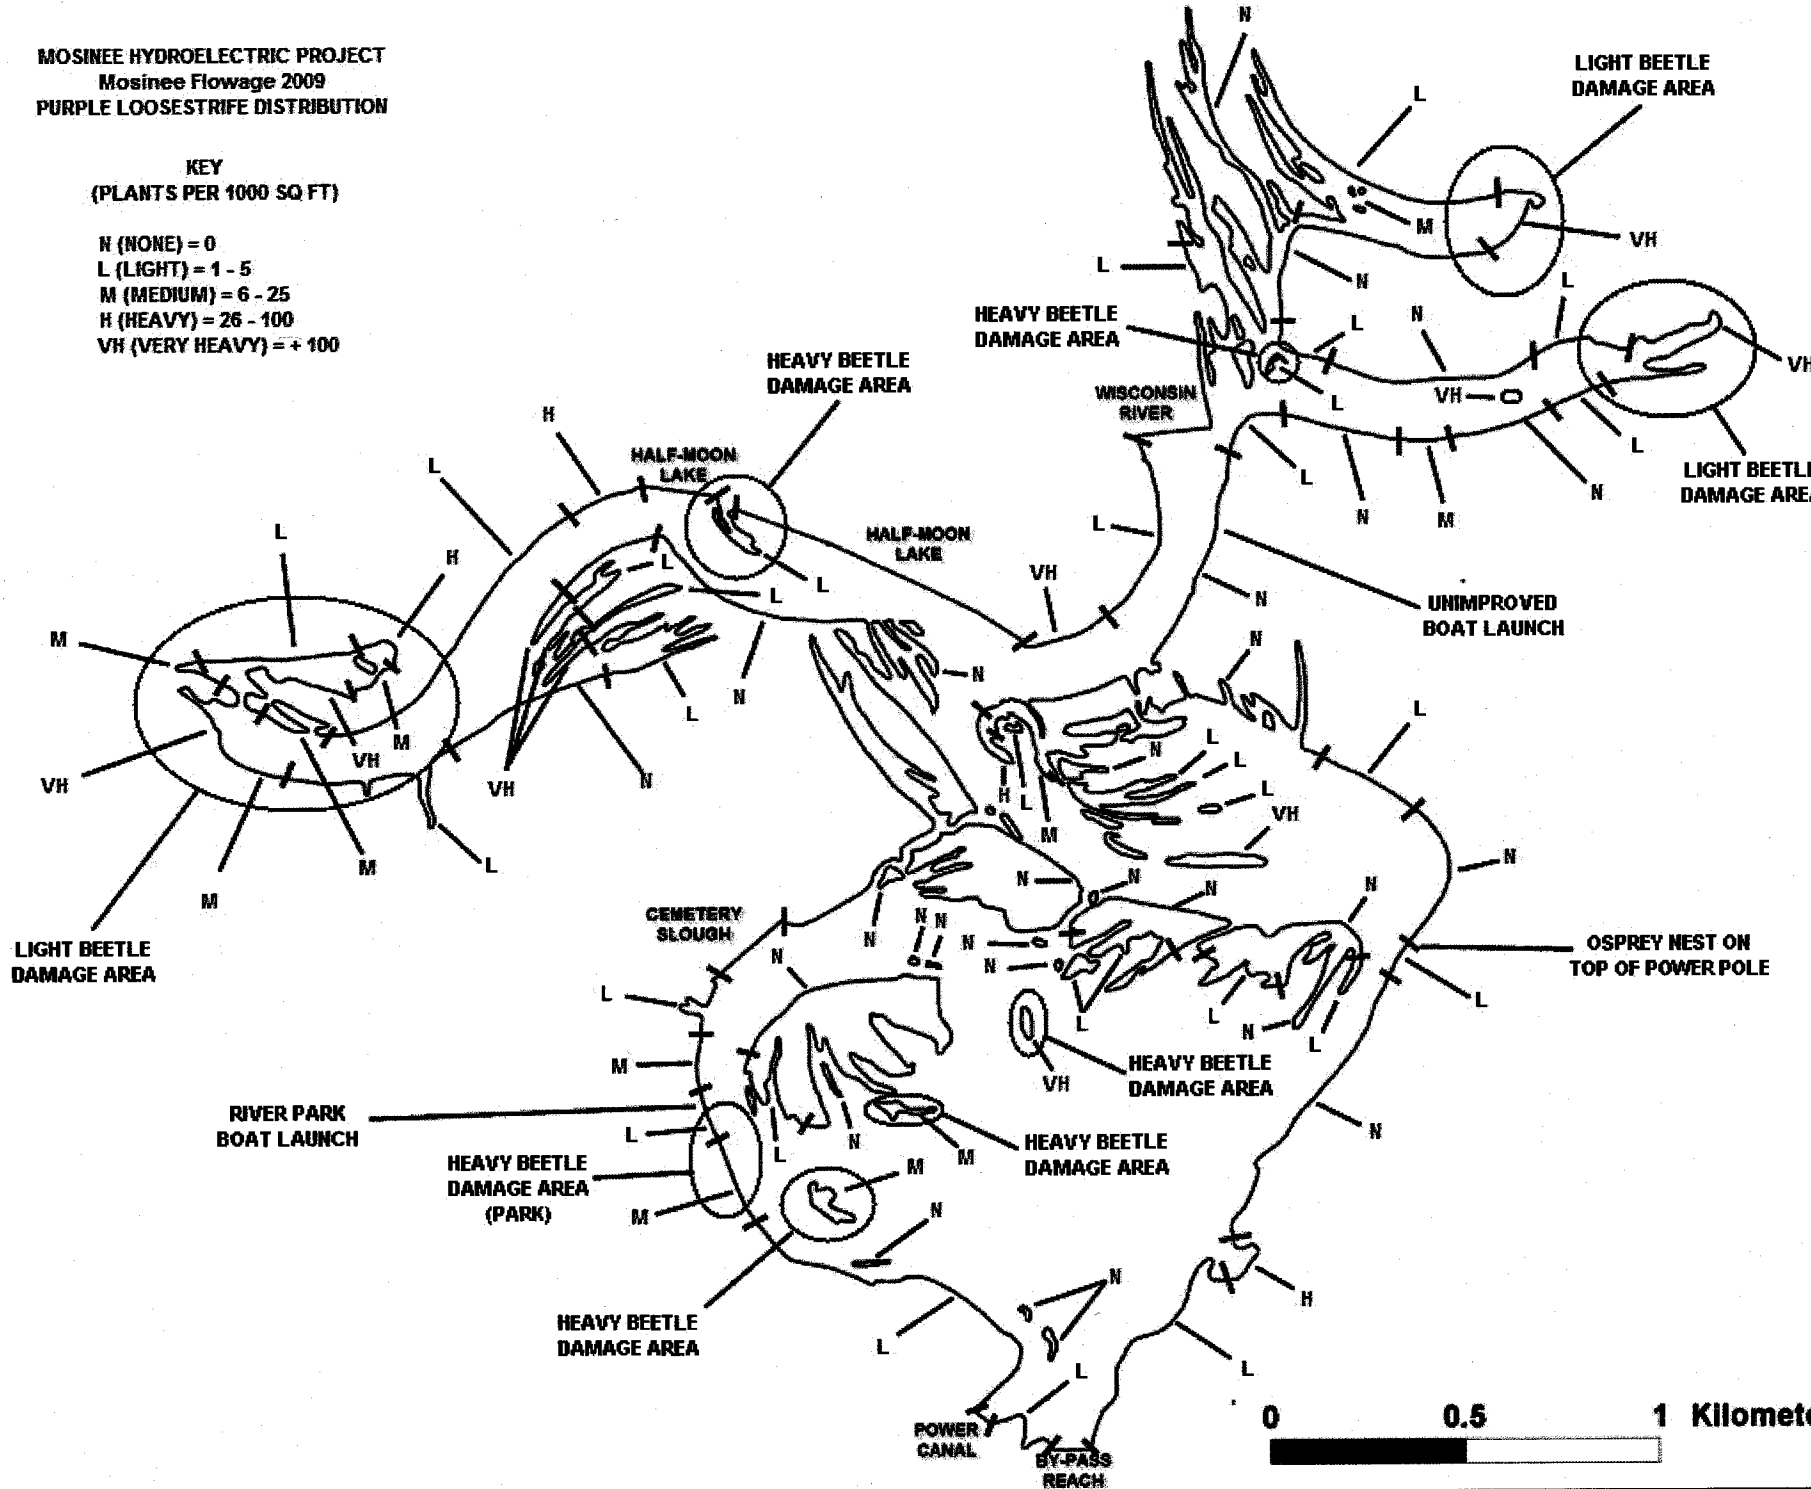
MOSINEE HYDROELECTRIC PROJECT
 Mosinee Flowage 2009
 PURPLE LOOSESTRIFE DISTRIBUTION

- N (NONE) = 0
- L (LIGHT) = 1 - 5
- M (MEDIUM) = 6 - 25
- H (HEAVY) = 26 - 100
- VH (VERY HEAVY) = + 100

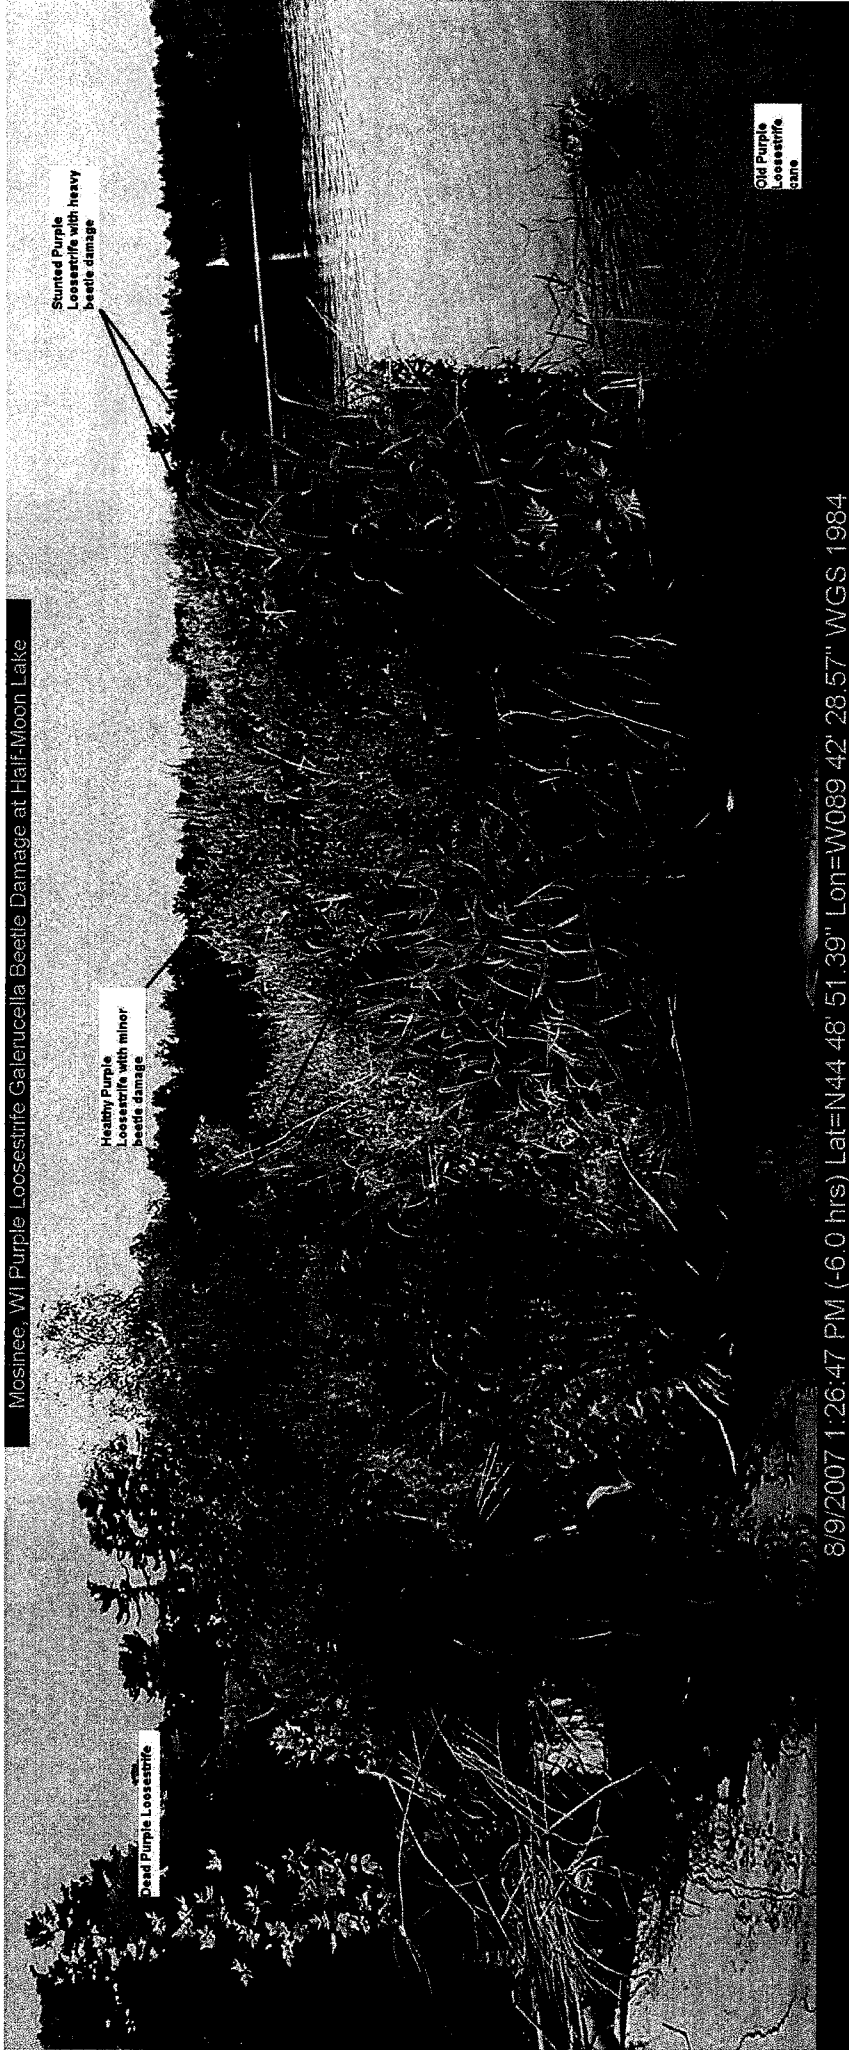
Mosinee, WI Purple Loosestrife *Galerucella beetle* Damage at Half-Moon Lake
