Re: Mosinee Hydroelectric Project, FERC Project No. 2207
Invasive Species Survey Report - 2010

Re: Mosinee Hydroelectric Project, FERC Project No. 2207, Invasive Species Survey – 2010

**Submitted By
Mosinee Paper Corporation**

December 2010

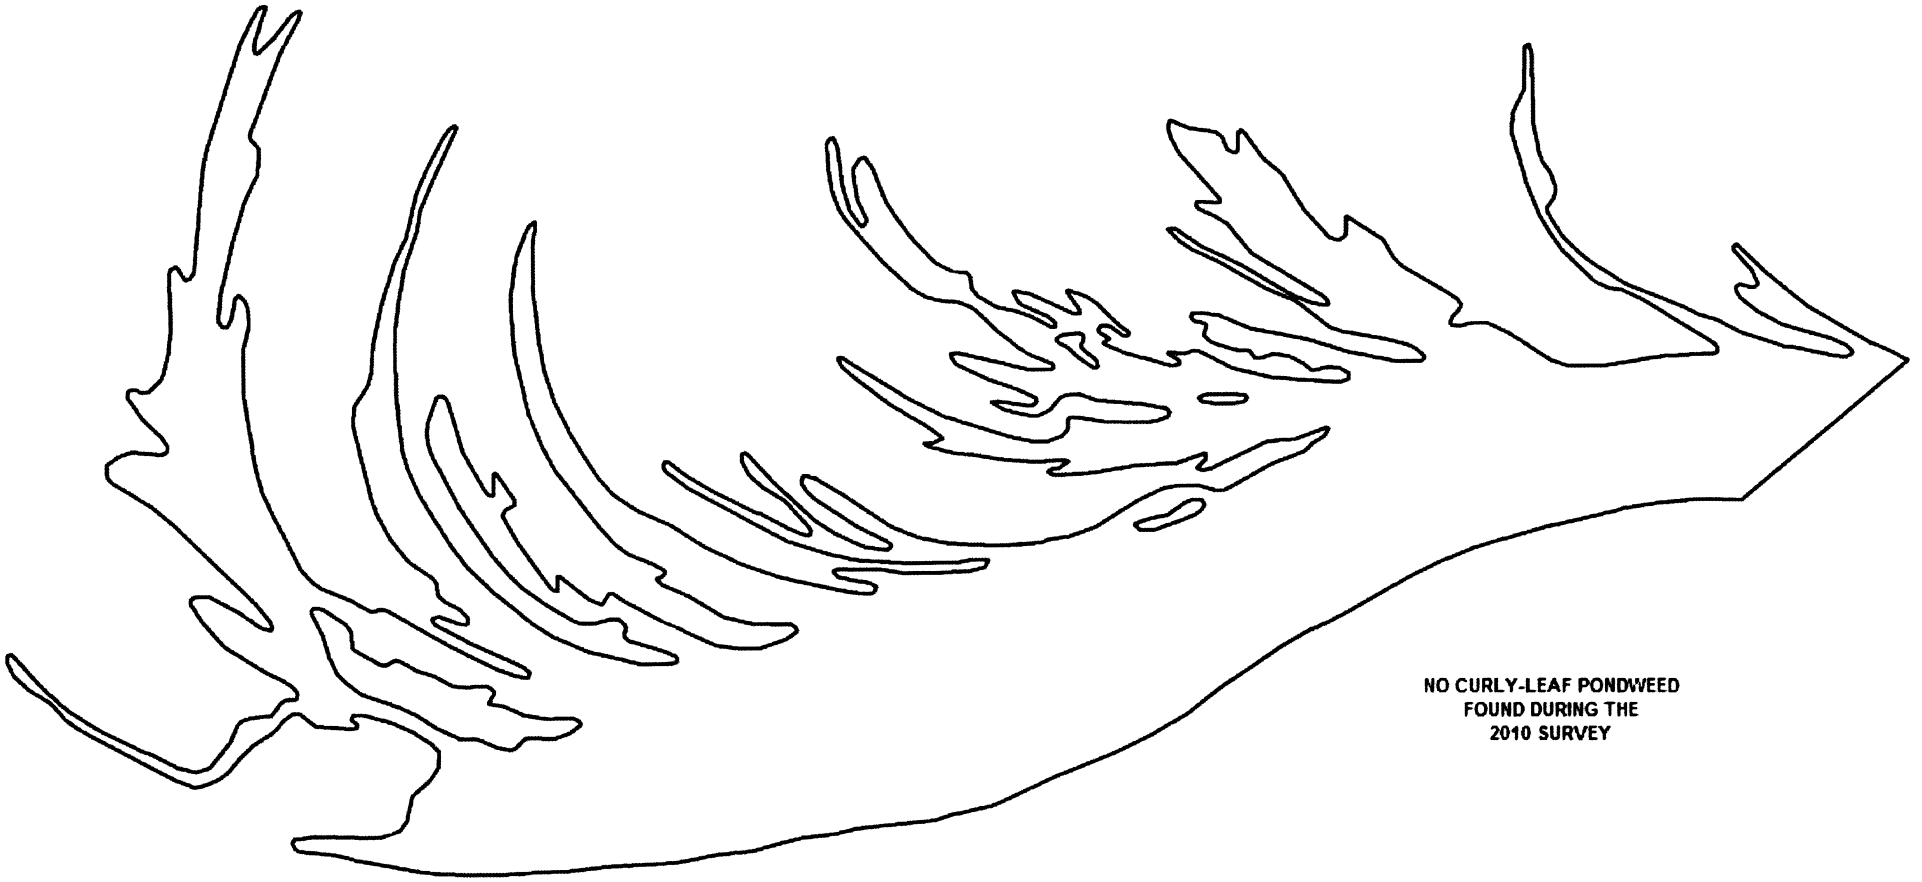
MOSINEE HYDROELECTRIC PROJECT
CEMETERY SLOUGH 2010
CURLY-LEAF PONDWEED
DISTRIBUTION

NO CURLY-LEAF PONDWEED
FOUND DURING THE
2010 SURVEY
