**Subject: 2016 Purple Loosestrife Monitoring Report
Holcombe Hydro (P-1982), Cornell Hydro (P-2639), Jim Falls Hydro (P-2491),
Wissota Hydro (P-2567), Chippewa Falls Hydro (P-2440) and Dells Hydro (P-
2670)**

PURPLE LOOSESTRIFE ASSESSMENT – 2016

**Dells Pond, Chippewa Falls Flowage, Lake Wissota, Old Abe Flowage,
Cornell Flowage, Holcombe Flowage, and Jim Falls Spillway Channel**

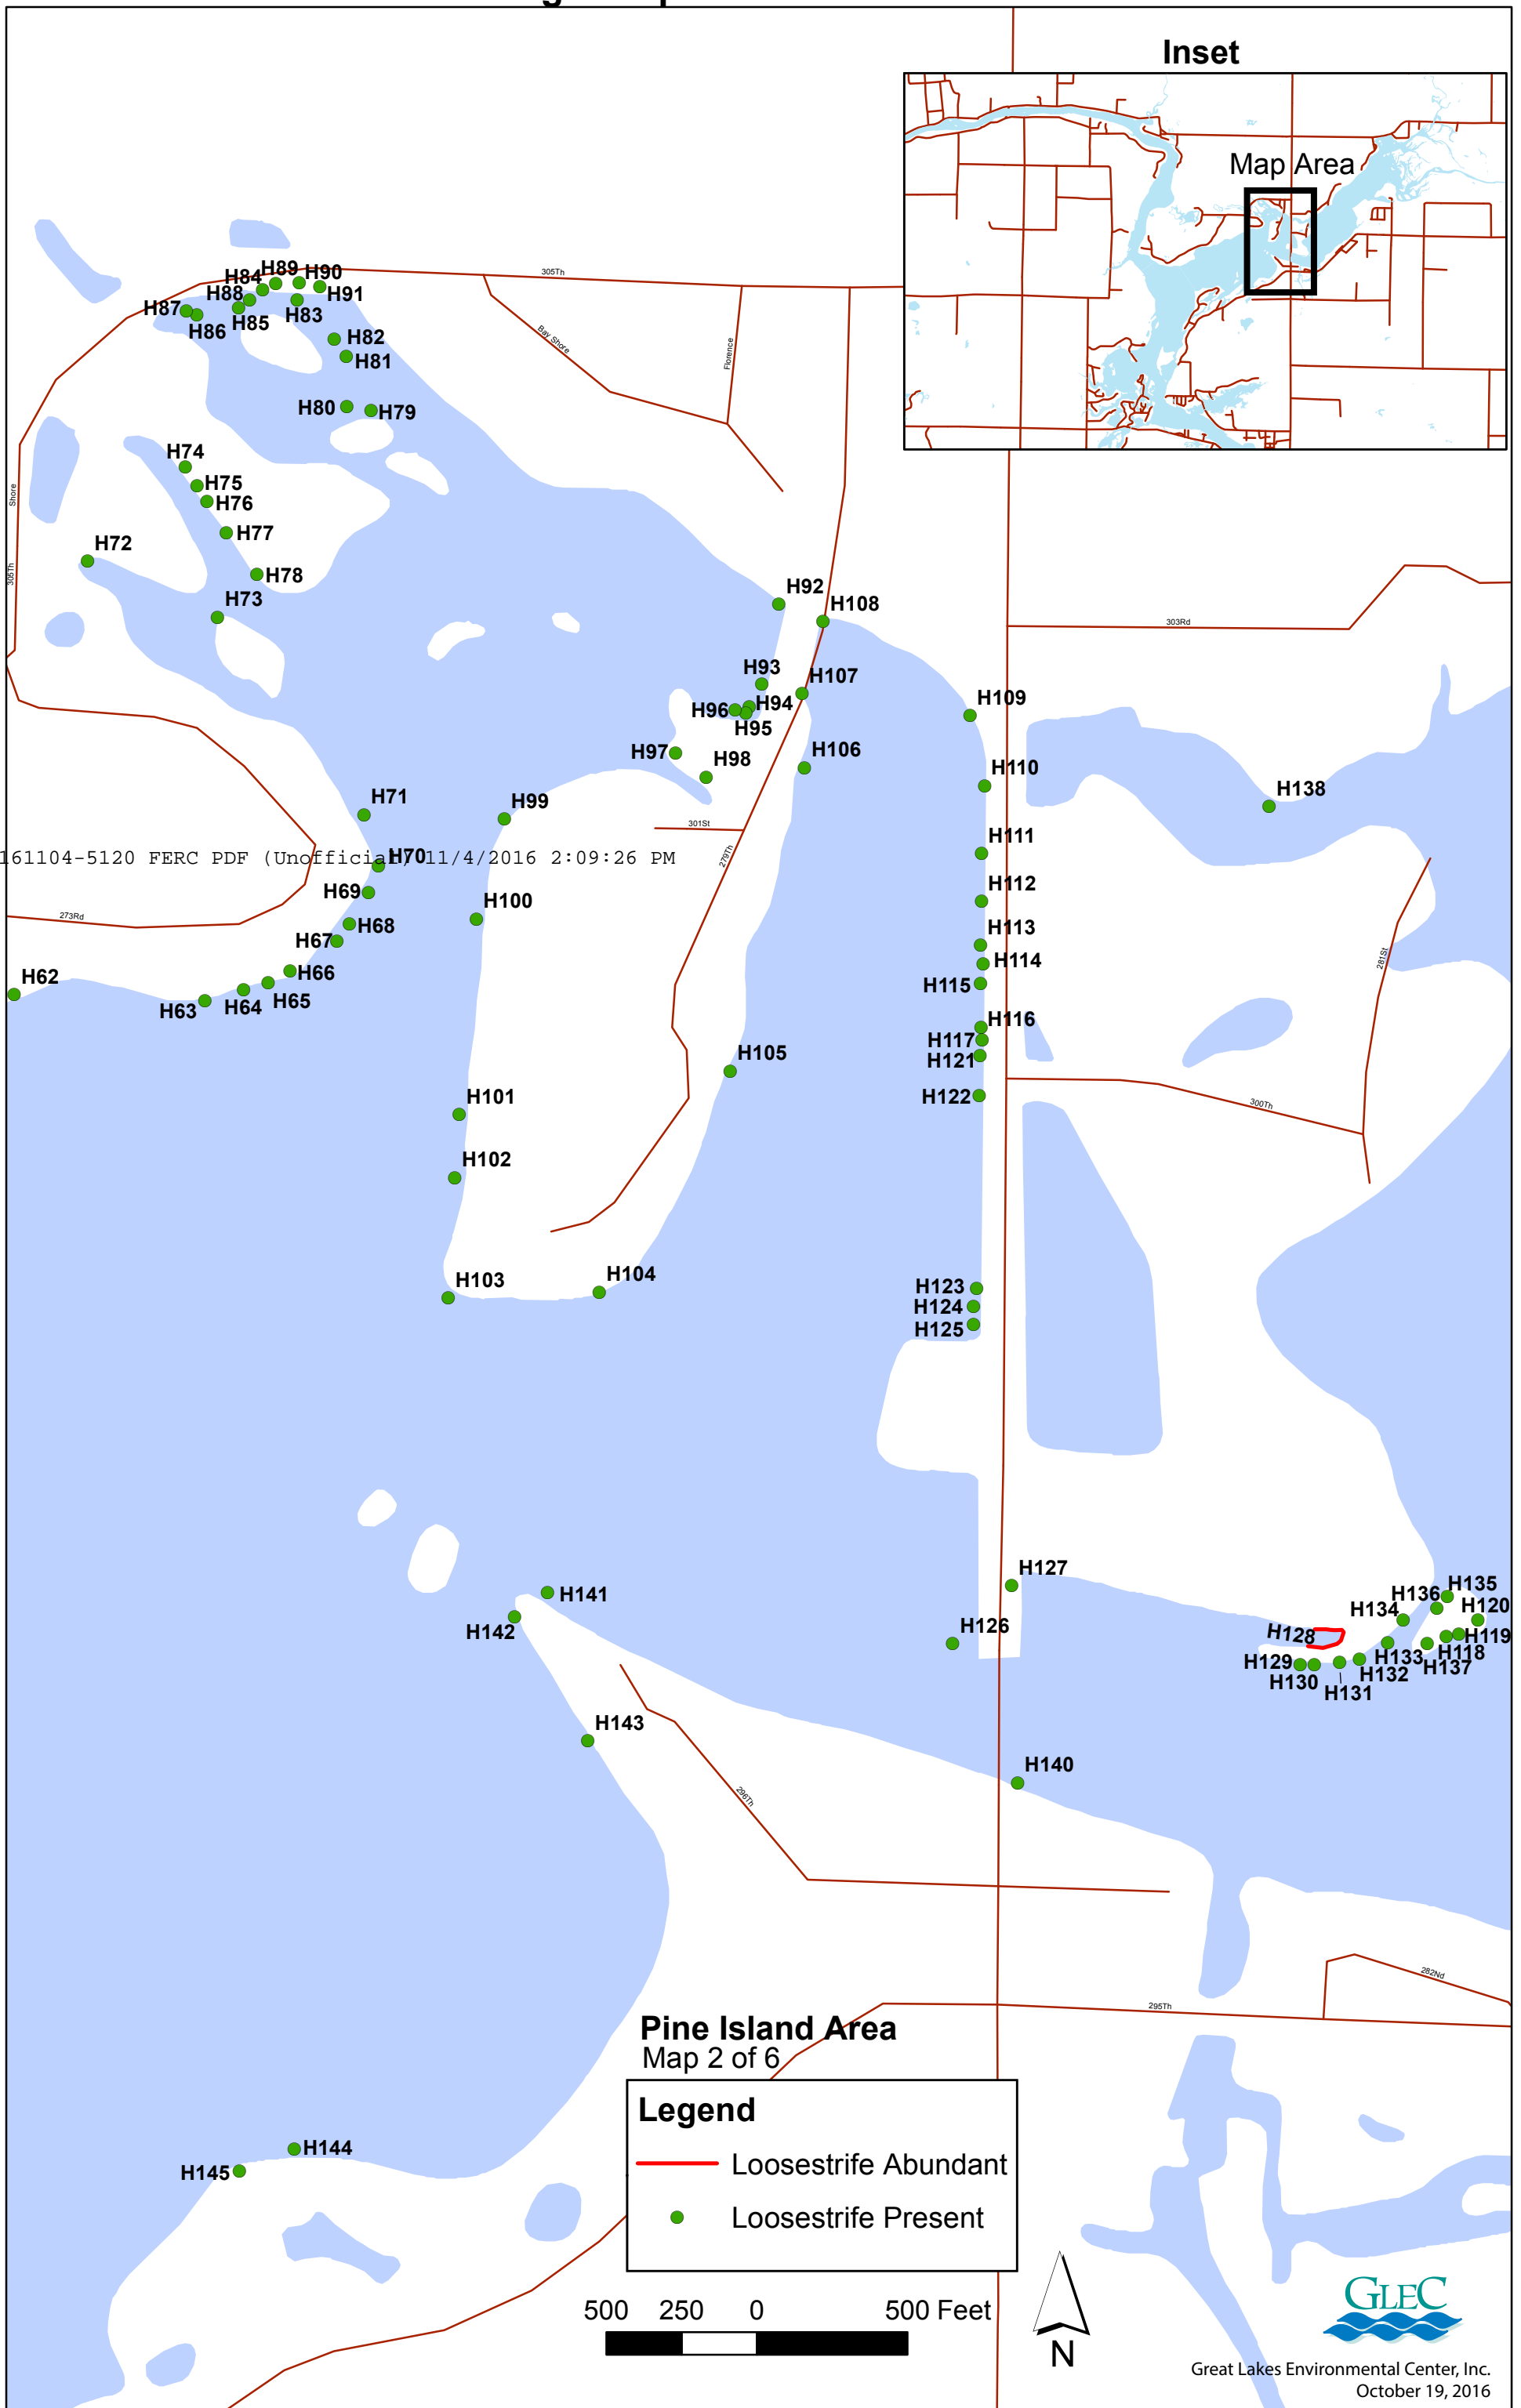
Holcombe Flowage Purple Loosestrife Assessment - 2016

The majority of plants on Holcombe Flowage were again found in the area on and near Pine Island and along Highway 27. A comparison to the 2014 and 2015 surveys show much similarity with the overall loosestrife populations in this area (see Holcombe Map 2). Several small infestations were again found just to the east of the Highway 27 Bridge. This area had a similar degree of infestation last year. The only area of abundant plant growth this year was also classified as abundant in 2015. No purple loosestrife was found on the Pine Lake or Cranberry Lake areas of Lake Holcombe.

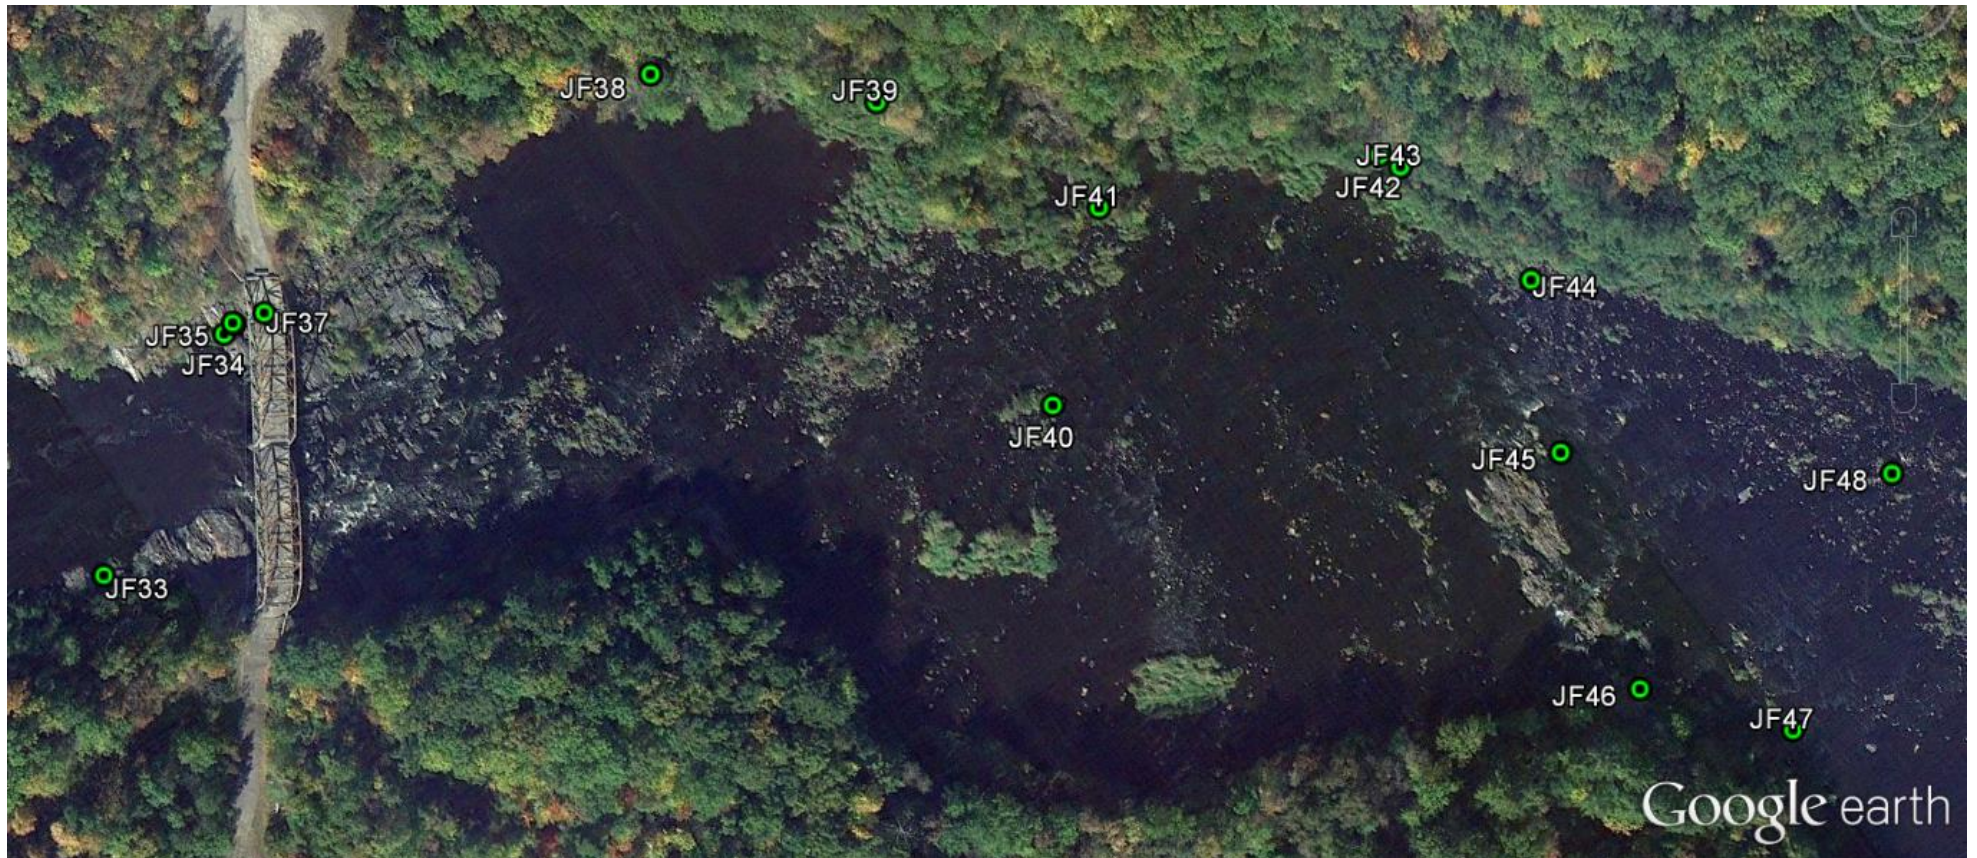
The minimum flow channel at Jim Falls Hydro remains infested with a relatively high concentration of purple loosestrife plants. A significant decrease in the number of plants was noted in 2012 followed by a rebound in 2013 and 2014. Over the past two years, the degree of infestation has decreased steadily (Table 3). Loosestrife was found scattered throughout the channel, with the lower third being moderately infested (see maps of Jim Falls Spillway Channel). The area of greatest concentration occurs just upstream from the County Highway Y Bridge (see Jim Falls Spillway map 2). The coverage of loosestrife in this area has decreased from approximately 9,461 square feet in 2015 to 6,695 square feet in 2016 (Table 4). The loosestrife is scattered throughout the area and therefore is not classified as abundant. It also appears to be less dense overall than in previous years. Small areas of loosestrife in both the upper and lower portions of the spillway channel increased in both number and amount of shoreline affected. Collectively, these locations accounted for 313 feet of infested shoreline versus 217 feet in 2015. Most of these locations were comprised of small plant clumps infesting between one and ten feet of shoreline, with a few more significant areas of infestation.

Six years have passed since the introduction of the bio-control beetles into the minimum flow channel. While it is difficult to make a determination as to their success, the fact that the density of loosestrife in the lower area of the spillway channel is continuing to decrease, and the fact that loosestrife infestation in the remaining portion of the channel appears to be stabilizing are encouraging.
