**INVASIVE SPECIES 5-YEAR COMPREHENSIVE REPORT
(2006 – 2010)
FOR THE
RHINELANDER HYDROELECTRIC PROJECT
ONEIDA COUNTY, WISCONSIN
FERC Project No. 2161**

**Submitted By
Wausau Paper Corporation**

**Prepared By
North American Hydro, Inc.
P.O. Box 167
116 State Street
Neshkoro, Wisconsin 54960
(920) 293-4628**

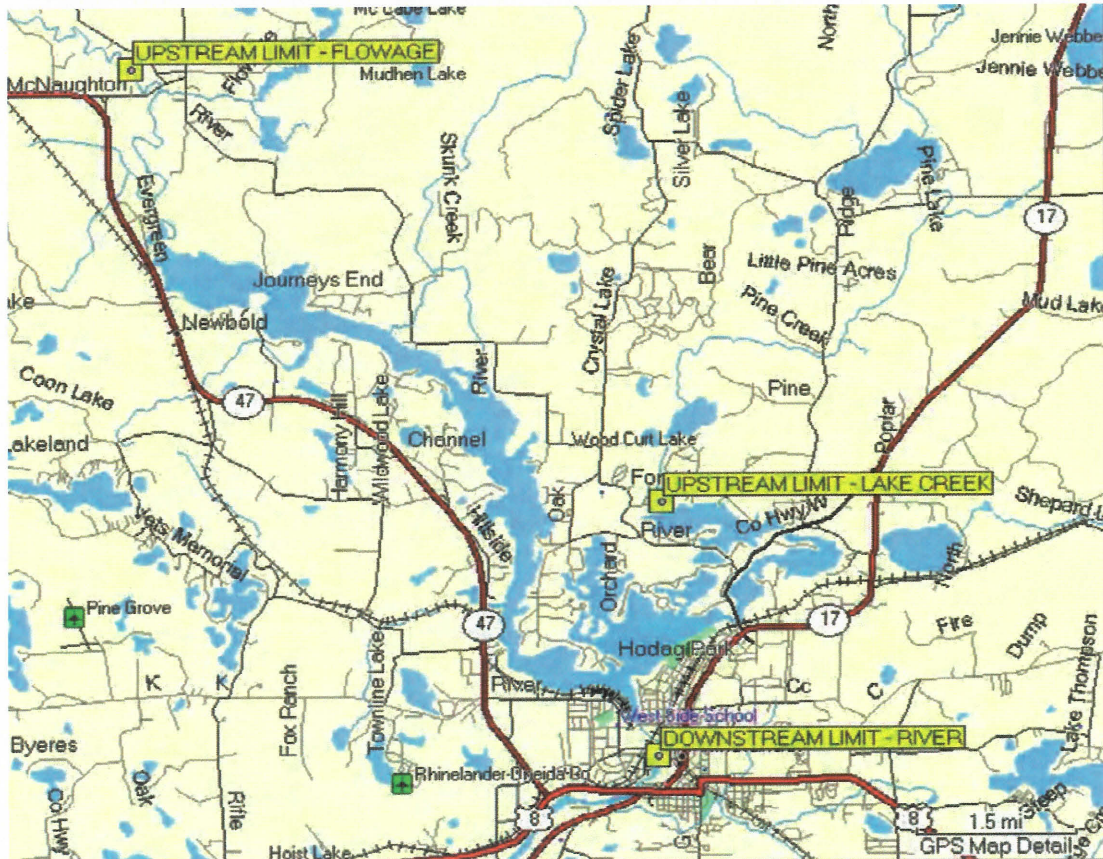
SURVEY LIMITS

The upstream and downstream survey limits for both PL and EWM are shown on the following map labeled Survey Limits and were defined as follows. The waters and shoreline of the Rhineland Flowage from N45° 44' 10.1" W89° 31' 08.4"

WGS84 approximately 0.5 miles upstream of the McNaughton Road Bridge to the dam at the Rhinelander Hydroelectric Project; the waters and shoreline of the power canal, bypass reach, and tailrace from the dam at the Rhinelander Hydroelectric Project downstream to N45° 38' 12.4" W89° 25' 00.0" WGS84 approximately 400' downstream of the Davenport Street Bridge; the waters and shoreline of Boom Lake, Bass Lake, and Thunder Lake; the waters and shoreline of Lake Creek up to the confluence with the stream from South Pine Lake at N45° 40' 24.5" W89° 24' 57.5" WGS84.
