Reference: Wetland Delineation for Terravessa Project; City of Fitchburg, Dane County, Wisconsin

Stantec Consulting Services Inc. (Stantec) performed a wetland determination and delineation of the Fitchburg Lands portion of the NE Neighborhood, now called Terravessa ("Terravessa" or "the Property"), which is approximately 250 acres and is located northwest of the intersection of CTH MM and Goodland Park Road, in Sections 1 and 12 of Township 6 North, Range 9 East, City of Fitchburg, Dane County, Wisconsin (Figure 1). The determination and delineation was completed by Jeff Kraemer of Stantec on September 15, 2016. The work was done to verify or update previously delineated wetland boundaries delineated by Jeff Kraemer of Stantec on October 29, 2007 (see attached 2007 report) because of a regulatory agency policy that a wetland delineation may only be relied upon for up to five years. Mr. Kraemer is an assured delineator qualified via the Wisconsin Department of Natural Resources (WDNR) Wetland Delineation Assurance Program. Three wetland areas were identified within the Property in 2016, corresponding to the delineated wetland boundaries located by Mr. Kraemer in 2007.

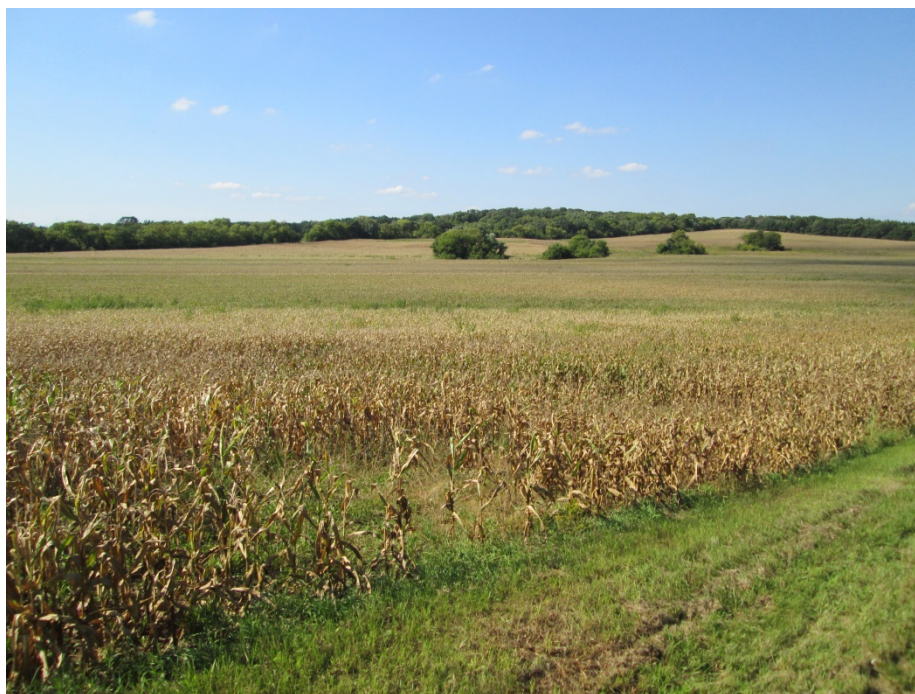
Photo 1. Wetland W-3, looking west-northwest from Larson Road.

Wetland 3 (W-3) is a 7.49 acre farmed wetland located in the east-central portion of the Property. The wetland lies within an active agricultural field most recently planted with a corn crop. Minor crop stress (stunting) was observed. A Review of Farm Service Agency (FSA) crop history slides confirm the presence of consistent and distinct wetland signatures within this area (Appendix B). W-3 generally contains a seasonally saturated and inundated hydroperiod that is influenced primarily by surface water runoff from the adjacent upland areas which becomes perched within the less permeable soils of the wetland. This wetland is in a depression and displays three secondary wetland hydrology indicators: C9-Saturation Visible on Aerial Imagery, D1-Stunted or Stressed Plants, and D2-Geomorphic position. Therefore, the wetland hydrology criterion was met.

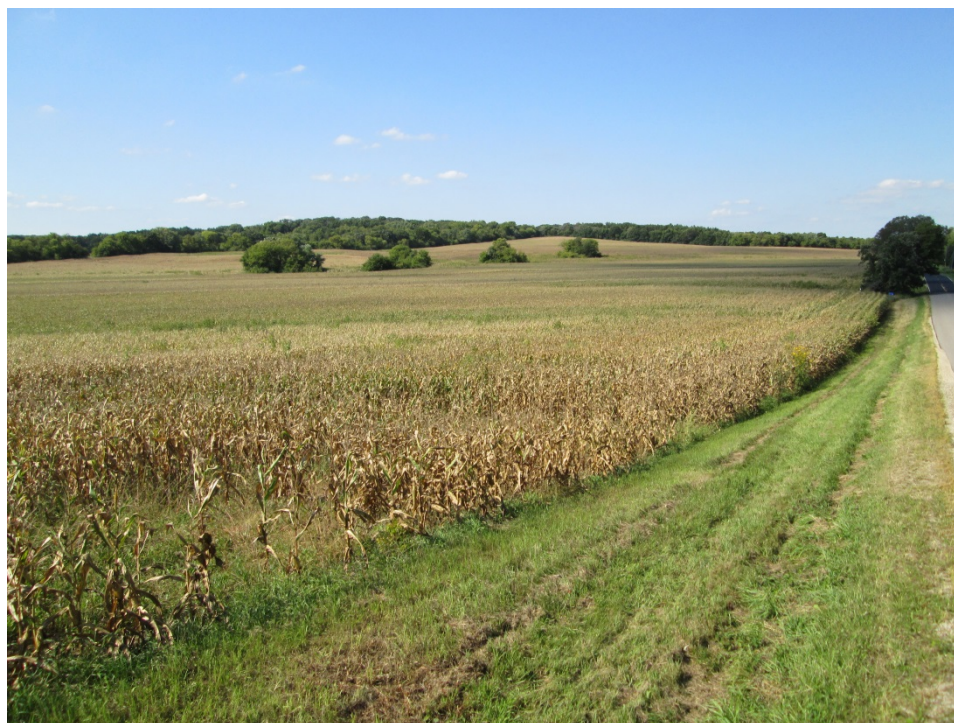
Photo 2. Wetland W-3, looking northwest from Larson Road.

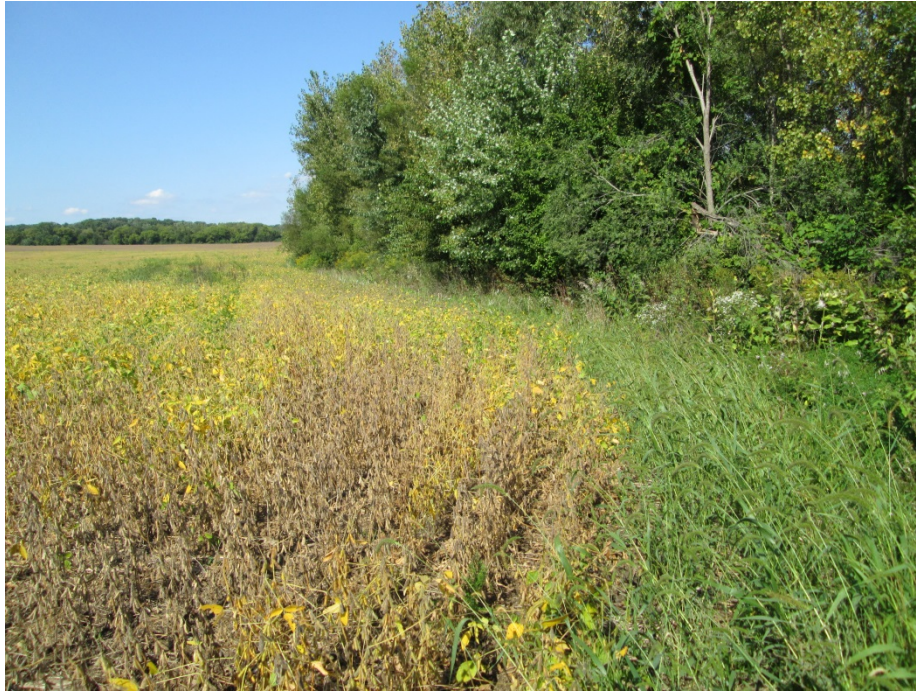
Photo 3. Wetland W-1, looking northeast from the west side of W-1.

W-1 contains occasionally to permanently saturated to inundated soils and is influenced primarily by surface water runoff from the adjacent upland areas which is perched above fine textured, low permeability soils. The OHWM lies approximately 3 feet below the upper banks of the pond. Primary wetland hydrology indicators observed included saturation within the upper 12 inches of the ground surface. Secondary indicators included positive FAC-neutral tests. Therefore, the wetland hydrology criterion was met.

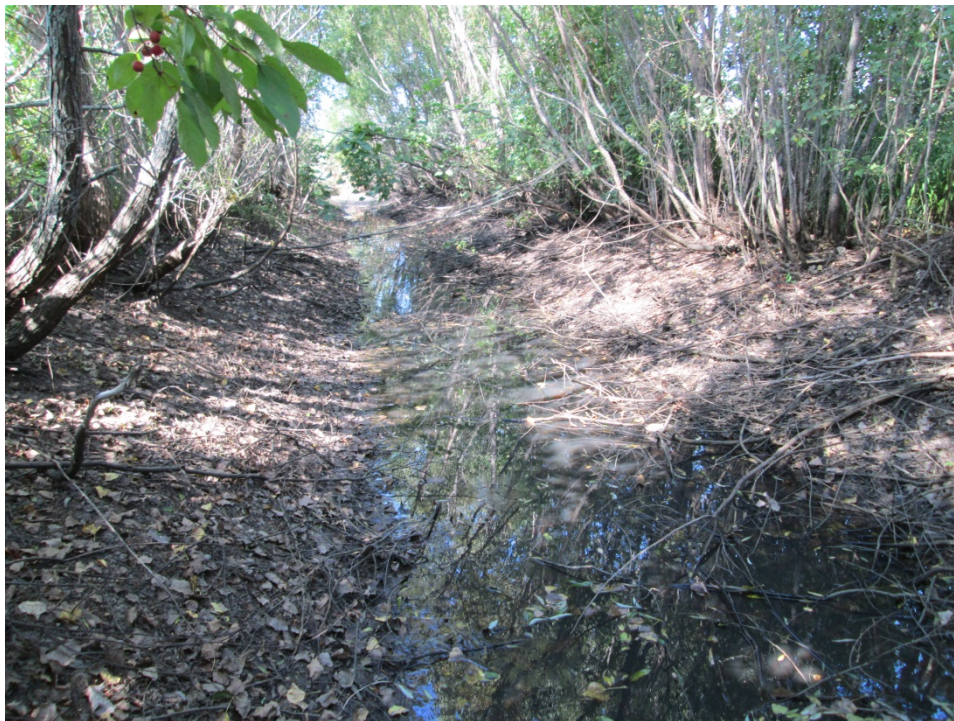
Photo 4. Wetland W-1, view north from the central portion of the wetland.

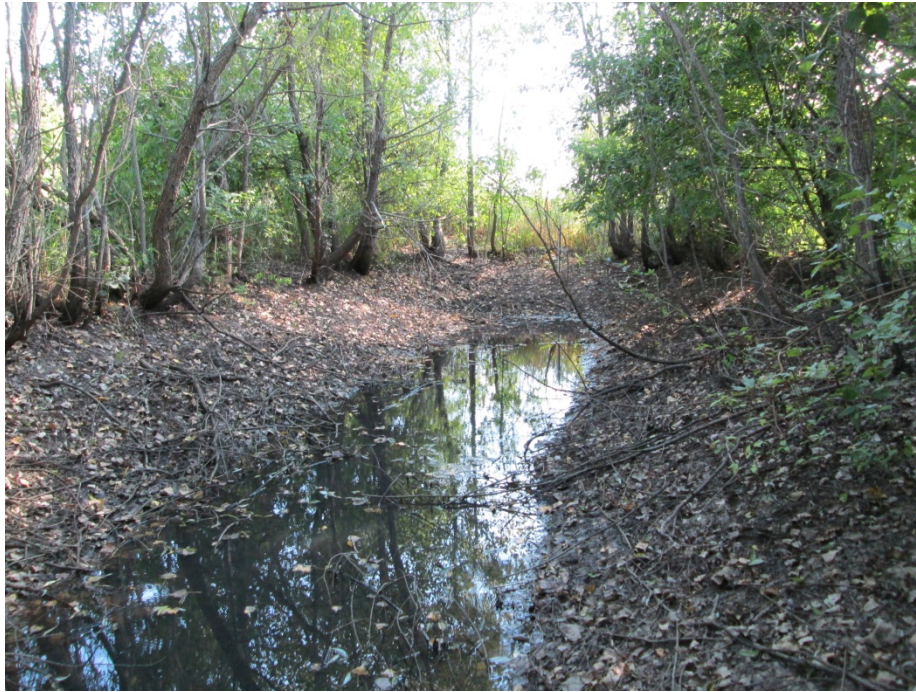
Photo 5. Wetland W-1, view south from the central portion of the wetland.

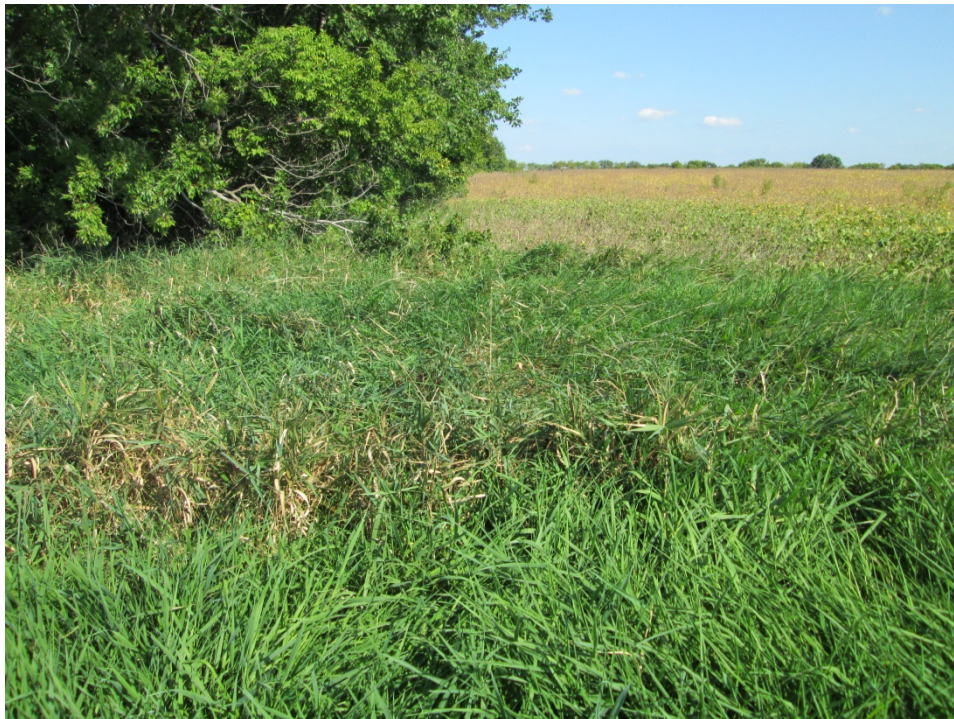
Photo 6. Wetland W-2, view east from the west edge of W-2.

The soils within W-2 are mapped as Troxel and Plano silt loam (Figure 2). The Troxel series is listed on the NRCS Hydric Soil List to contain wet hydric inclusions and the Plano series is not listed as hydric. The field evaluated soils within W-2 confirmed the presence of a hydric inclusion and did not match the typical profile of the Plano series. The hydric soil indicator A12-Thick Dark Surface was observed, and therefore the hydric soil criterion was met.

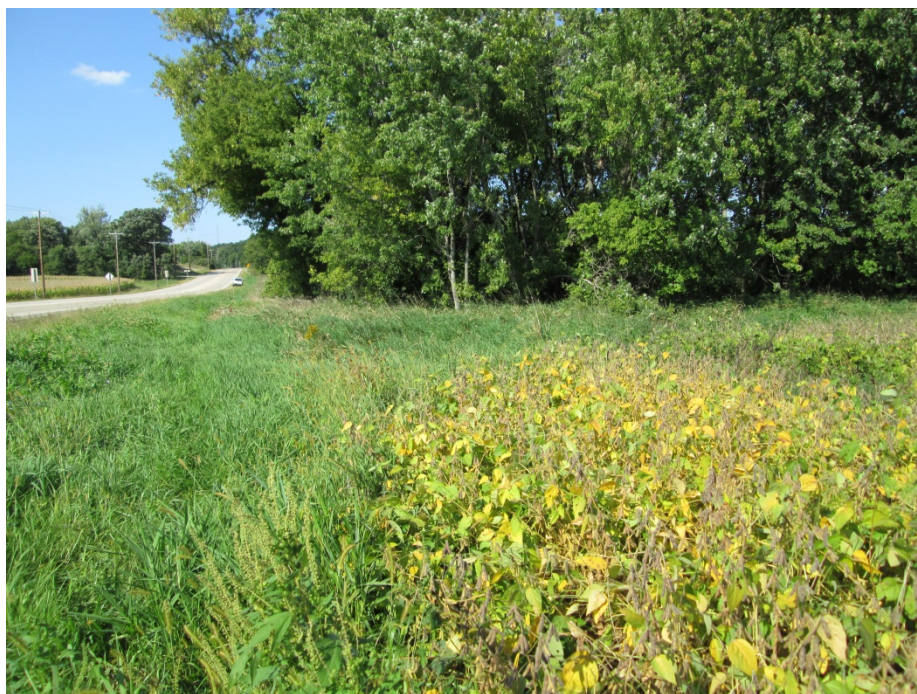
Photo 6. Wetland W-2, view north from the south edge of W-2.

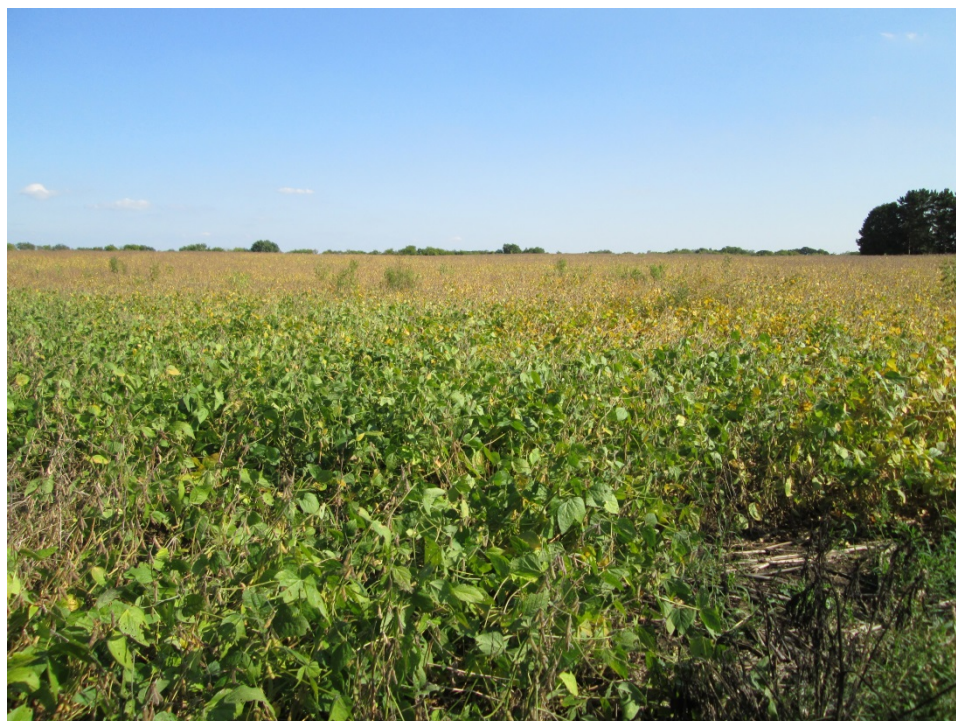
Photo 7. Wetland W-2, view southeast from W-2.
