**Curly-leaf pondweed (*Potamogeton crispus*)
Point-Intercept and Bed Mapping Surveys, and
Warm-water Macrophyte Point-intercept Survey
Long Lake - WBIC: 2478200
Polk County, Wisconsin**

Long Lake Protection and Rehabilitation District, Harmony Environmental,
and the Wisconsin Department of Natural Resources

Endangered Resource Services, LLC
Matthew S. Berg, Research Biologist
St. Croix Falls, Wisconsin
June 11 and July 23-24, 2016

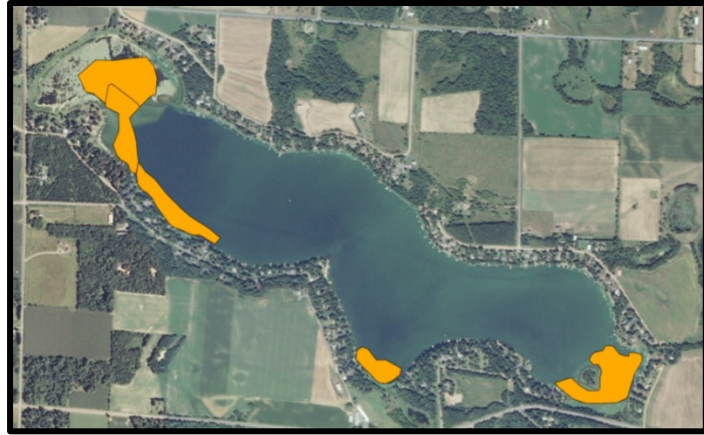
Figure 2: Long Lake with 2016 CLP Treatment Areas

Long Lake and the Long Lake Protection and Rehabilitation District (LLPRD) have an extended history of battling Curly-leaf pondweed (*Potamogeton crispus*) (CLP) - an exotic invasive species that thrives in the nutrient rich sediments found in many parts of the lake. In the past, CLP often grew so densely in the spring and early summer that it made lake access and boating difficult for Long Lake residents. CLP's late June-early July senescence was also cited in past studies by Barr Engineering and the Polk County Land and Water Conservation Department (PCLWCD) as a significant contributor to the lake's overall phosphorus load and was at least partially responsible for the lake's frequent late summer toxic blue-green algae blooms. In 2010, after years of study, the LLPRD, the PCLWCD, and the Wisconsin Department of Natural Resources (WDNR) authorized lakewide herbicide treatments in accordance with the District's WDNR approved Aquatic Plant Management Plan (APMP). Following an initial treatment of over 65 acres of CLP in 2010, the lake treated nearly 57 acres in 2011, 58 acres in 2012, 27 acres in 2013, and 20 acres in 2014. Although **the 2010-2013 treatments resulted in highly significant reductions** in both CLP coverage and density on the lake, **the 2014 treatment showed no significant change from pretreatment levels**. A follow-up survey of CLP turions in the lake's sediment suggested 2015 CLP levels would likely be very low in most parts of the lake. Based on these data and following a discussion with the lake's executive board and APMP director Cheryl Clemens (Harmony Environmental) in the fall of 2014, it was decided **not to treat CLP in 2015**. However, because point-intercept and turion surveys suggested CLP had made a significant rebound throughout much of the lake in 2015, **it was decided that herbicide treatments would resume in 2016**, and, on May 5th, Aquathol K[®] was applied to 34.97 acres of CLP (12.9% of the lake's surface area) (Figure 2).

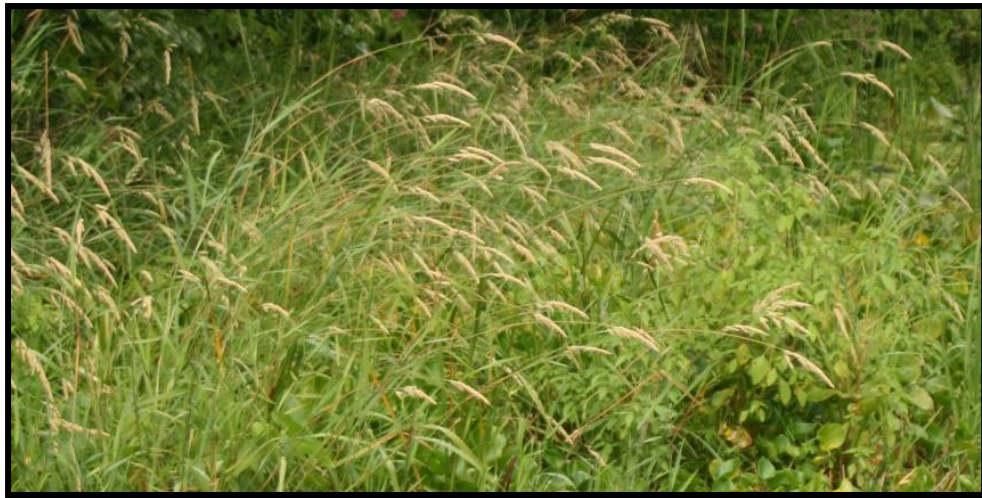
Figure 15: Reed Canary Grass

Despite only being reported from the boat survey, Reed canary grass was often a dominant plant just beyond the lakeshore (Figure 15). We noticed patches in wetlands adjacent to the lake and next to mowed and otherwise disturbed shorelines. A ubiquitous plant in the state, there's likely little that can be done about it.
